# HISTORIC LANDMARK COMISSION

## DUE DILLIGENCE REPORT

Property Name: **Charles E. Barnhardt House**- 2733 Country Club Lane, Charlotte, NC.

**Project:** 2733 Country Club Lane  
Barnhardt -Cramer House  
Charlotte, NC

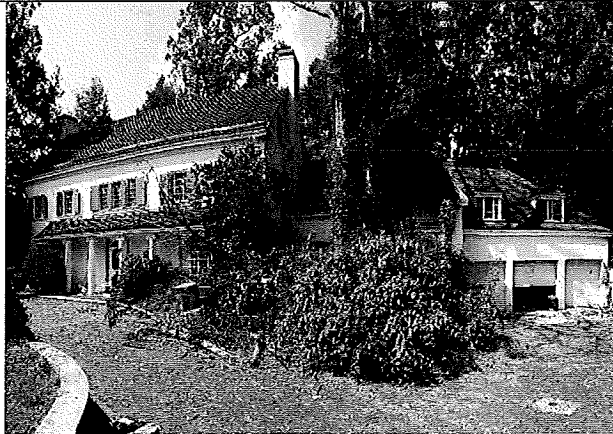
**Photo #1:**

This is the front of the home facing east at 2733 Country Club Lane, Charlotte, NC. Vegetation obscures much of the exterior. A three-bay garage on the right front of the home has more recently served as an entry point for unauthorized persons. The middle garage door did not close completely at the time of my observations. A large hickory tree in front of the home near the center of this photo is dead and should be removed. A large uprooted-tree stump on the left side of the home should also be removed.

- Remove the large oak tree to the right of the front door.
- Remove or prune all remaining foundation plants around the house within a 20' radius of the structure.

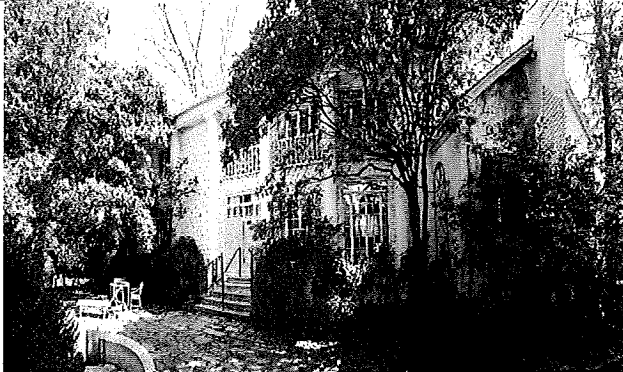
**Photo #2:**

This photo is taken from the left rear corner of the home. A terrace at the rear contains a small fountain. Vandals have damaged concrete railings surrounding the terrace at the right rear of the home. Doors leading to the solarium from the rear terrace have been boarded to prevent unauthorized entry.

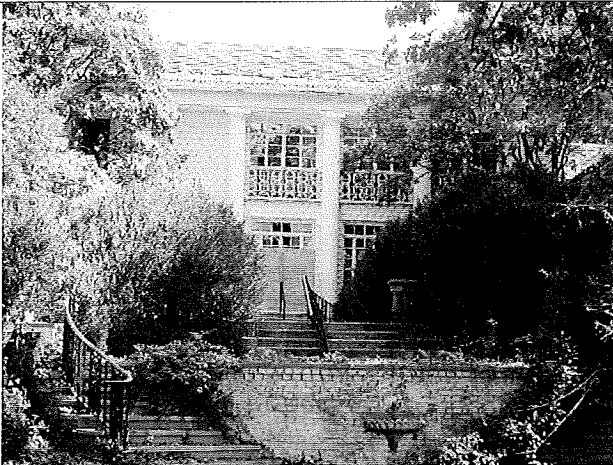
**Photo #3:**

Taken from the back yard, this photo shows concrete steps leading from the terrace, descending to the rear of the property. Heavy cast-iron railings are present. The railing within the upper stairs has been partially dislodged from its anchorage within the stair treads. Ornamental concrete railings surrounding the terrace are damaged on the left-side of the photo. Railings on the right side of the terrace are in good condition. A low-slope portion of the roof near the rear edge is not visible but appears to be covered with metal roofing from aerial imagery – see photo #32.

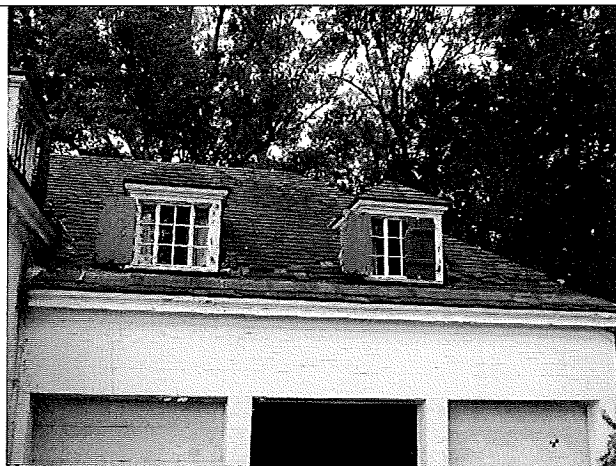
**Photo #4:**

Copper gutters have been stolen from the roof on the front, right-side and rear of the garage. In the process of removing the gutters, damage to the clay-tile roofing was sustained. No leaks have become apparent due to the roof damage. What appears to be asphalt-impregnated felt underlayment is now exposed and will potentially offer only temporary protection from weather. One operable window shutter on the left dormer in this photo and another on the rear of the garage are missing.

- Demo the existing carport.
- Repair the roof as needed. The existing roof is in need of repair. We will repair/replace the tiles that are missing or loose. Our warranty only covers the areas of the roof where repairs are completed. Not the entire roof where repairs were not completed. If additional sub roof structure damage is found during the repair, we will notify Peter Wasmer immediately to establish a plan to correct.

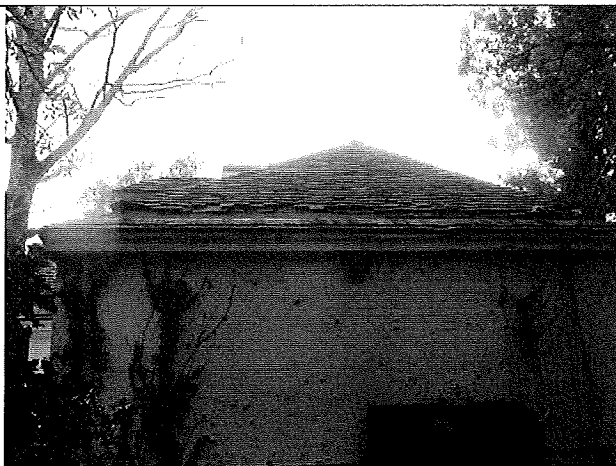
**Photo #5:**

Damage to the hip roof end over the right-side of the garage is visible in this photo, along the bottom of the roof slope where gutters have been stolen. The aforementioned dead hickory tree is visible within the left-side of this photo.

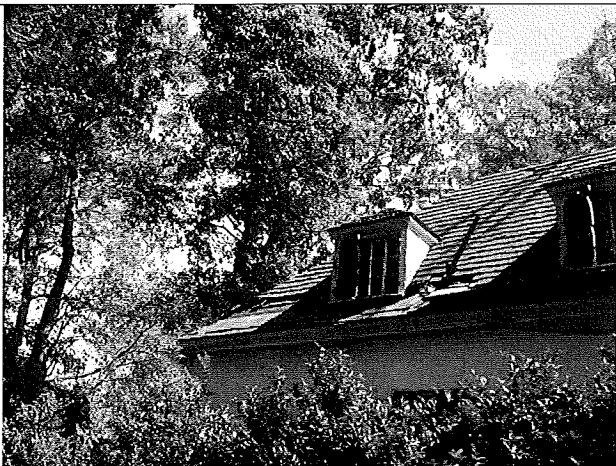
**Photo #6:**

Missing copper gutters and damage to the roofing extends to this point on the rear of the garage roof. One shutter is missing from the left dormer in this photo.

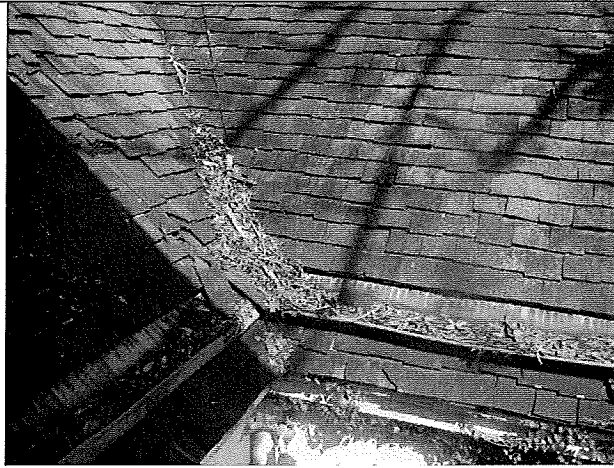
**Photo #7:**

This photo shows the unconventional copper gutters that are located along the bottom of the roof slope around the perimeter of the home. Damage was observed to the clay-tile shingles in this location above the first-floor laundry room. This photo was taken from the second-floor window in bedroom #3.

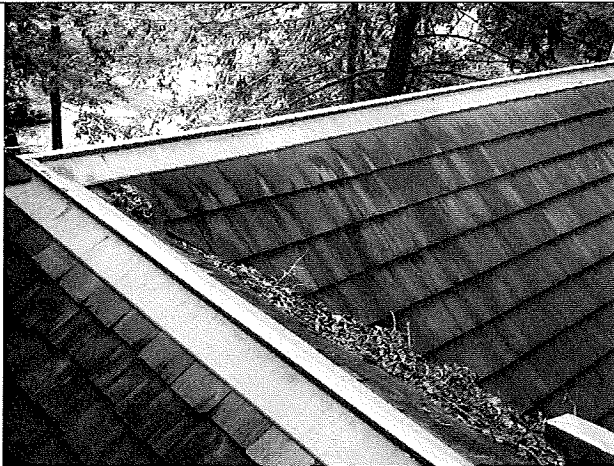
**Photo #8:**

Copper ridge caps are in-place and in good condition. Shingles in most locations on the roof are in good condition. There are no signs of roof leaks, past or present, within the home. This photo was taken from the upper attic window on the left-side gable-end of the home. A lower attic exists below the roof on this one-story portion of the home over bedroom #4.

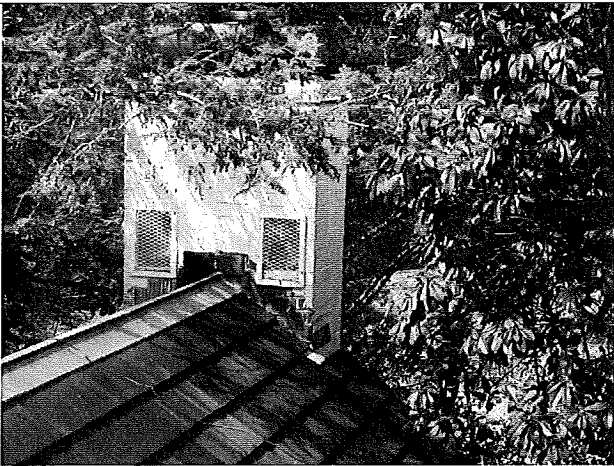
**Photo #9:**

This photo is taken from the upper attic and shows the roof covering over first-floor bedroom #4. A lower attic exists in the space below this roof that is accessible from the second-level living space. The chimney at the rear of bedroom #4 appears to be missing some copper counter-flashing just above the sloped roof surface. Two grates covering openings of unknown purpose are visible in this side of the chimney.

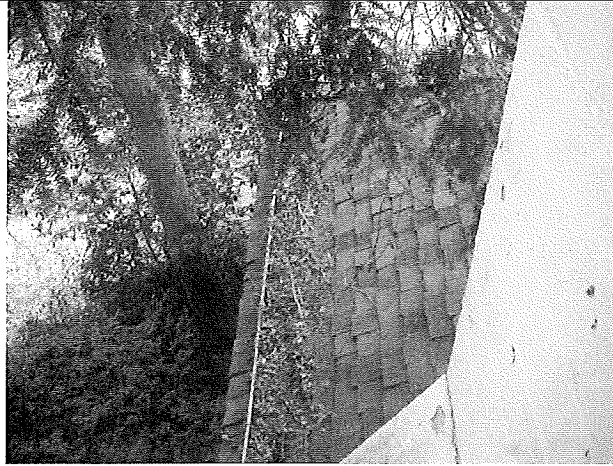
**Photo #10:**

Leaves and other debris fill the gutter on the front-slope of the roof over bedroom #4 on the left-side of the home. A hemlock tree grows a few feet from the home's foundation in this area.

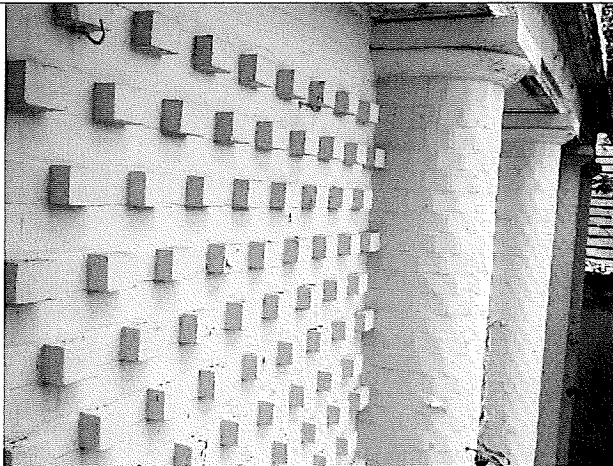
**Photo #11:**

Exterior walls of the home are constructed with multiple-wythe load-bearing brick that has been painted on the exterior. This photo is taken from the balcony located off the rear of upper-level bedroom #2. This balcony can be reached by climbing the nearby magnolia tree, and may have served as an entry for unauthorized persons in the past.

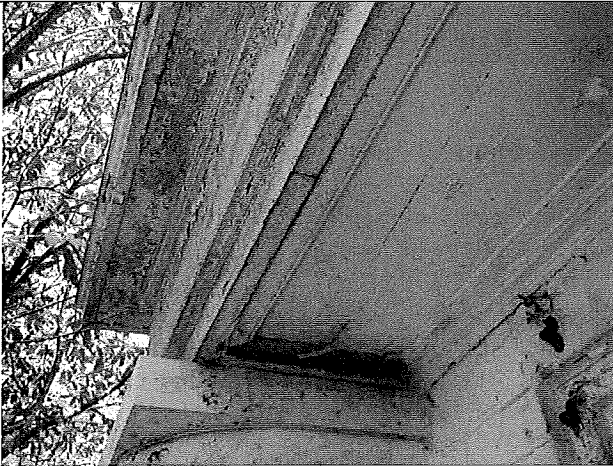
**Photo #12:**

Paint is peeling from exterior wood surfaces that are present primarily at window sills and roof overhangs. Despite lack of maintenance, exterior wood is in good condition with no visible rot. Much of the painted wood on the exterior of the home may be decay-resistant "heart" cypress as specified on the original construction documents.

- Pressure wash the home.
- Scrape all loose paint. All of the windows need to be re-glazed or the windows will not be paintable some are almost falling out now. Since the house has lead based paint the painters will need to wear white protective suits and respirators during the prep work of the home. Prime all areas of the home as needed. Paint the entire exterior with a high quality Sherwin Williams Super paint. The color is quoted a white.

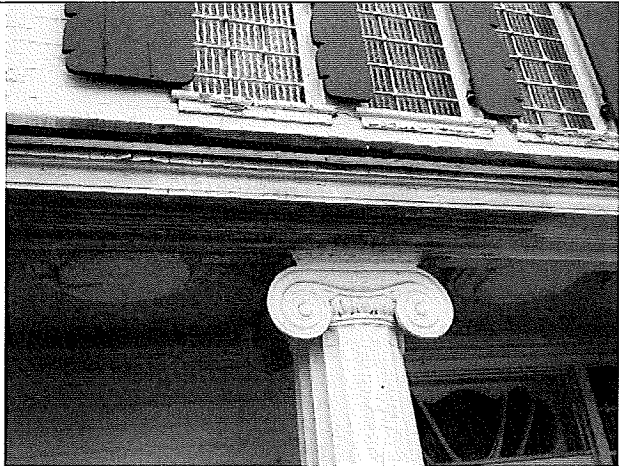
<p><b><u>Photo description:</u></b></p> <p>This photo was taken of the front-porch ceiling and second-story windows above. Wooden window sills and columns are in excellent condition with no visible rot.</p>
<p><b><u>Photo #14:</u></b></p>

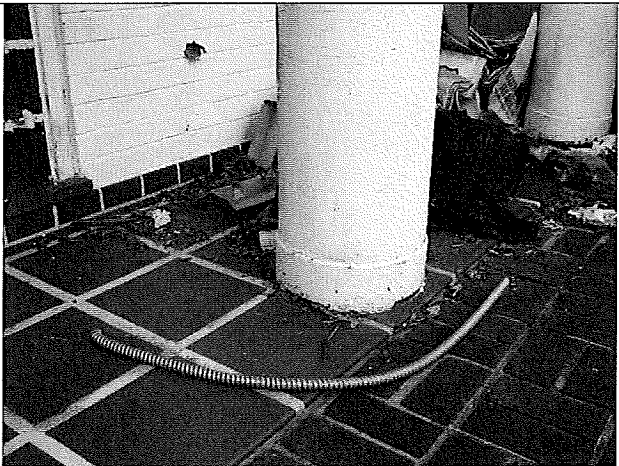
<p><b><u>Photo description:</u></b></p> <p>The bottom of wood columns on the front porch are raised above the clay-tile floor by metal bases that prevent water and debris from collecting below the columns. This detail prevents wood decay and premature failure of paint from moisture wicking into end-grain.</p>
<p><b><u>Photo #15:</u></b></p>

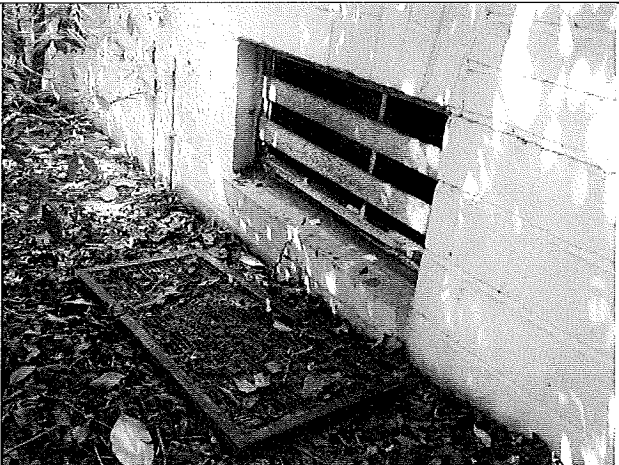
<p><b><u>Photo description:</u></b></p> <p>This vent on the left-side of the home leads into the space below the home where mechanical ductwork can be seen. I was unable to locate an entry point into this space. Areas between this vent, and the "conditioner room" on the other end of the home, are not included in these observations. I was unable to verify the condition of the home below the first-floor concrete slabs, including foundations contained within this area.</p>

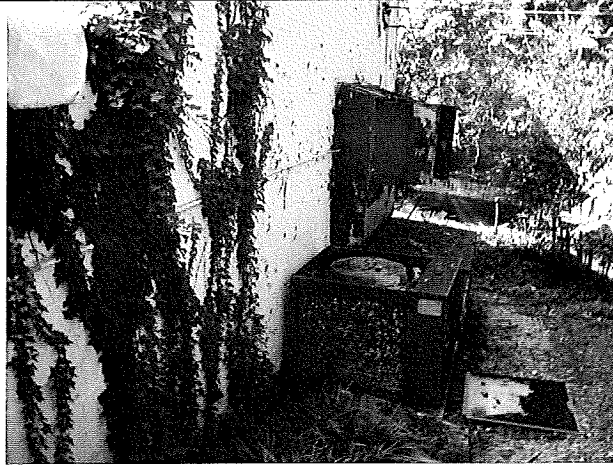
**Photo #16:**

Mechanical equipment is located on the right-side of the home's exterior adjacent to the attached garage. This equipment appears to be old and in poor condition.

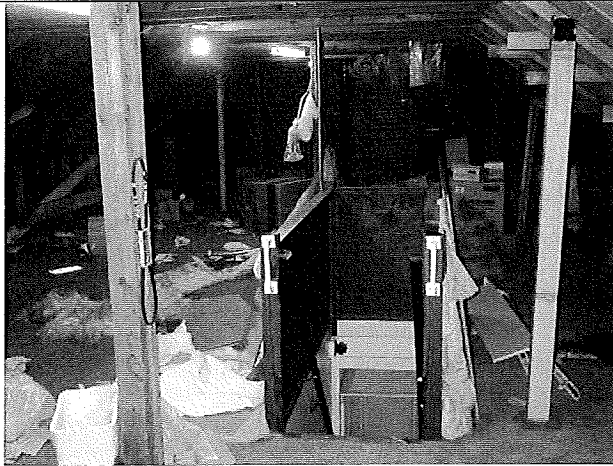
**Photo #17:**

This photo was taken from the attic space above the second story of the home. The floors in the home are poured-in-place concrete and in the attic these floors are exposed. Two large attic fans at the right-side gable end are visible in the background of this photo. Stairs visible in the foreground of this photo lead down to the second level of the home.

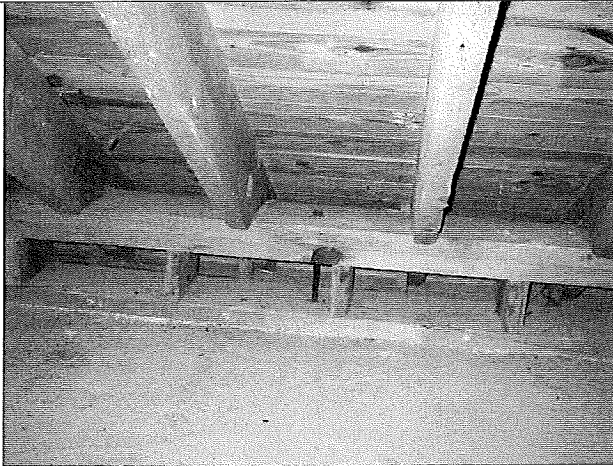
**Photo #18:**

The roof framing and sheathing are all made of pine and are in excellent condition. Sill plates supporting the bottom of rafters are connected to the concrete slab below with steel anchors space 32-inches on center. Fire resistance of this home is exceptional due to the robust concrete floor-slabs and masonry walls, and it would likely serve as an excellent storm shelter.

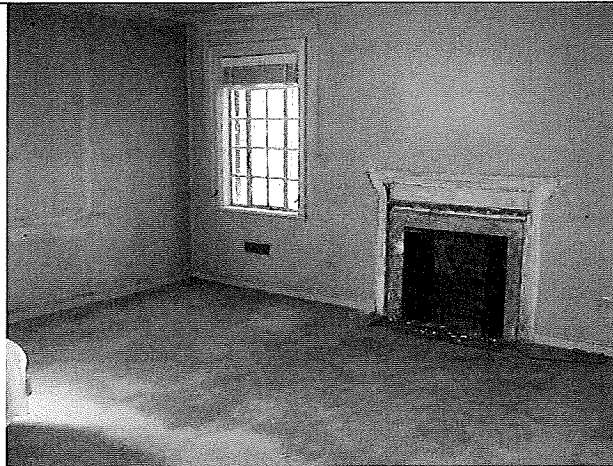
**Photo #23:**

This is the left-rear corner of the home within bedroom #4 on the main level. This fireplace has gas logs and is missing the original mantel. The floor in this room slopes toward the middle. I was unable to access the space below this floor to observe the condition of the slab and its supports.

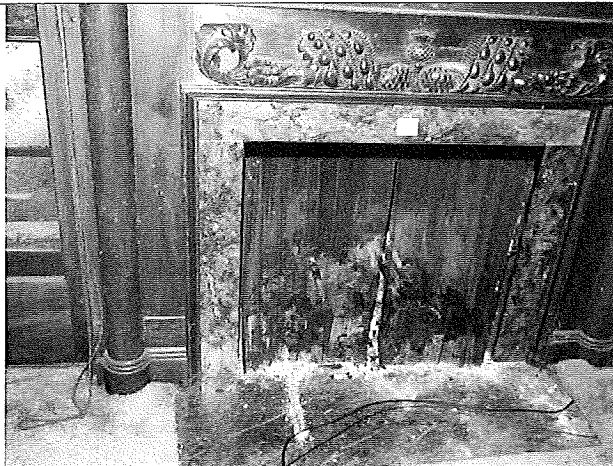
**Photo #24:**

This is the fireplace in the wood-paneled first-floor library located at the right-rear corner of the two-story central portion of the home. The fireplace contains partially burned wood within the firebox. A yellow sticky-note on the marble surround reads, "damper closed."

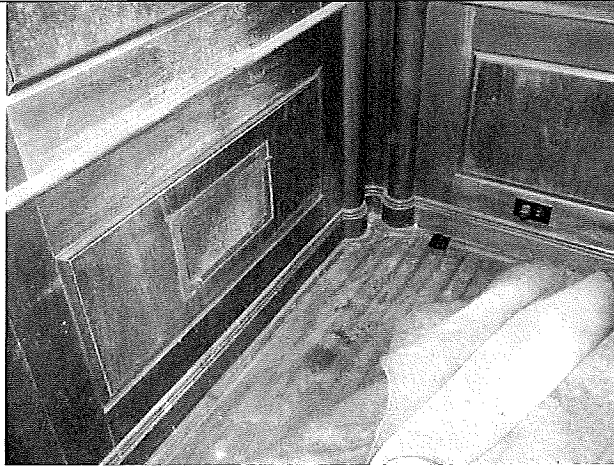
**PHOTO APPENDIX****Photo #25:**

Most of the hardwood floors within the home are covered by carpet and padding such as in this location within the library. The flooring is in good condition where I pulled back carpeting. Flooring is installed on wooden sleepers that are attached to the concrete floor-slabs. The wood floor-assemblies (sleepers and flooring) appear to be solid and performing well.

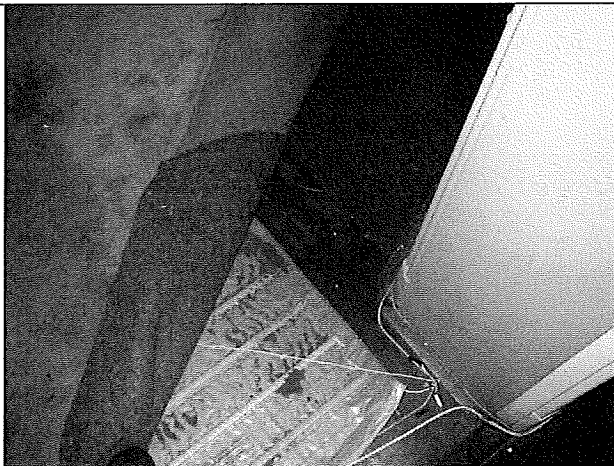
**Photo #26:**

Electric-resistance heating strips were observed below the carpet padding in some areas such as in this location at the rear of the entrance hall.

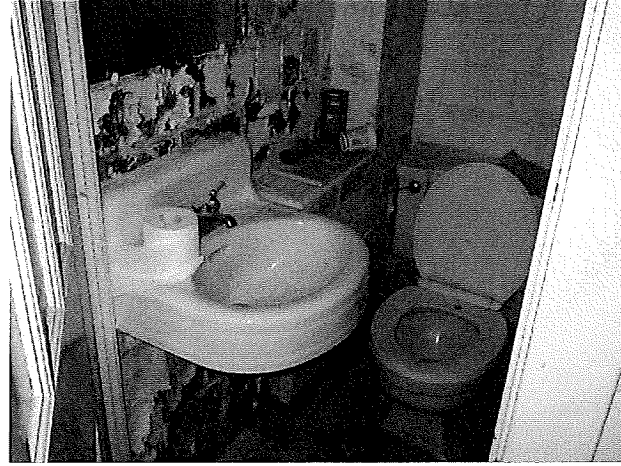
<p><b>Photo description:</b></p> <p>This bathroom at the bottom of the stairs to the basement, is located at the right-front corner of the full-height foundation walls. Peeling paint on these walls is an indication of moisture transmission, either from the soil outside, or due to condensation at the surface. No signs of liquid-water leaking into the basement through the foundation walls was visible.</p>
<b>Photo #29:</b>

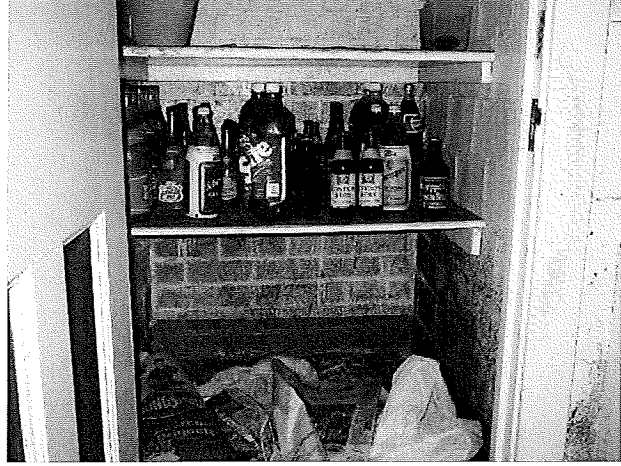
<p><b>Photo description:</b></p> <p>This pantry located adjacent to the bathroom in the photo above has signs of mildew on the surface of the walls indicating the possibility of elevated moisture levels at some time in the past. At the time of my observation the pantry was dry.</p>
<b>Photo #30:</b>

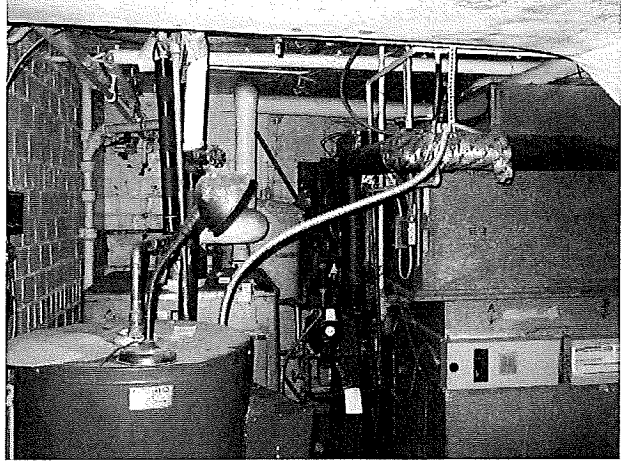
<p><b>Photo description:</b></p> <p>This photo was taken inside the basement level "conditioner room." Equipment located here includes a water heater, boiler-tank, air handler, heat exchanger, and plumbing. Ductwork passes from the air handler on the right, through the wall at the rear of the photo, and into the crawl-space/basement beyond (at arrow.) I was unable to access the space beyond to determine conditions there. Foundation walls within the basement are in good condition and appear to be functioning adequately to retain soil pressure.</p>

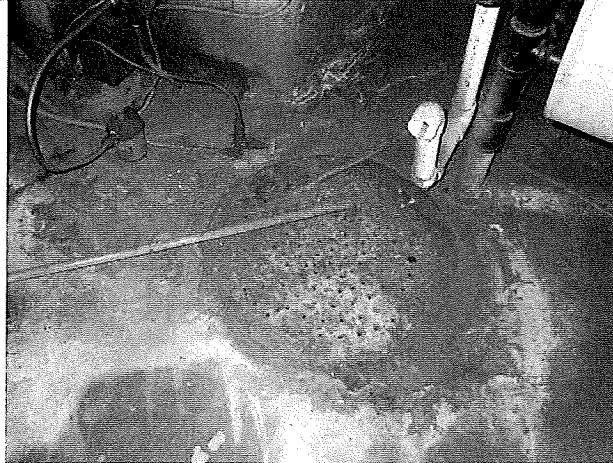
**Photo #31:**

A round steel plate covers a sump within the floor of the "conditioner room." It is likely that this sump drains to daylight toward the rear of the property.

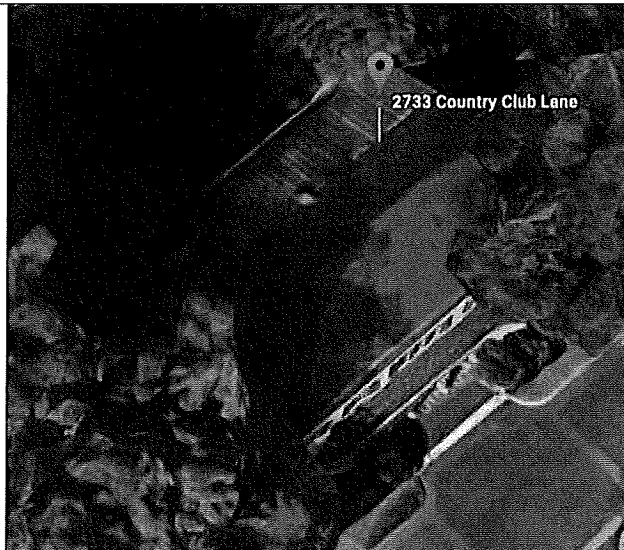
**Photo #32:**

This photo taken from Google Maps affords a look at the home from above. What appears to be ribbed metal-roofing covers the low-slope rear portion of the roof.
