## Roof – Scope of Work

#### Scope of Work

## Gutters – Scope of Work

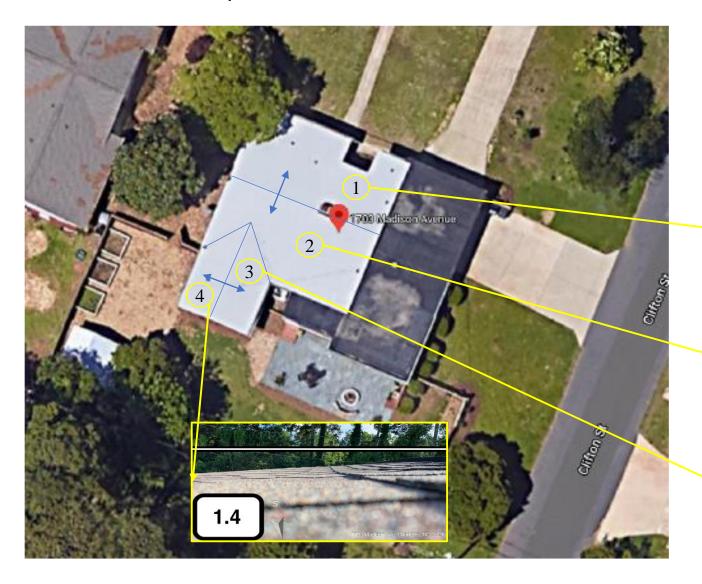
# Roof – Primary Concern

Various portions of the roof have a pitch of less than 2:12 rendering shingled roof unwarrantable by the manufacturer and out of NC Building Code

- Replace shingled roof portion of the home with standing seem metal roof that is black or charcoal in color
- Metal roof to be supplied from McElroy Metal (supplemental brochure with detailed specs attached)
  - 1500 Hamilton Road Bossier City, LA 71111

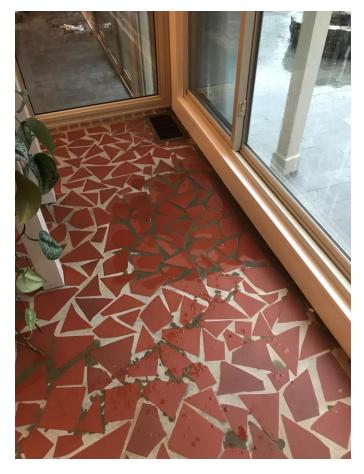
Water penetration through office windows in rear of home

- Existing gutters have been improperly maintained over the years
- Existing gutters are too shallow to accommodate for proper drainage during heavy rains
- These factors have led to drainage issues, wood rot and leaking in the house

- Terminate internal gutter system and replace with 6"-7" seamless box-style gutters
- New gutters to be either aluminum or copper
- If aluminum, color to match color of roof (black/ charcoal/ slate)
- Box style gutters are being chosen since they will most closely replicate the look of the existing internal gutters

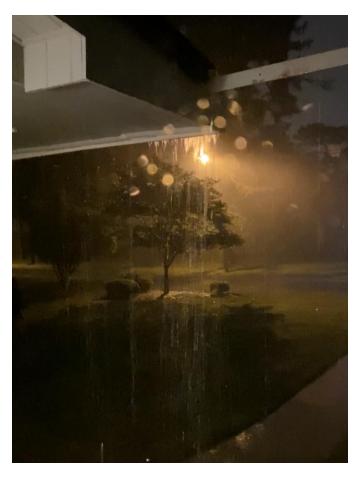
Improperly sloped gutters resulting in overflowing, erosion and wood rot

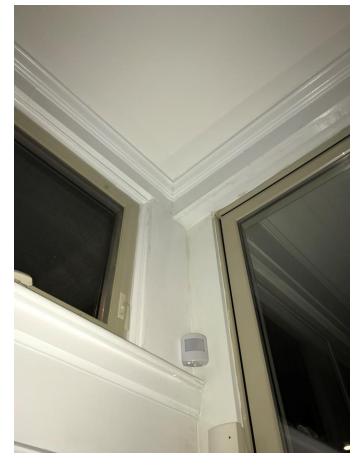
Water penetration through ceiling of lower level in rear of home

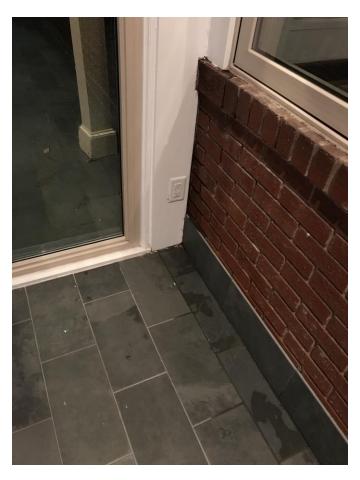
Water pooling in lower level by office

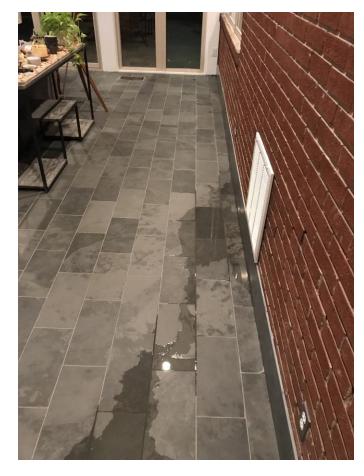
Water pooling in lower level
