AERIAL PHOTO of SITE

JOHNSTON MILL • NORTH WING • PRIOR TO RENOVATION.

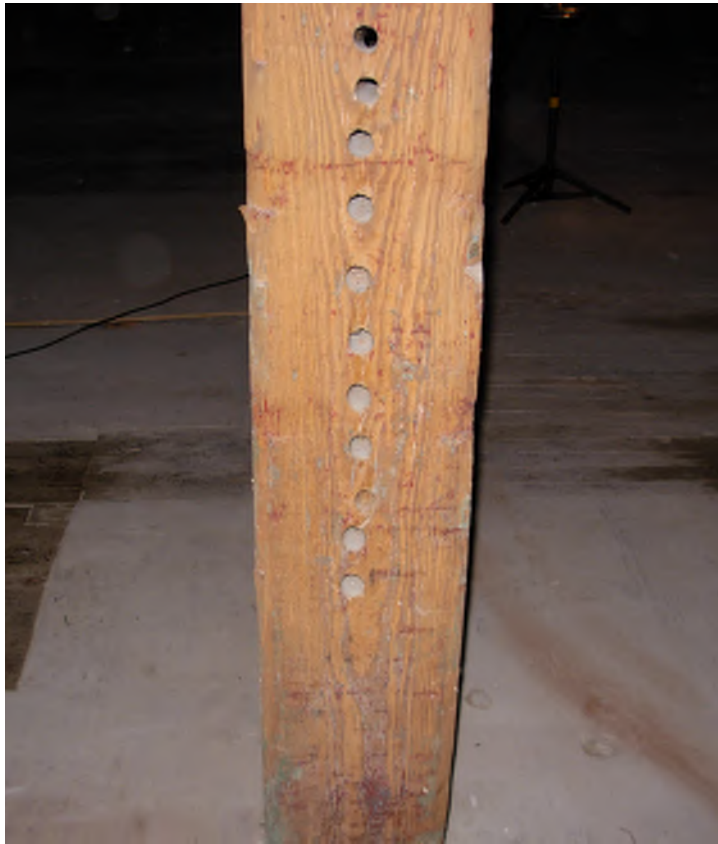
Photo #3: Excessive reduction in column cross section due to improper modification during utility routing.

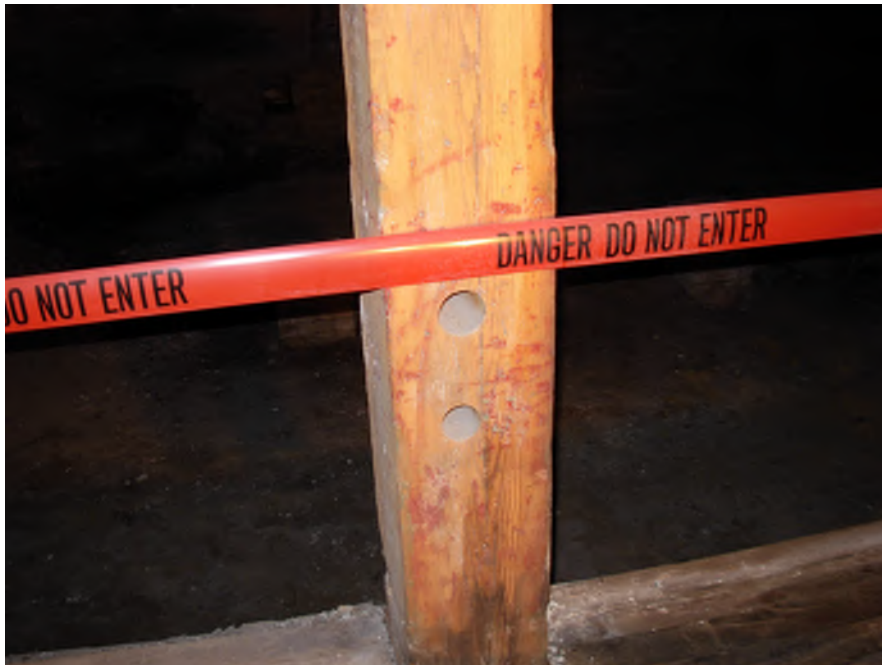
Photo #4: Multiple large 2" diameter holes in column for utility routing. Excessive reduction in member cross sectional area is unacceptable.

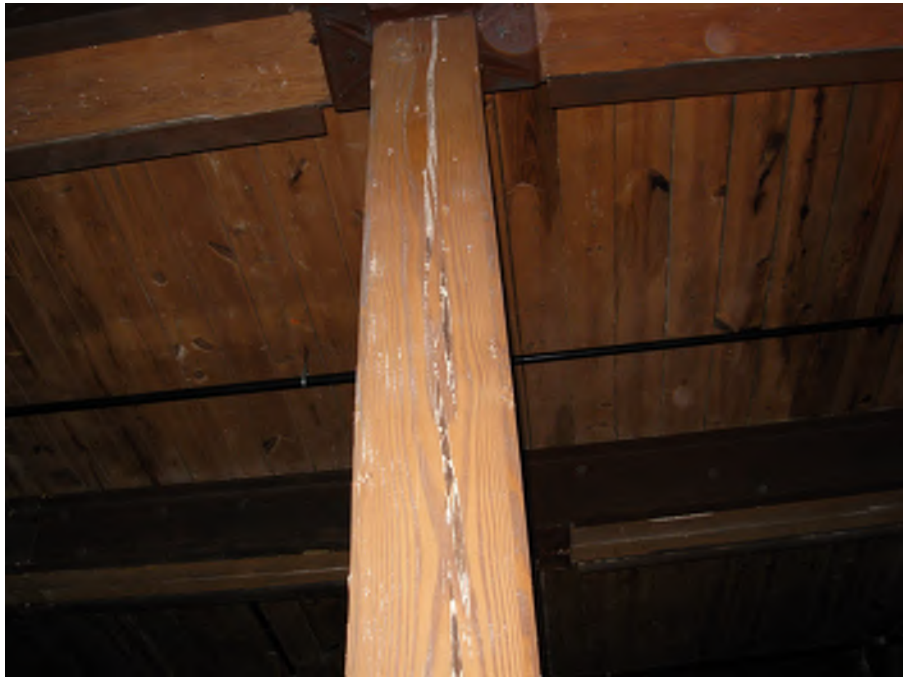
Photo #5: Large checks in wooden column. White filler material assumed to be drywall joint compound and not an attempt to epoxy the cracks.

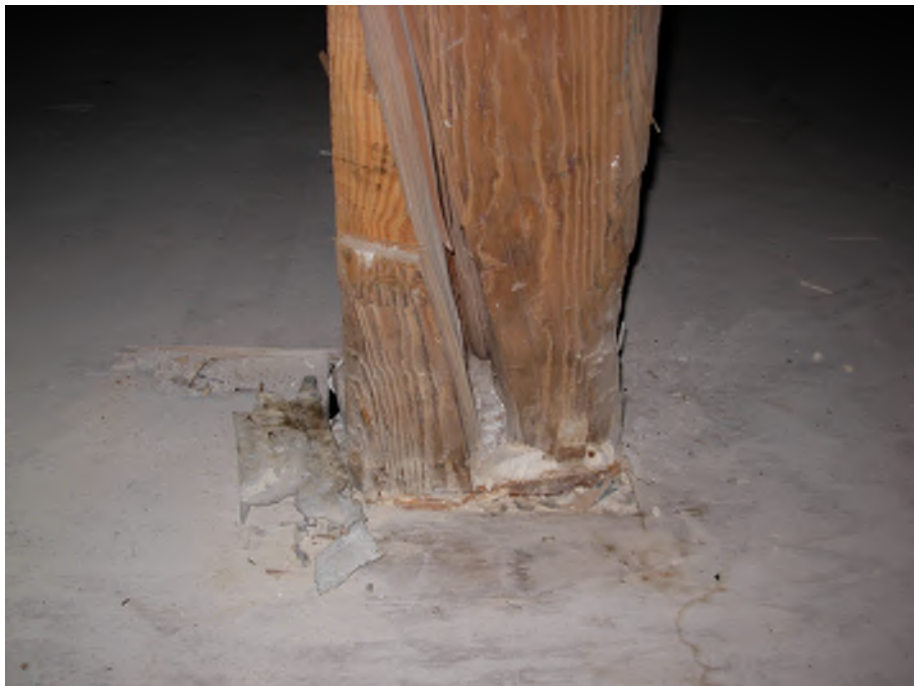
Photo #6: Damaged column base either from impact or overloading. Column needs replacement.

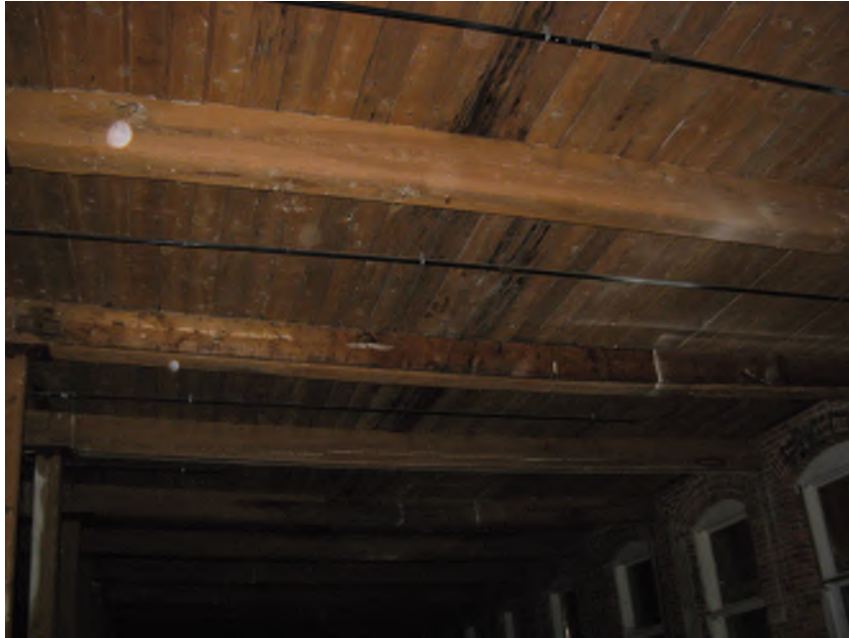
Photo #7: Dimensional lumber used to reinforce existing timber beam. Reinforcing likely used to stabilize member due to damages.

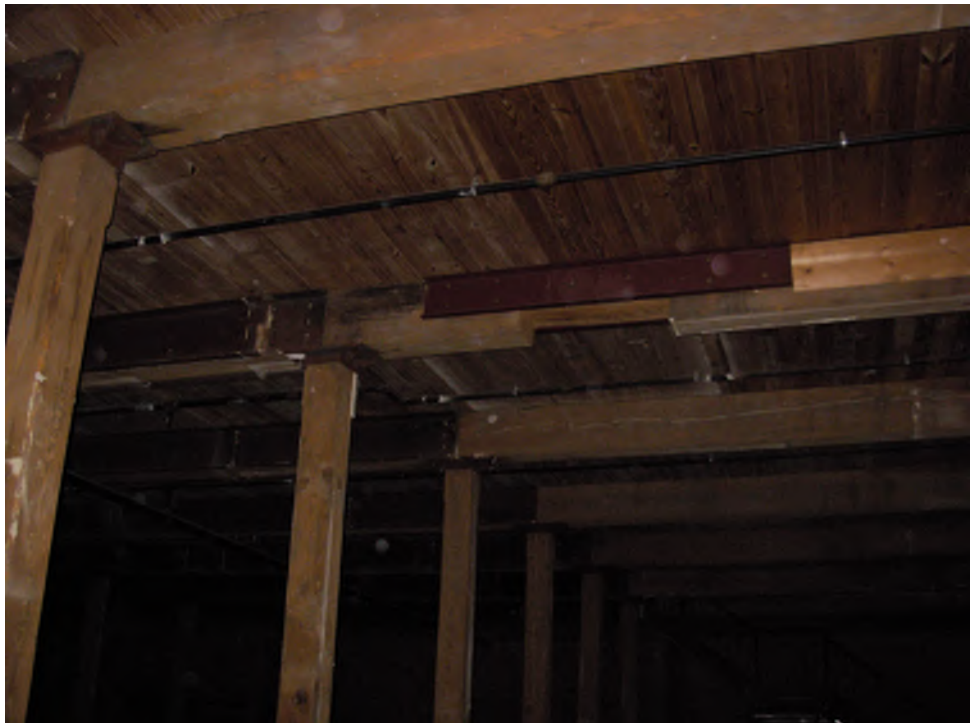
Photo #8: Small partial length steel channel and dimensional lumber reinforcing around large notch in wooden beam.

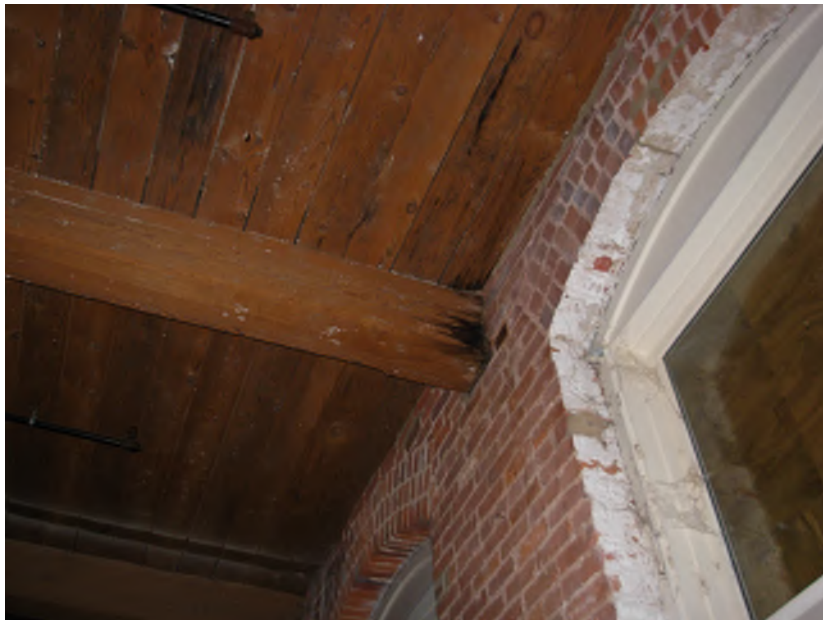
Photo #10: Rotten end of timber at masonry bearing condition.

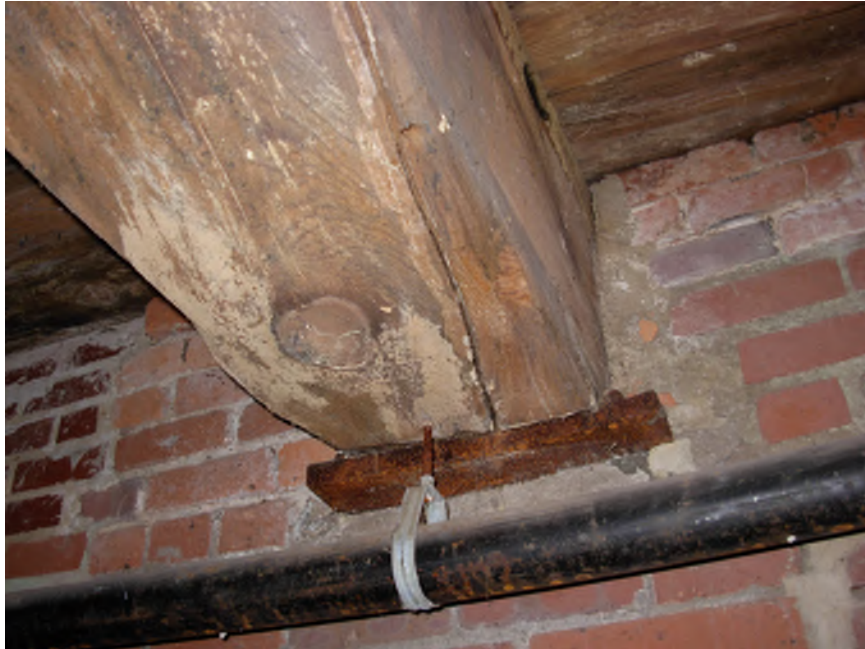
Photo #11: Severe checking in beam. This particular check spirals about the length of the beam and the member needs to be replaced.

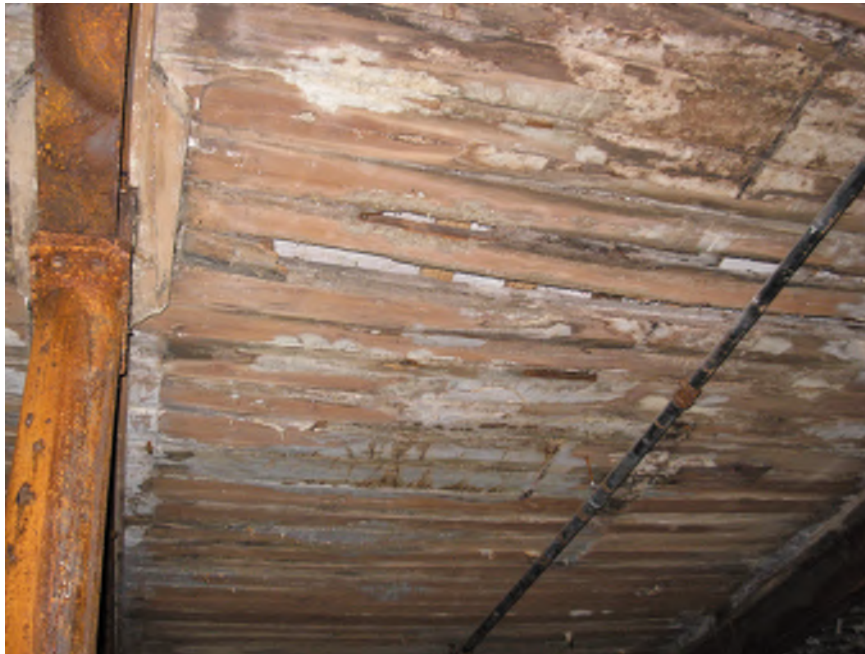
Photo #12: Steel structure shows heavy surface rusting but appears to be sound although wood decking needs to be removed and replaced.

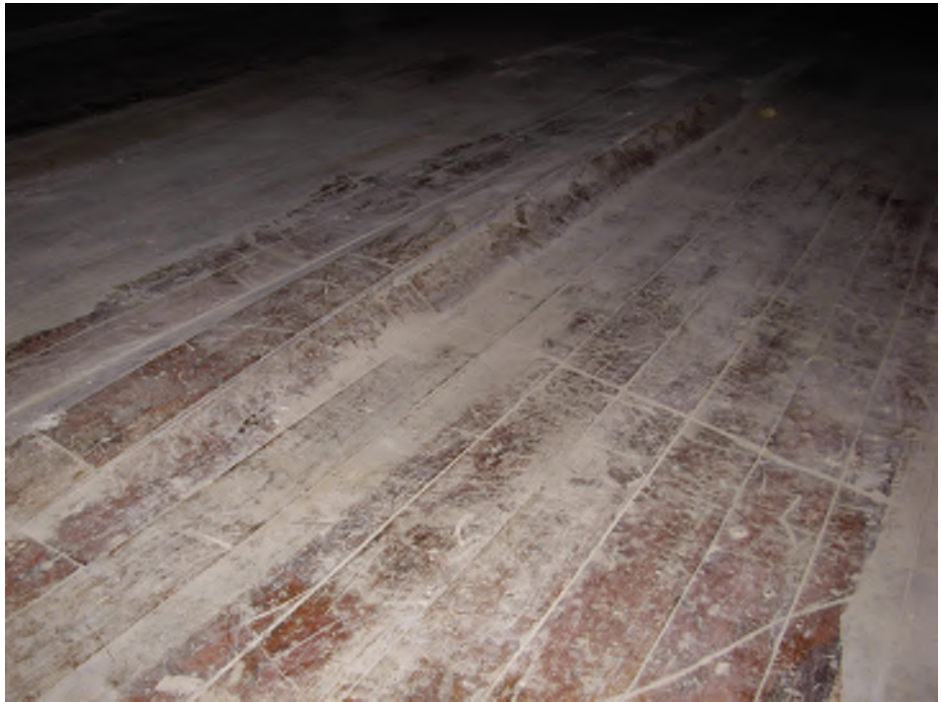
Photo #13: Buckled finished pine flooring likely due to water damage that could have deteriorated structural wood decking below.

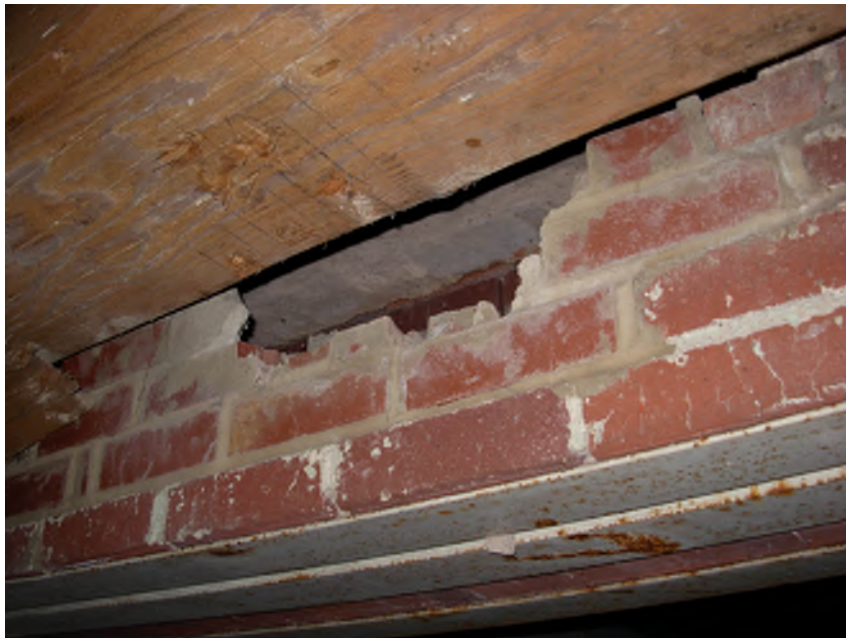
Photo #14: Opening in brick likely for utility routing that needs to be repaired.

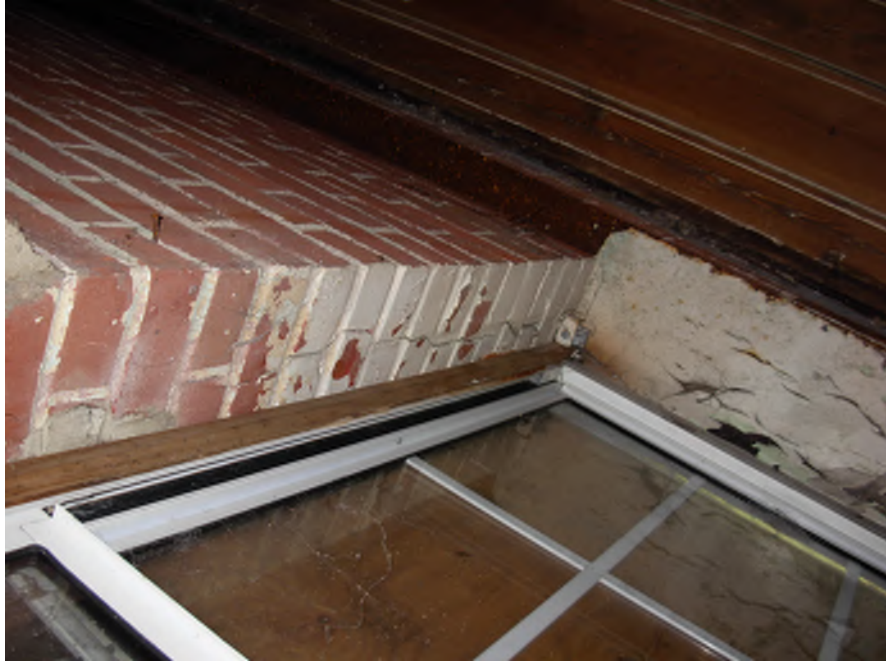
Photo #15: Cracking in brick that needs repair.

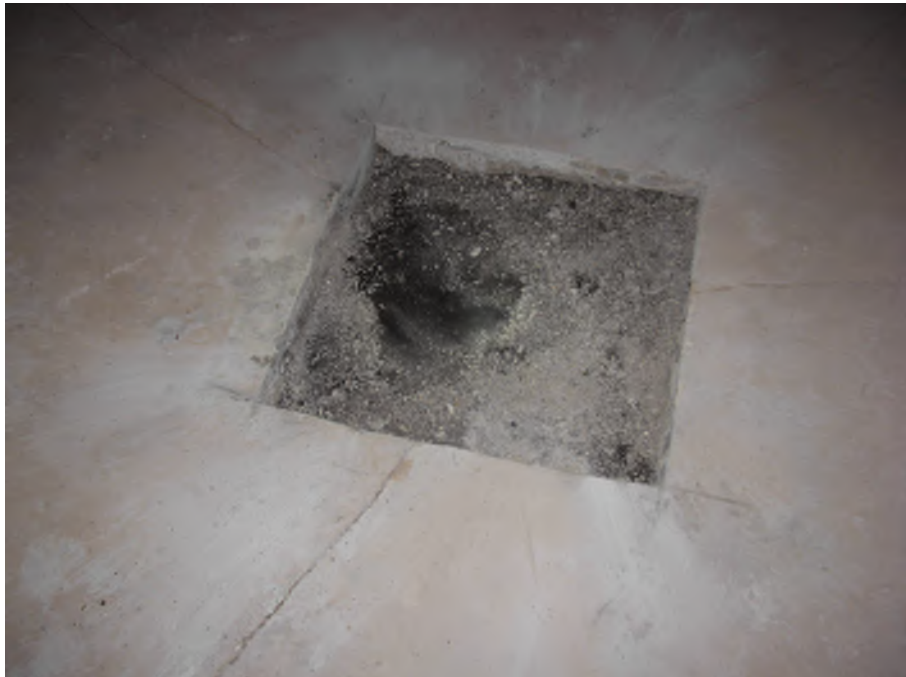
Photo #20: Test location of on grade flooring in basement. Notice the numerous large cracks.

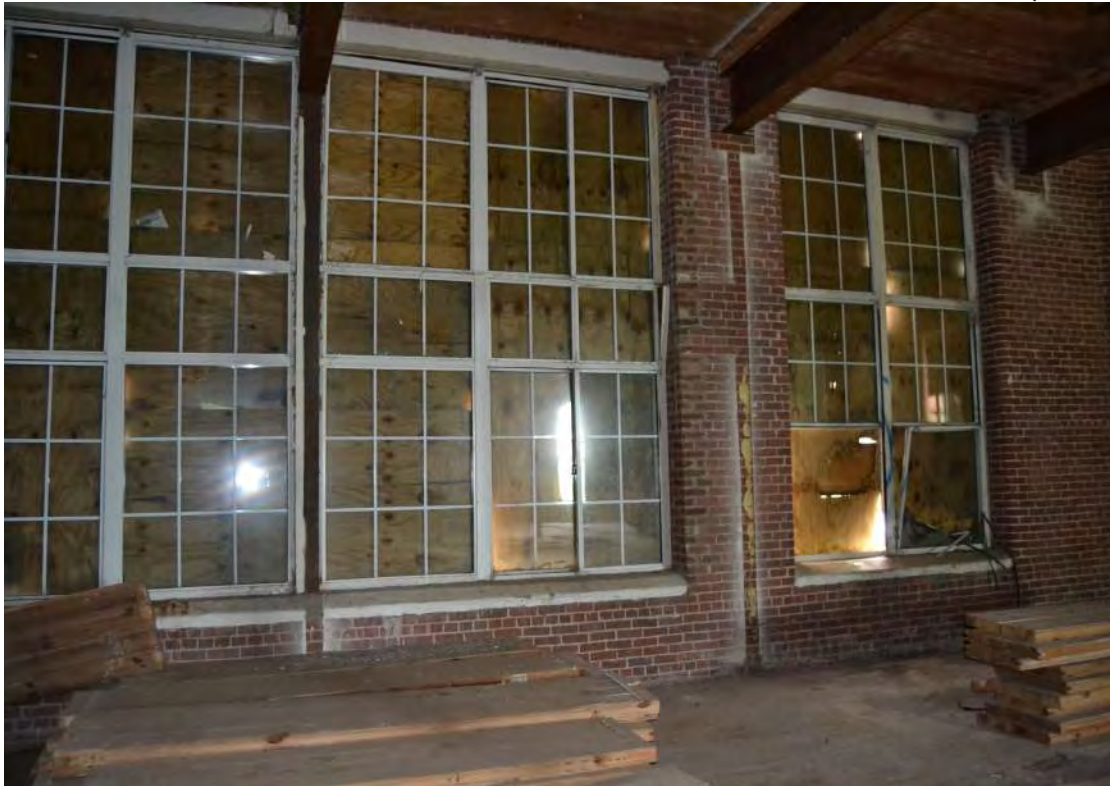
40. First floor, damaged floor structure in south wing
