HISTORIC PRESERVATION CERTIFICATION APPLICATION PART 2 – DESCRIPTION OF REHABILITATION

Property name Johnston Mill

NPS Project Number 40,603

Property address 3315 North Davidson Street, Charlotte NC 28205

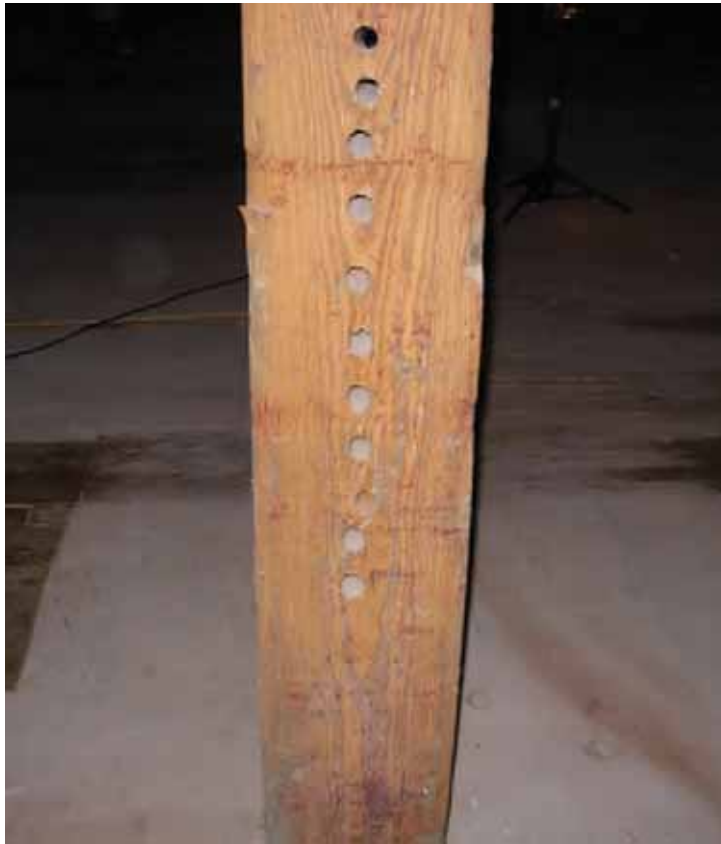
Photo #3: Excessive reduction in column cross section due to improper modification during utility routing.

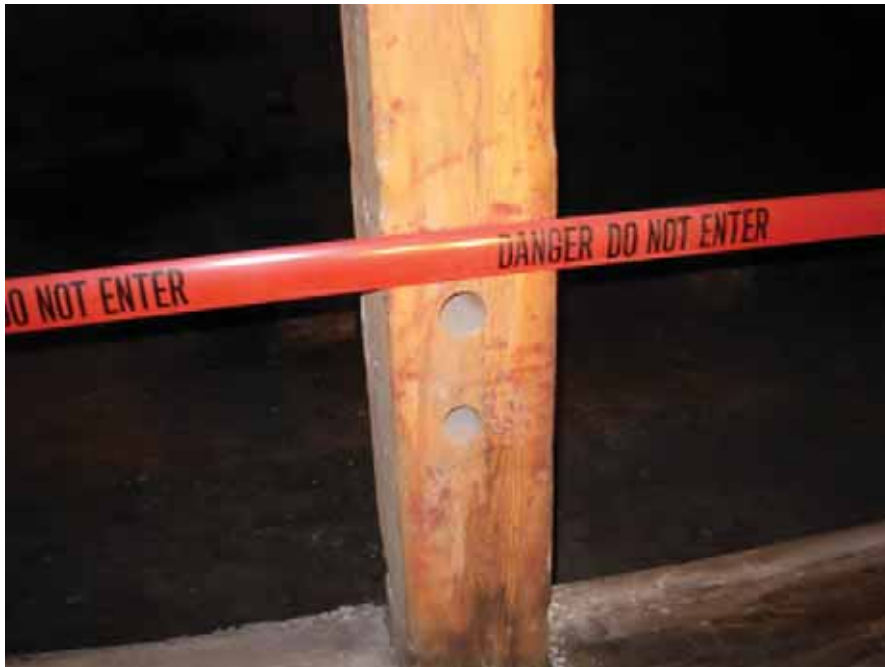
Photo #4: Multiple large 2" diameter holes in column for utility routing. Excessive reduction in member cross sectional area is unacceptable.

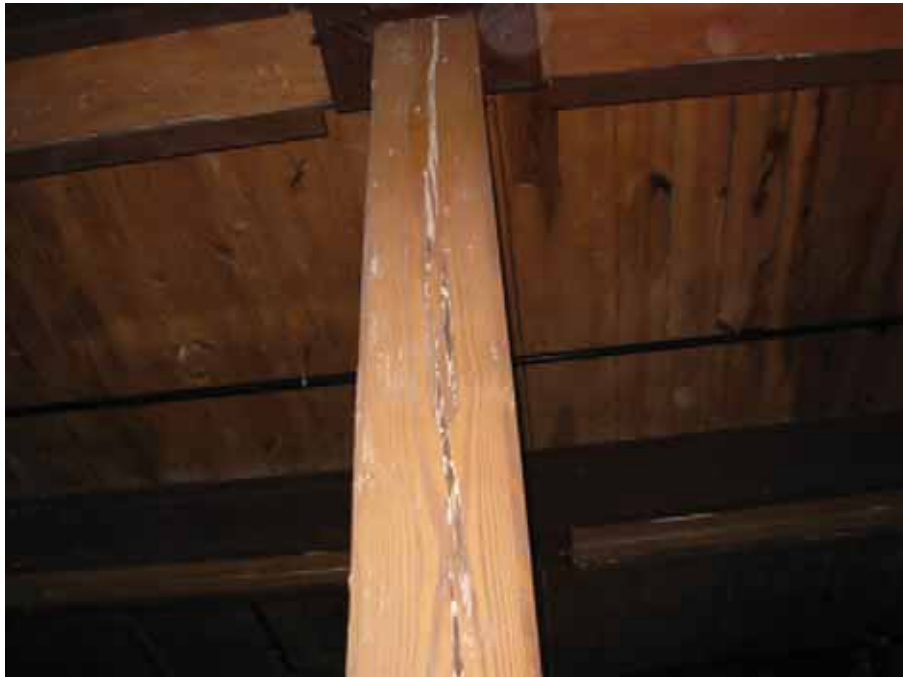
Photo #5: Large checks in wooden column. White filler material assumed to be drywall joint compound and not an attempt to epoxy the cracks.

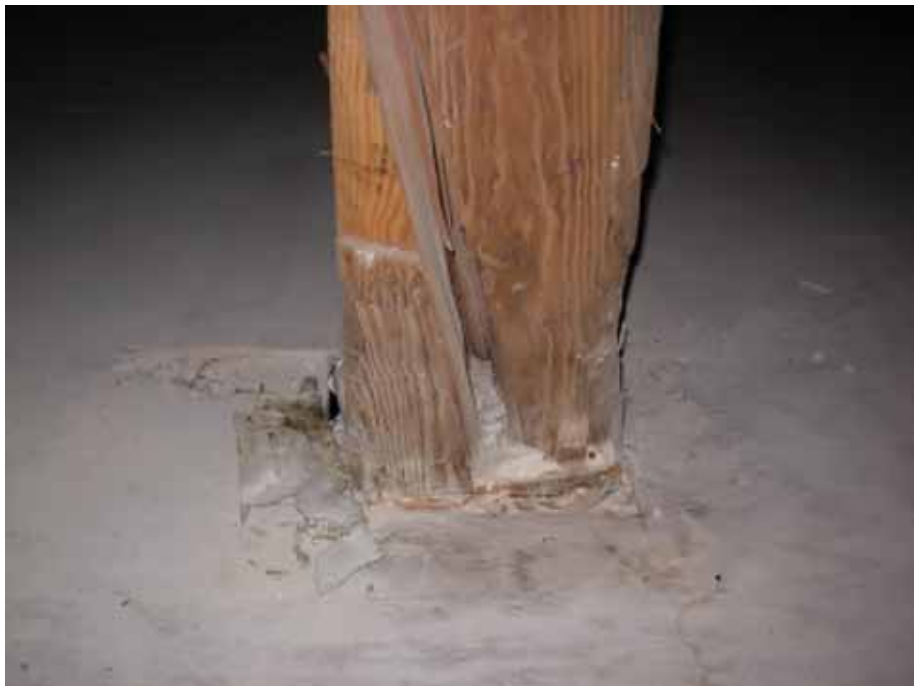
Photo #6: Damaged column base either from impact or overloading. Column needs replacement.

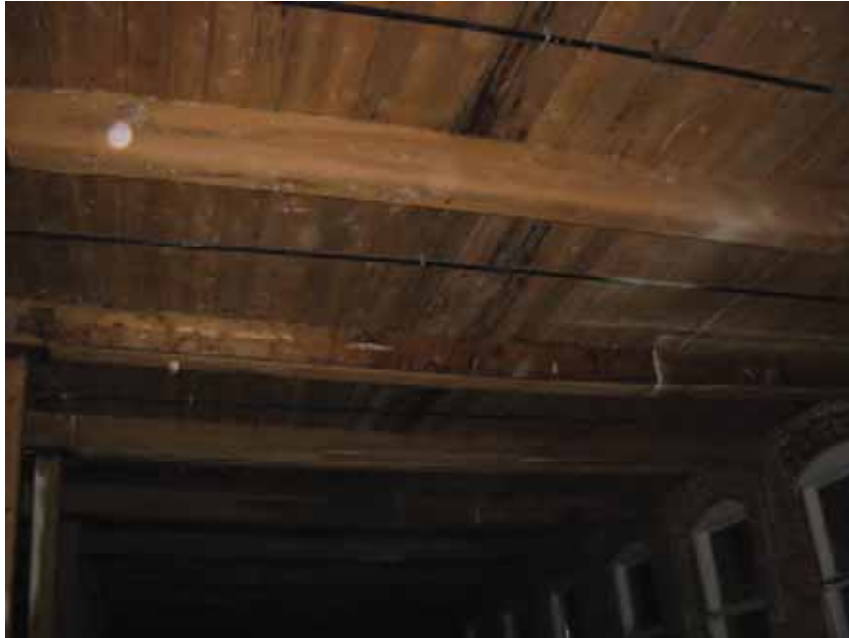
Photo #7: Dimensional lumber used to reinforce existing timber beam. Reinforcing likely used to stabilize member due to damages.

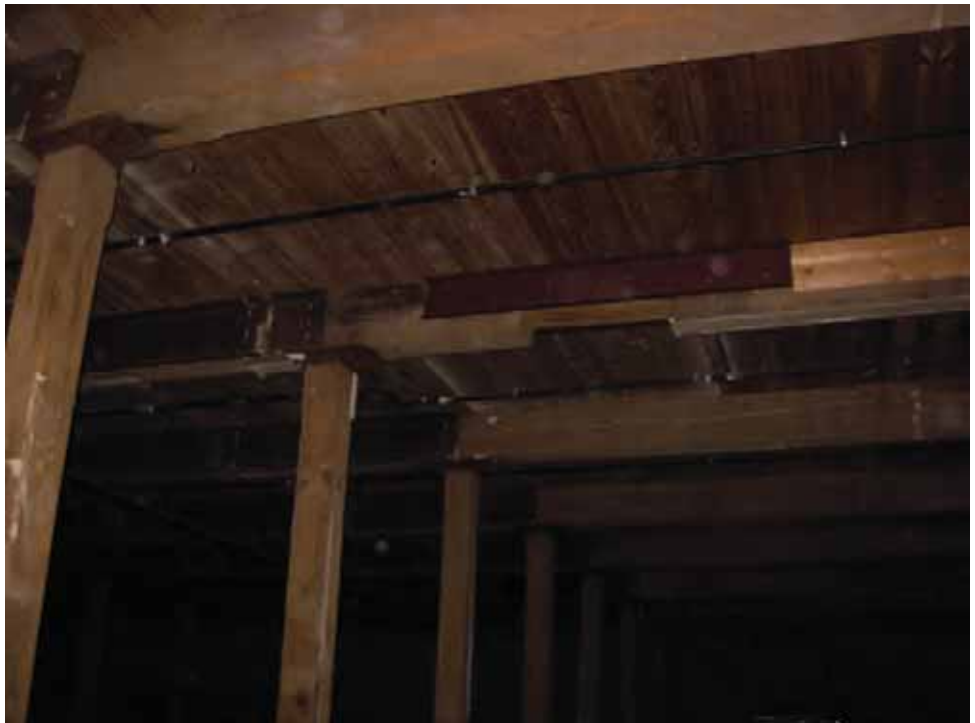
Photo #8: Small partial length steel channel and dimensional lumber reinforcing around large notch in wooden beam.

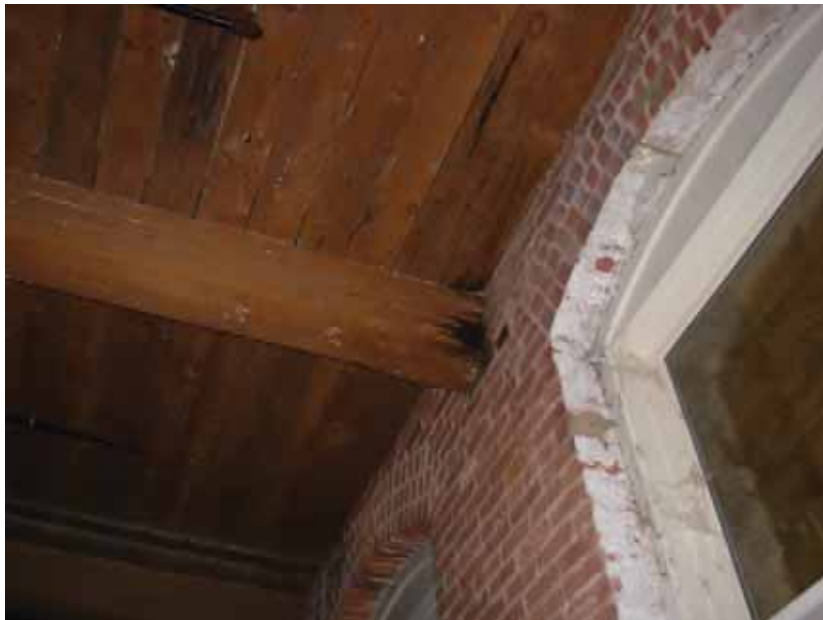
Photo #10: Rotten end of timber at masonry bearing condition.

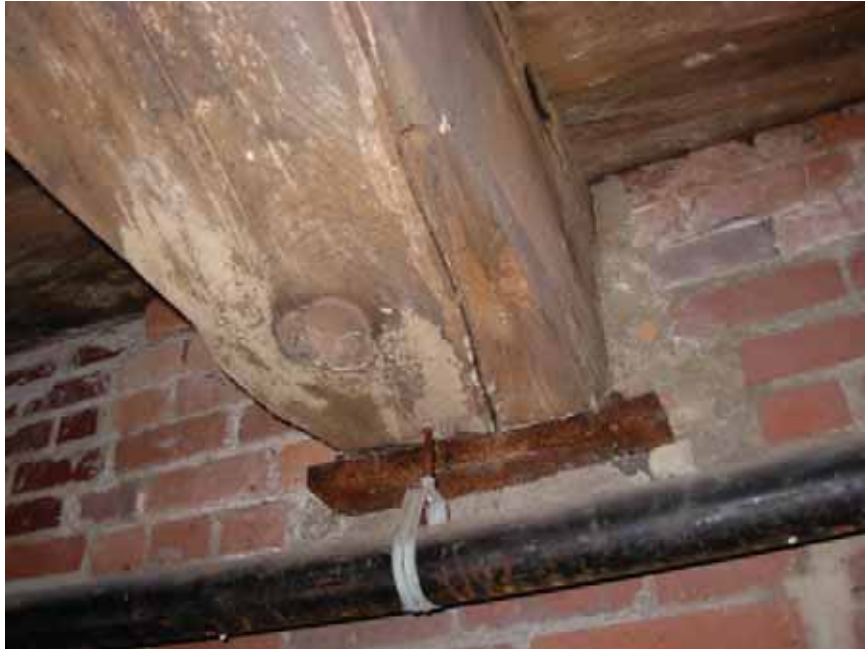
Photo #11: Severe checking in beam. This particular check spirals about the length of the beam and the member needs to be replaced.

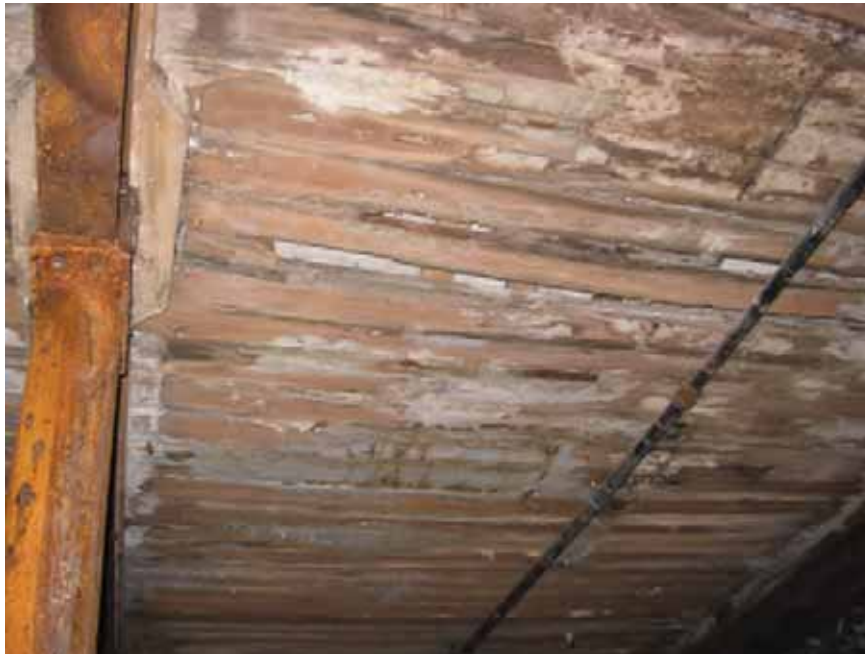
Photo #12: Steel structure shows heavy surface rusting but appears to be sound although wood decking needs to be removed and replaced.

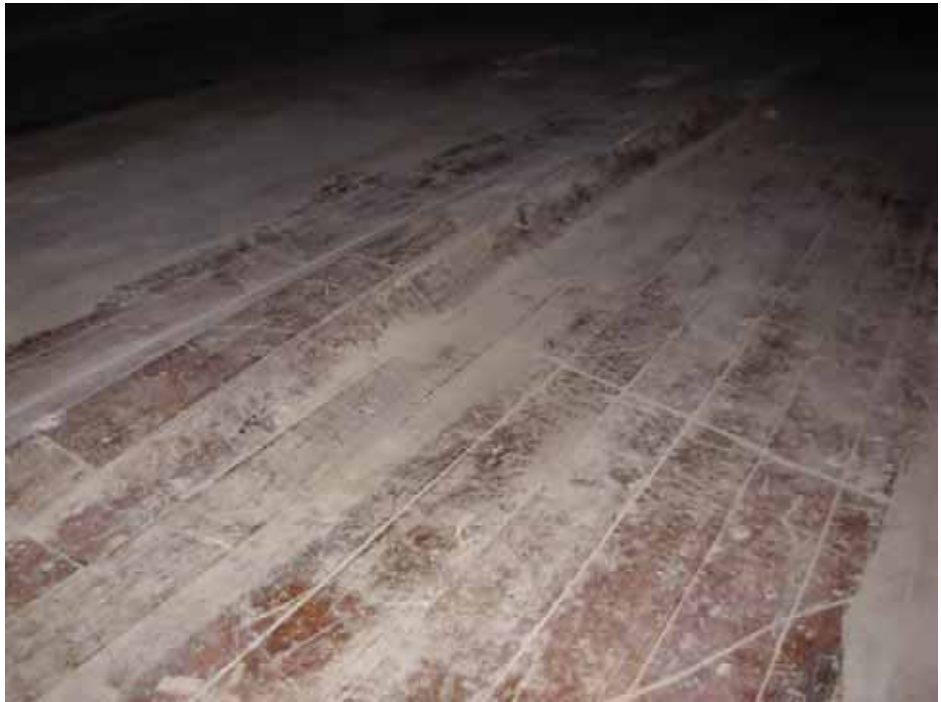
- The floor still has the original finished flooring over top of the structural decking. The finished flooring has buckled and warped likely due to water damage causing the wood to swell.

Photo #13: Buckled finished pine flooring likely due to water damage that could have deteriorated structural wood decking below.

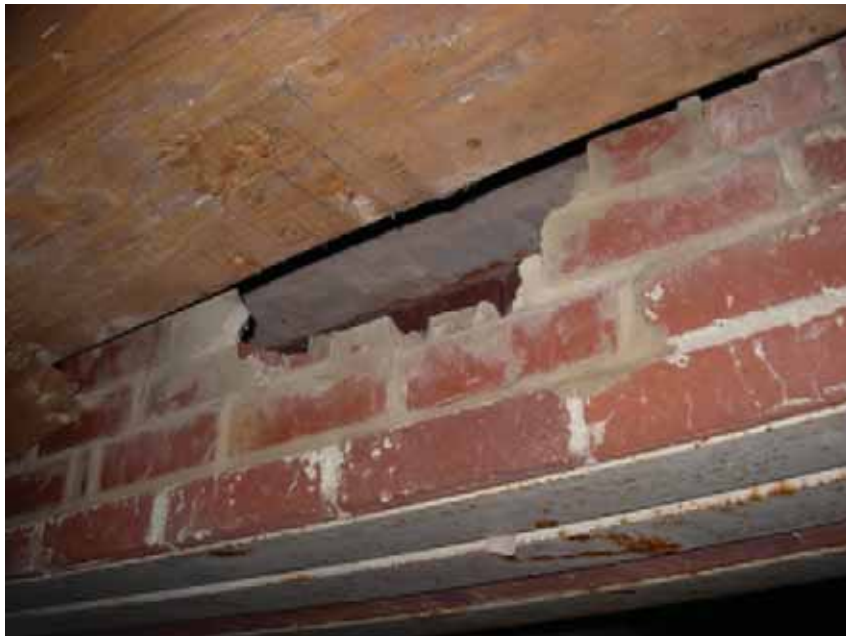
Photo #14: Opening in brick likely for utility routing that needs to be repaired.

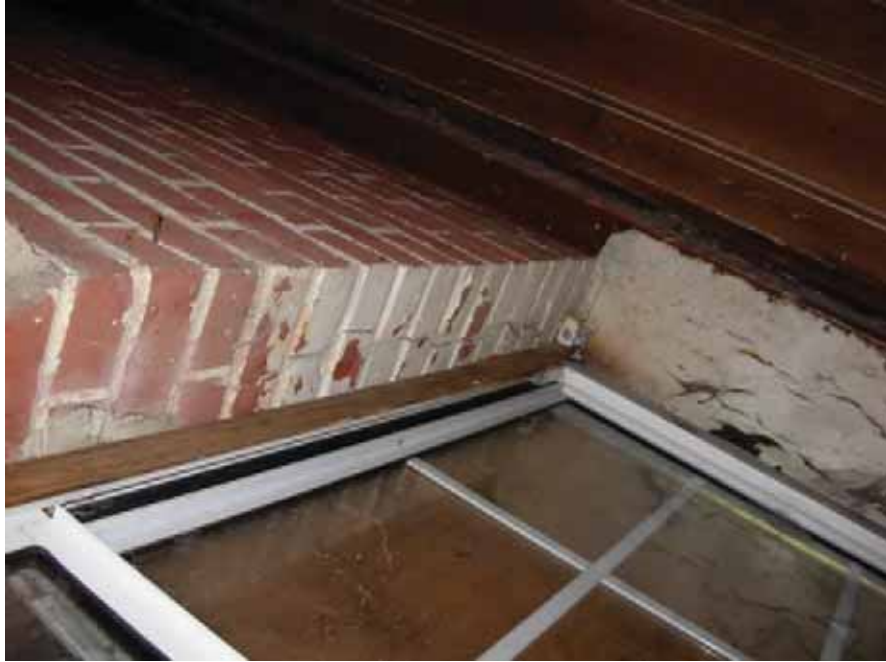
Photo #15: Cracking in brick that needs repair.

- Cracked bricks throughout the exterior masonry walls will be replaced in kind with new brick only where determined brick is cracked beyond repair. Bricks out of plumb or loose will be re-placed in alignment.

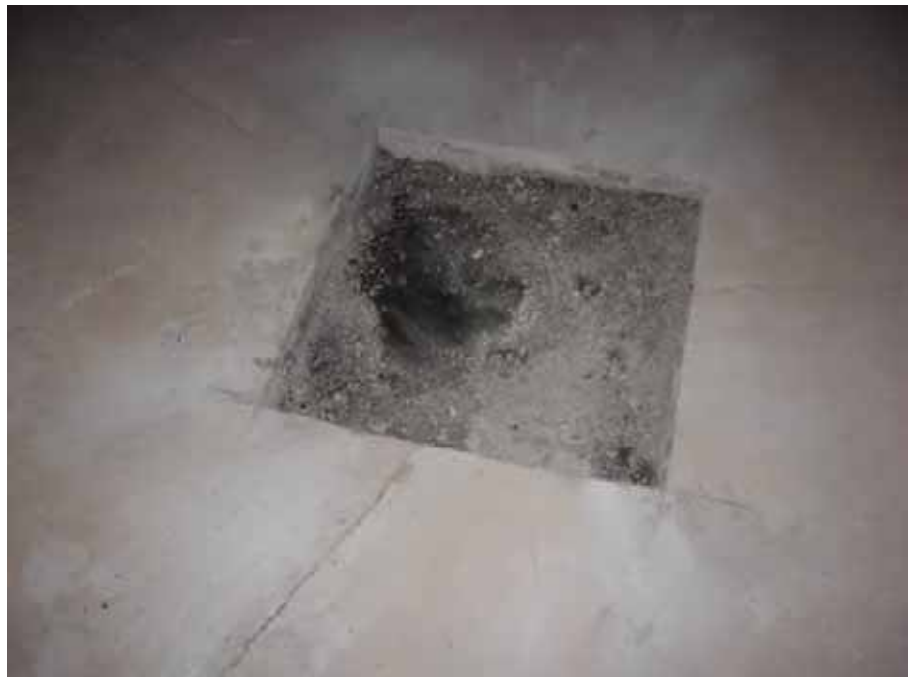
- The basement portion of the wood timber structure appears to rest on compacted coal fines.
 - Under the steel framed sections there appears to be a slab on grade, but some significant cracks radiating out from the center."

Photo #20: Test location of on grade flooring in basement. Notice the numerous large cracks.

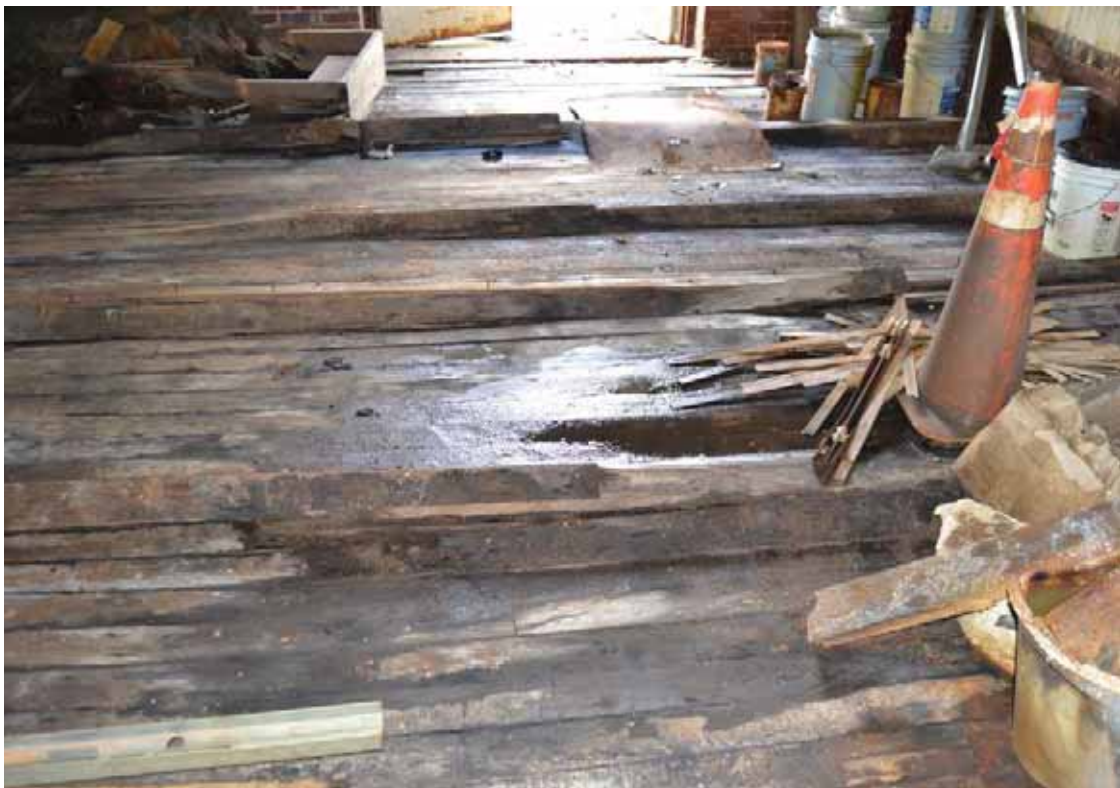
40. First floor, damaged floor structure in south wing

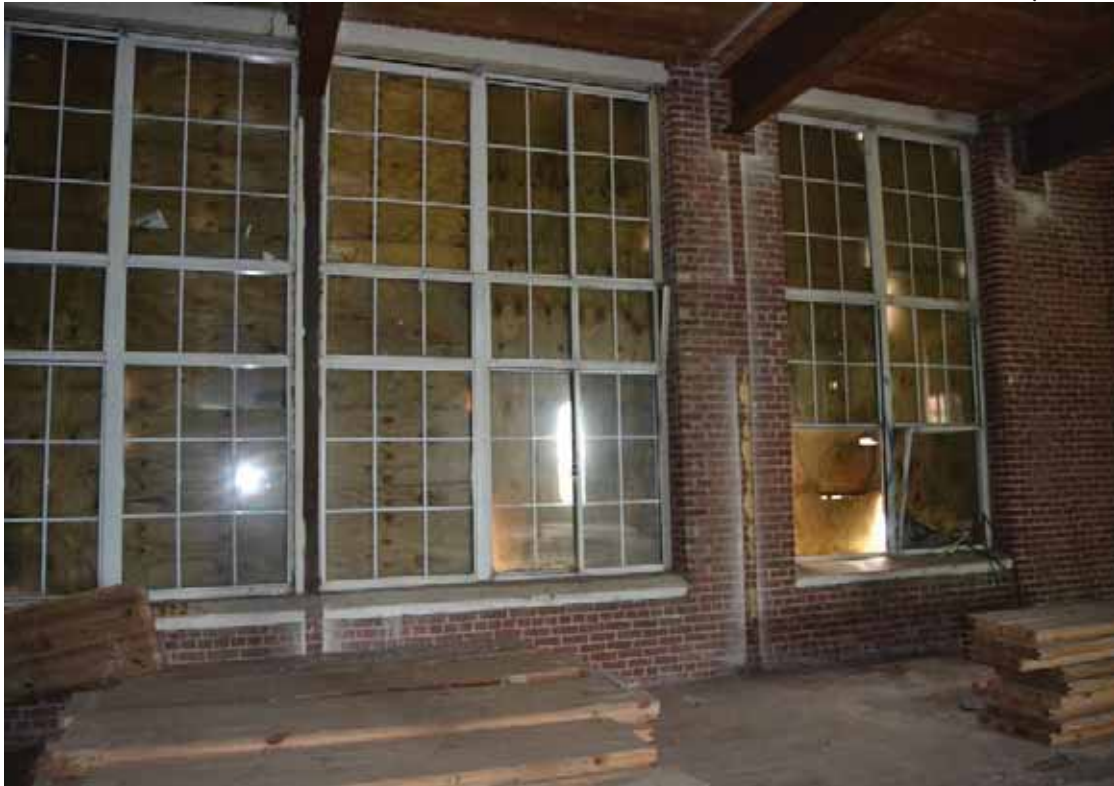
41. First floor, south wing, detail at windows (typical)
