**Staff Report and Comments
John Douglas House
7601 Christie Lane, Charlotte
Application for COA HLC282**

Issued: November 4, 2022
Revision 1: February 8, 2023
Terracon Project No. FY226106

Re: Structural Evaluation Services
Limited Visual Condition Assessment
John Douglas House
7601 Christie Lane
Charlotte, North Carolina 28202

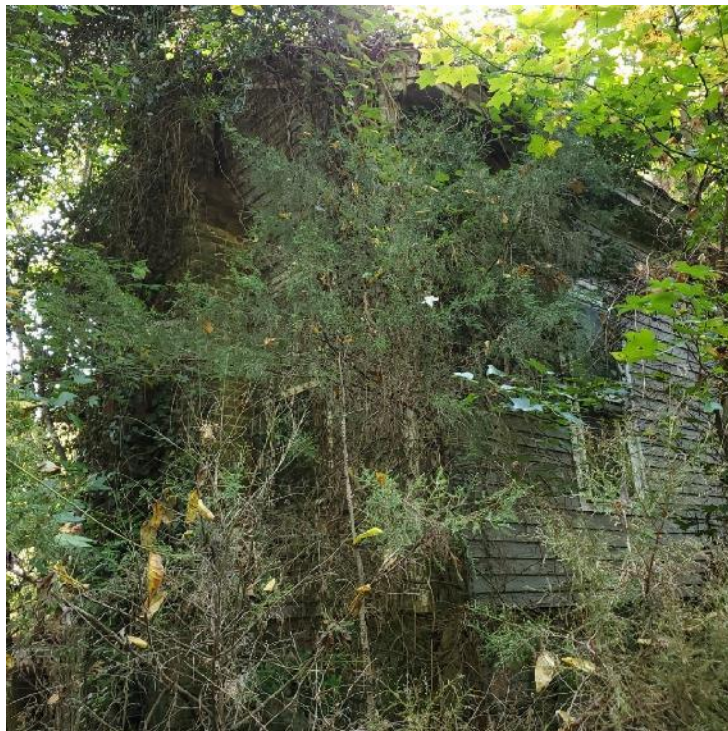
1. Heavy vegetation growth was observed along the rear portion of the residence, north elevation (**Photo 12**). Additional vegetation growth along or adjacent to the residence was observed in multiple locations (**Photo 13**). The electric hookup to the residence was located along the rear portion of the residence within an area of heavy vegetative growth (**Photo 14**).

Due to a lack of maintenance to the property, the vegetation and landscaping were overgrown, with heavy vegetative growth observed along portions of the exterior walls. The driveway access to the property is not conducive to larger vehicles and equipment as it is also overgrown.

Photograph 12: View of heavy vegetative growth at rear portion of residence.

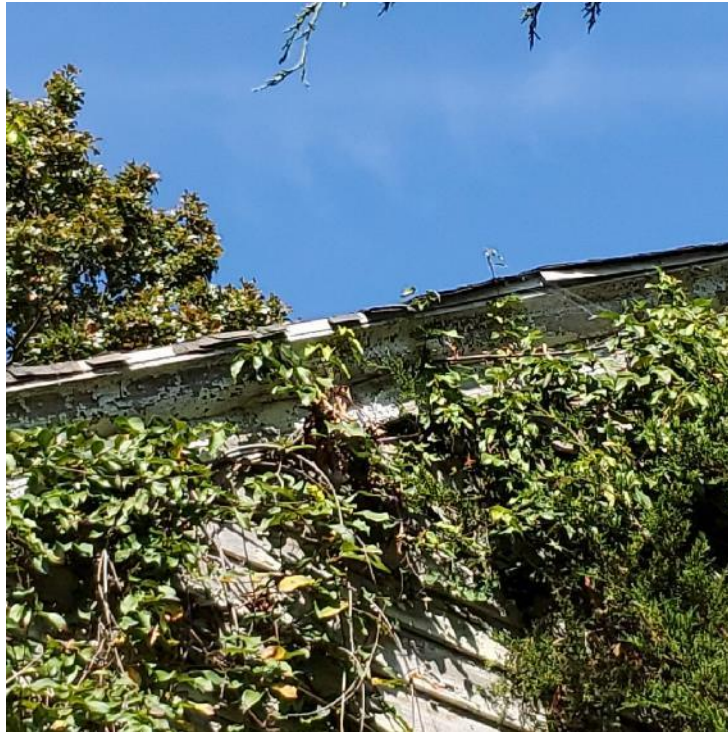
Photograph 13: View of vegetative growth along east elevation of original portion of residence.

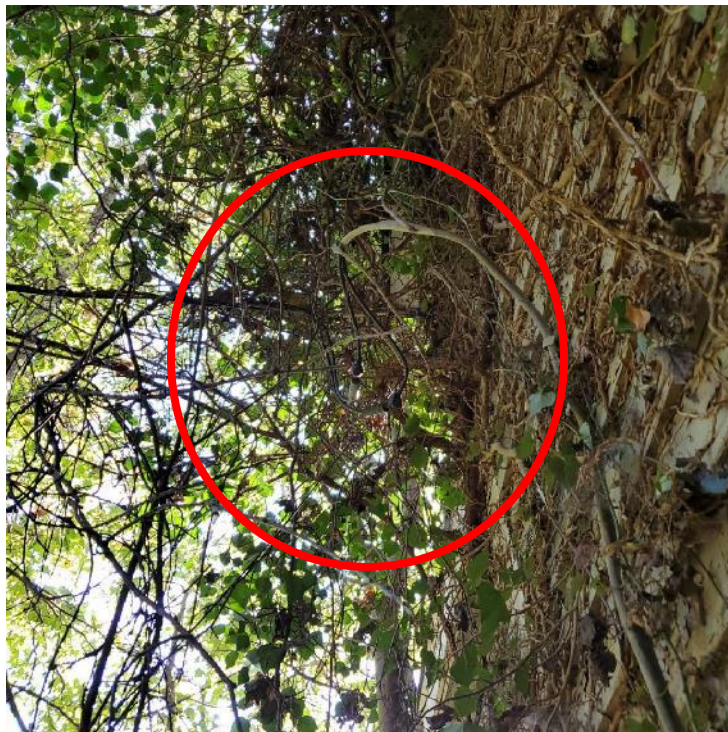
Photograph 14: View of vegetative growth at city electric line to residence (oval).

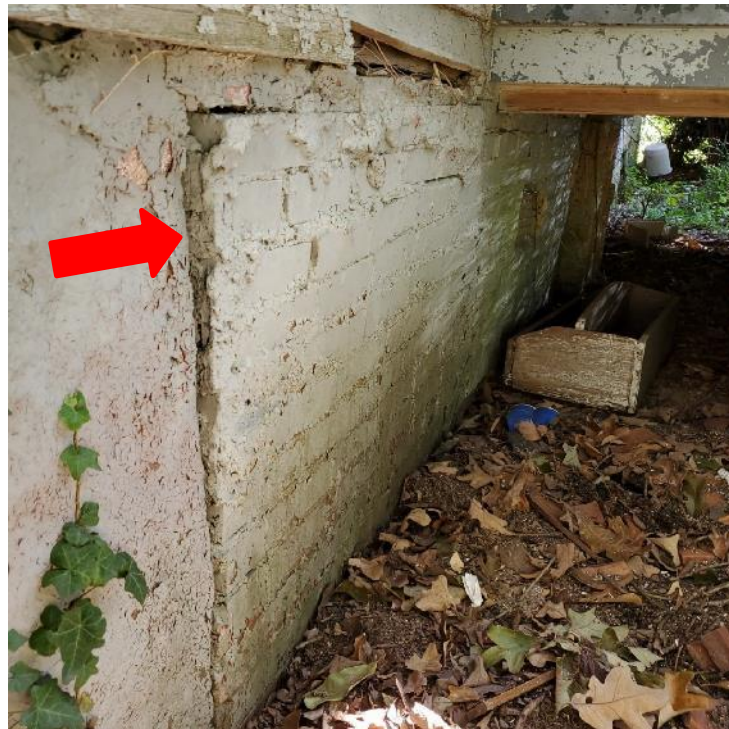
2. The elevated CIP concrete front porch slab was noted to bear on the brick masonry infill between the mass stone piers along the south elevation. The brick infill was noted to be one (1) wythe thick at the porch bearing location. The brick infill in proximity to the front porch bearing was observed to lean away from the residence. The exposed side of the brick was painted (**Photos 15 through 19**).

The elevated concrete front porch slab appeared to bear along the top of the single-wythe brick masonry infill along the south elevation of the residence. The brick masonry infill was displaced away from the structure, as viewed at the mass stone pier locations. It was noted that the exposed side of the brick was painted; therefore, the brick was leaning prior to the painting effort. It is unclear when or if the movement has occurred. However, the single-wythe brick masonry infill is intended to be aesthetic and should not be used as a structural element.

Photograph 18: View of vertical displacement of brick infill adjacent to the front porch (arrow). Note the paint along the side of the exposed brick.

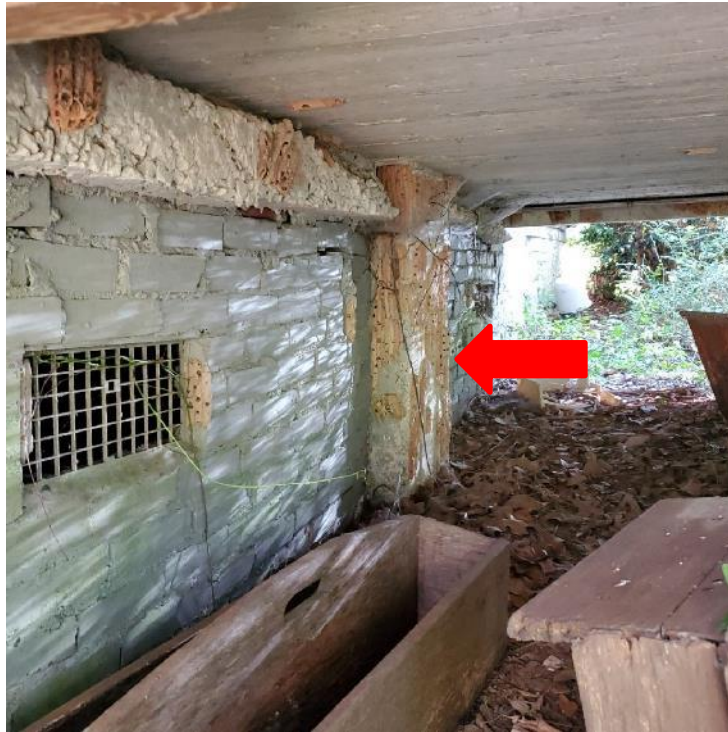
Photograph 19: View of mass stone pier located along south elevation porch slab bearing (arrow).

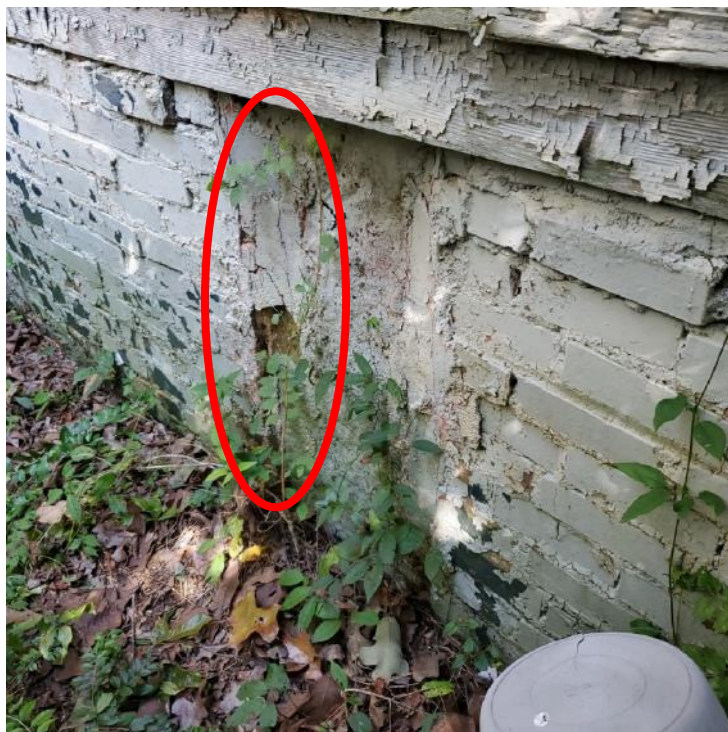
3. Delamination of the exterior face of a mass stone pier was observed towards the east end of the south elevation (**Photos 20 and 21**).
4. The southwest corner of the roof over the main portion of the residence had different color shingles and a replaced section of fascia along the eave (**Photo 22**).

Photograph 20: View of delamination on the exterior face of the mass stone pier along the south elevation (oval).

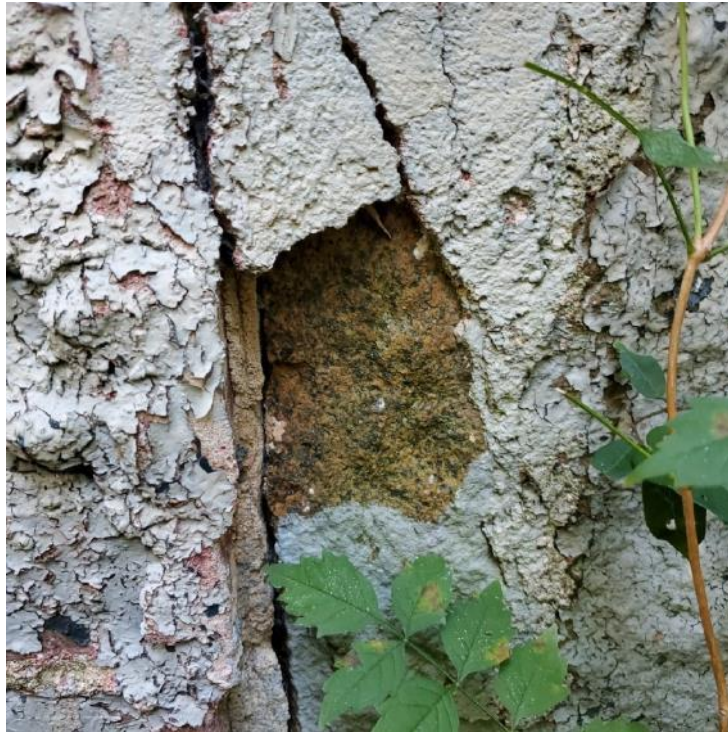
Photograph 21: Close-up view of delamination on the exterior face of the mass stone pier along the south elevation.

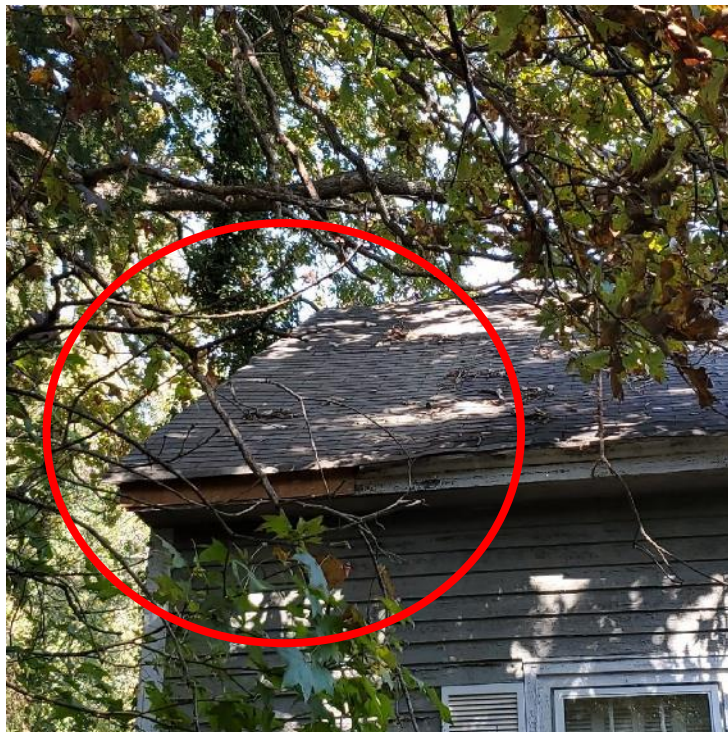
Photograph 22: View of different color shingles and replaced fascia at southwest corner (oval).

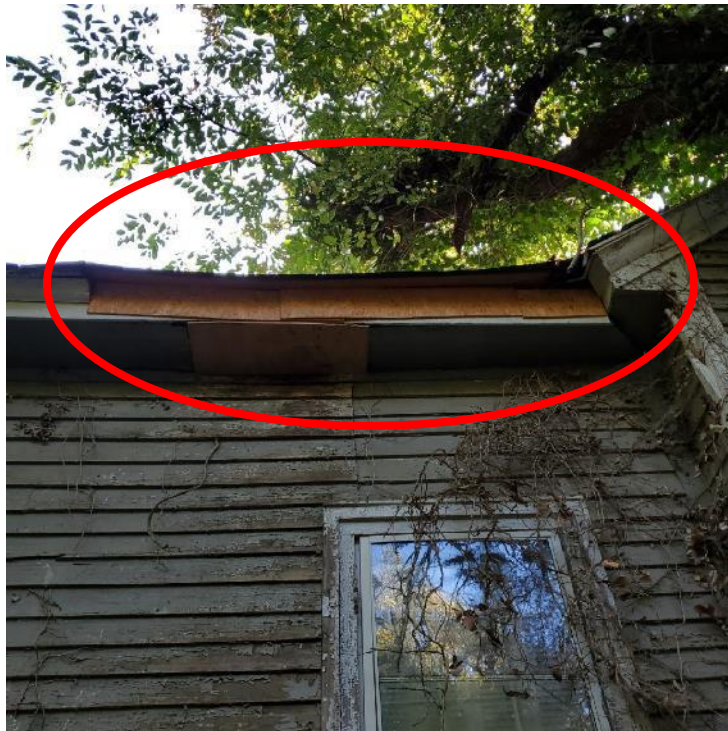
6. Plywood was installed along a section of fascia along the west elevation at the transition from the main portion to the rear portion of the residence (**Photo 24**). Below this eave location, the horizontal lap siding at the floor level visually appeared to be sagging. A step crack was observed in the brick infill masonry below the sag in the siding (**Photo 25**).

Photograph 24: View of plywood at fascia along the west elevation of the rear portion of the residence (oval).

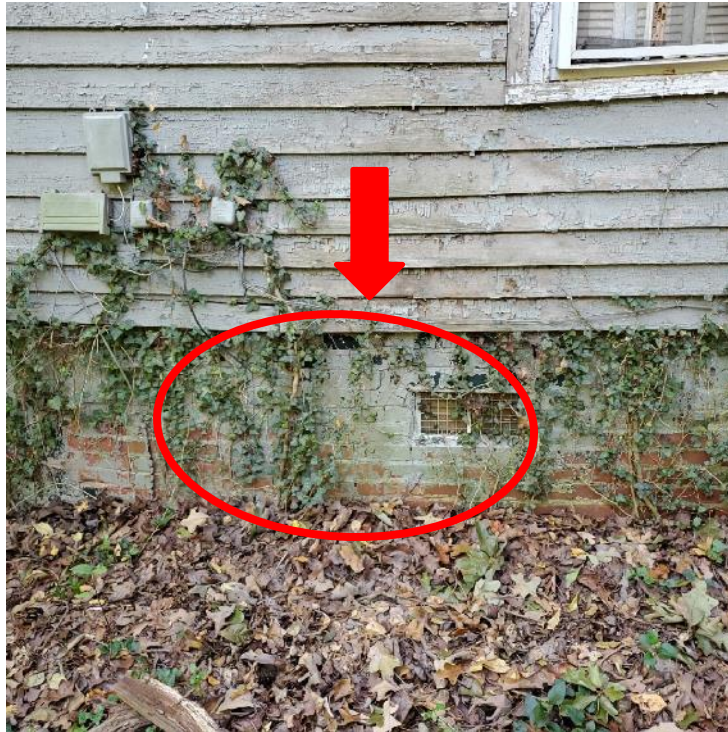
Photograph 25: View of sag in siding at the first-floor level along the west elevation of the rear portion of the residence (arrow). Note the step crack in the brick masonry infill (oval).

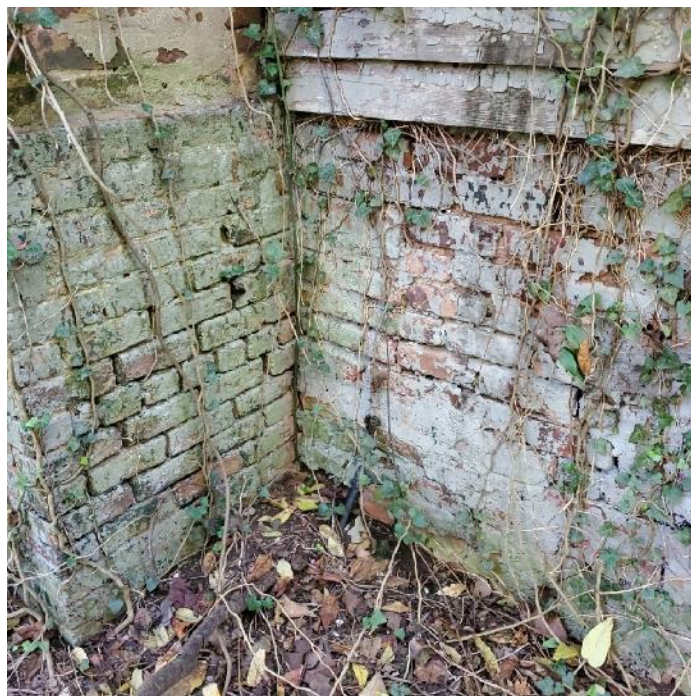
7. Recessed mortar joints were observed at the exterior chimney and brick infill along the north elevation of the rear portion of the residence (**Photo 26**).

Photograph 26: View of recessed mortar joints in brick infill masonry and in the exterior chimney masonry.

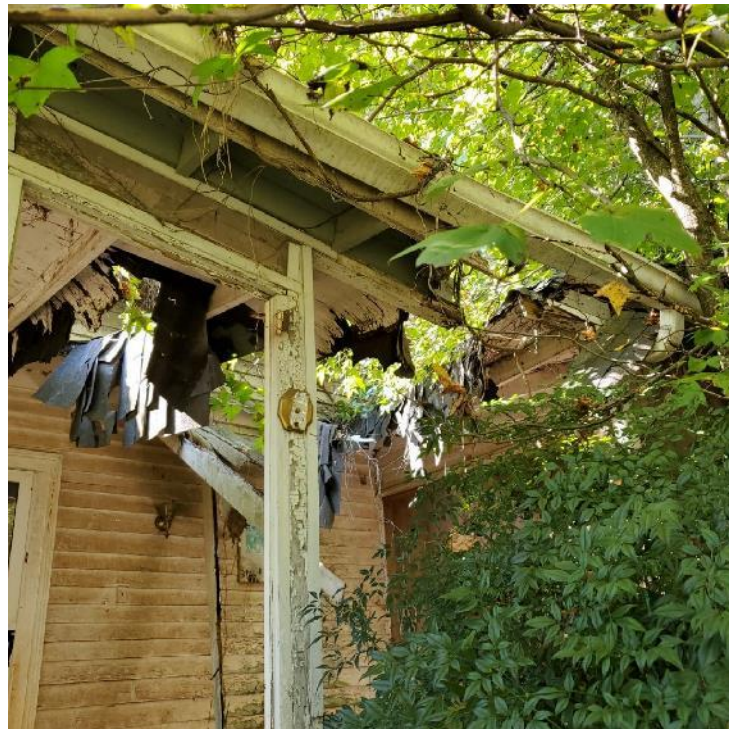
The floor and roof of the L-shaped porch along the rear elevation of the residence had partially collapsed. The porch beam supporting the bathroom addition was observed to be in a failed state at the girder connection. The porch beam was displaced downward at the girder bearing and was rotated along its length. The rear portion of the residence was noted to be in a degraded state due to section loss of floor framing members caused by insect and moisture-related damage. While the floor framing for the main portion of the residence was noted to be in better condition than the framing in the rear portion of the residence, failure of framing at the rear portion of the residence could have a deleterious effect on the main portion of the residence; the rear portion of the residence is not a separate self-supporting structure and is connected to the original portion of the residence.

Photograph 28: View of collapsed porch roof.

- Due to the collapsed and deteriorated state of the L-shaped porch, the L-shaped porch would need to be demolished prior to a relocation effort.
- Extensive structural remediation would be warranted prior to a relocation effort involving moving of the residence in its current state. A remediation effort would require additional evaluation to identify the extent of the required repairs and/or replacement, including likely removal of cladding and/or interior finishes where insect and/or water-related damage was observed. Additional evaluation regarding the extent of insect-related damage would be required.

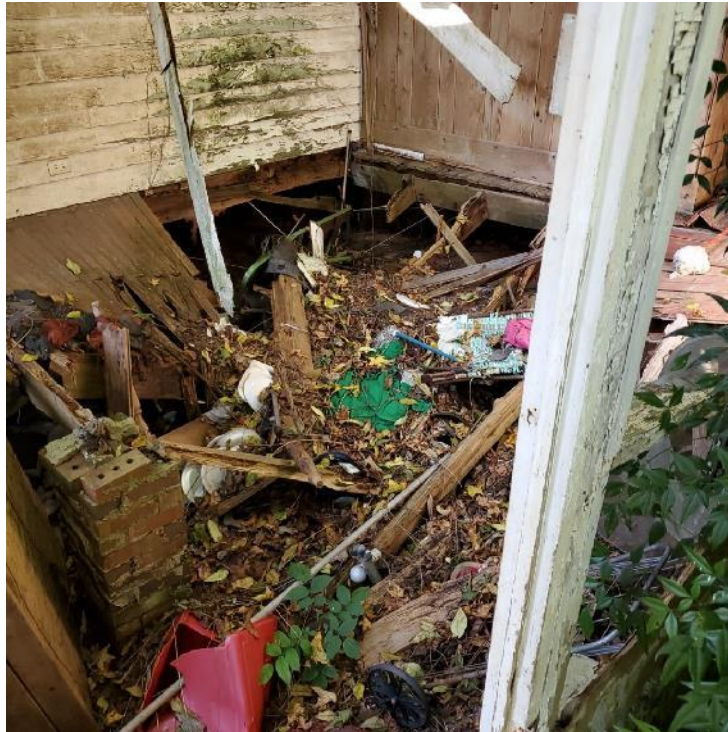
Photograph 29: View of collapsed porch floor.

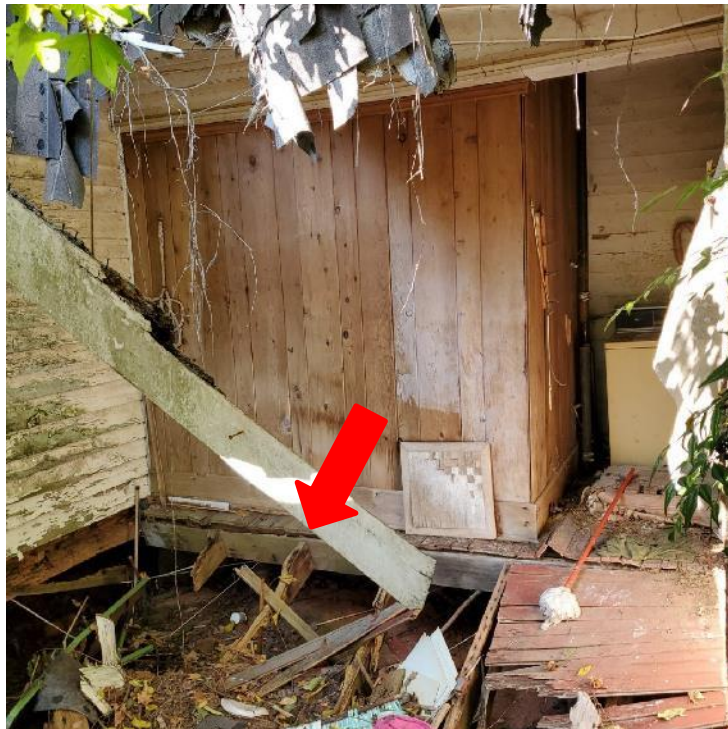
- a. The porch framing supporting the bathroom addition had rotated and displaced downwards at the girder bearing connection (**Photos 30 and 31**).
 - b. Insect-related damage was observed in multiple locations. Brick piers were observed at the L-shaped porch location (**Photos 32 through 34**).

Photograph 30: View of bathroom addition located above the porch framing (arrow).

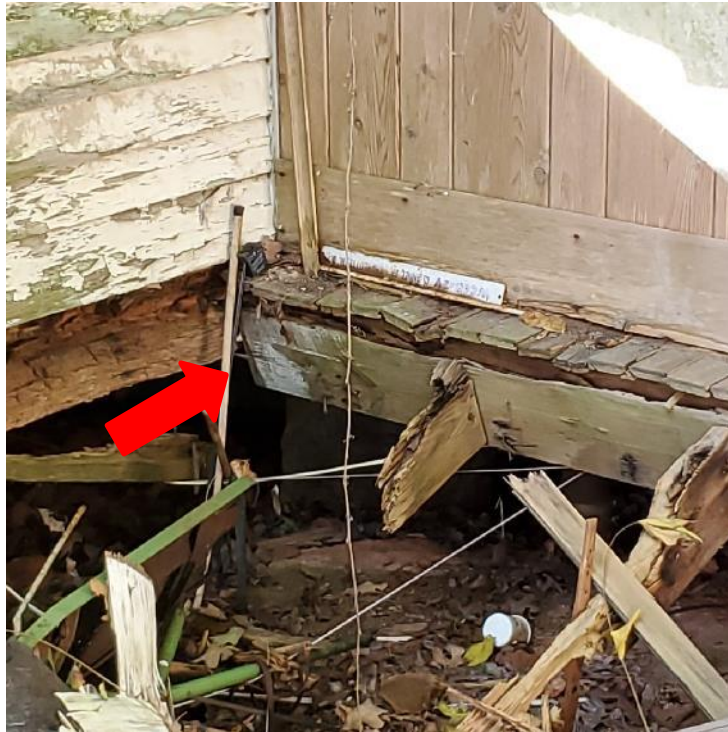
Photograph 31: View of failed joist connection below bathroom addition (arrow).

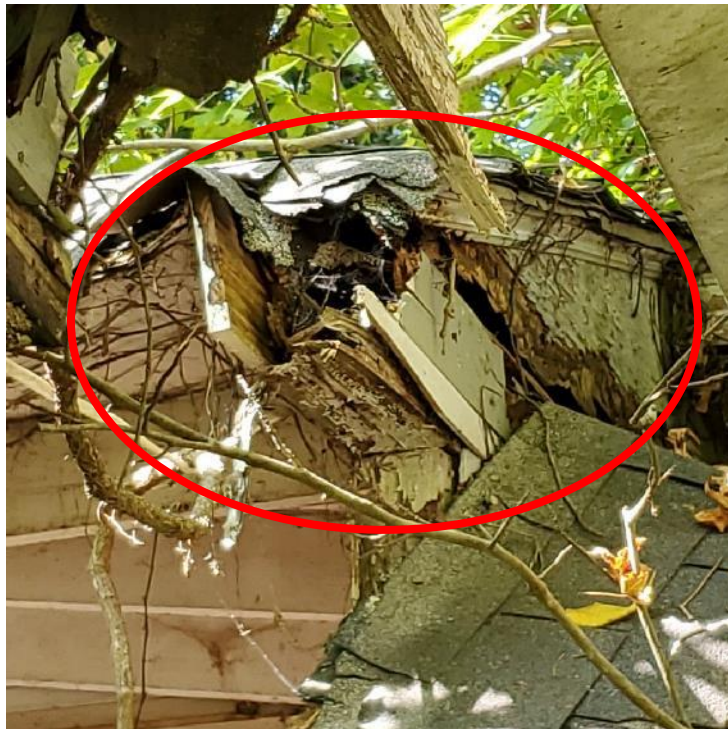
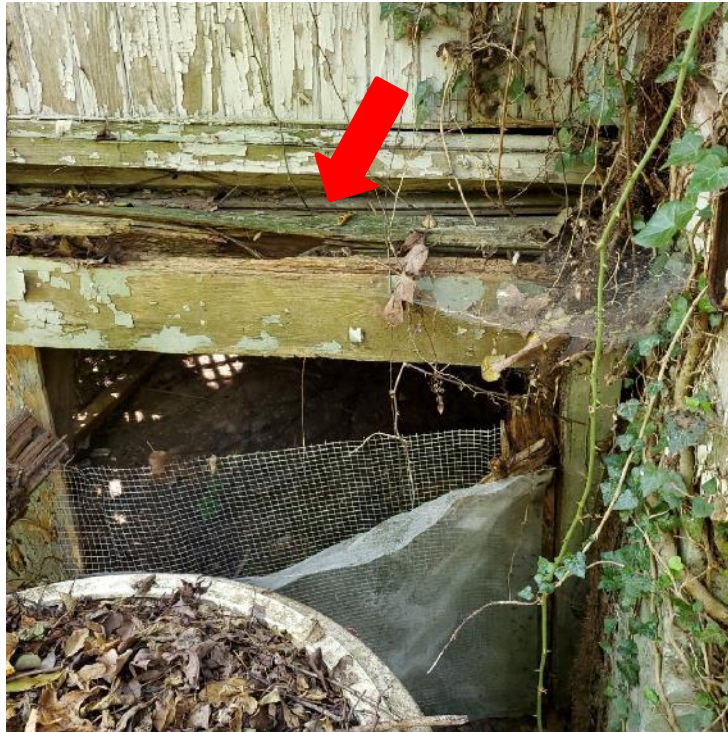
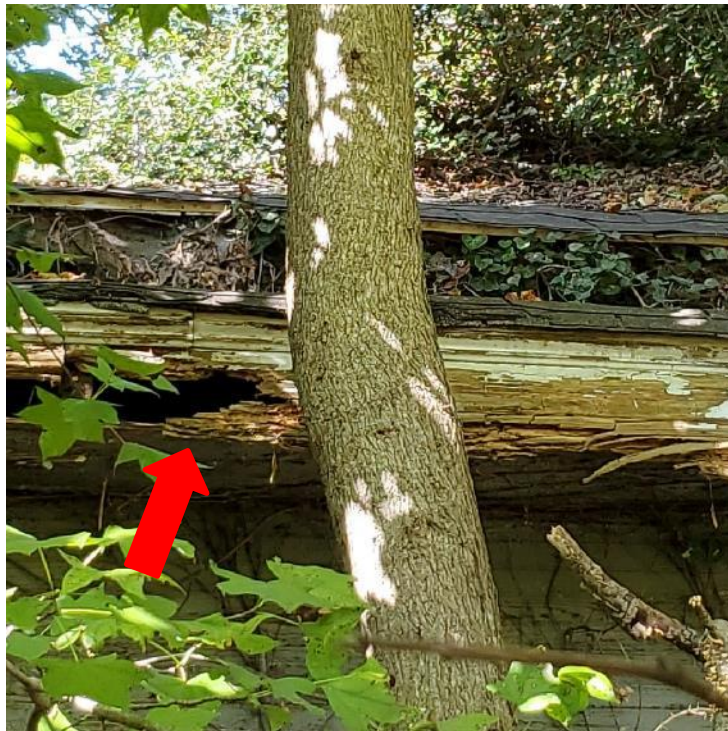
Photograph 32: View of water and/or insect related damage to porch framing (oval).

Photograph 33: View of water and/or insect related damage to porch framing (arrow).

Photograph 34: View of water and/or insect related damage to porch framing (arrow).

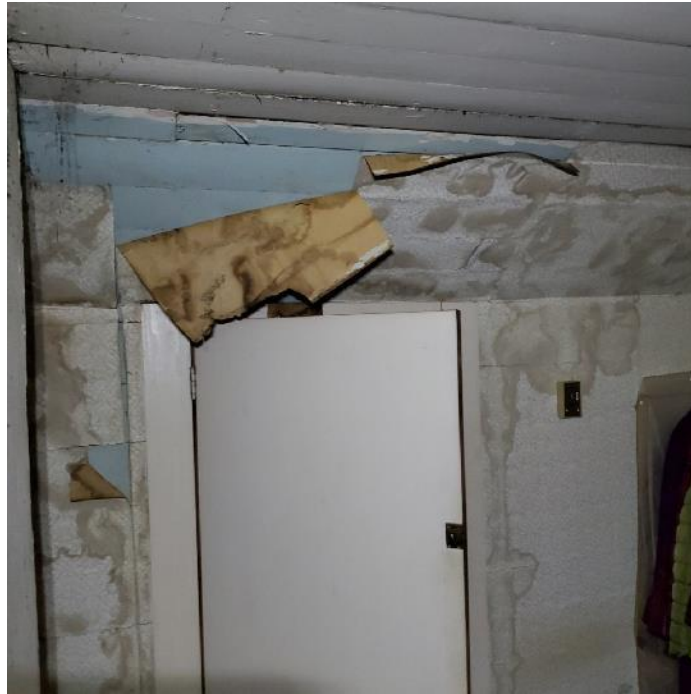
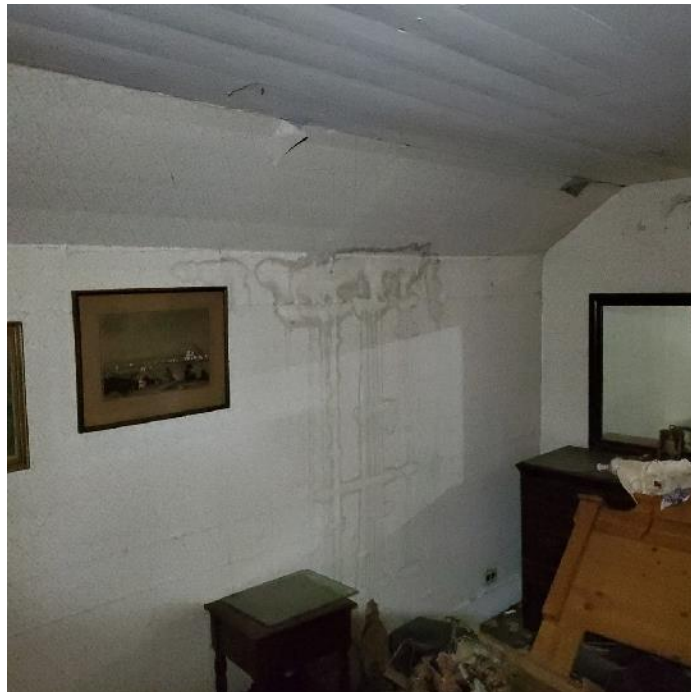
10. Water-stained wallpaper was noted along the north and south interior walls of the upstairs room at the western end of the main portion of the residence (**Photos 35 and 36**).

Photograph 35: View of water-related staining on wallpaper.

Photograph 36: View of water-related staining on wallpaper.

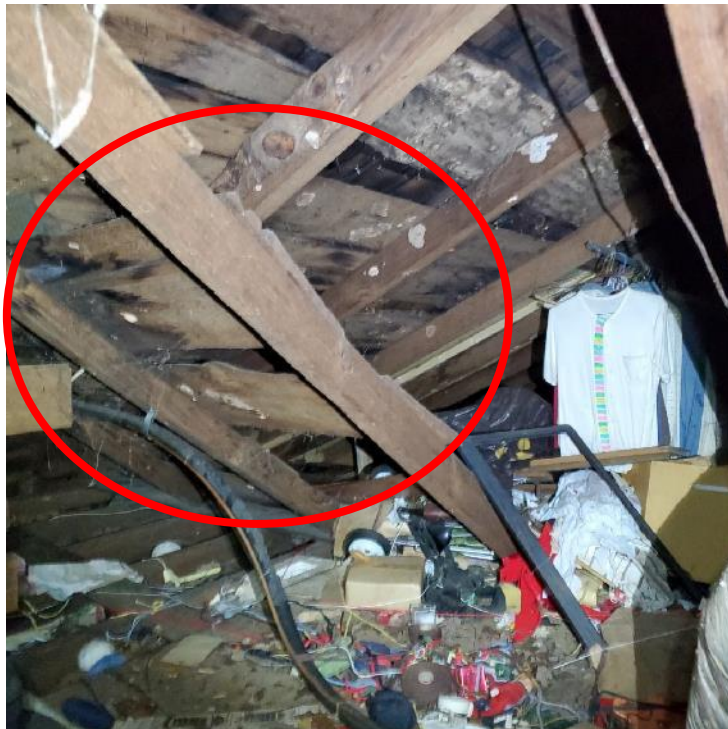
11. The attic space above the transition from the main to the rear portion of the residence was used for storage (**Photo 37**). Water-related staining was noted on the roof deck boards at the overframing for the rear portion of the structure (**Photo 38**).

Photograph 38: View of water-related staining at original to rear portion roof transition (oval).

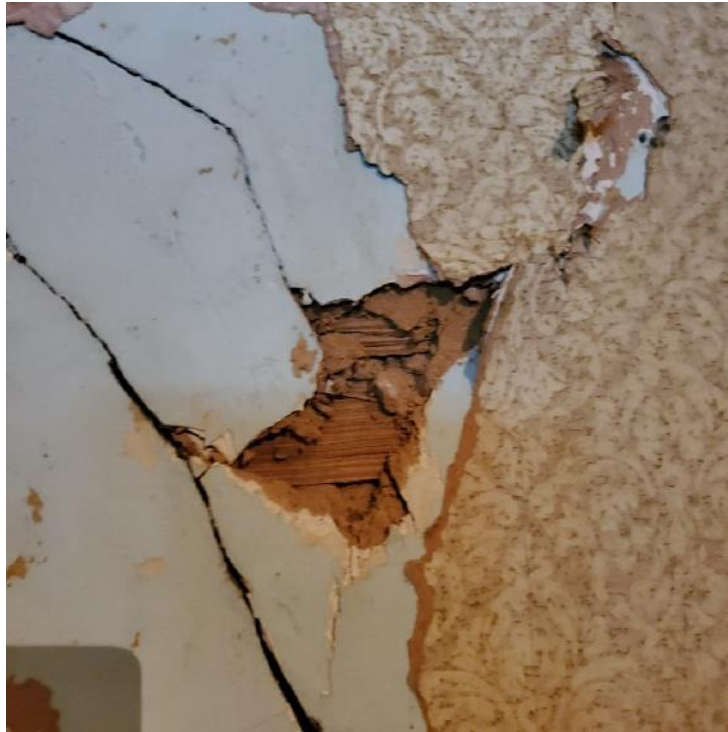
12. Cracking within the interior finishes was noted as a general condition within the first-floor area of the main portion of the residence (**Photos 39 and 40**). Wood lath, a clay-type material, plaster, potentially a paint coating, and wallpaper was observed at a section of failed interior finishes (**Photo 41**).

Photograph 41: View of wall construction at failed interior finish location.

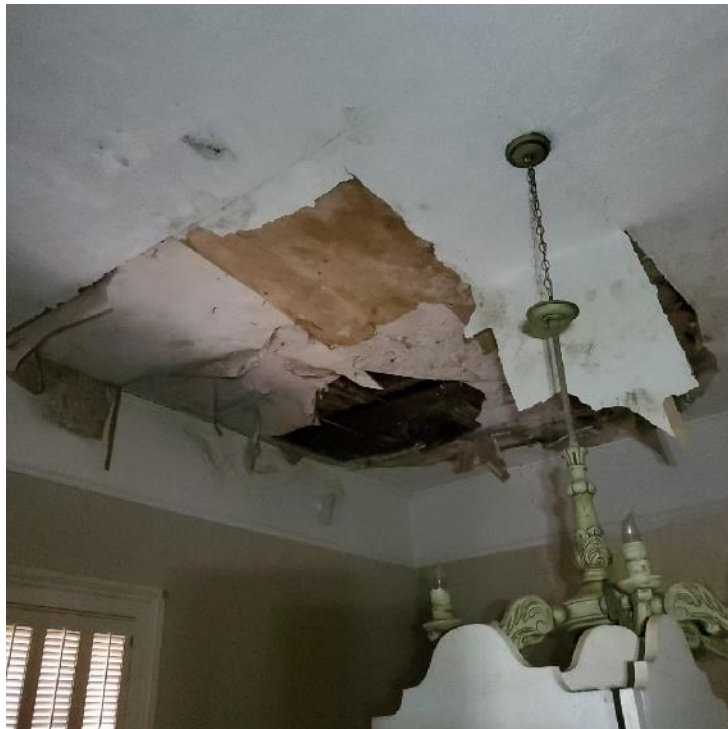
13. Water-related damage to the ceiling was observed at the southwest corner of the main portion of the residence (**Photo 42**). This observation generally aligned with the location of Observation #4.

Photograph 42: View of water related damage to the ceiling at the southwest corner.

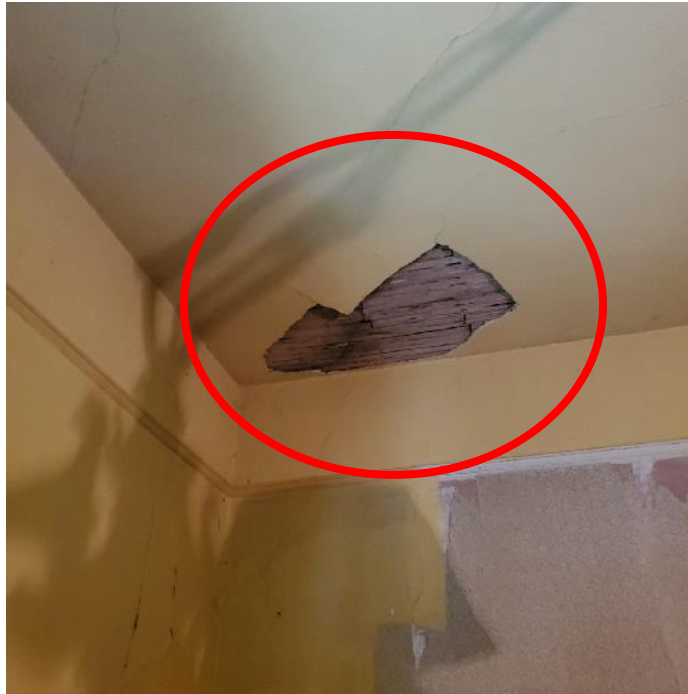
14. A portion of the interior ceiling finishes at the southeast corner of the main portion of the residence had failed (**Photo 43**).
15. A lower ceiling below the original ceiling was constructed in the room located at the northwest corner of the main portion of the residence (**Photo 44**). A lower ceiling below the original ceiling was constructed in the rear portion of the residence.

Photograph 43: View of failed ceiling finishes at the southeast corner (oval).

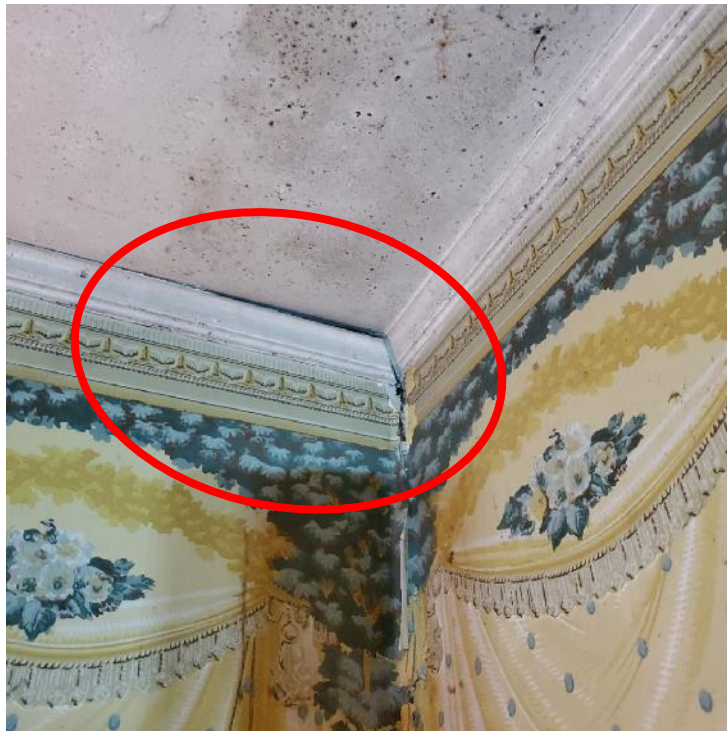
16. A bathroom that appeared to be an addition to the main portion of the structure was observed at the southwest corner of the L-shaped porch (**Photo 45**). A gap was noted between the ceiling finishes and ceiling trim at the southeast corner along the east elevation interior wall (**Photo 46**). The wallpaper at the southeast corner was torn and appeared to be sheared from downward movement (**Photo 47**).

Photograph 46: View of gap between ceiling finishes and wall trim (oval).

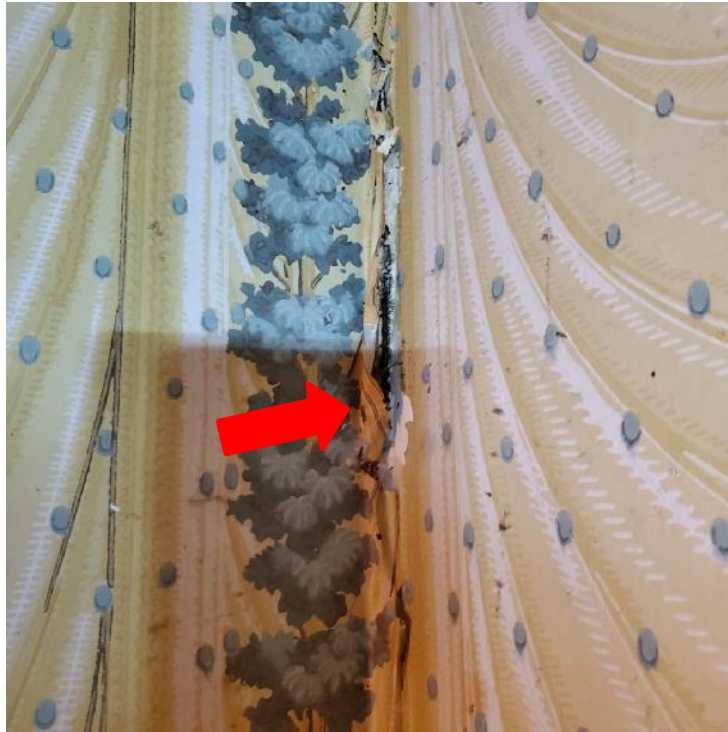
Photograph 47: View of torn wallpaper at southeast corner of bathroom addition (arrow).

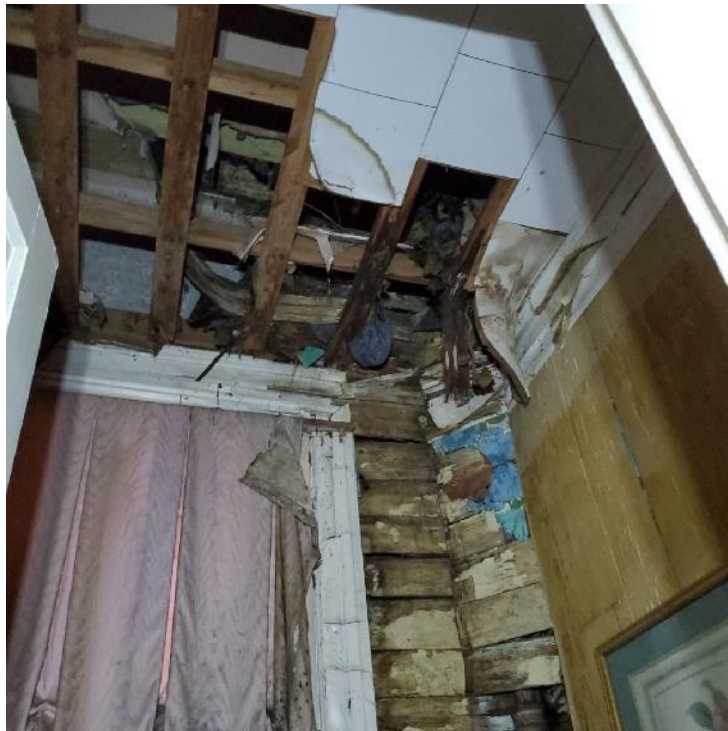
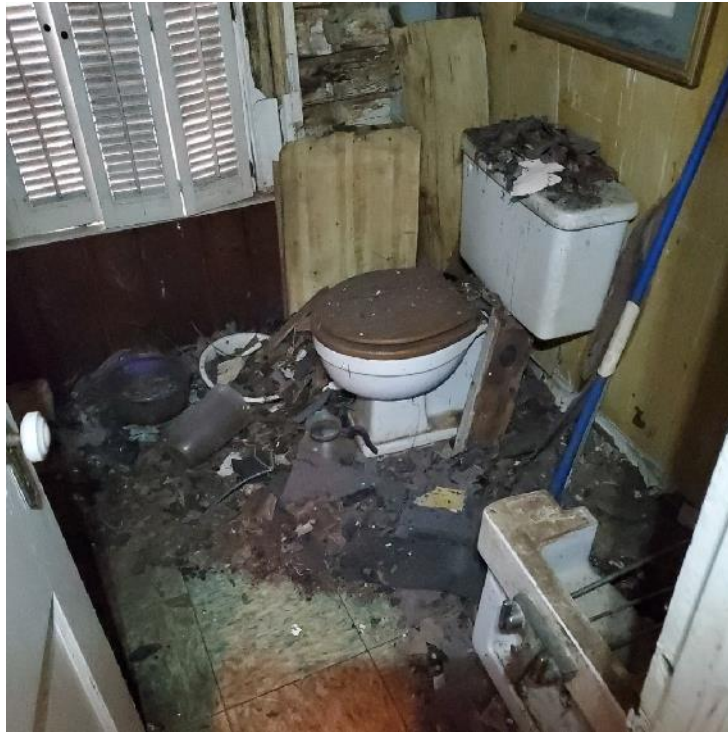
17. Water-related staining and damage to the ceiling and the exterior wall was observed in the bathroom along the west elevation of the rear portion of the residence (**Photo 48**). Debris was noted on the bathroom flooring below (**Photo 49**). Water-related damage and staining at the ceiling and the exterior wall along the eastern elevation at the southwest corner of the bedroom in the rear portion of the residence was observed (**Photos 50 and 51**). These observations generally aligned with the location of Observation #6.

Photograph 48: View of water-related staining and damage at bathroom along west elevation in rear portion of residence.

Photograph 49: View of debris at bathroom along west elevation in rear portion of residence.

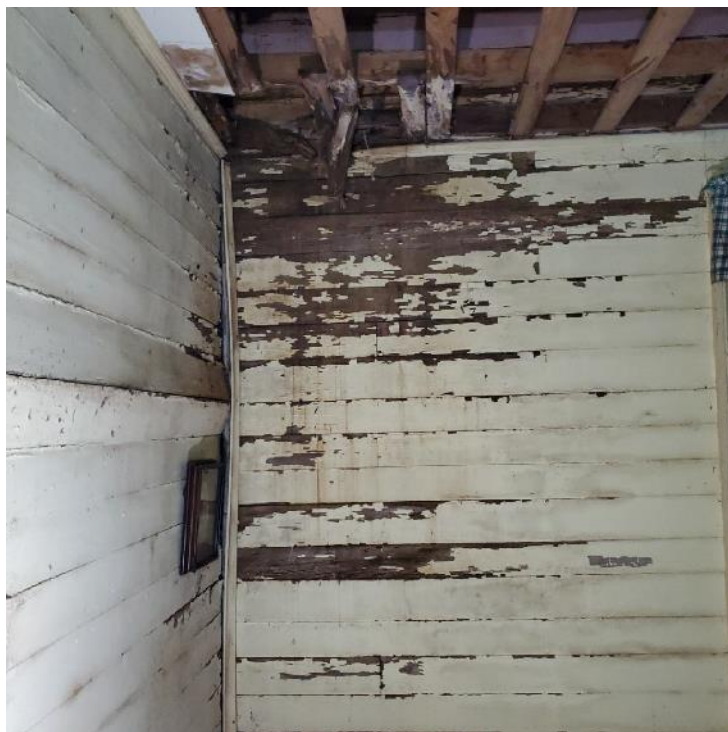
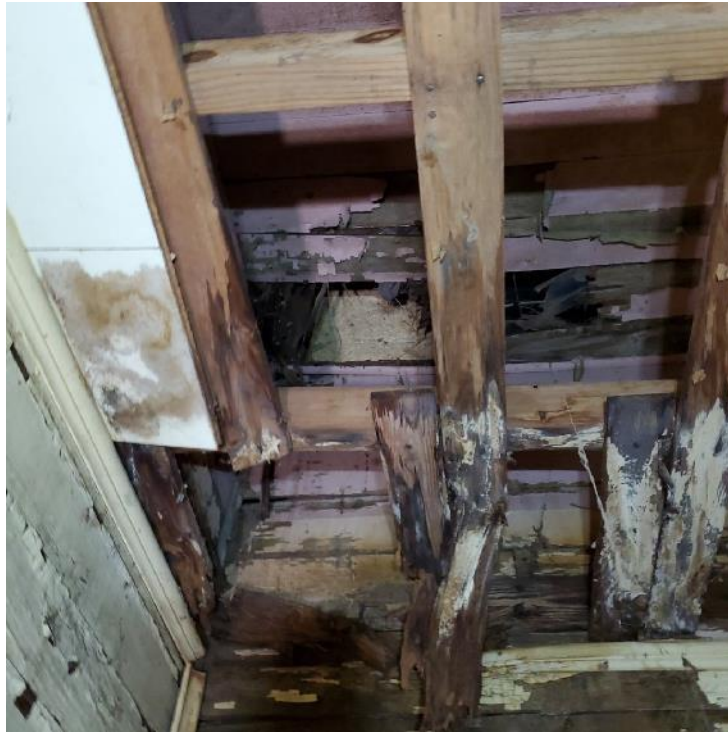
Photograph 50: View of water-related staining and damage in bedroom at north end of the rear portion of residence.

Photograph 51: View of water-related staining and damage in bedroom at north end of the rear portion of residence.

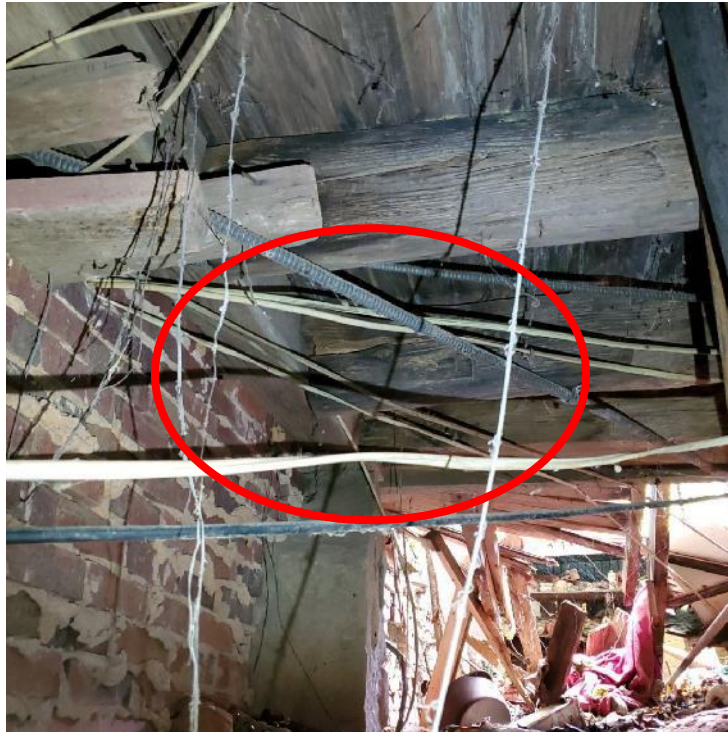
22. Multiple joist members were observed to have cracking extending from the notch at the girder bearing location (**Photo 59**).
23. Potential movement was observed at multiple girder lap joints (**Photo 60**).

Photograph 59: View of split at notched beam end connection (oval).

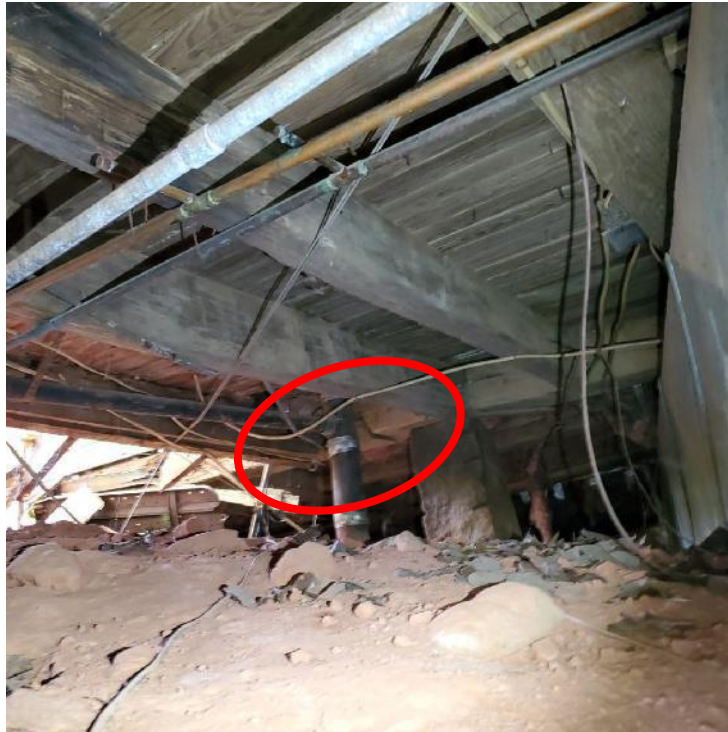
24. A view of the framing under the bathroom addition is provided in **Photo 61**.
25. Multiple wooden posts from the floor framing to the soil were observed (**Photo 62**).

Photograph 61: View of porch framing below bathroom addition. Note the distress of the floor framing at the beam to girder connection (oval).

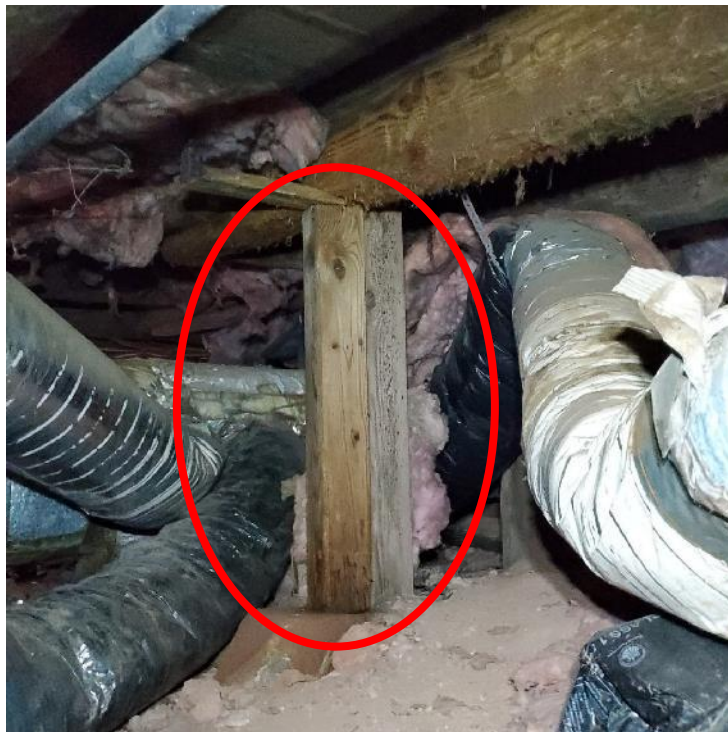
Photograph 62: Representative view of wooden post to ground (oval).

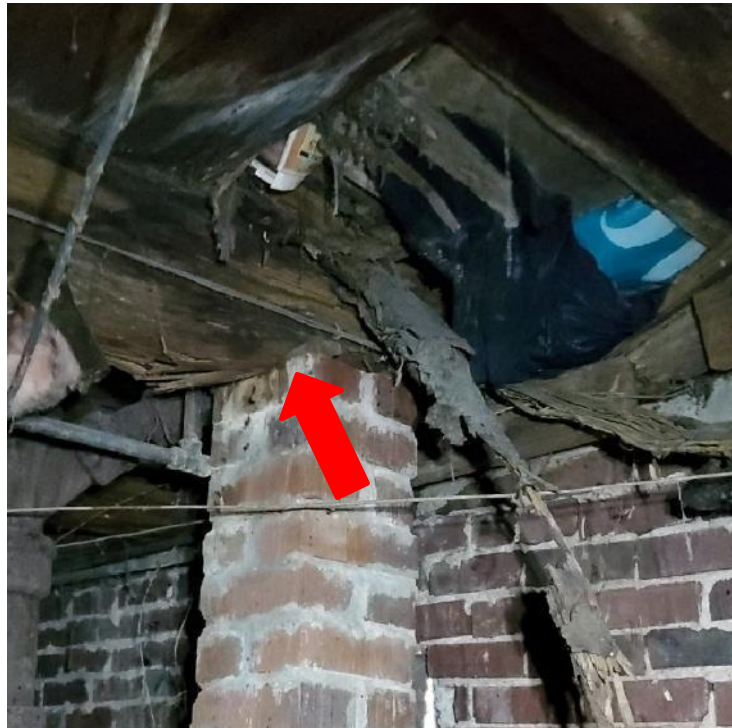
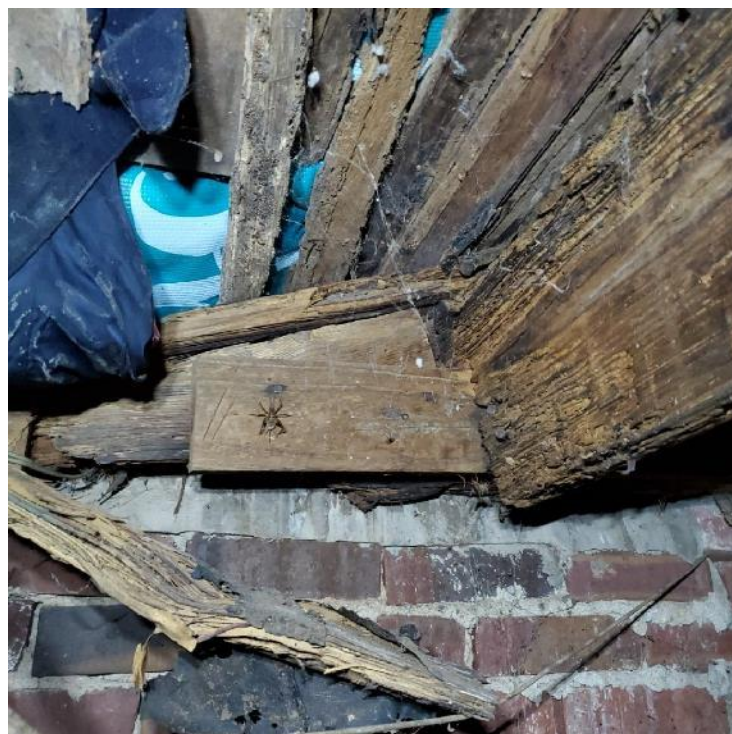
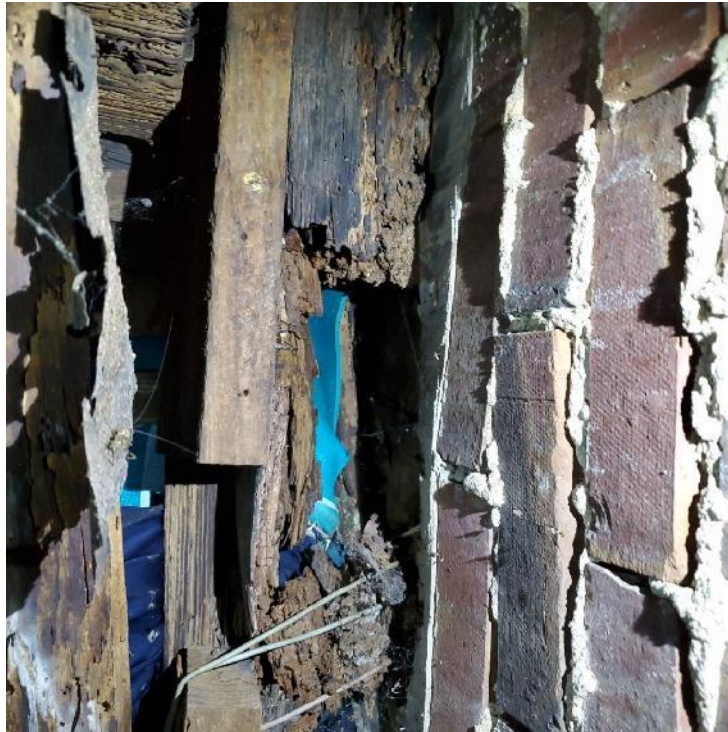
26. Insect-related and/or water-related damage was observed in multiple locations within the crawlspace.
 - a. Insect and water-related damage was observed to the flooring, joist, and girder along the west elevation within the rear portion of the residence (**Photos 63 through 65**). Crushing of the joist was observed at the pier bearing location. Discontinuous supplemental framing was installed at a portion of the perimeter girder that had complete section loss.

It is Terracon's opinion that the deteriorated floor framing noted at the rear portion of the residence is a hazard and a life safety condition that could result in the partial collapse of the structure, as previously discussed with the Client. Further, it is Terracon's opinion that the main portion of the structure has the potential to be compromised should the rear portion of the structure experience a partial collapse.

Photograph 63: View of brick pier at location of insect and water related damage to flooring.
Note the crushed beam at the pier bearing (arrow).

Photograph 64: View of insect and water related damage at beam, girder, and flooring.

Photograph 65: View of insect and moisture related damage at perimeter girder.

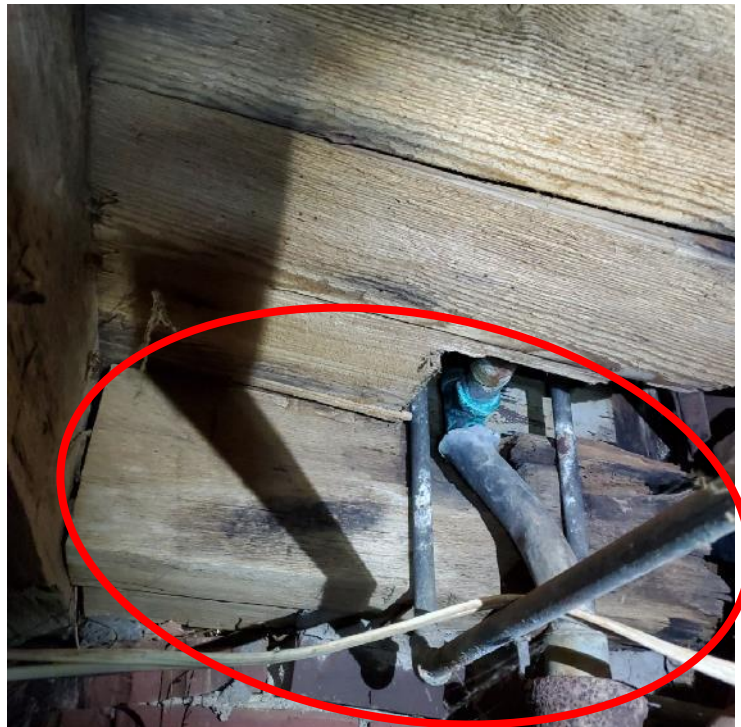
- b. Water and/or insect-related damage was observed to the flooring, a joist, and the girder along the west elevation within the rear portion of the residence (**Photos 66 and 67**). This location was to the south, in close proximity to the framing noted in observation 26 "a."

Photograph 66: View of insect and/or water related damage and downward displacement of the perimeter girder, see additional photo below (oval).

Photograph 67: View of insect and/or water related damage, see additional photo above.
