**Staff Report and Comments
John Douglas House
7601 Christie Lane, Charlotte
Application for COA HLC282**

Issued: November 4, 2022
Revision 1: February 8, 2023
Terracon Project No. FY226106

Re: Structural Evaluation Services
Limited Visual Condition Assessment
John Douglas House
7601 Christie Lane
Charlotte, North Carolina 28202

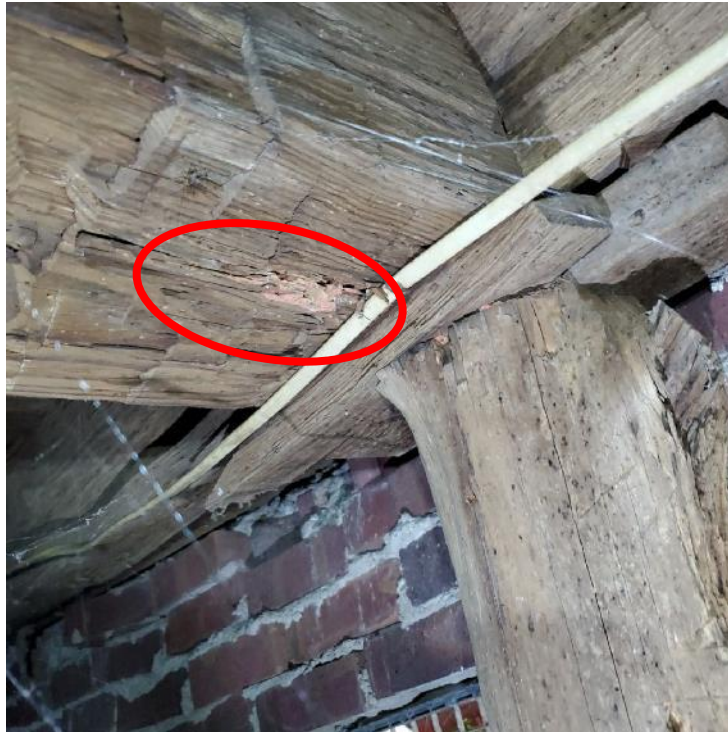
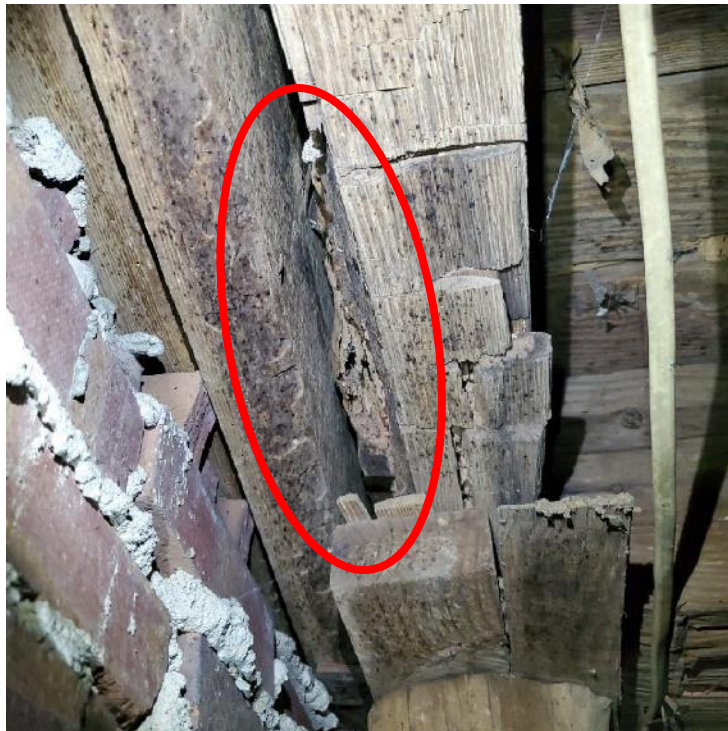
- c. Insect-related damage was observed along a wood post and at the framing above the wood post (**Photos 68 through 70**)
27. Potential insect-related damage was observed in multiple locations within the crawlspace.

Photograph 68: View of wooden post to ground where insect related damage was observed (oval).

Photograph 69: View of insect related damage (oval).

Photograph 70: View of insect related damage (oval).

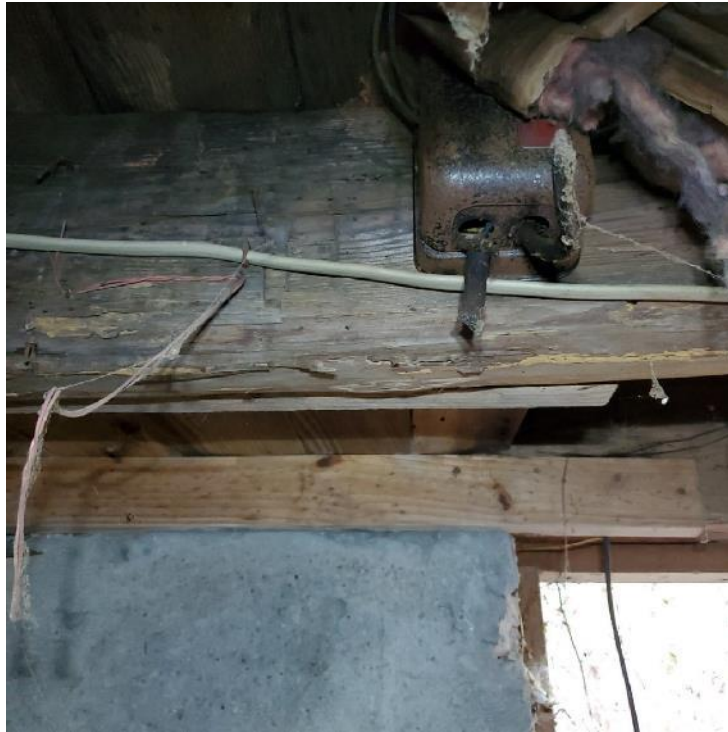
- a. Potential insect-related damage was observed along a joist at the rear portion of the residence (**Photo 71**)
 - b. Potential insect-related damage was observed along a joist at the rear portion of the residence (**Photo 72**)

Photograph 71: View of potential insect related damage.

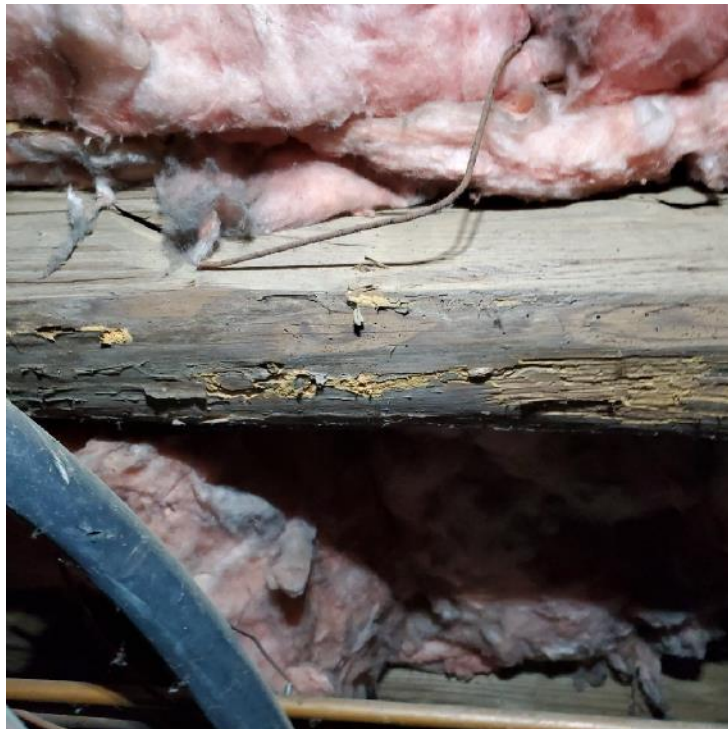
Photograph 72: View of potential insect related damage (oval).

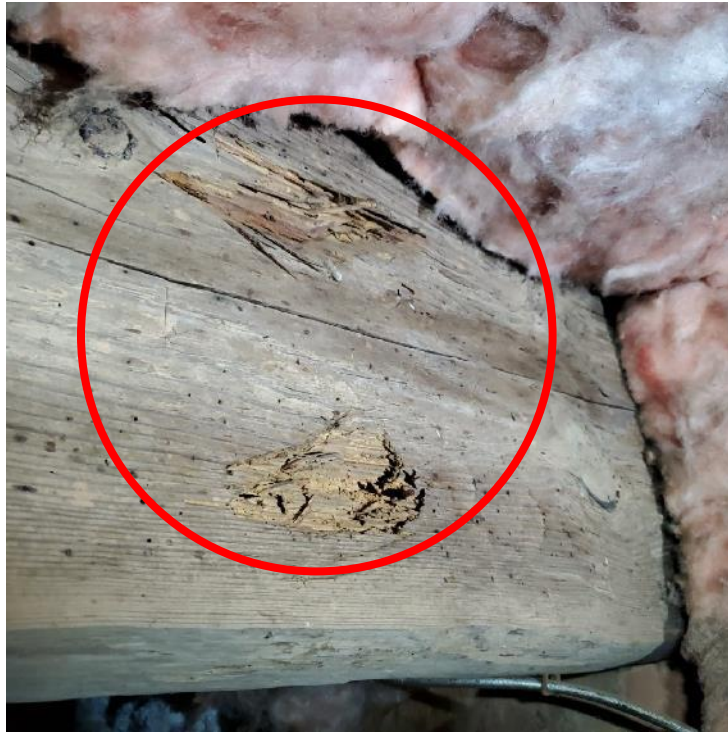
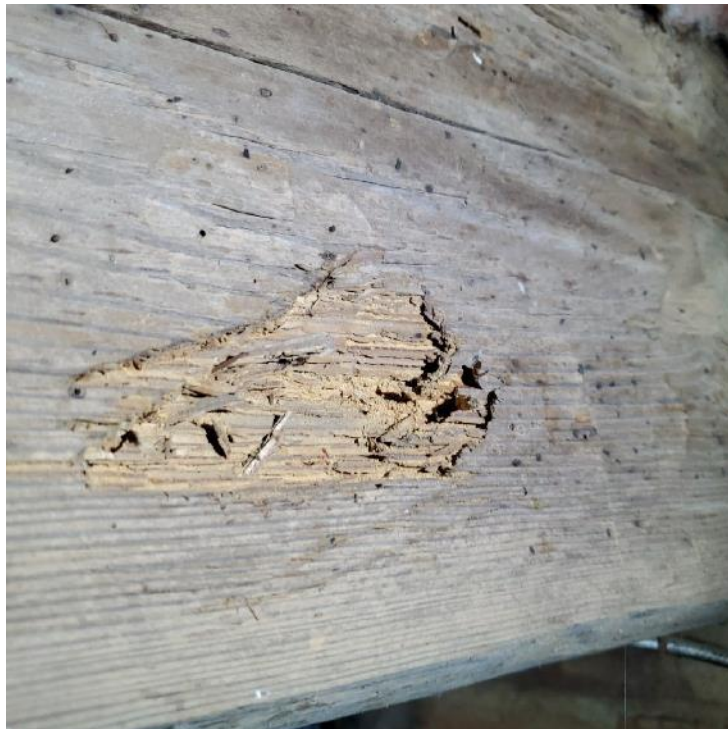
- c. Potential insect-related damage was observed along a joist at the main portion of the residence (**Photos 73 and 74**)
28. Moisture-related damage was visually observed on a portion of floor framing at the southwest corner of the original portion of the residence (**Photo 75**).

Photograph 73: View of potential insect related damage (oval).

Photograph 74: Close up view of potential insect related damage.

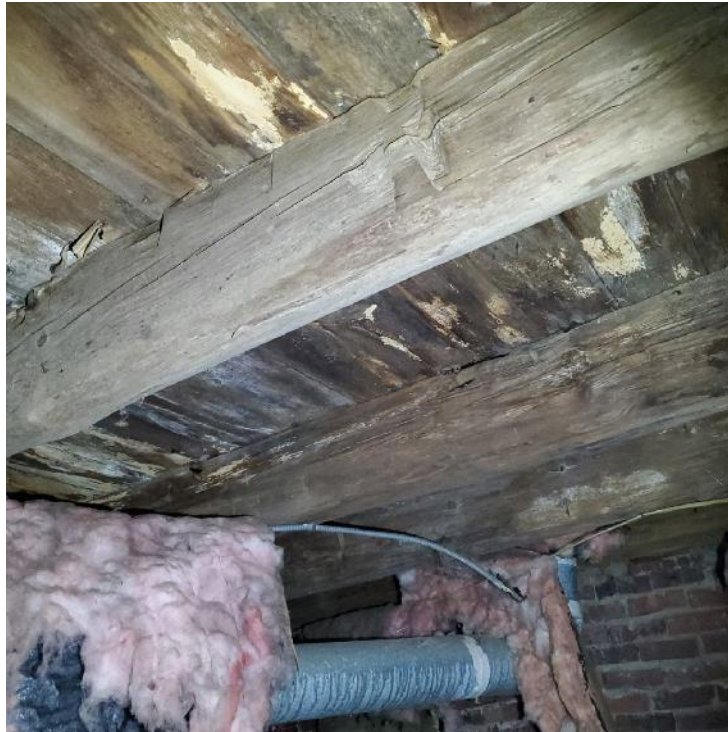
Photograph 75: View of moisture related damage at wood flooring.
