**Staff Report and Comments
John Douglas House
7601 Christie Lane, Charlotte
Application for COA HLC282**

Exhibits presented to and considered by the Commission:

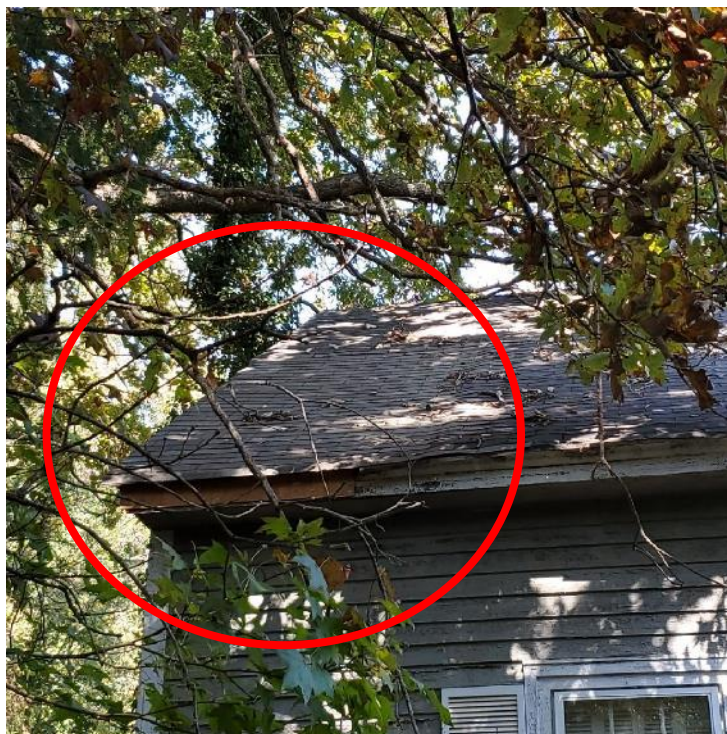
Photograph 22: View of different color shingles and replaced fascia at southwest corner (oval).

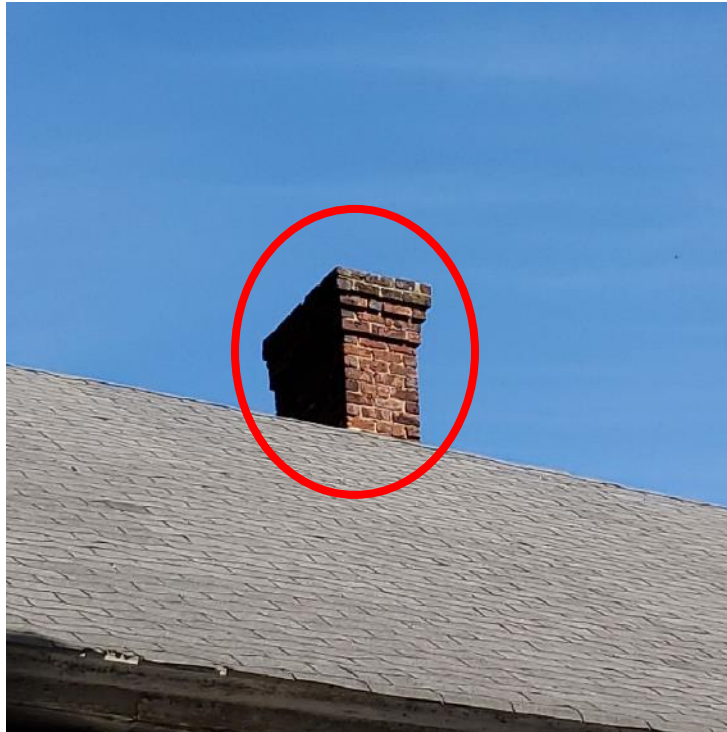
Photograph 23: View of chimney above roof level (oval).

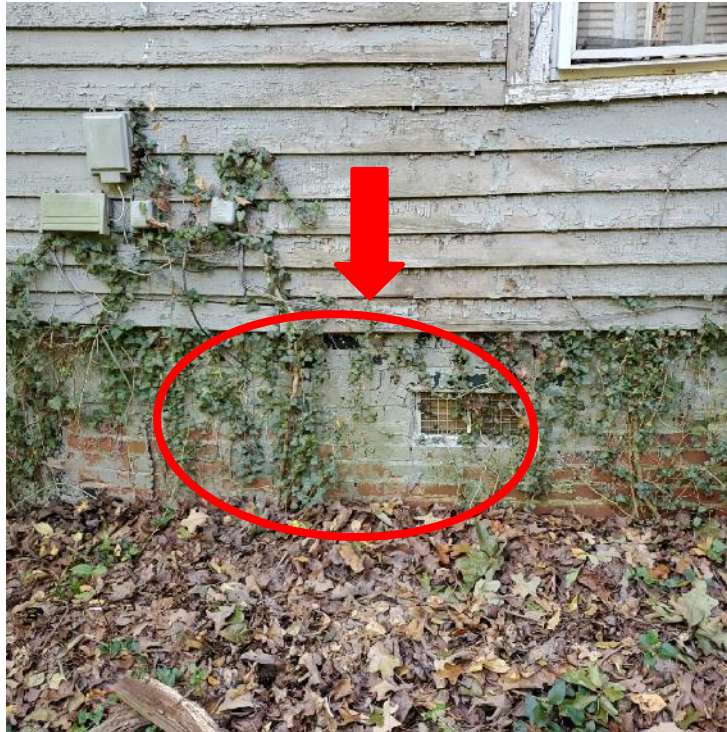
Photograph 25: View of sag in siding at the first-floor level along the west elevation of the rear portion of the residence (arrow). Note the step crack in the brick masonry infill (oval).

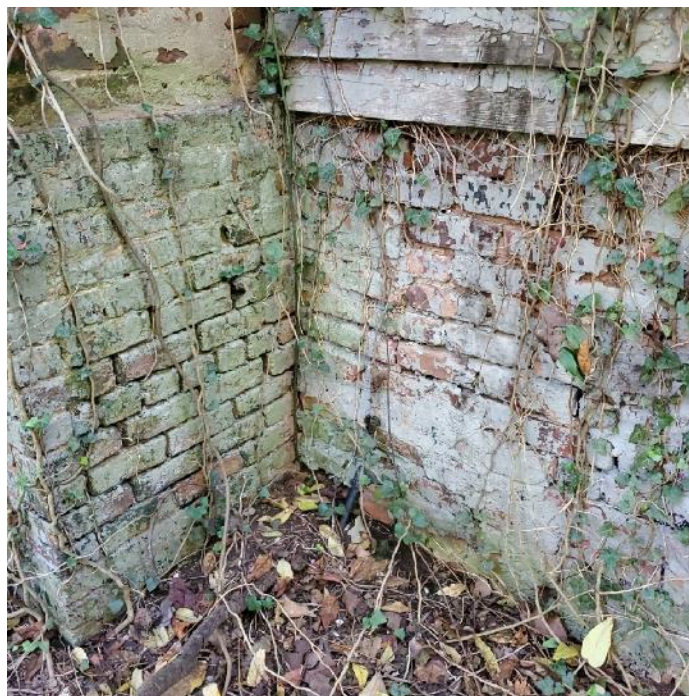
Photograph 26: View of recessed mortar joints in brick infill masonry and in the exterior chimney masonry.

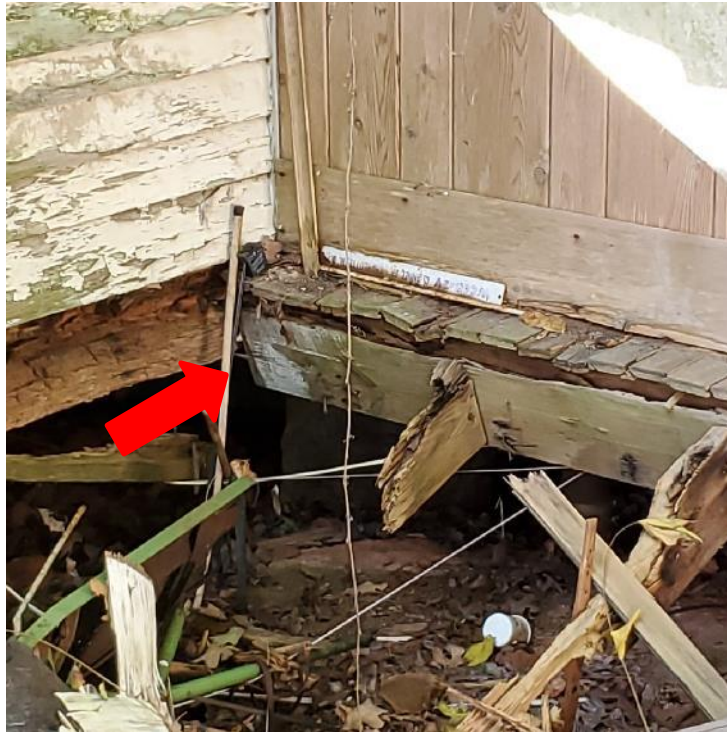
Photograph 31: View of failed joist connection below bathroom addition (arrow).

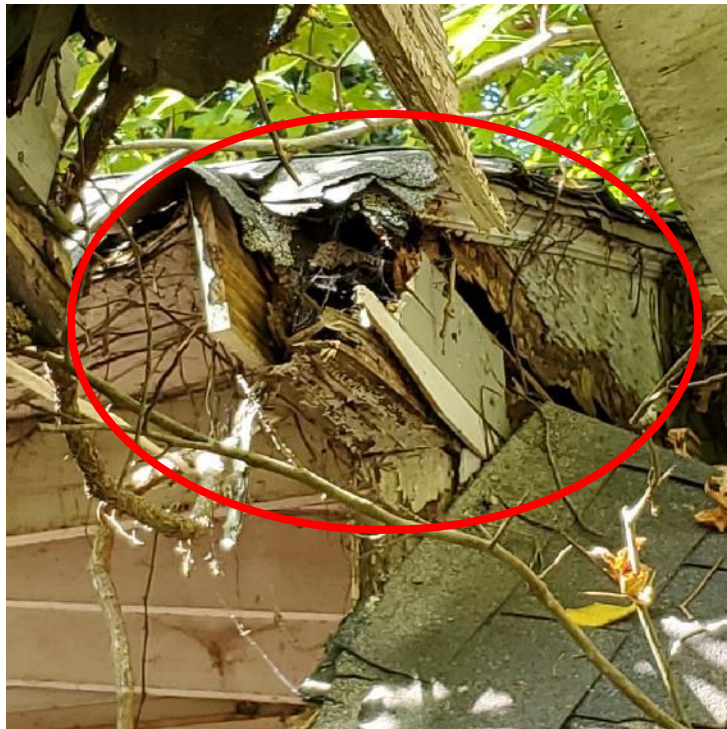
Photograph 32: View of water and/or insect related damage to porch framing (oval).

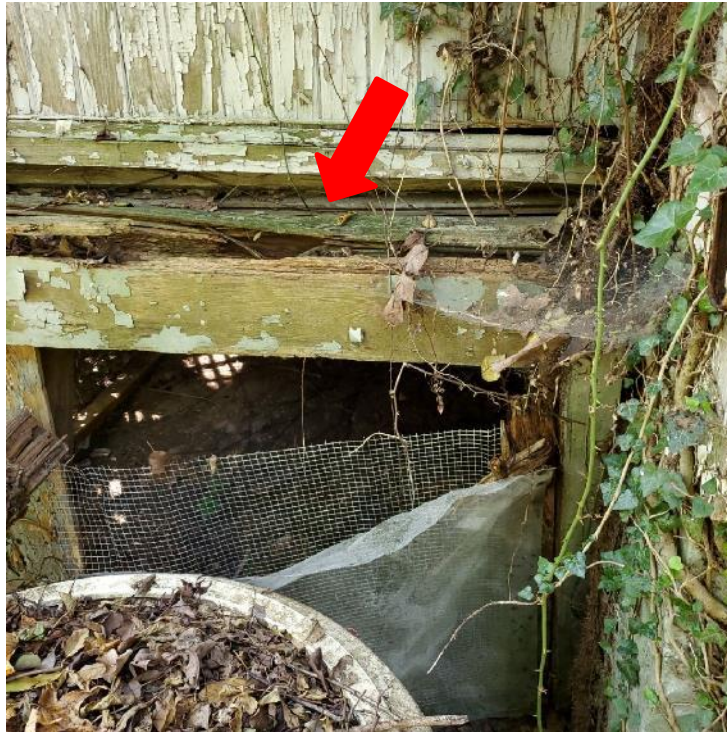
Photograph 33: View of water and/or insect related damage to porch framing (arrow).

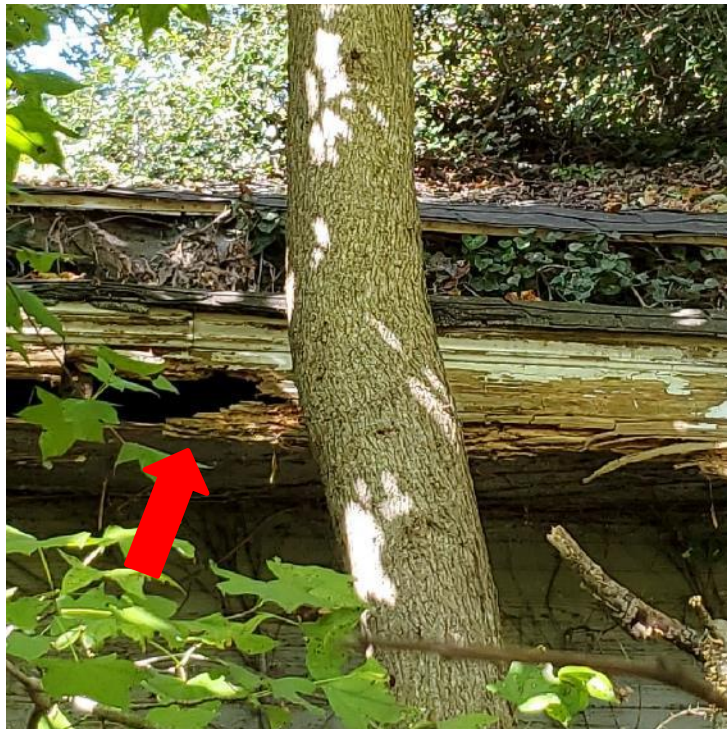
Photograph 34: View of water and/or insect related damage to porch framing (arrow).

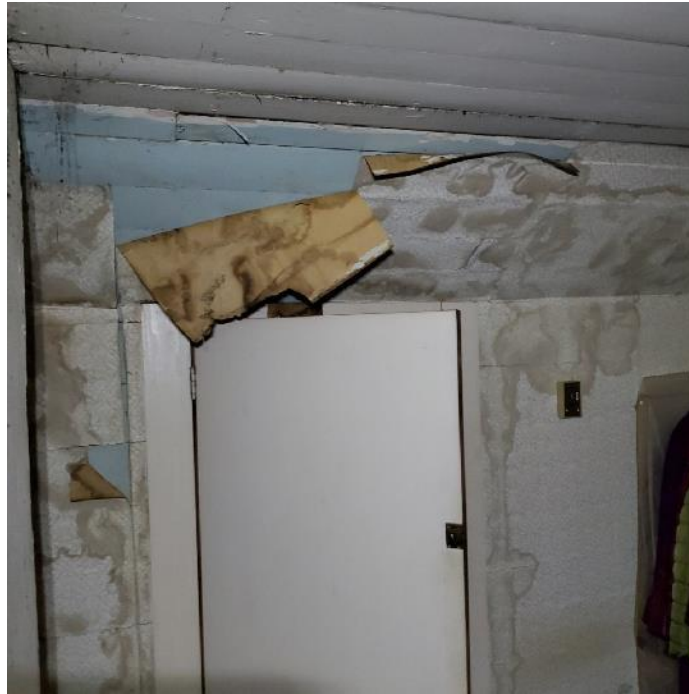
Photograph 35: View of water-related staining on wallpaper.

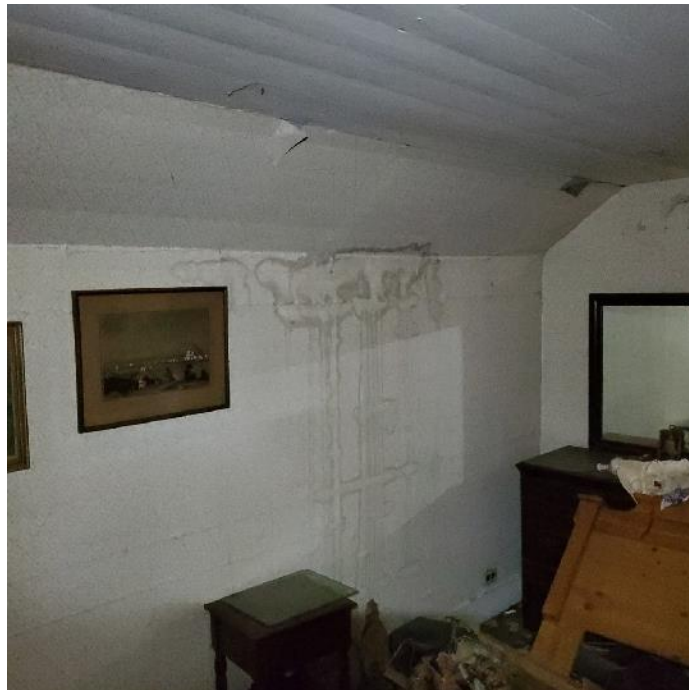
Photograph 36: View of water-related staining on wallpaper.

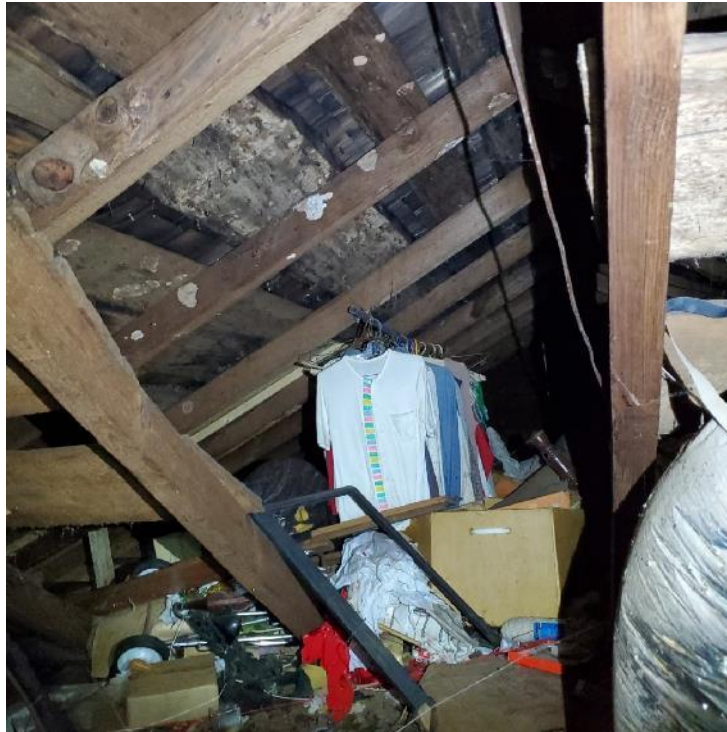
Photograph 37: View of storage in attic space at original to rear portion transition.

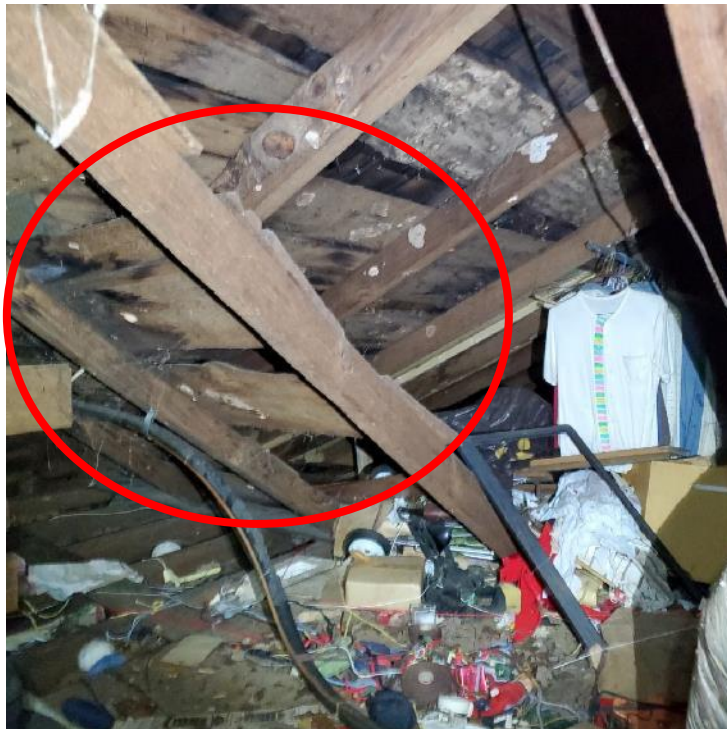
Photograph 38: View of water-related staining at original to rear portion roof transition (oval).

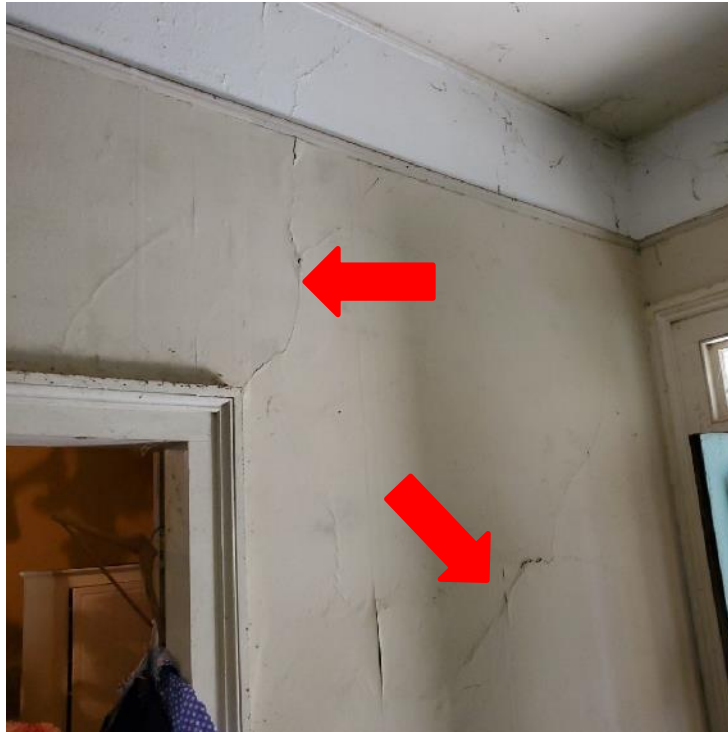
Photograph 39: Representative view of cracking within interior finishes of the original portion of the residence (arrows).

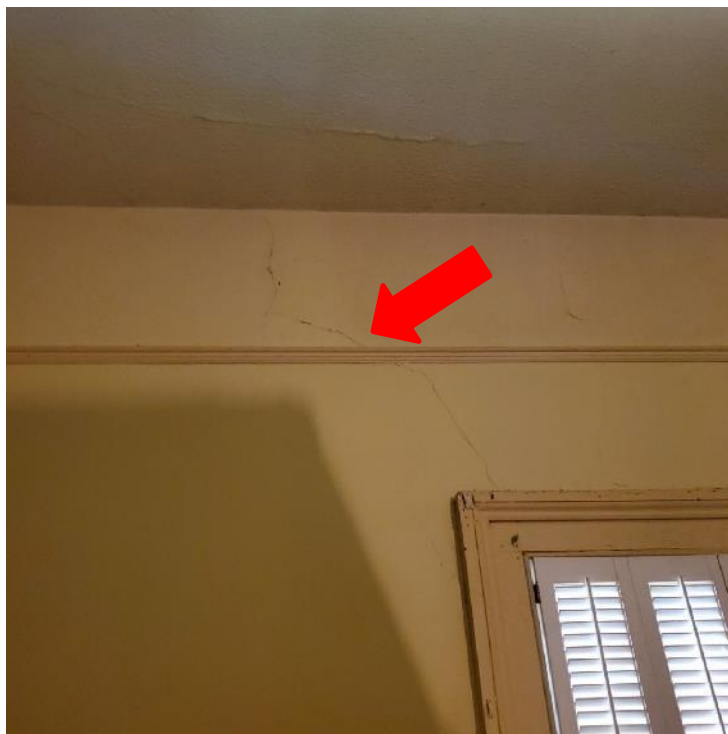
Photograph 40: Representative view of cracking within interior finishes of the original portion of the residence (arrow).

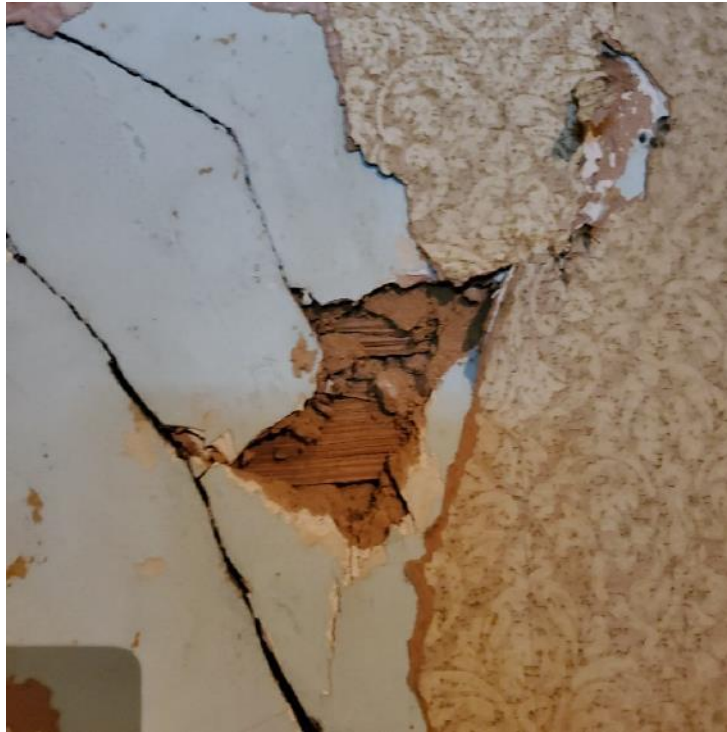
Photograph 41: View of wall construction at failed interior finish location.

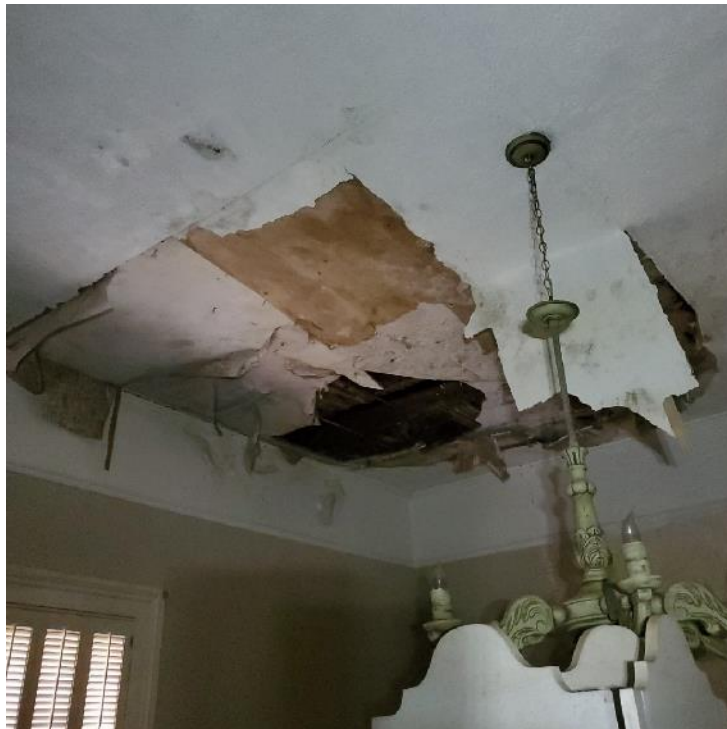
Photograph 42: View of water related damage to the ceiling at the southwest corner.

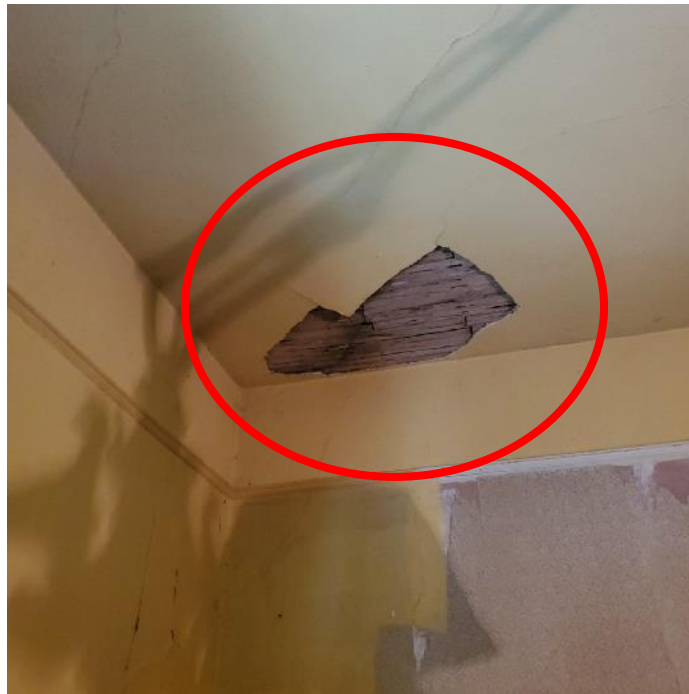
Photograph 43: View of failed ceiling finishes at the southeast corner (oval).

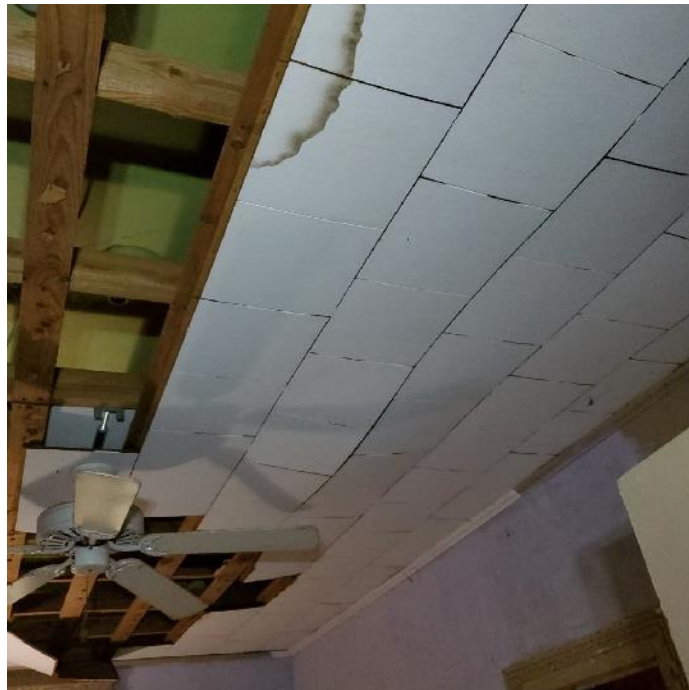
Photograph 44: Representative view of ceiling below original ceiling.

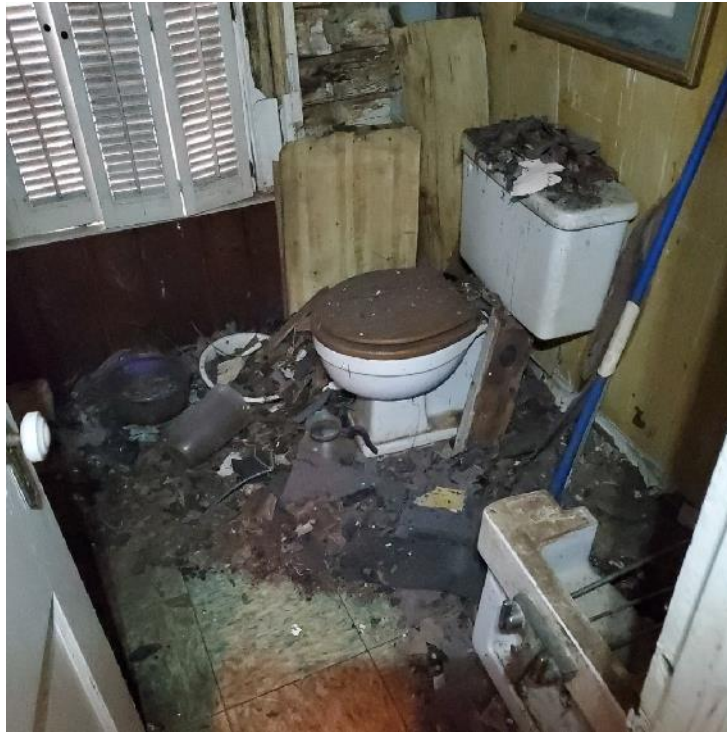
Photograph 49: View of debris at bathroom along west elevation in rear portion of residence.

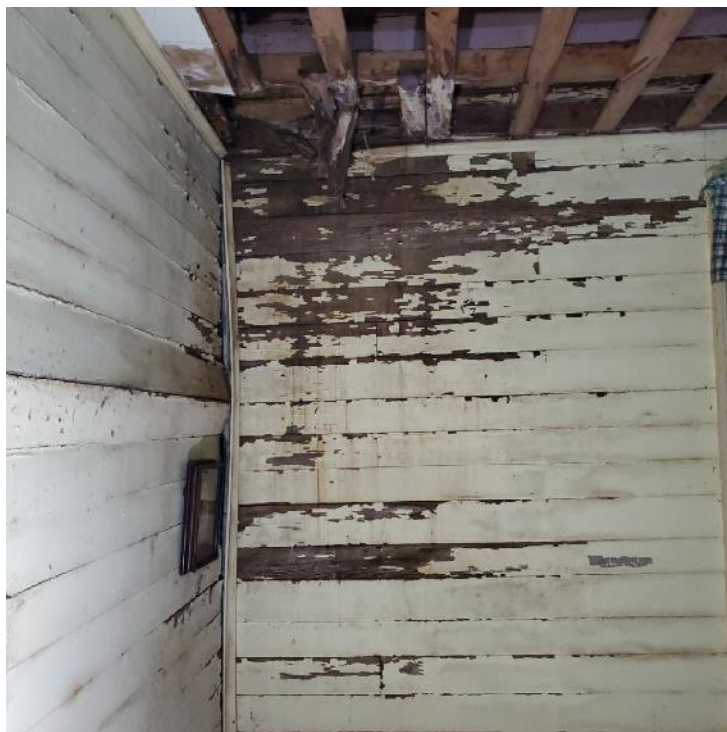
Photograph 50: View of water-related staining and damage in bedroom at north end of the rear portion of residence.

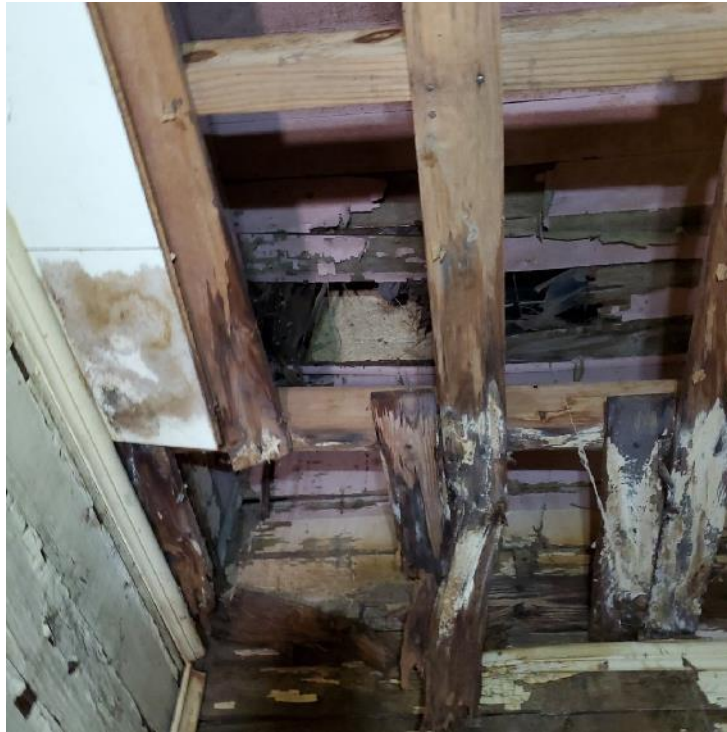
Photograph 51: View of water-related staining and damage in bedroom at north end of the rear portion of residence.

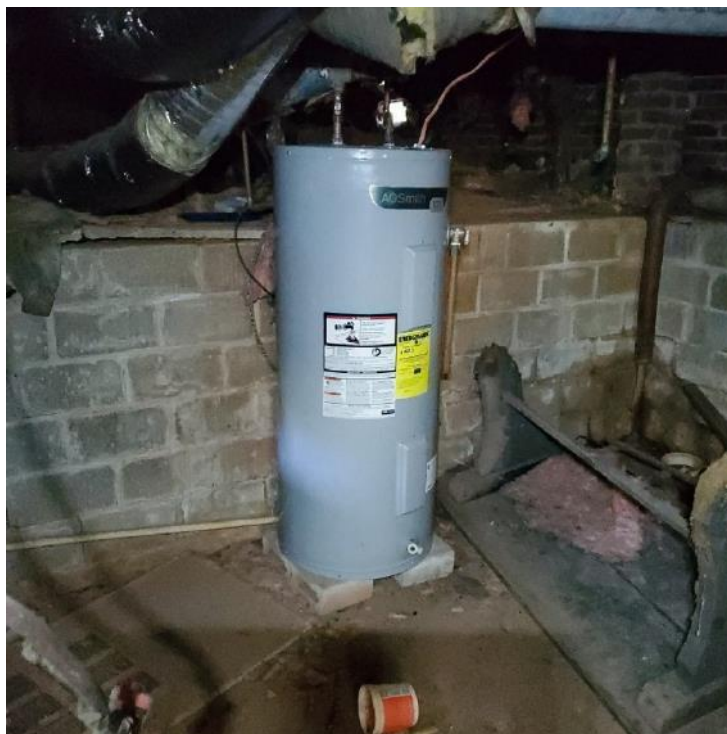
Photograph 52: View of lowered crawlspace floor in the rear portion of the crawlspace.

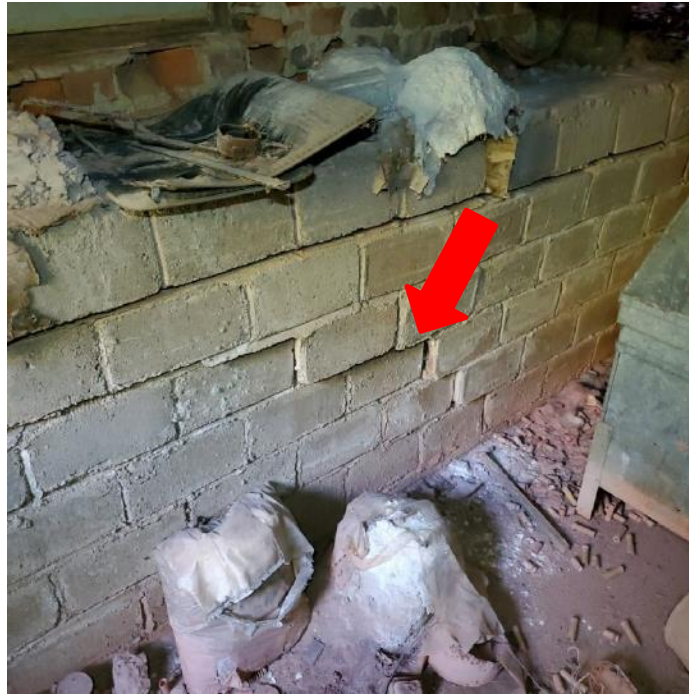
Photograph 53: View of cracking and out of plane displacement of crawlspace CMU retaining wall (arrow).

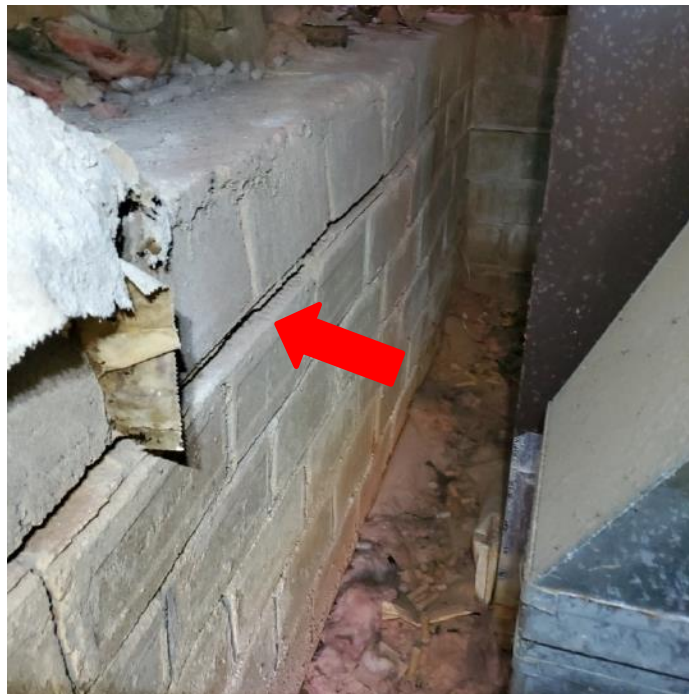
Photograph 54: View of cracking and out of plane displacement of crawlspace CMU retaining wall (arrow).

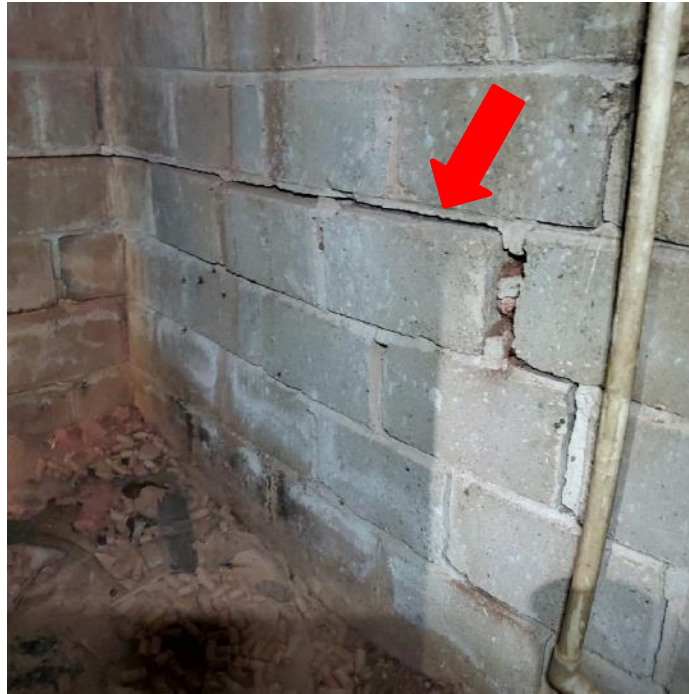
Photograph 55: View cracking and out of plane displacement of crawlspace CMU retaining wall (arrow).

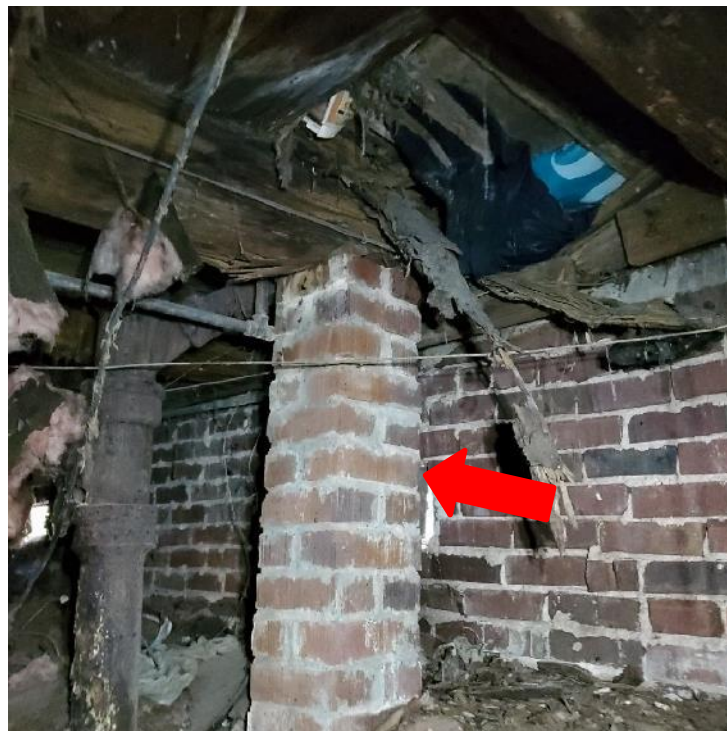
Photograph 56: View of brick masonry pier in crawlspace (arrow).

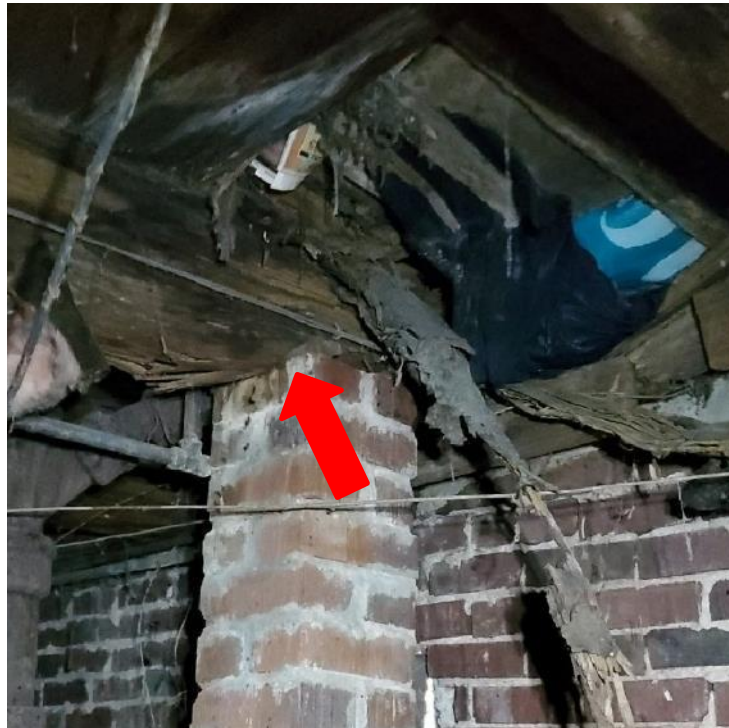
Photograph 63: View of brick pier at location of insect and water related damage to flooring. Note the crushed beam at the pier bearing (arrow).

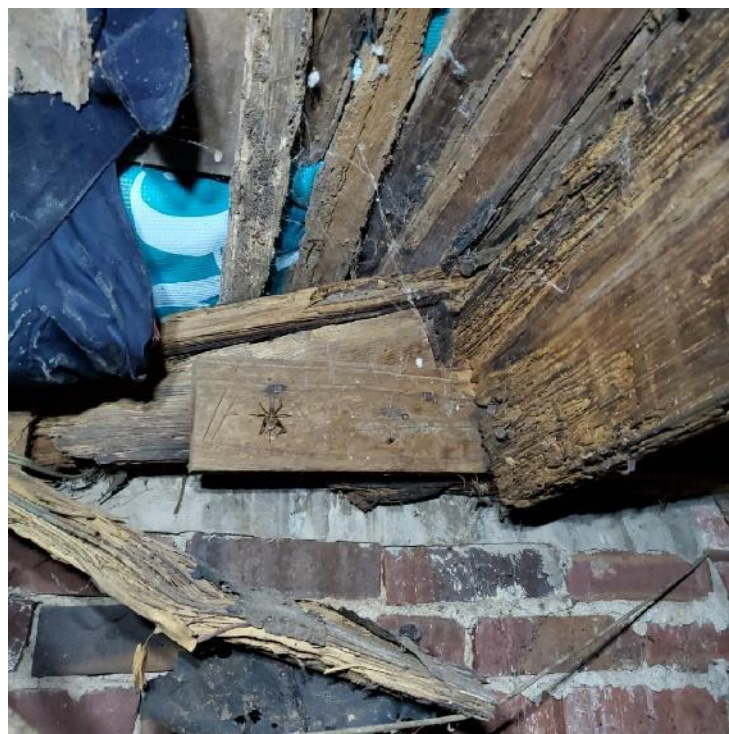
Photograph 64: View of insect and water related damage at beam, girder, and flooring.

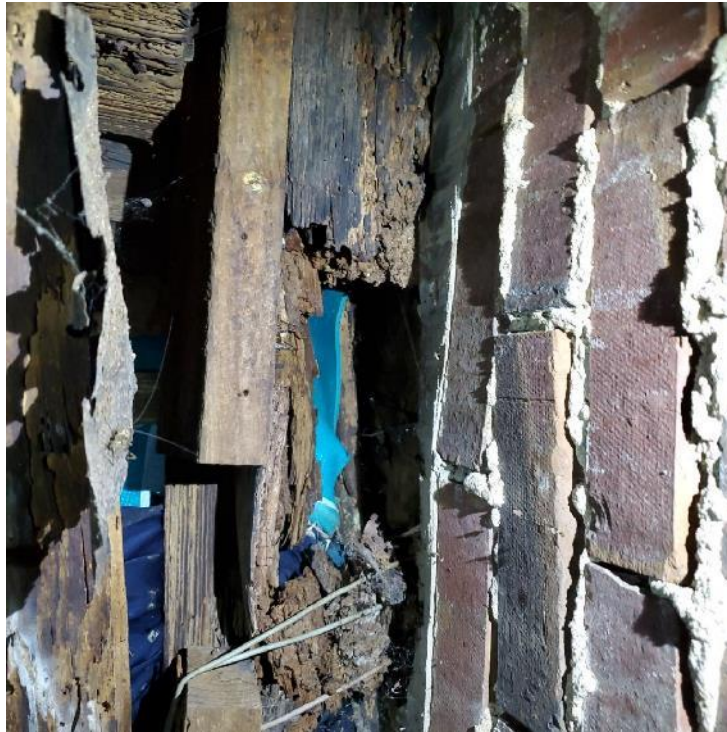
Photograph 65: View of insect and moisture related damage at perimeter girder.

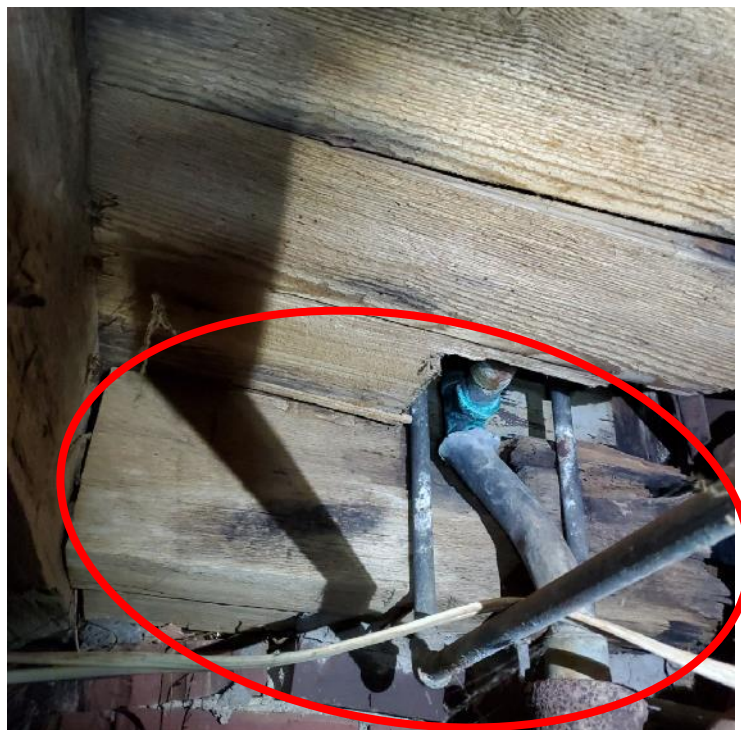
Photograph 66: View of insect and/or water related damage and downward displacement of the perimeter girder, see additional photo below (oval).

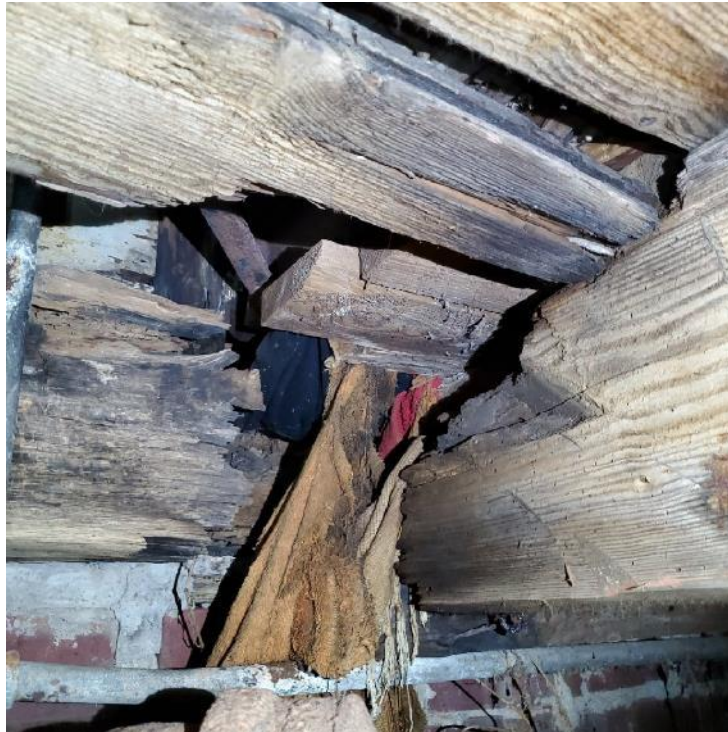
Photograph 67: View of insect and/or water related damage, see additional photo above.

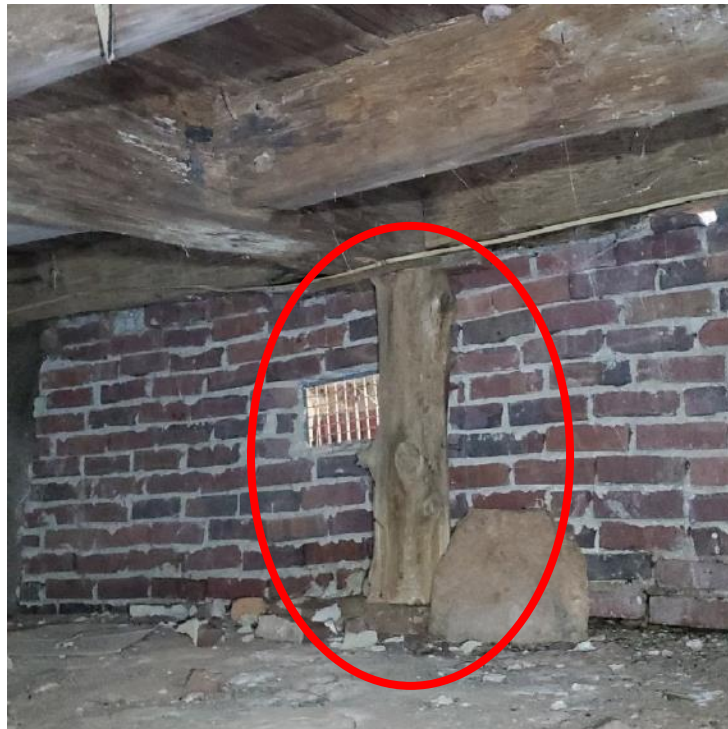
Photograph 68: View of wooden post to ground where insect related damage was observed (oval).

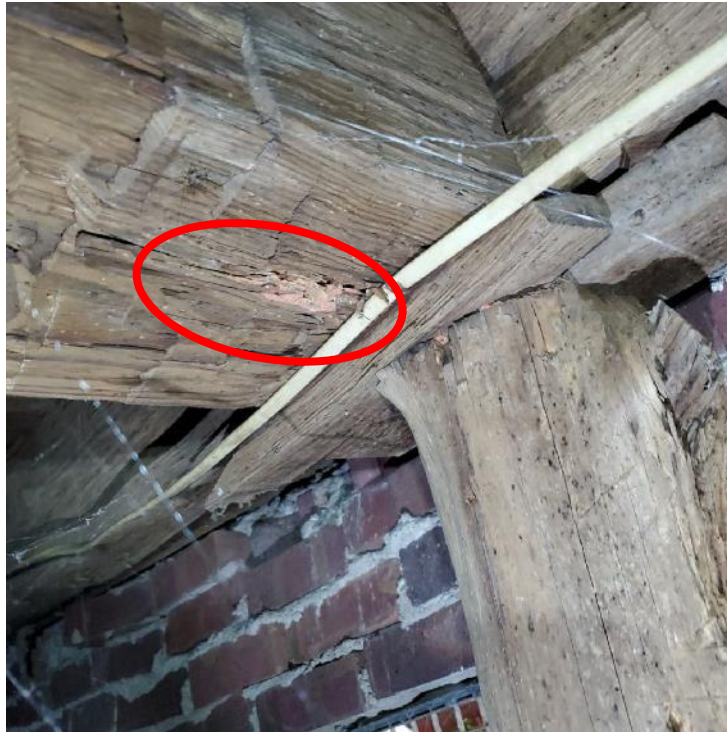
Photograph 69: View of insect related damage (oval).

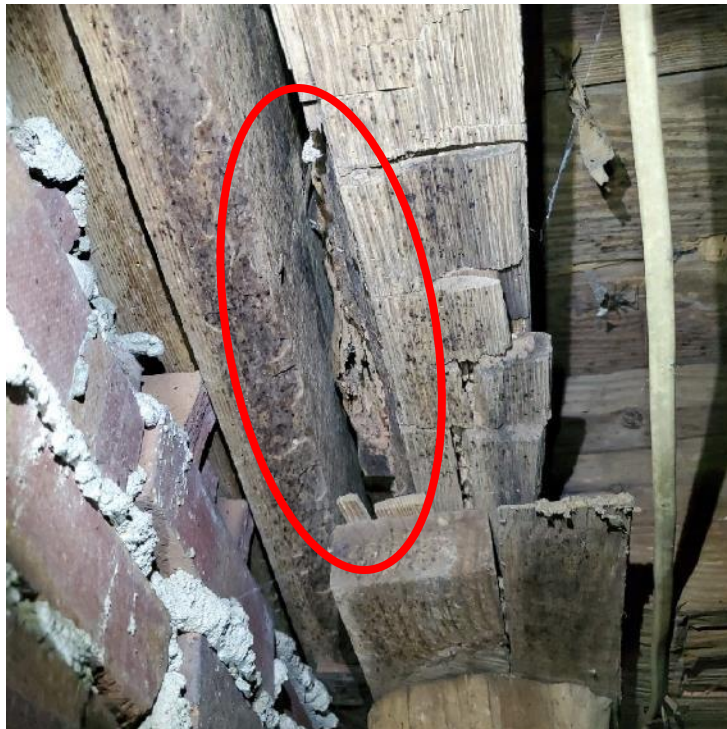
Photograph 70: View of insect related damage (oval).

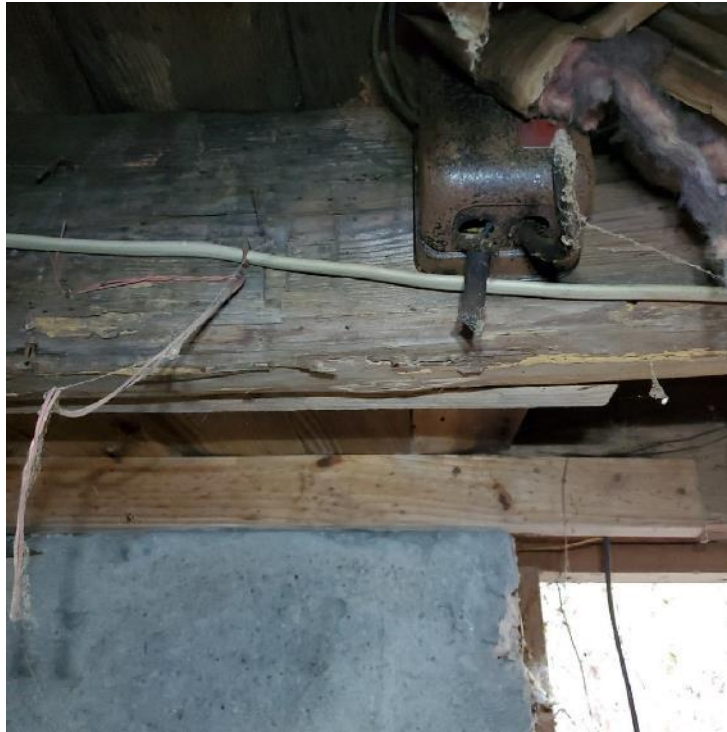
Photograph 71: View of potential insect related damage.

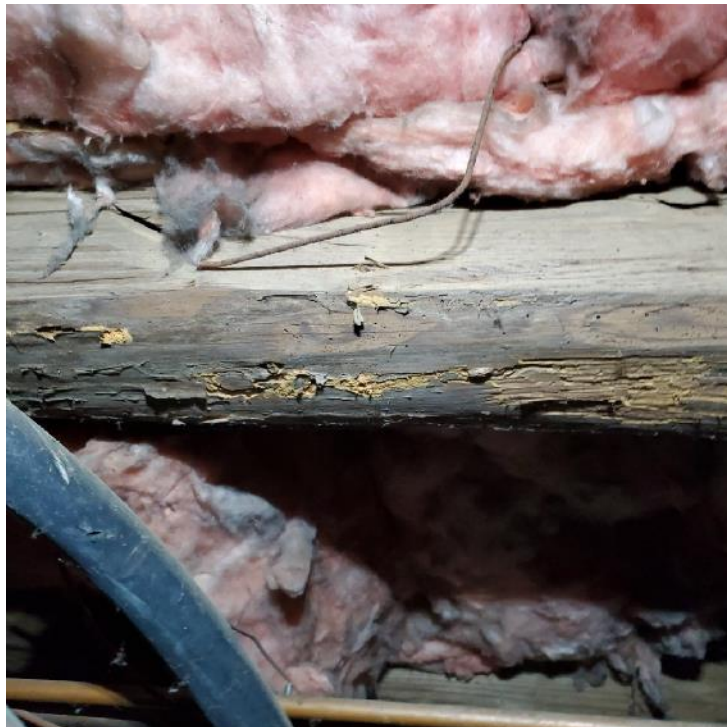
Photograph 72: View of potential insect related damage (oval).

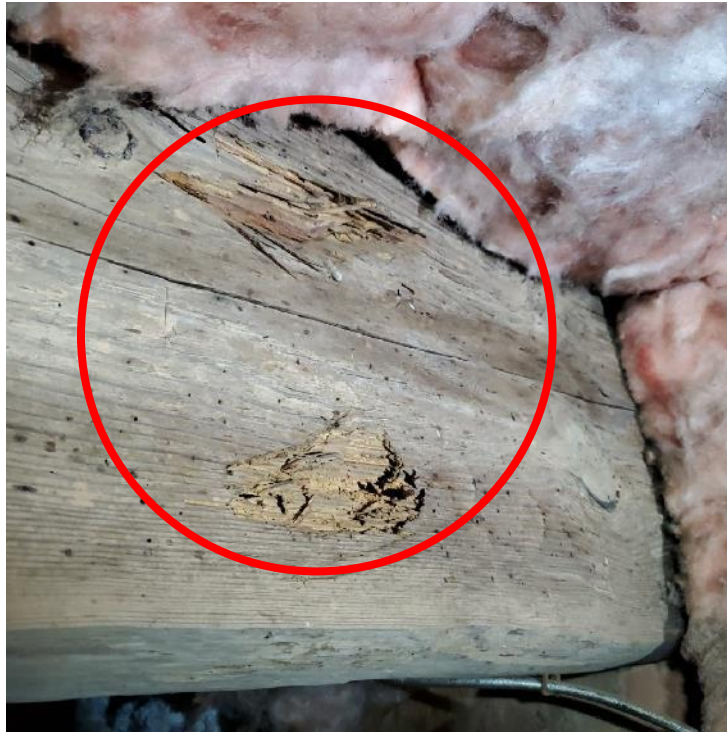
Photograph 73: View of potential insect related damage (oval).

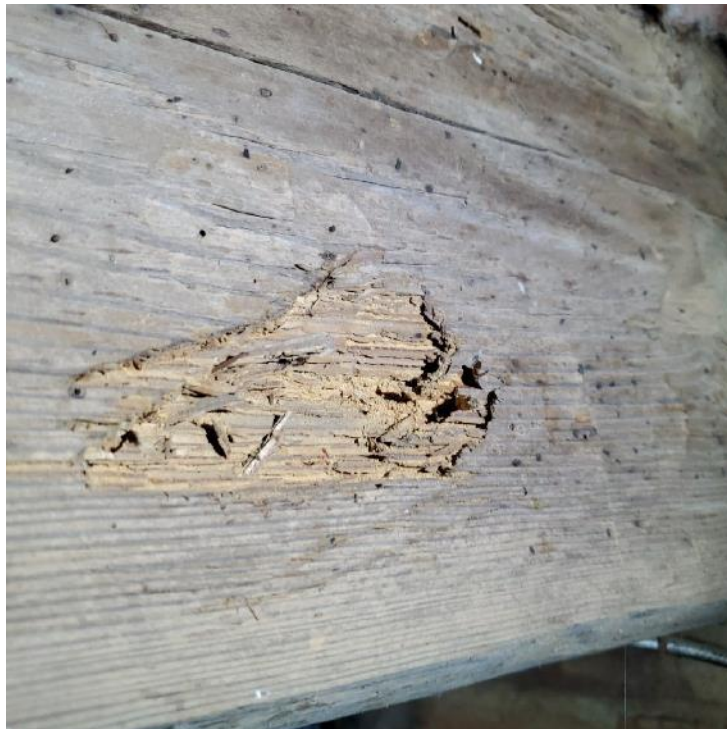
Photograph 74: Close up view of potential insect related damage.

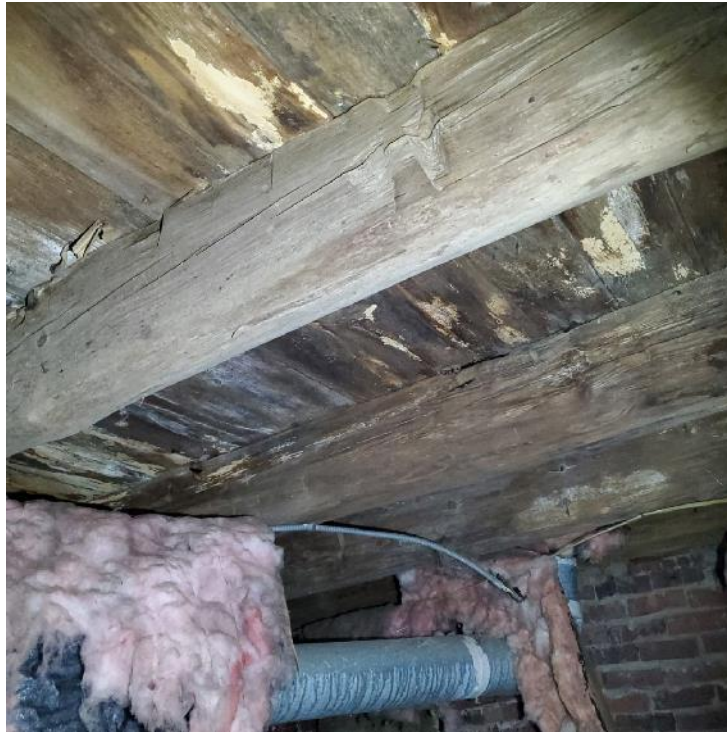
Photograph 75: View of moisture related damage at wood flooring.
