PROPERTY CONDITION ASSESSMENT

EXCELSIOR CLUB
921 BEATTIES FORD ROAD
CHARLOTTE, NORTH CAROLINA

ECS PROJECT NO. 48:4336

JULY 9, 2025

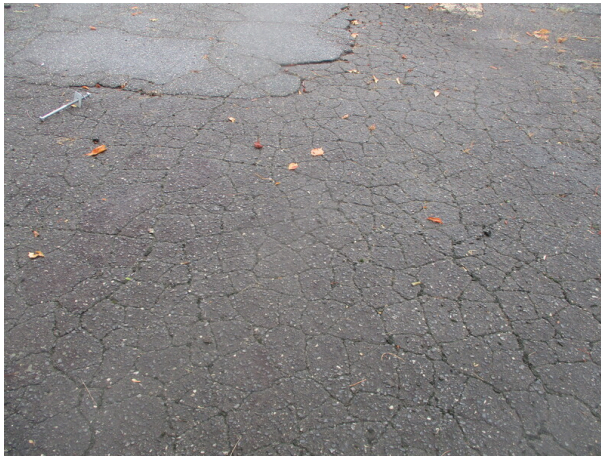
Typical pavement distress

Cost Recommendation	EUL	EFF AGE	RUL	Year	Cost
MILL, OVERLAY AND RESTRIPE EXISTING ASPHALT	20	-	20	1	\$68,200
Total					\$68,200

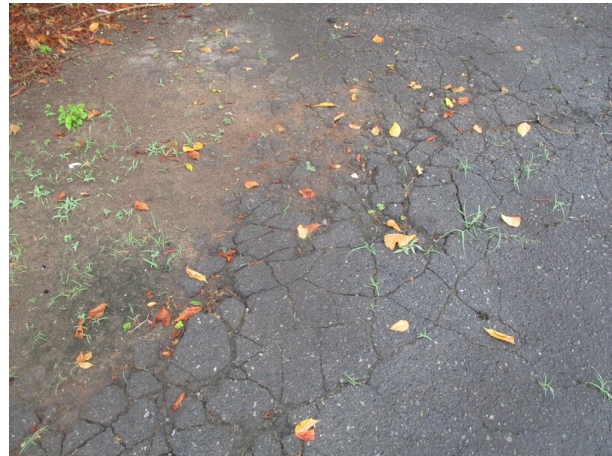
Typical pavement distress, failed overlay

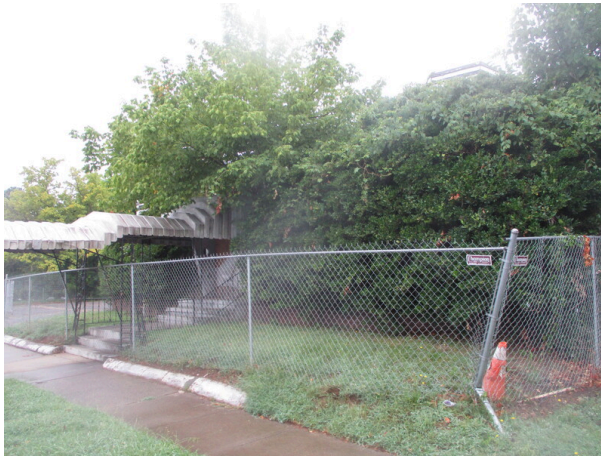
Chain link perimeter fencing was observed around the site, with a gate at the northwest corner. Localized damage to the fencing was observed at the northeast and southwest corners, with fallen tree impact apparent at the southwest corner. We presume the fencing was installed when the building was vacated. We recommend repairs if the fencing is to remain.

Extreme vegetation overgrowth at east elevation, damaged fencing

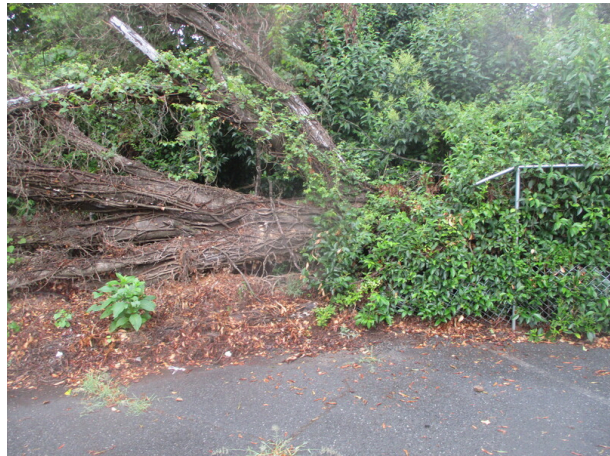
Fencing damaged by tree

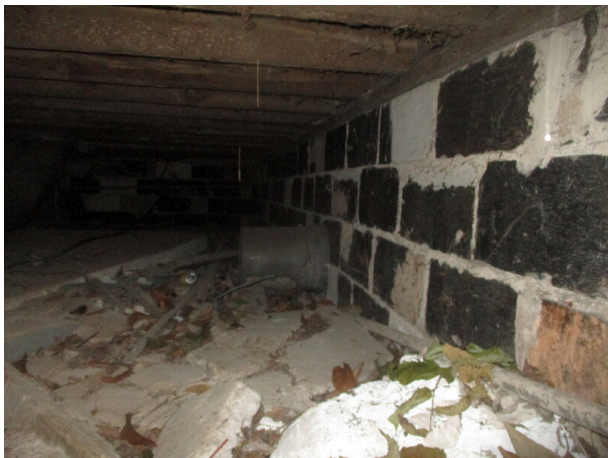
Concrete had been placed over the wood subflooring and framing in the main area of the first floor. A portion of the first floor framing at the center area of the building had collapsed into the crawl space; this area of the crawl space was not accessible. The foundation system, including masonry knee walls, was observed to be in fair to poor overall condition based on our limited observations. We anticipate repairs to be required and have shown an allowance.

Crawl space

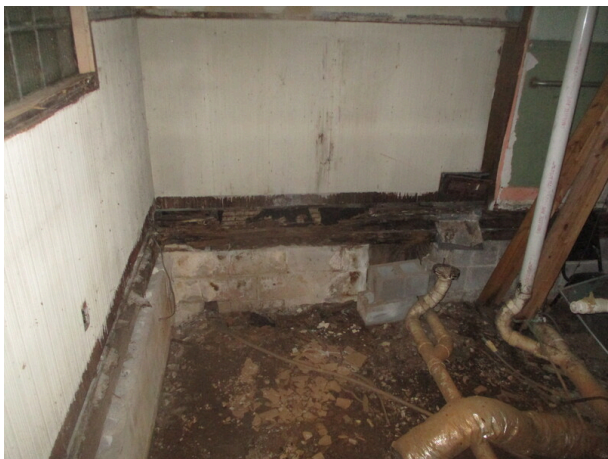
Area at east elevation previously demolished,
PVC piping remnants, damage at foundation
wall

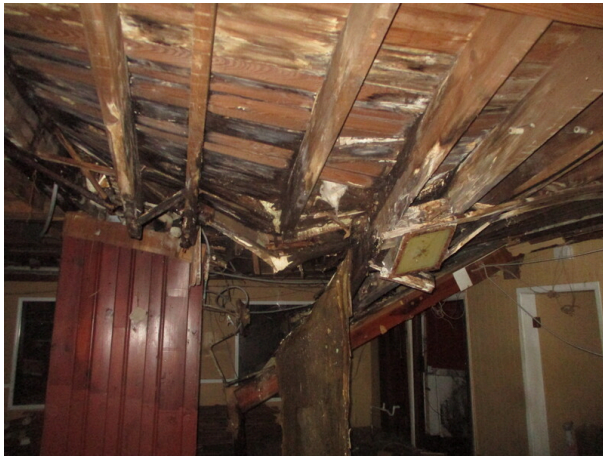
The building was deemed unsafe by the City of Charlotte in 2019. The apparent level of structural damage to the building is severe. Long-term water intrusion has contributed to significant degradation, and water intrusion was active at the time of our site visit. A cost-benefit analysis was beyond our scope of services, but based on the level of damage observed, it is likely that reconstruction of the superstructure will be required. For such major reconstruction, a contractor should be engaged for providing cost estimates.

Partially collapsed second floor, heavy damage

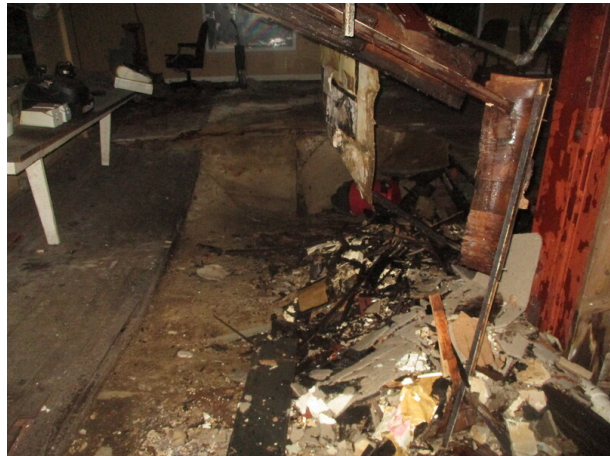
Collapsed area of first floor

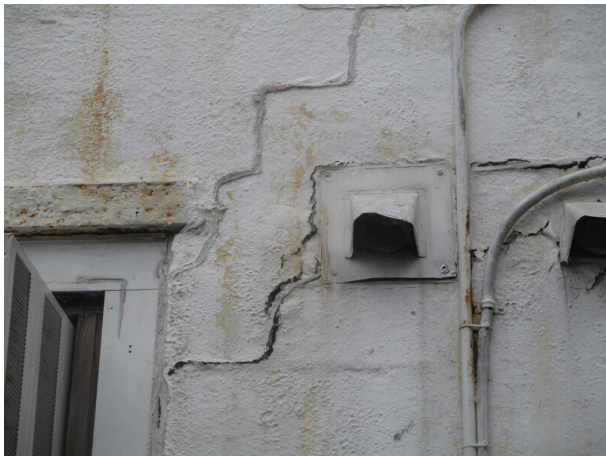
Typical exterior cracking

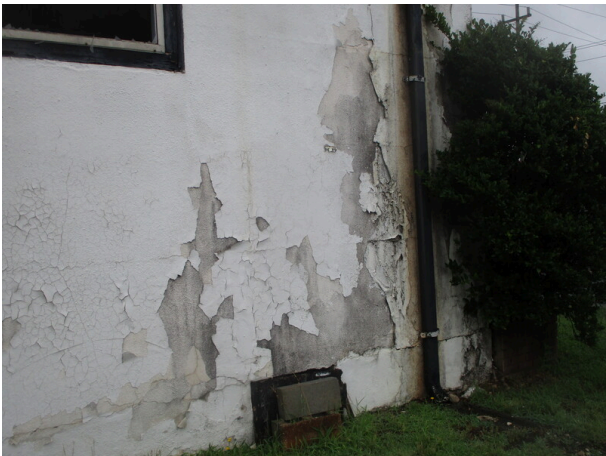
Typical exterior deterioration

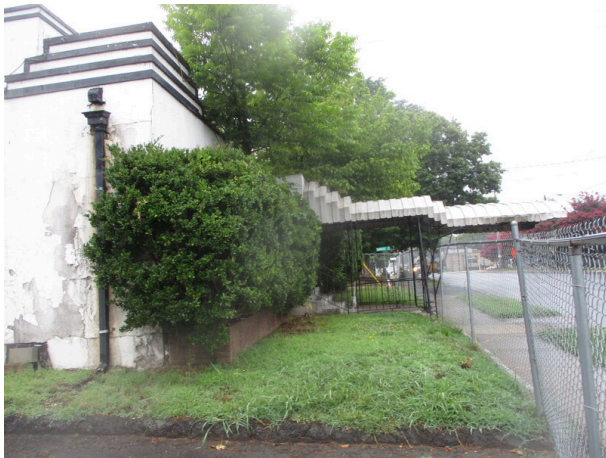
Front awning and perimeter fencing

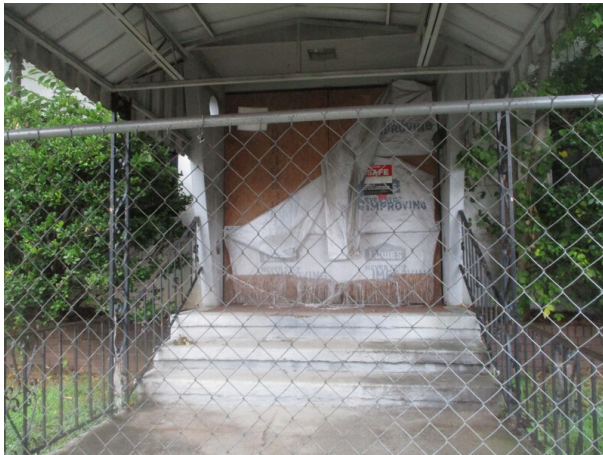
Wooden personnel doors are located at the west and north elevations nailed shut. The personnel doors were generally in poor overall condition and should be replaced.

Boarded up main entrance

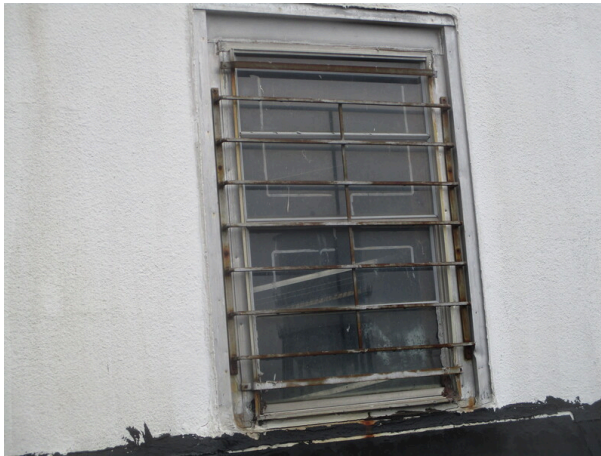
Fenestration for the building primarily consists of aluminum frame single pane window units that appeared to be in fair to poor overall condition. Surface corrosion at window flashing was apparent. The windows have a cage made of steel bars mounted on the jambs. Damage to some glass panes was observed. In addition, wooden sills were deteriorated in some locations. Windows on the north elevation are obscured by extensive vegetation overgrowth. We recommend the windows be replaced.

Typical window with bars

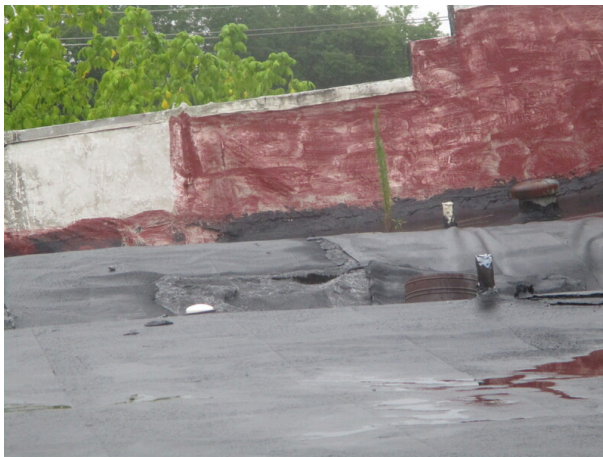
High roof apparent partial collapse, note the sloped front parapet

Based on the poor condition of the roofing system, replacement is recommended. However, roof replacement is dependent on restoration of the structural integrity of the building and its framing systems. Refer to Section 3.3.2 for more information on the structural framing.

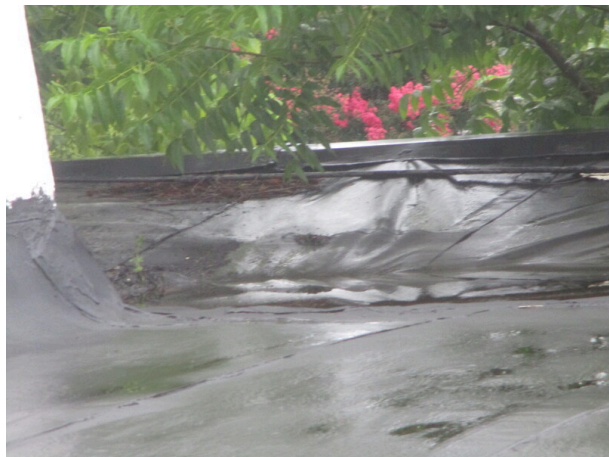
Low roof apparent collapse area

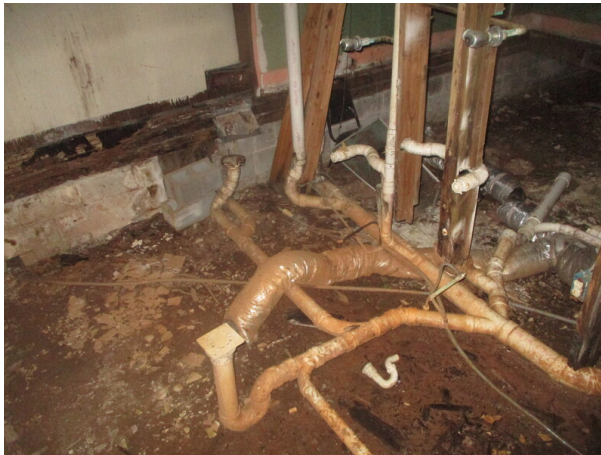
Area at east end previously demolished, PVC piping remnants, damage at foundation wall

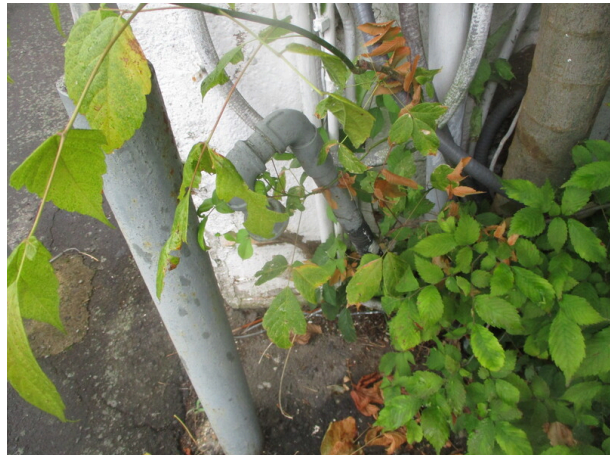
Natural gas was reportedly provided to the building at one time, but the meter appeared to have been removed.

Gas meter removed

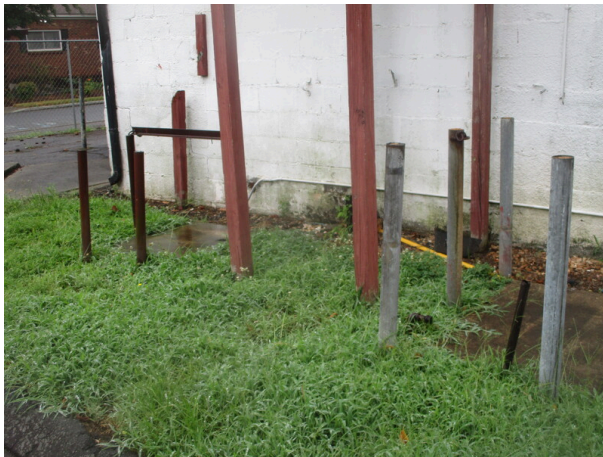
Location of previous condensing units

If the mechanical equipment is to be replaced in kind, we recommend an allowance.

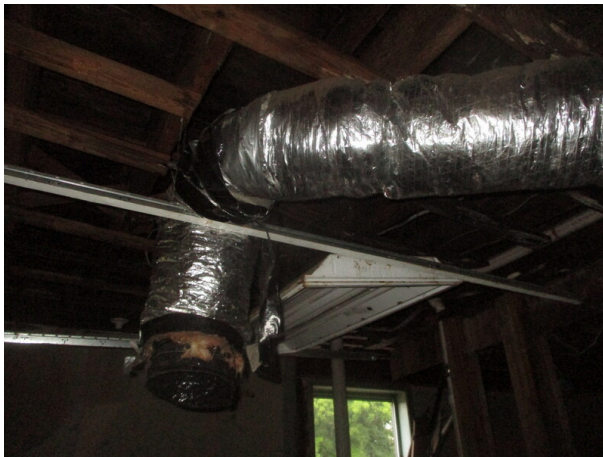
The building has been vacant for several years, and the outside condensing units have been removed. Previous demolition activities have rendered the mechanical distribution system incomplete and unusable. Remnants of ductwork were observed within the lower floor and crawl space. The upper floor was inaccessible. We recommend an allowance for replacement of the mechanical distribution system when replacing the mechanical equipment.

Ductwork remnants

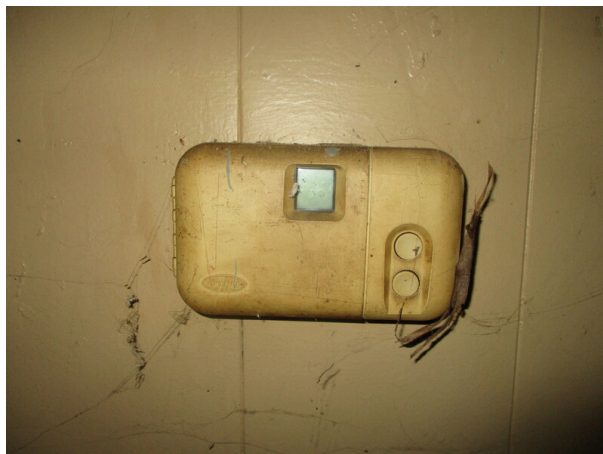
The building is vacant and not powered. The condition of the thermostats is unknown.

Thermostat

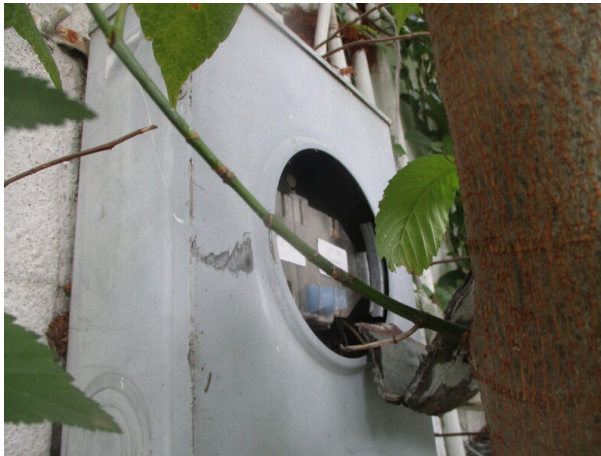
Electric meter removed

We recommend that the electrical requirements be further assessed and an allowance for electrical upfit be included. Actual costs will depend on the needs determined.

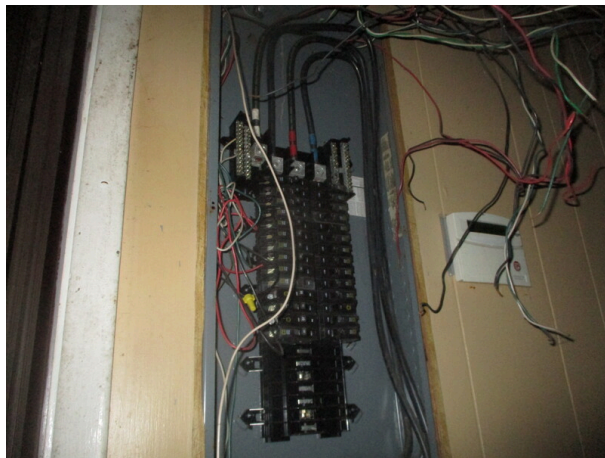
Electrical panel

We recommend that the electrical distribution requirements be further assessed and an allowance for electrical upfit be included. Actual costs will depend on the needs determined.

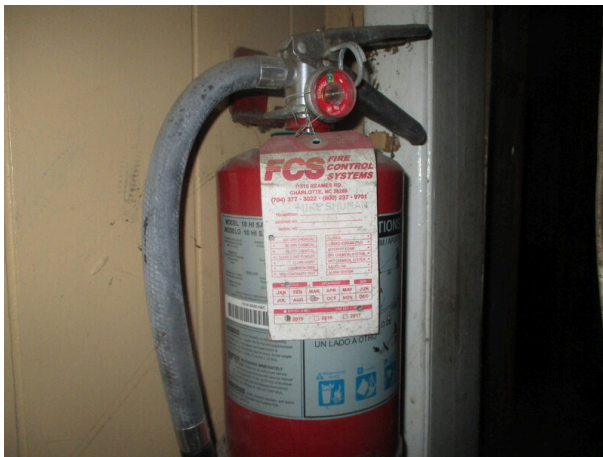
Fire extinguisher, last inspected in 2015

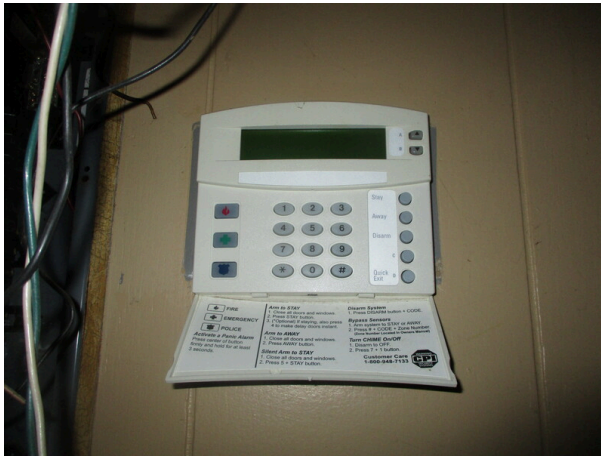
The building has a CPI security panel, but the system has been inactive for several years. We recommend assessment as part of maintenance.

Security panel

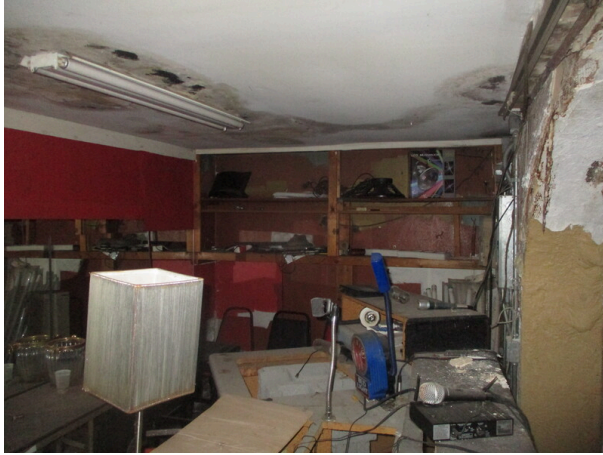
The level of interior damage is both severe and widespread, and includes areas impacted by structural collapse. The City of Charlotte has deemed the building to be unsafe. Refer to Section 3.0 for further information on the structural systems.

Typical damage to interior finishes

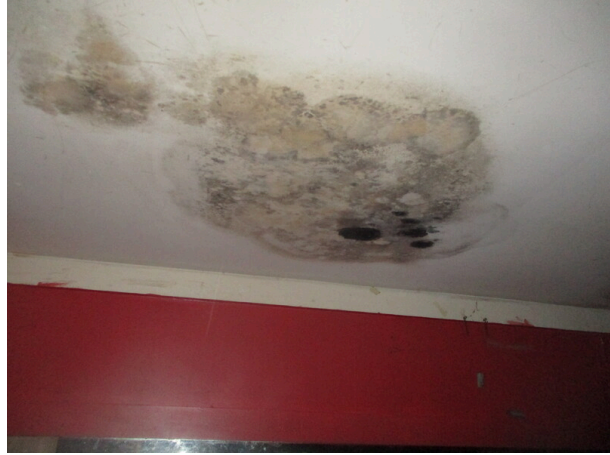
Biological growth

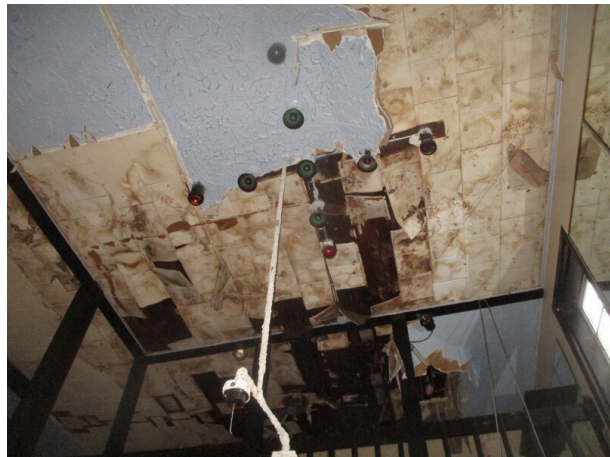
Damage to second floor ceiling finishes

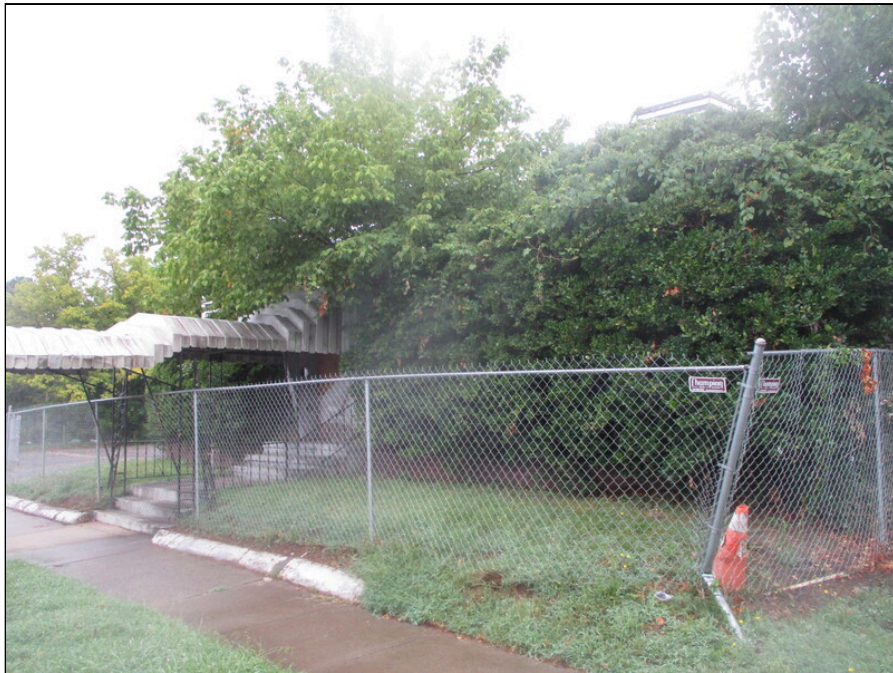
6 - Extreme vegetation overgrowth at east elevation, damaged fencing

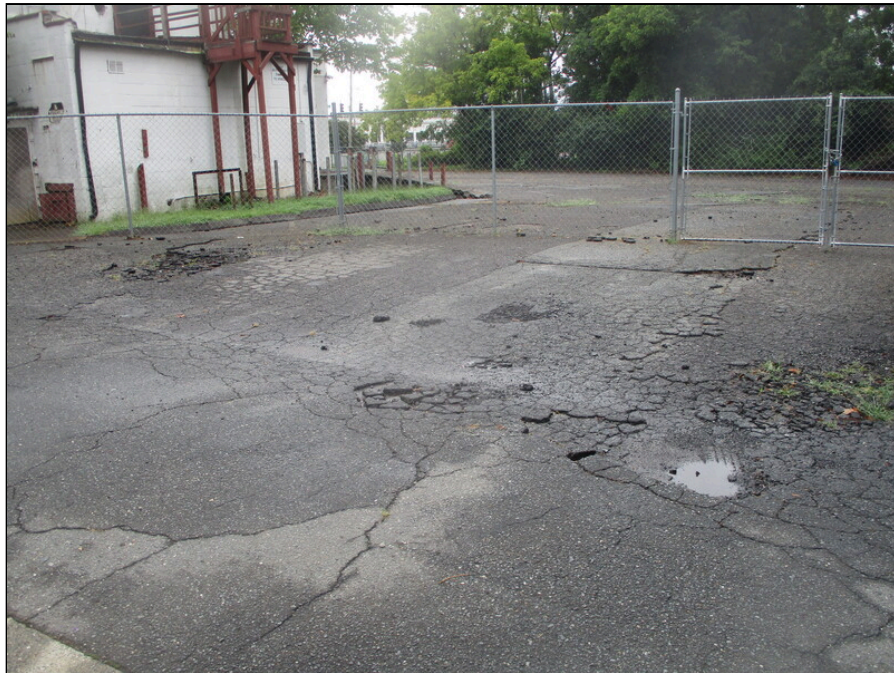
10 - Pavement damage near locked gate

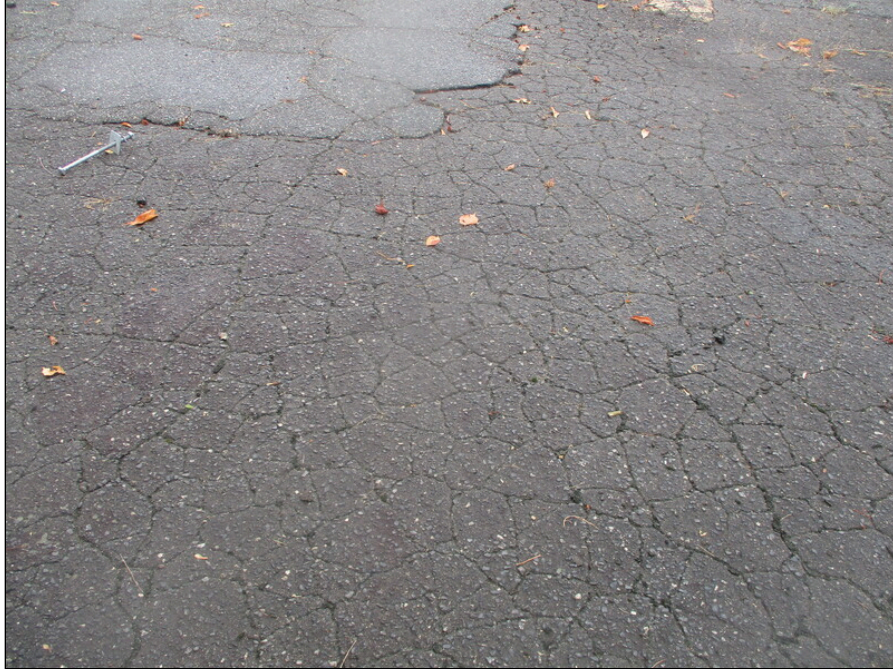
11 - Typical pavement distress

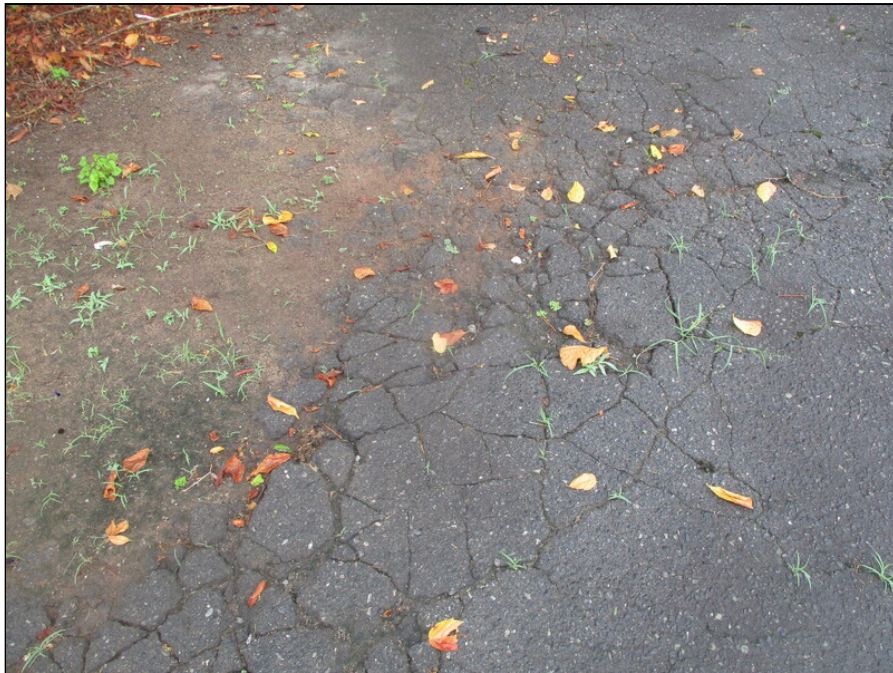
12 - Typical pavement distress, failed overlay

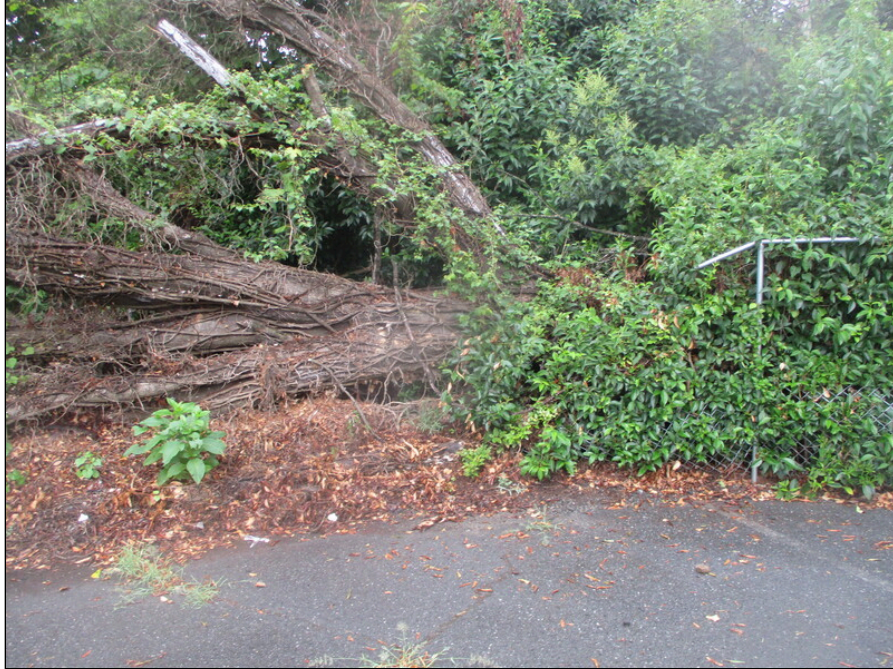
13 - Fencing damaged by tree

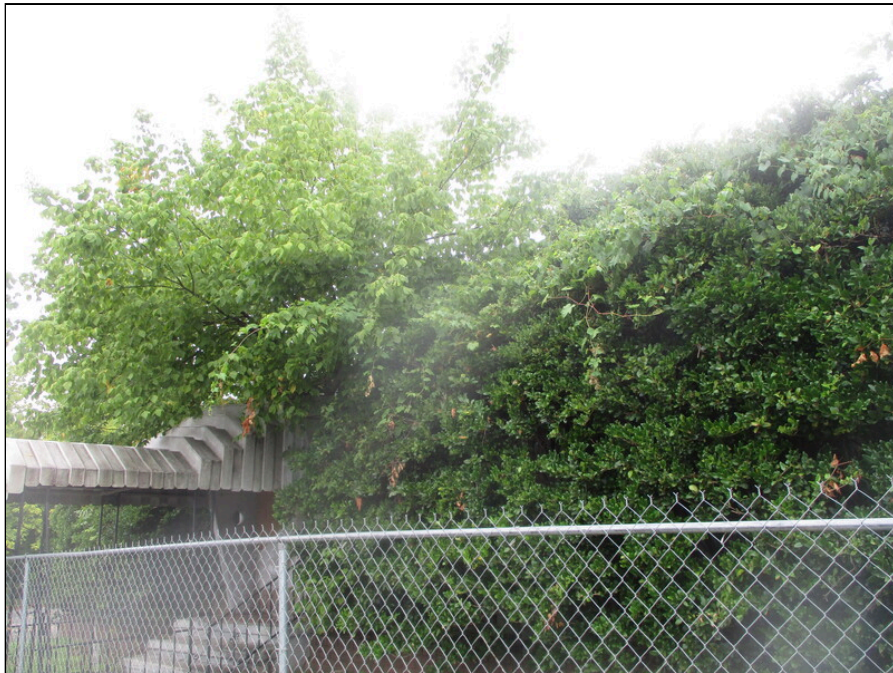
14 - Excessive vegetation overgrowth at east elevation

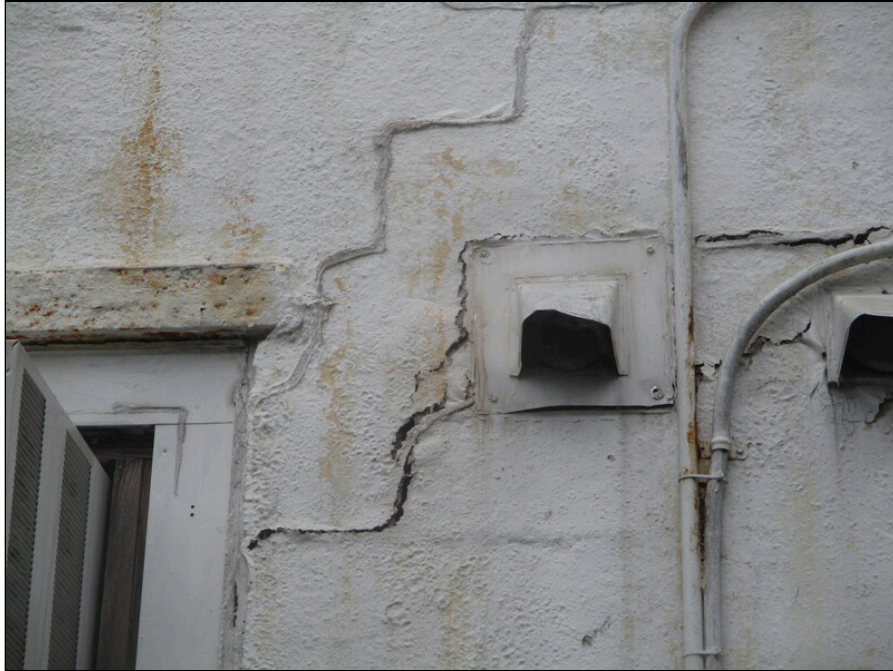
19 - Typical exterior cracking

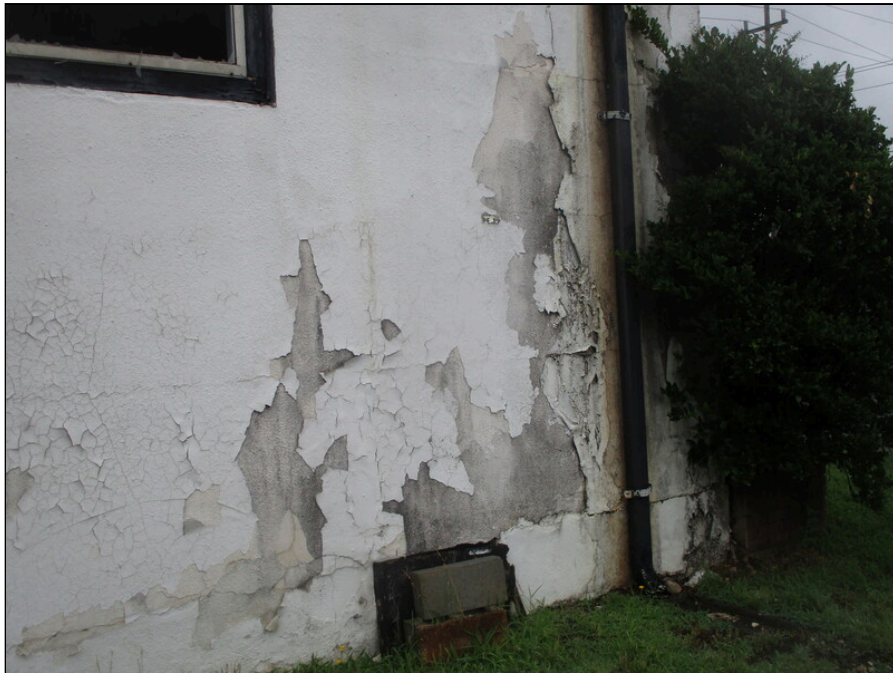
20 - Typical exterior deterioration

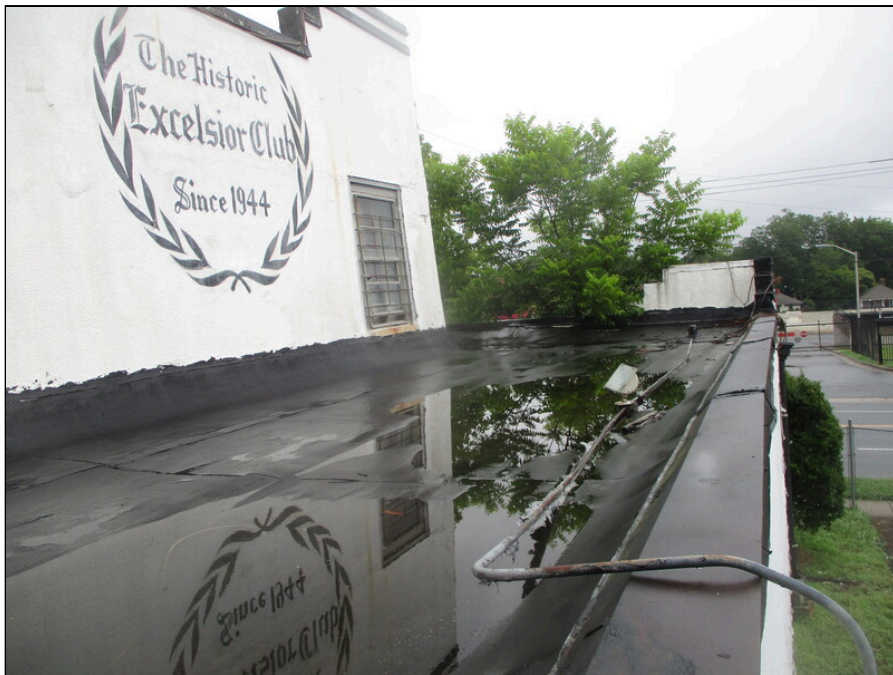
24 - Low roof overview, ponding

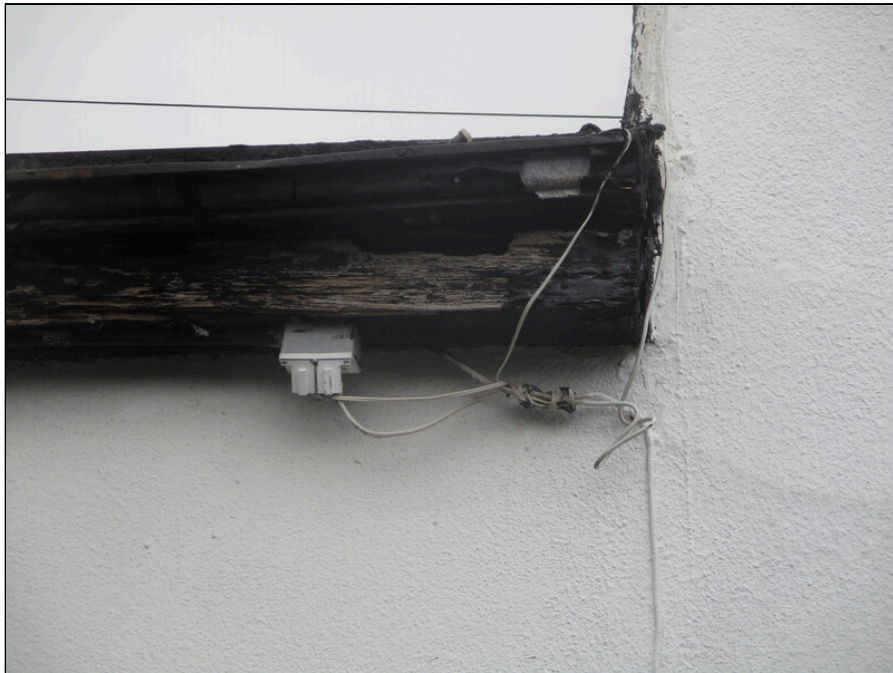
26 - Typical deteriorated wood rake edge

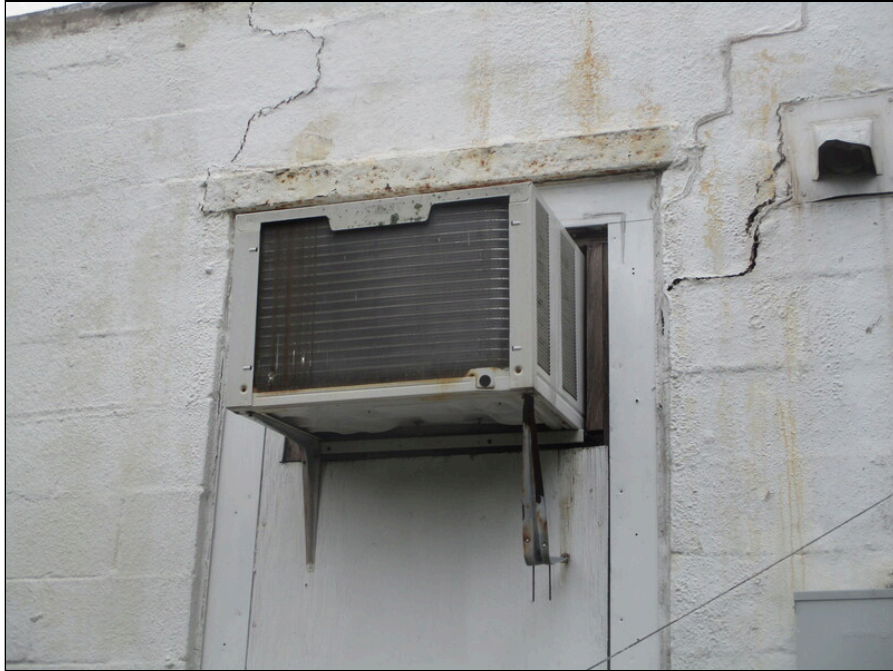
29 - Typical second floor air conditioner, wall cracking

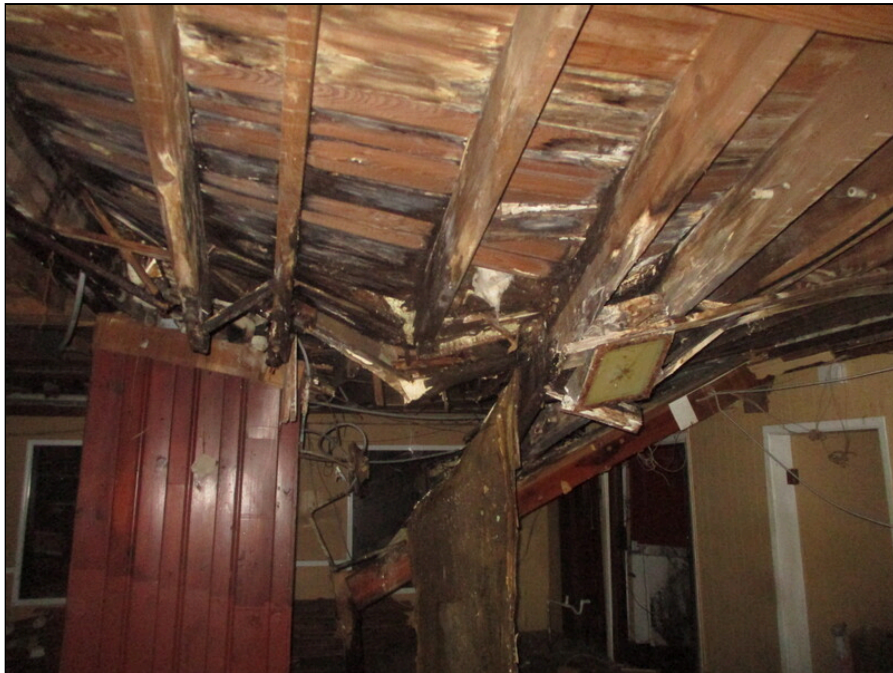
40 - Partially collapsed second floor, heavy damage

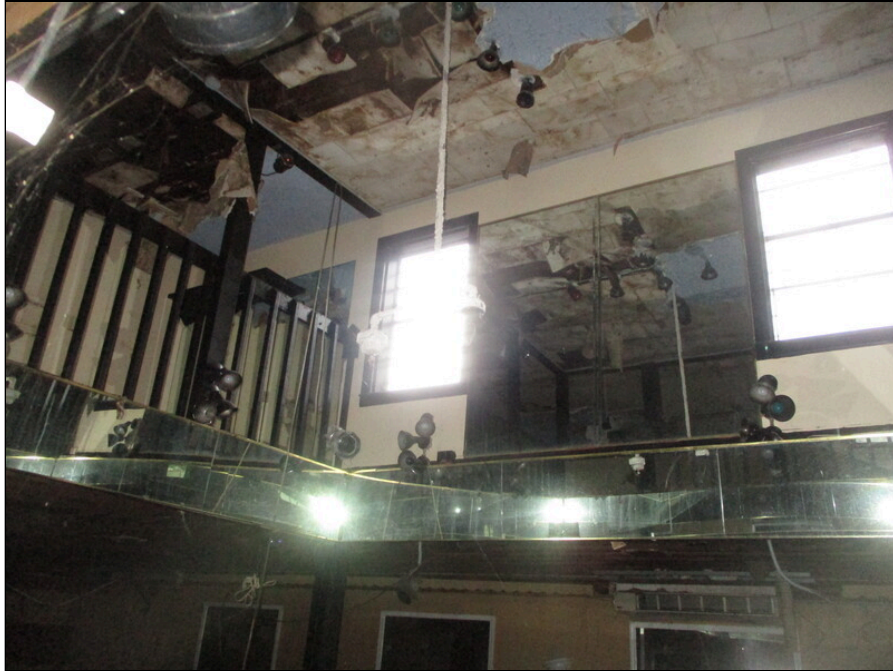
41 - Partial view of second floor balcony area, damaged finishes

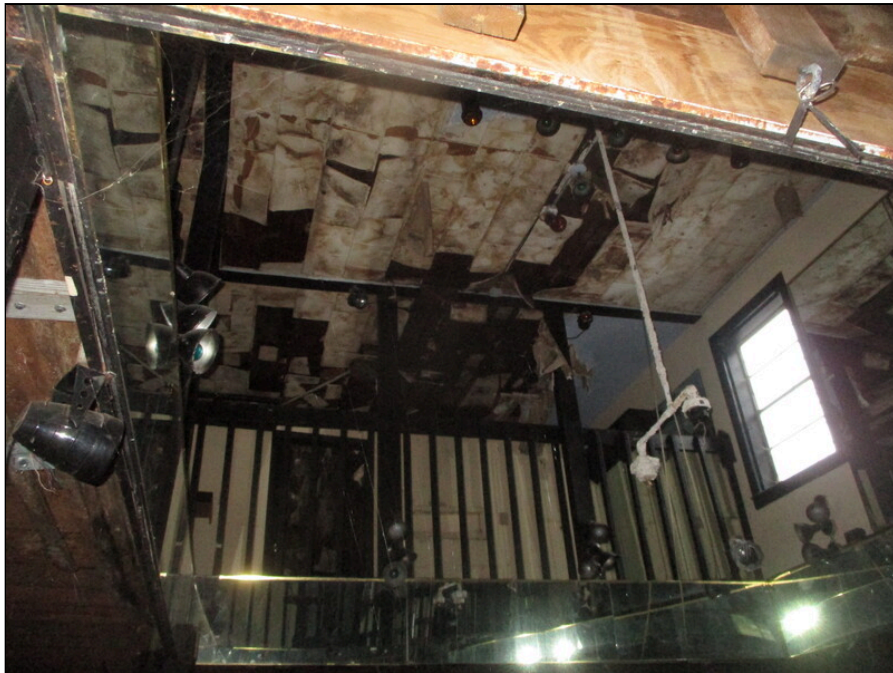
42 - Partial view of second floor balcony area, damaged finishes

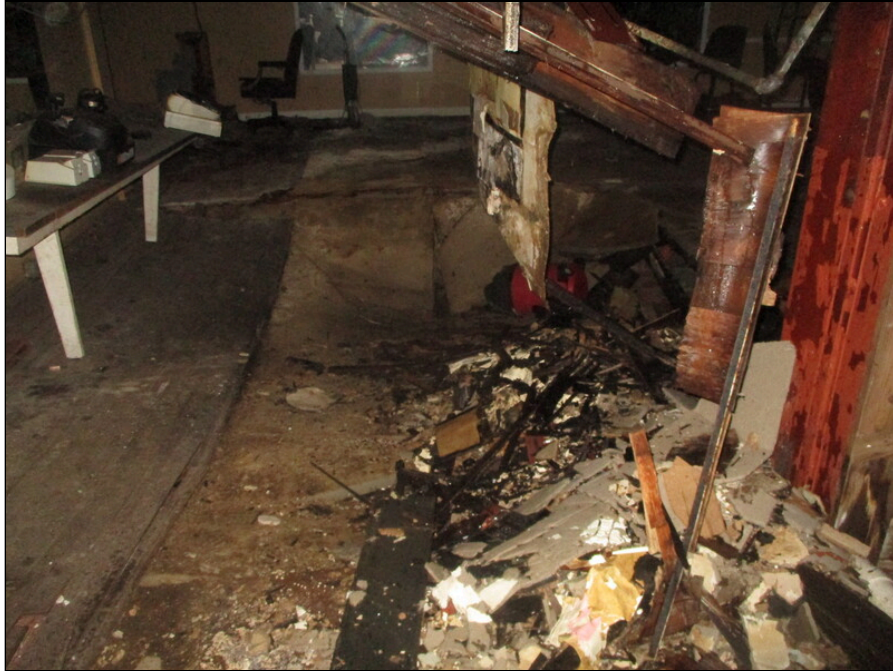
43 - Collapsed area of first floor

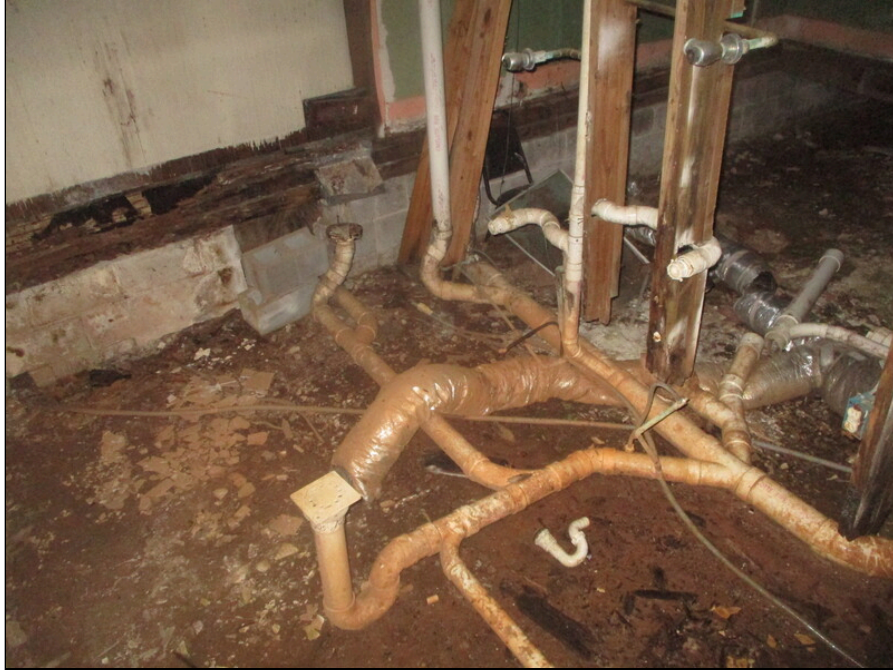
47 - Area at east end previously demolished, PVC piping remnants, damage at foundation wall

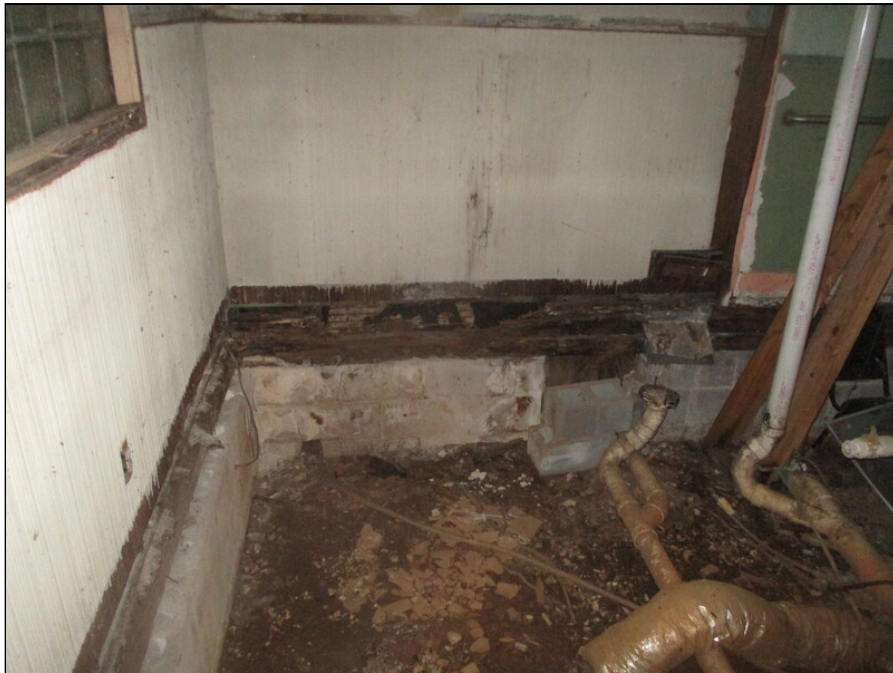
48 - Area at east elevation previously demolished, PVC piping remnants, damage at foundation wall

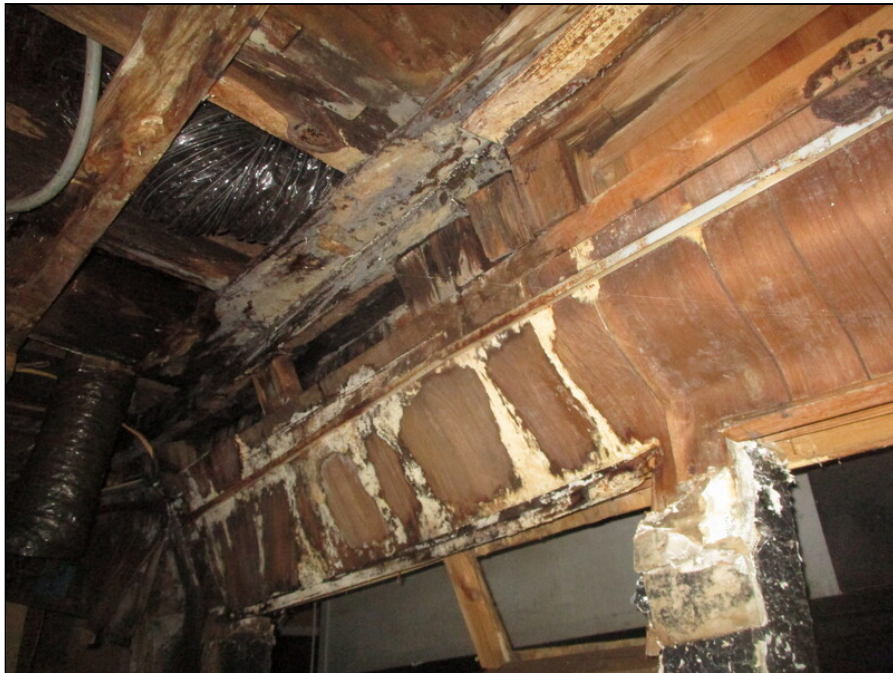
52 - Typical damaged framing and finishes, partial ductwork

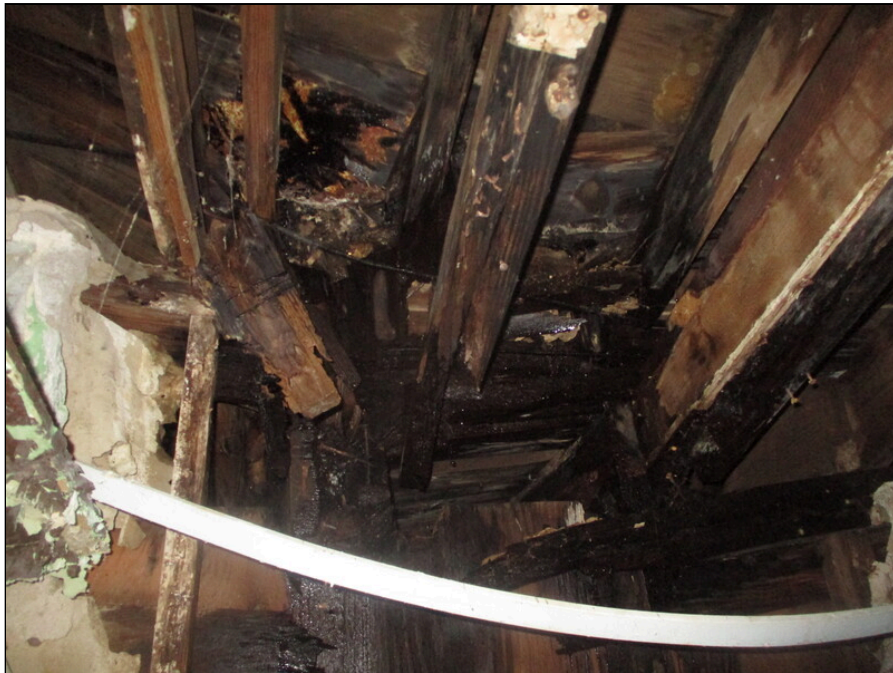
56 - Extensive wood rot due to long-term water infiltration

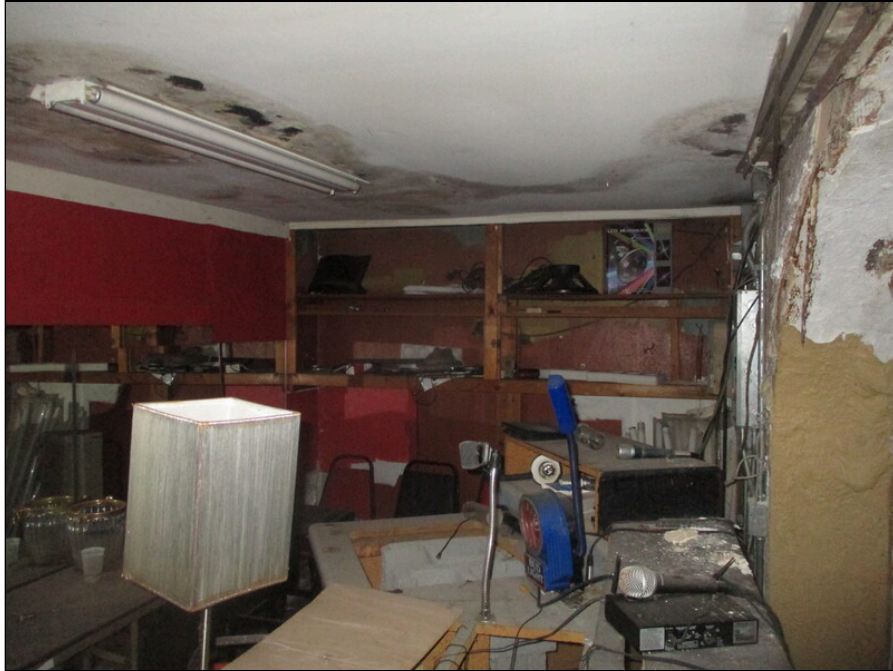
57 - Typical damage to interior finishes

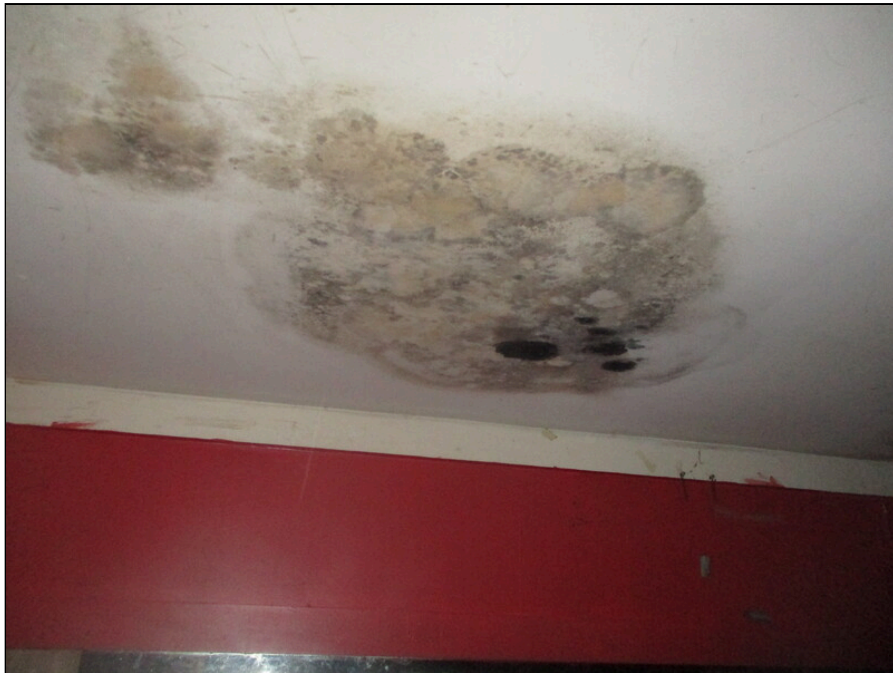
58 - Biological growth

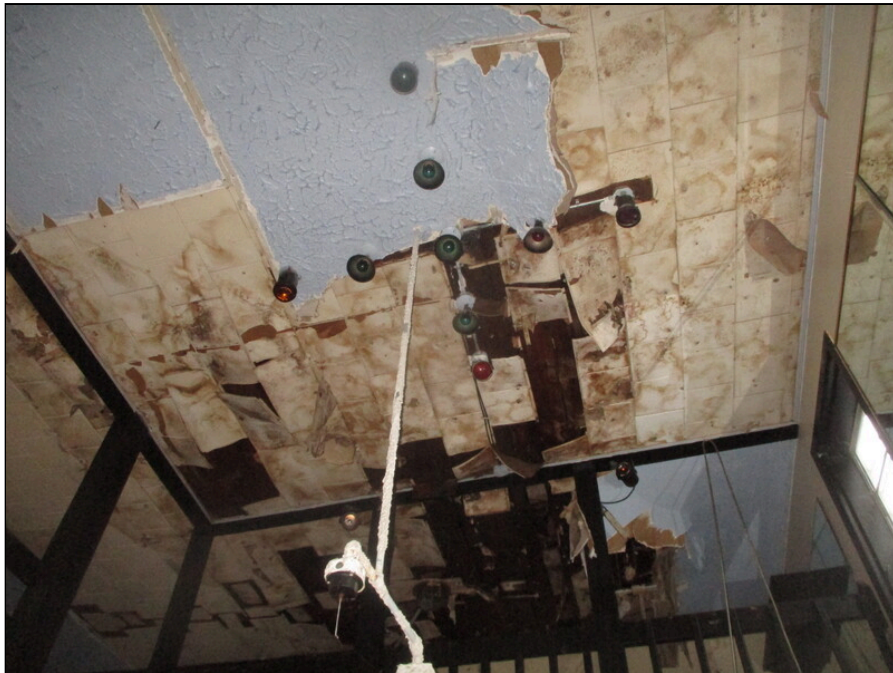
60 - Damage to second floor ceiling finishes

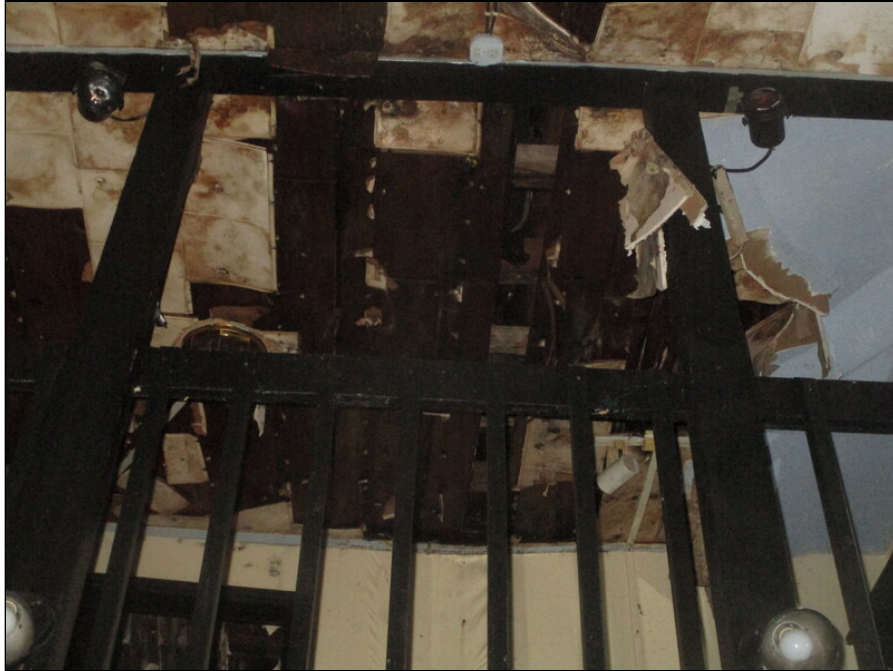
61 - Damage to second floor ceiling finishes
