Survey and Research Report

Delburg Cotton Mill House

The Delburg Cotton Mill House
303 Delburg Street
Davidson, North Carolina.

11. Date of Preparation of this Report: December 5, 2014

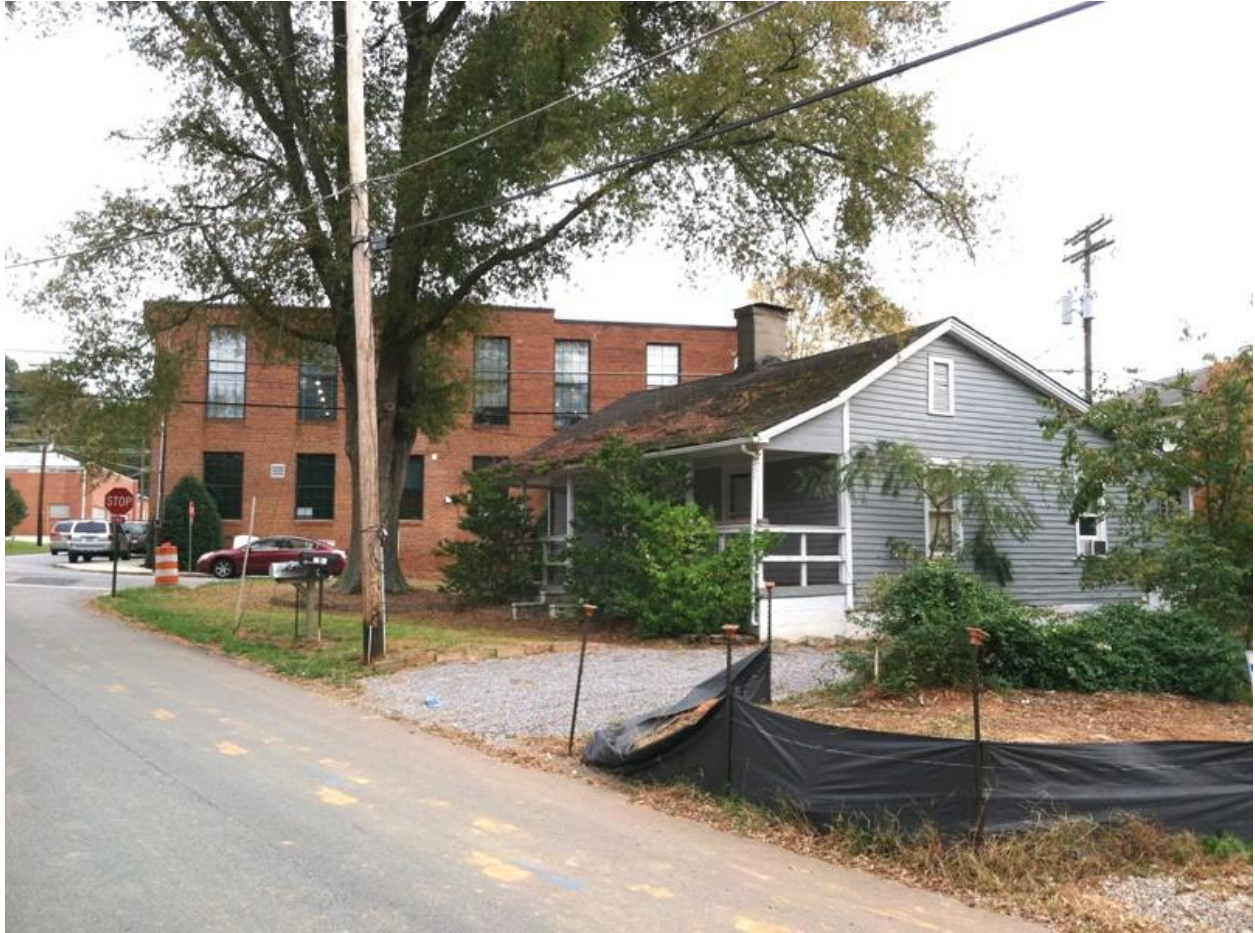
With the substantial loss of integrity for the 300 block of Delburg Street to what was until recently an intact mill village setting, the significance of the Delburg Cotton Mill House located at 303 Delburg has greatly increased. With its unique location adjacent to the mill, the Delburg Cotton Mill House still conveys the historic relationship of the mill to the mill houses.

The Delburg Cotton Mill House, with the mill in the background

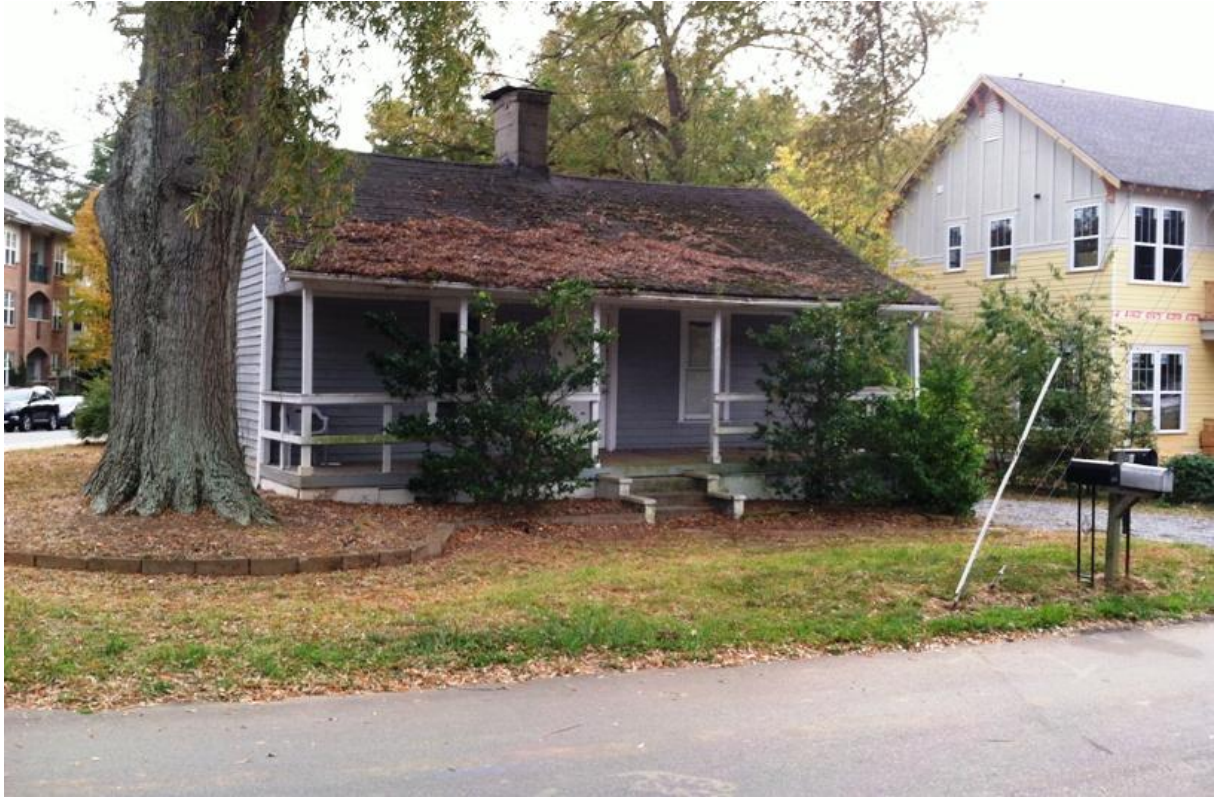
The Delburg Cotton Mill House at 303 Delburg Street is a one-story, frame, side-gabled house, typical of early-20th century Piedmont mill housing. The house faces north and sits on an irregularly shaped .10 corner lot. The house fronts on Delburg Street and is located approximately 21 feet from the pavement. The east side of the house faces Watson Street. Until recently, Delburg Street was populated by a fairly intact collection of one-story side-gabled and hipped-roof mill houses. Many of these houses have been demolished. The neighboring house to the west of the Delburg Cotton Mill House is a new two-story frame house. To the east, across Watson Street, is the two-story, brick Delburg Cotton Mill/Davidson Cotton Mill. A large water oak is located in the front yard.

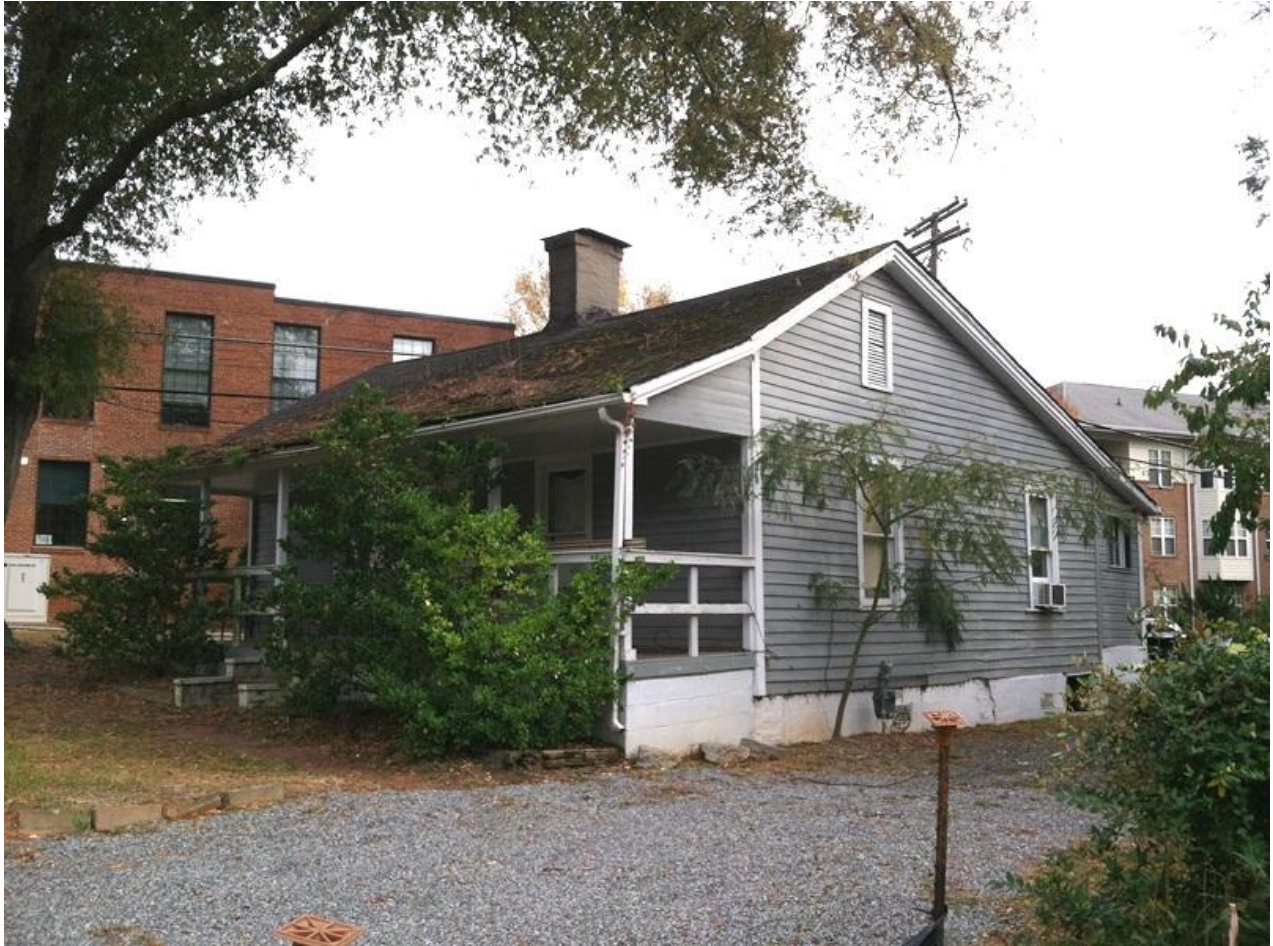
The front of the house is dominated by a full width engaged porch. The original porch floor has been replaced with pressure-treated boards supported by a block foundation. Block steps with block cheek walls lead to the porch. The porch roof is engaged with the principal roof, but has a slightly lower pitch. The porch roof is supported by six simple square posts. The porch ceiling is original tongue-and-groove boards. The front elevation fenestration is symmetrical with a replacement door centered between one-over-one windows. The double-hung windows contain replacement one-lite sash. Like the other elevations, the front elevation is covered with weatherboard that terminates at simple corner boards. Centered on the ridge is an internal chimney with a corbelled cap. The chimney has been parged.

It is likely that the house was originally a single-pile (one room deep) building. It appears that the roof was extended to cover additional rooms added to the rear of the house. On the west elevation, the original brick piers are exposed, and are now infilled with block. The principal section of the house is two bays wide. Each bay contains a single double-hung window with replacement single-light sash. An original rectangular louvered vent is located high in gable. The same siding found on the front was used on the side elevations. There is no transition in the siding on the side elevations indicating that the house was expanded to the rear.

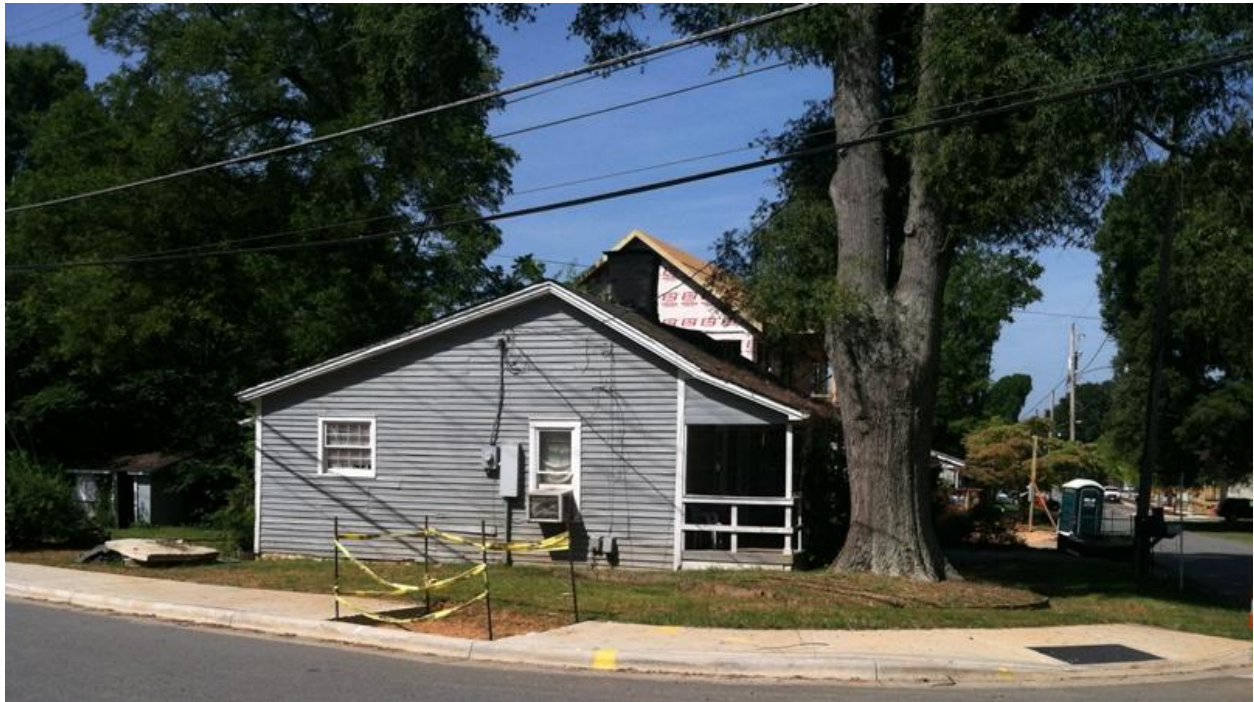
The east elevation is similar to the west elevation. The window in the rear bay was replaced with a shorter double-hung window to accommodate kitchen cabinetry. The lower section of the original window opening is patched with short pieces of siding. Unlike the west elevation there is no vent in the gable.

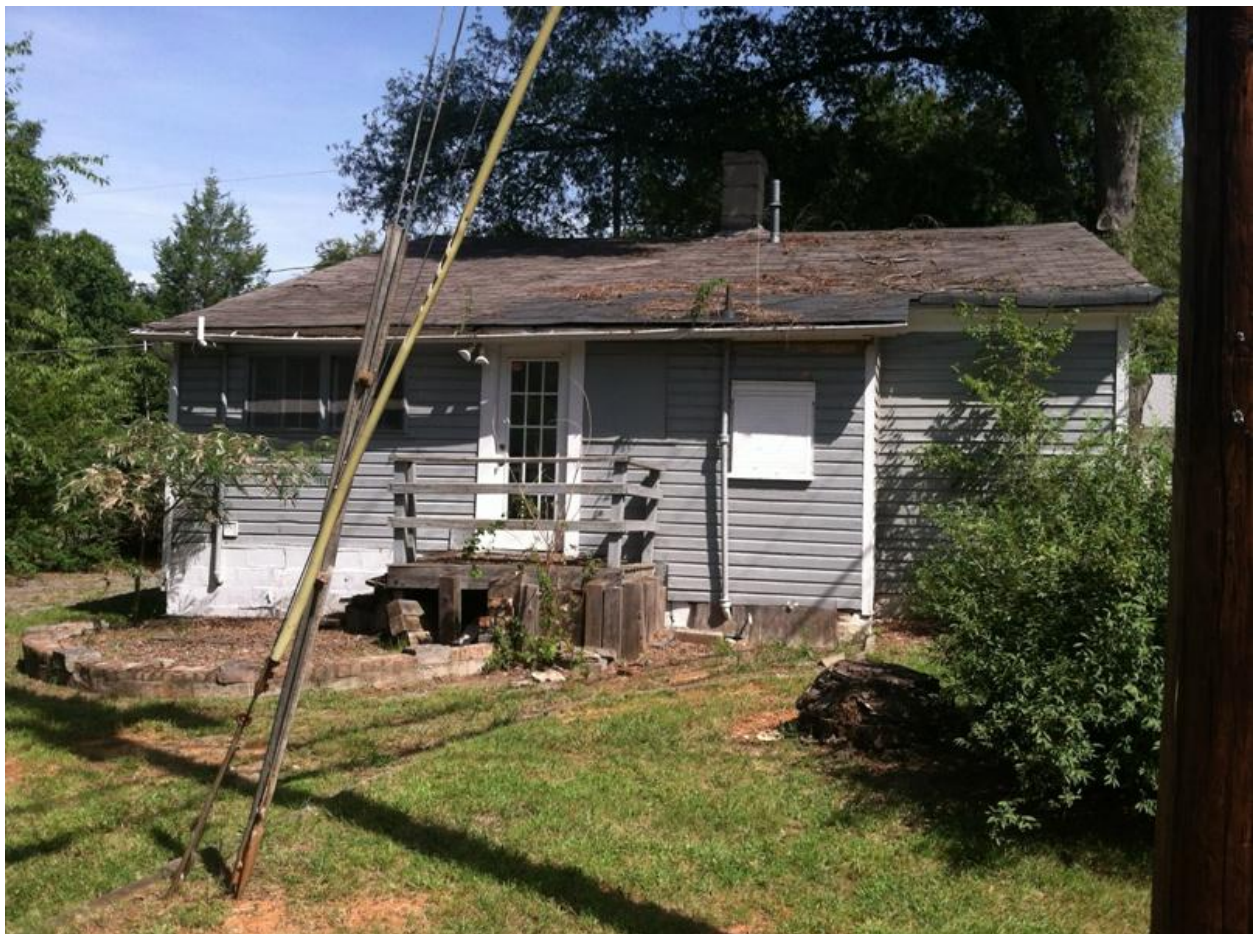
A shallow shed addition was added to the rear of the house and may incorporate portions of a rear porch. The addition is flush with the principal west elevation, and is set back approximately six feet from the principal east elevation. On the west side of the house, the weatherboard siding of the principal section is separated from the German siding of the addition by a vertical board. The west elevation of the addition is pierced with a six-light casement window.

The rear of the addition is covered with German siding. A replacement door is roughly centered on the rear of the addition. To the west of the door, the rear elevation is pierced by a pair of six-light casement windows. To the east of the door are two covered window openings. The opening closest to the door is covered with a plywood panel. The second window opening is set low in the wall and is covered with beaded board. The west side of the addition is supported by a continuous block foundation. The east side of the addition features a brick pier at the corner. The siding on the west side of the addition stops at the level of the door threshold. The siding on the east side of the addition extends lower by four courses. The east elevation of the addition is blank and is covered with weatherboard, as is the only exposed section of the rear elevation of the principal section of the house.

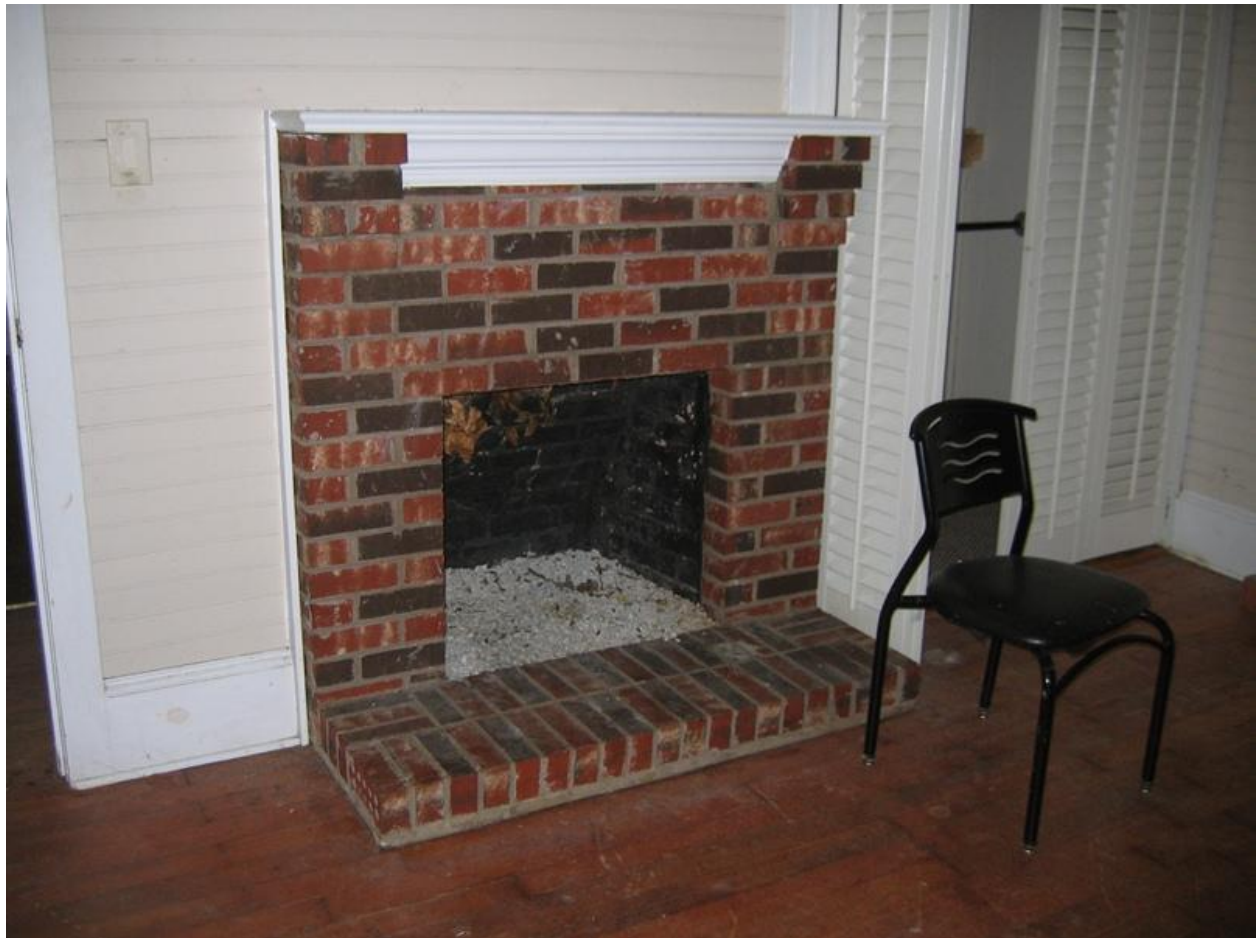
The interior of the Delburg Cotton Mill House has retained a good degree of integrity. The four-room layout of the principal section of the house has been retained, and the interior of the principal four rooms should be included in any landmark designation. The original pine floors appears to have survived in all four rooms. The front two rooms feature tall (approximately

9'6") ceilings. Wallboard has been added over the original ceiling boards. The living room walls are also covered with wallboard. Original window and door trim is in place. Tall original baseboards have been topped with additional moulded trim.

The front bedroom has also retained the original beaded-board wall covering. The central chimney services fireboxes in both front rooms. The brick fireplace surrounds and mantles are of recent construction. An original recessed space features recently added louvered doors.

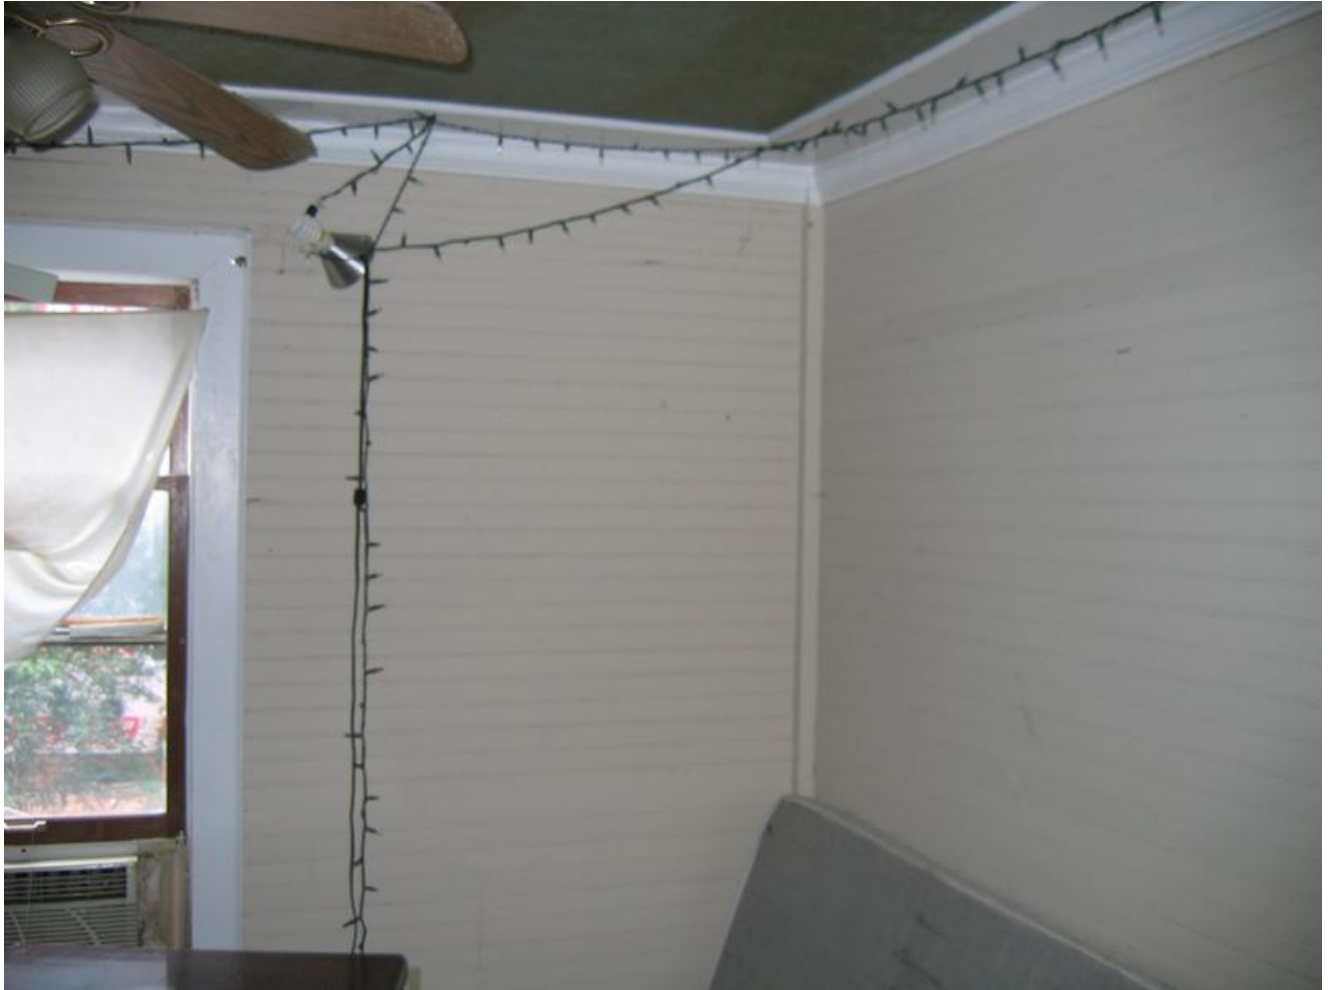
The rear two rooms feature lower ceilings. The rear bedroom features the original beaded-board wall covering, baseboard, and simple window trim. Recent trim has been added to juncture of the walls and ceiling. The ceiling has been covered with wallboard.

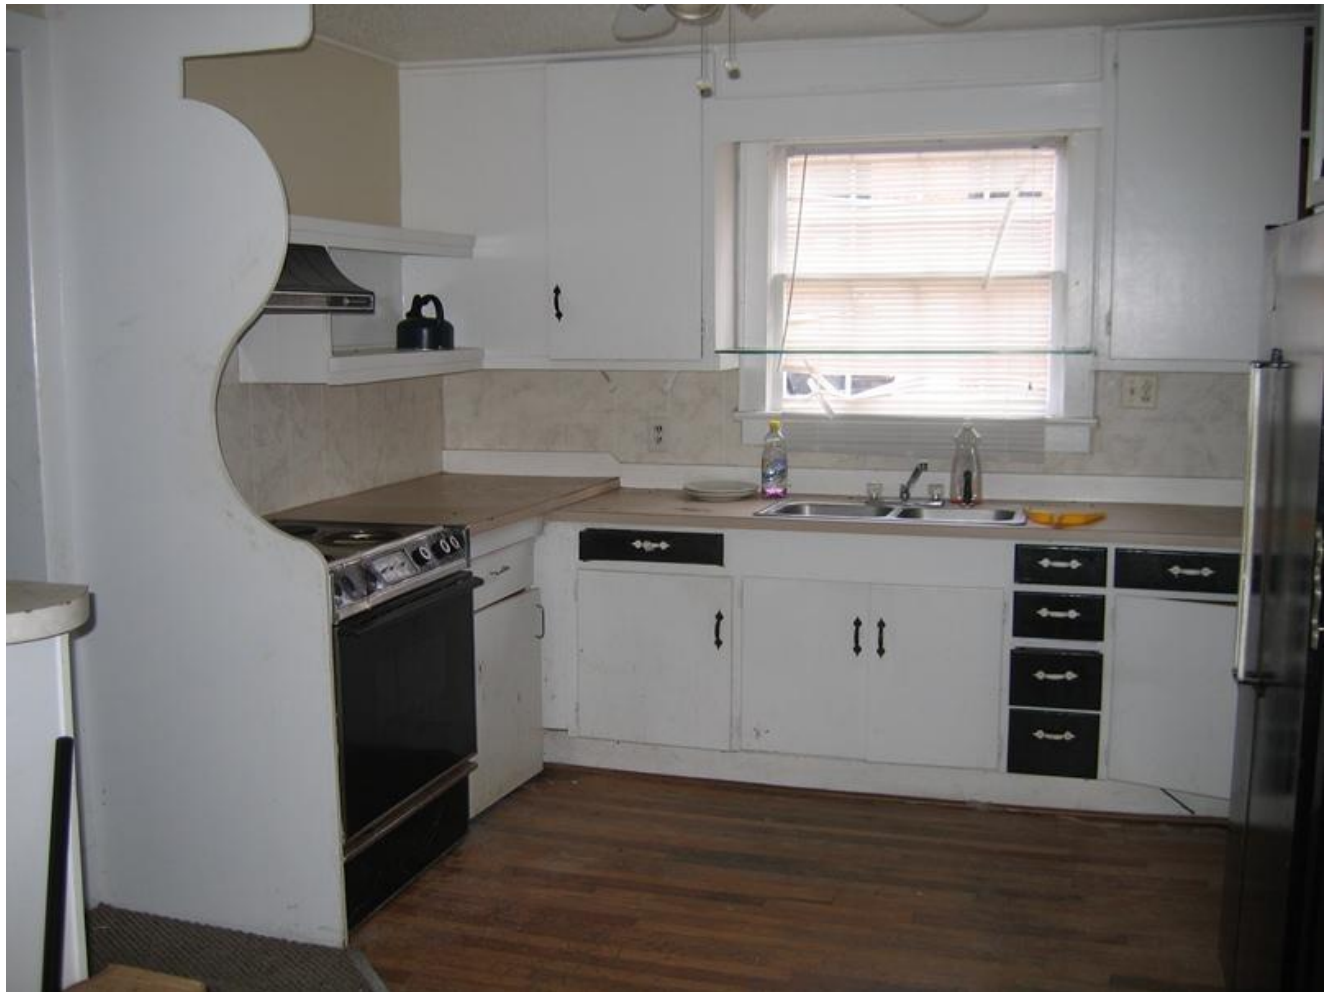
The kitchen has retained the original pine flooring. The ceiling is covered with wallboard, and the walls are covered with cabinetry and wallboard.

The rear addition of house contains a bathroom and a mudroom/laundry room. The interior features of the rear addition are in poor condition and do not contribute to the significance of the property.

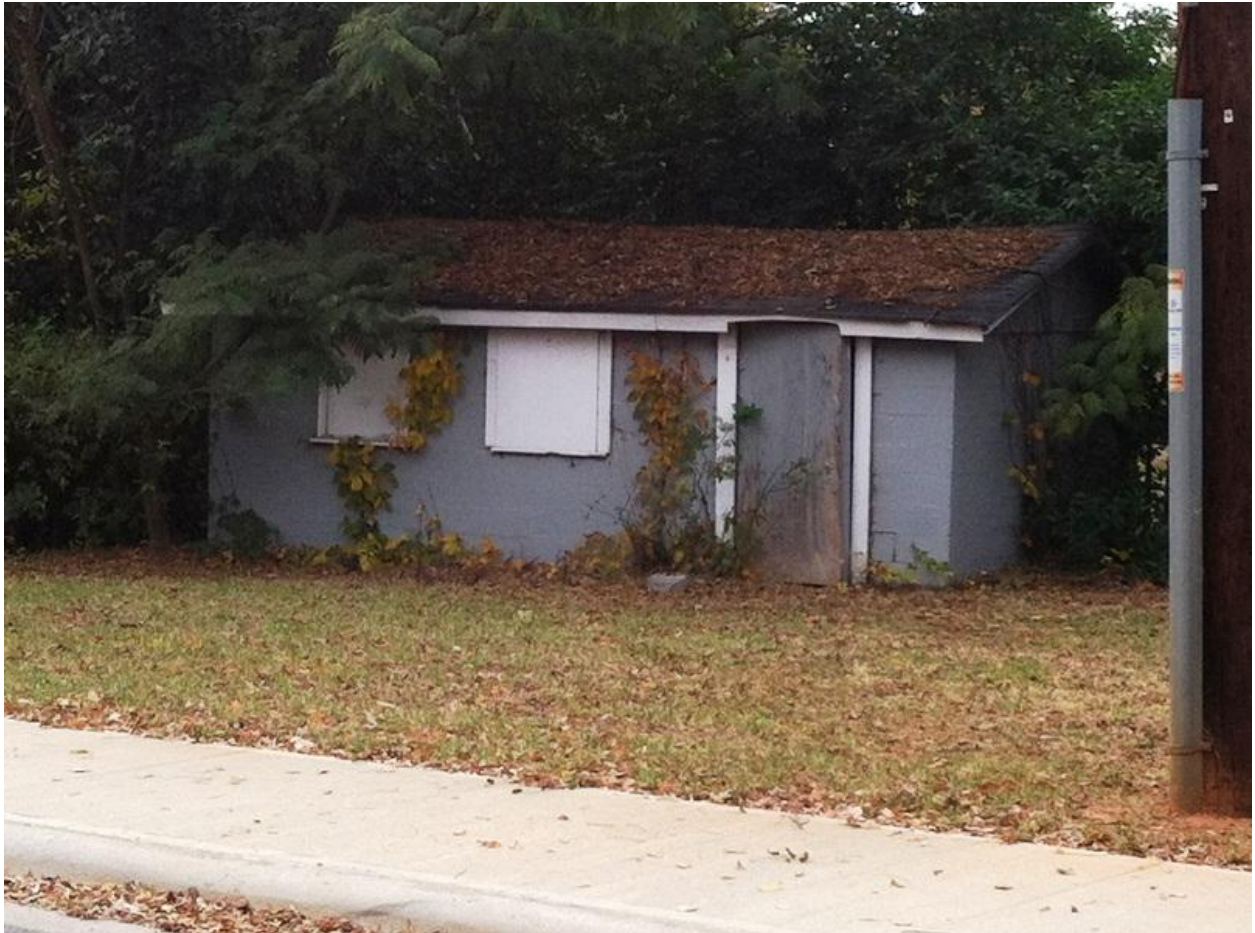
A small concrete block outbuilding with a gabled roof is located behind the house. The outbuilding dates from the second half of the 20th century, and does not contribute to the historical significance of the property.
