Survey And Research Report

Barnum and Sarah Sustare House

13700 Idlewild Road, Matthews, N.C.

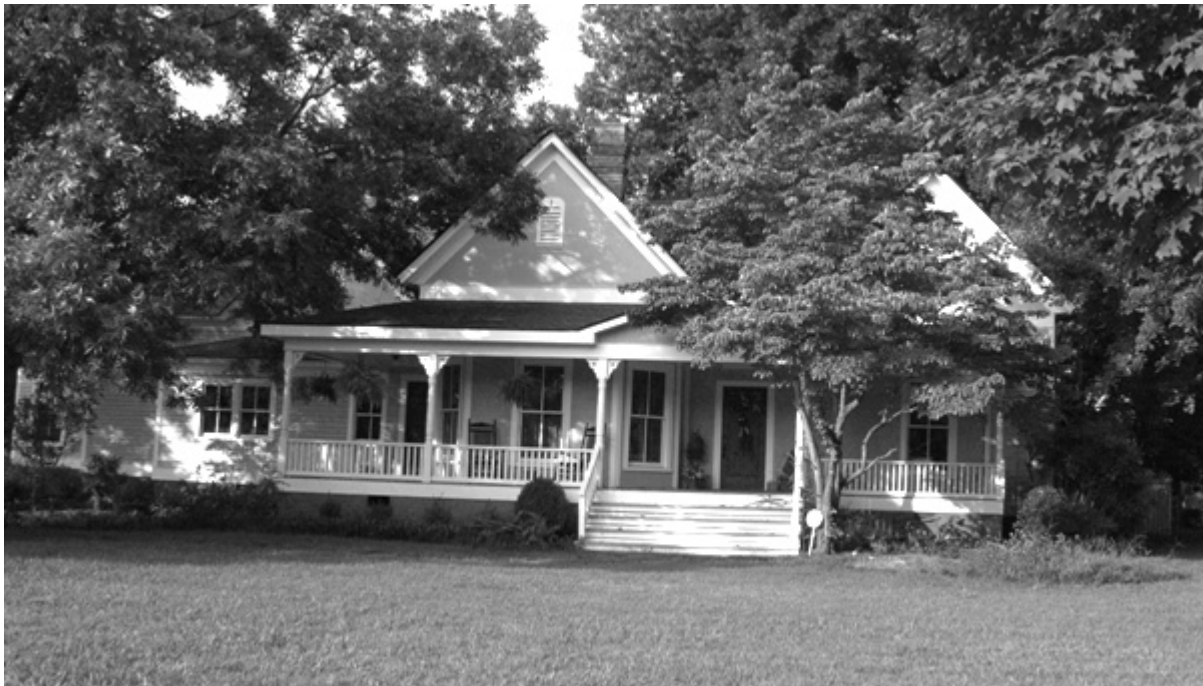
The Sustare House is a large massed-plan wood-framed one-story Queen Anne Style farmhouse. The house faces east and is set back approximately 60' from Idlewild Road. The house sits on a relatively level five acre lot. To the south of the house is an open field. A neighboring house sits close to the Sustare House to the north. The

neighborhood primarily consist of mid to late Twentieth Century ranch houses sitting on one acre lots.

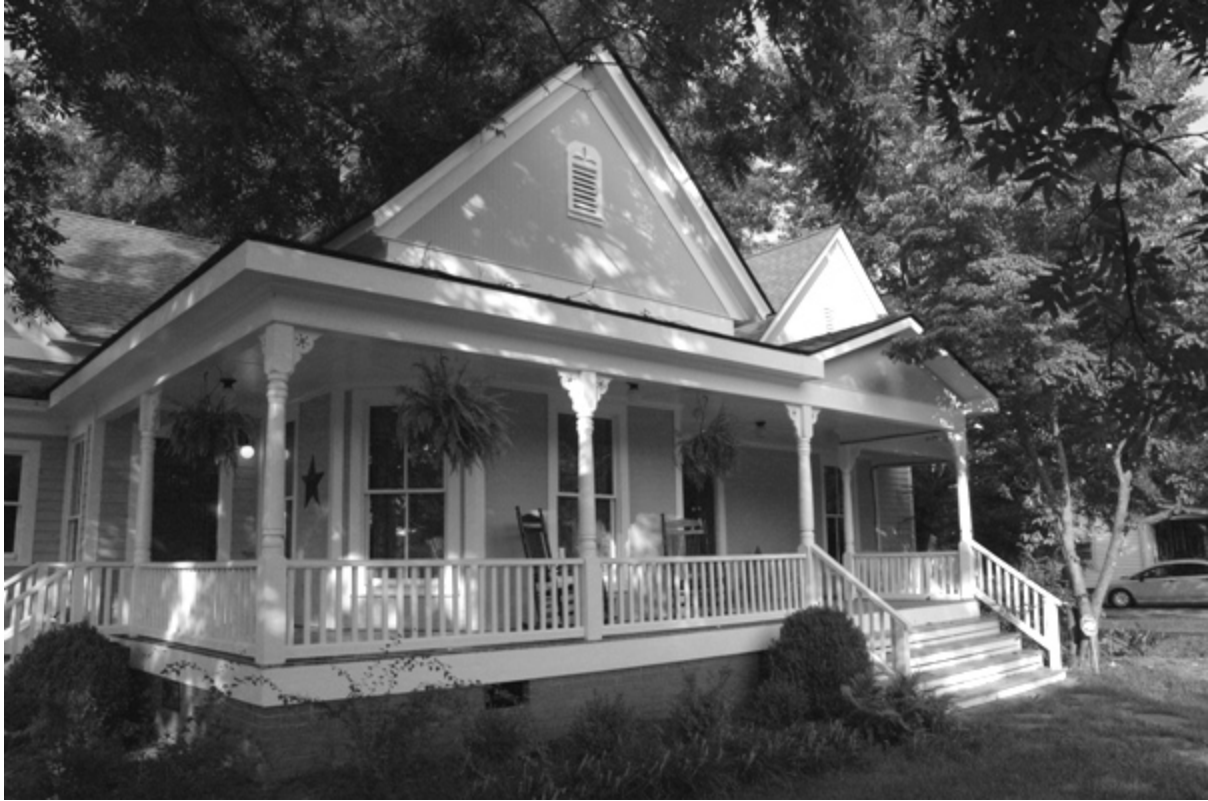
Facade detail

The facade features two moderately steep gables of roughly equal size. The southernmost of the gables projects forward over a wide cut-away bay that is also completely protected by the front porch. This gable contains vertical beaded board and a louvered vent with a sawn trim featuring a three leaf design. The gable features an overhanging closed rake, highlighted by moulded trim. The second gable extends to the north side elevation and is set back from the other gable, and contains the same woodwork features.

The cut-away bay contains three double-hung two-over-two windows. The window sash are modern based on the design of the original sash. Interior and exterior sills and trim are original. Nearly all sash in the house have been replaced. The facade is three bay wide. The front door is located to the north of the cut-away bay. The door is a six-light replacement door. A single window is centered below the north gable. Walls sheltered by the porch feature the same narrow moulded convex boards found in the porch gable set horizontally. The porch walls are topped with moulded trim. To the north of the porch, a small unsheltered section of the wall is sheathed with weather board, separated from the moulded siding by a single vertical board. The workmanship of the finish carpentry and the quality of the millwork, especially the millwork lavished on the facade, are notable.

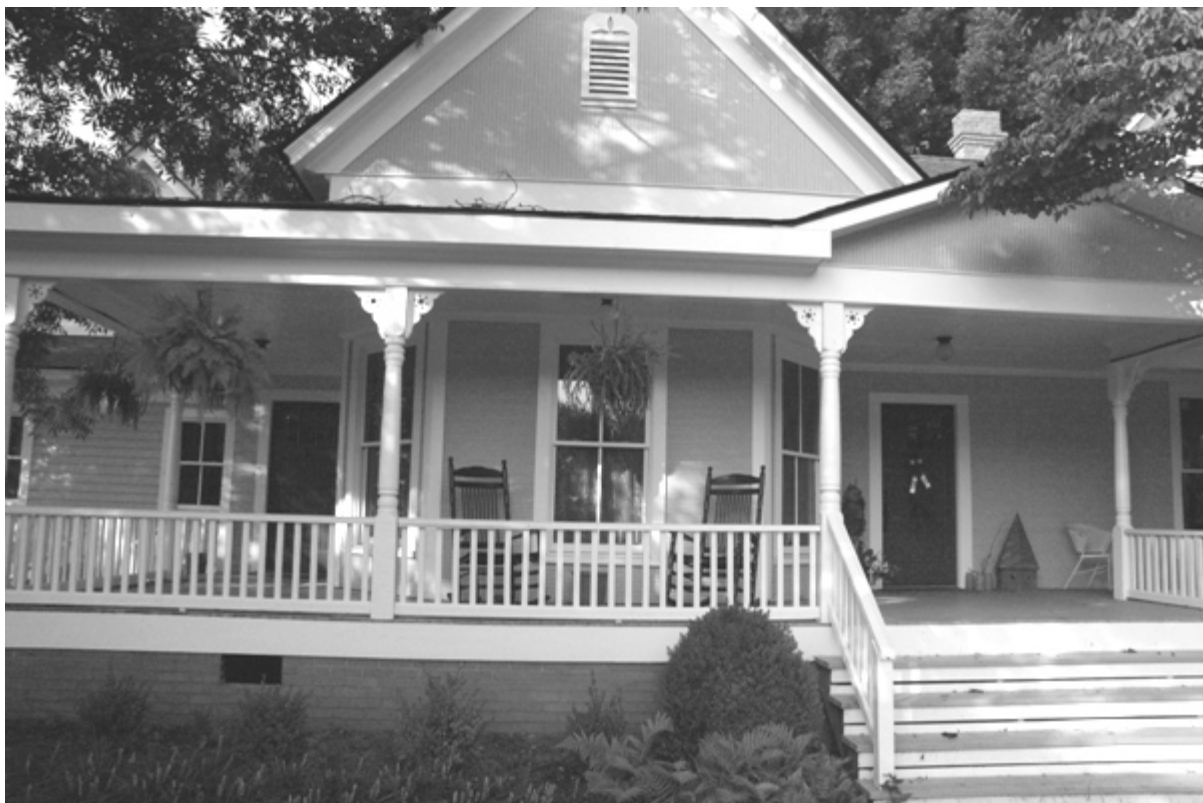
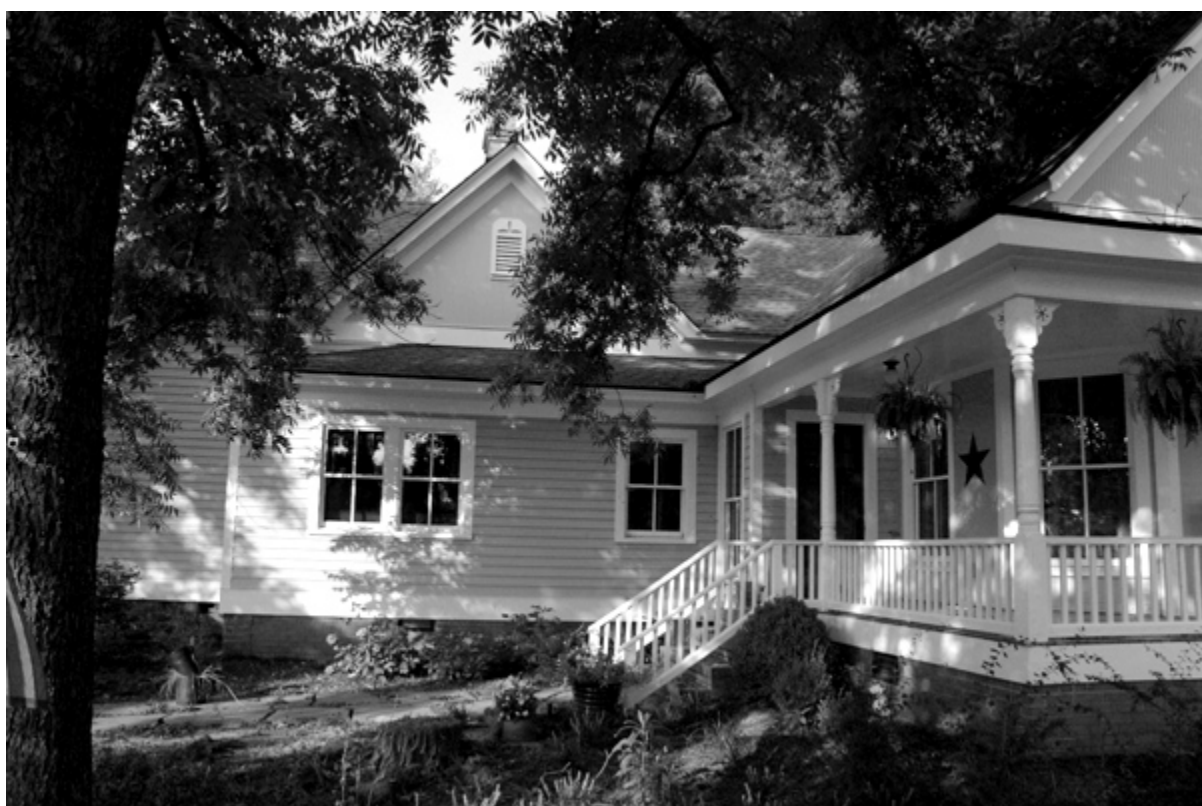
Detail of south elevation and south projecting wing

The south elevation of the principal section of the house is completely sheltered by the porch and contains a single tall two-over-two window. A small portion of the rear of the porch was enclosed with weatherboard early in the twentieth century forming a small vestibule. A tall two-over-two window and replacement door pierce the vestibule walls. Originally the porch wrapped around and sheltered the front of the wing that projects to the south. This portion of the porch was enclosed early in the twentieth century with weatherboard siding and is pierced by three short two-over-two windows. The gable features beaded board and the same woodwork found in the other forward-facing gables. The wing was originally cross-gabled, but with a recent addition to the rear of the house, the original south facing gable was replaced with a hip.

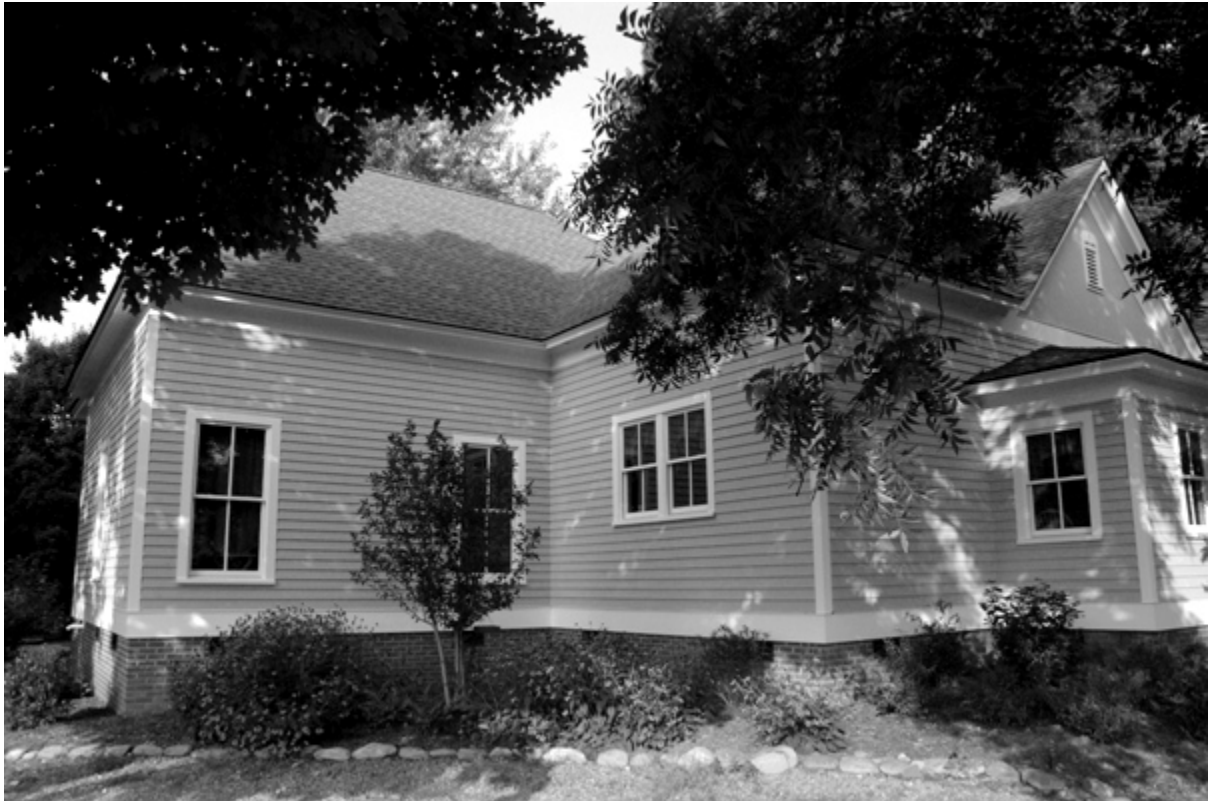
A new one-bay-wide hipped wing projects from the south elevation.

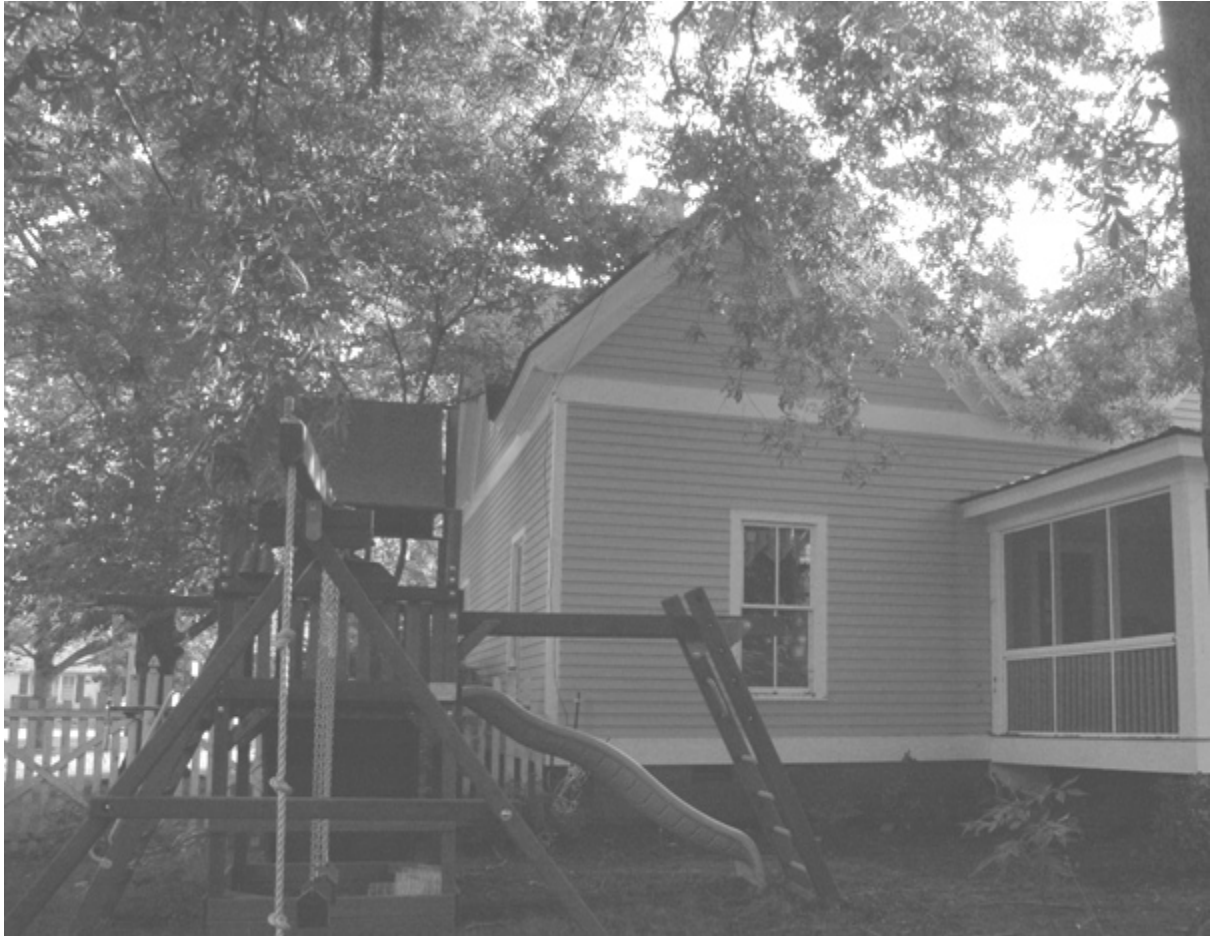
View of north elevation and rear (rear elevation features screened porch)

The north elevation is two bays wide. A gable is located adjacent to the facade. Unlike the front gables, this gable contains weatherboard siding and features a simple diamond-shaped louvered vent. A band that serves as a freeze board under the soffit adjacent to the rear elevation, runs across the base of the gable.

The northern section of the rear elevation is largely original and features a gable adjacent to the north elevation. Cornice/band and vent details are like those on the north elevation. A single two-over-two window is centered beneath the gable. A new hipped-roof porch shelters much of the center section of the rear elevation. It appears that the rear elevation once featured a recessed porch that was infilled to form bathrooms. A multi-hipped wing was added to the rear elevation in 2007, and it obscures the south portion of the original rear elevation. The new construction features a small gable above a cut-away bay.

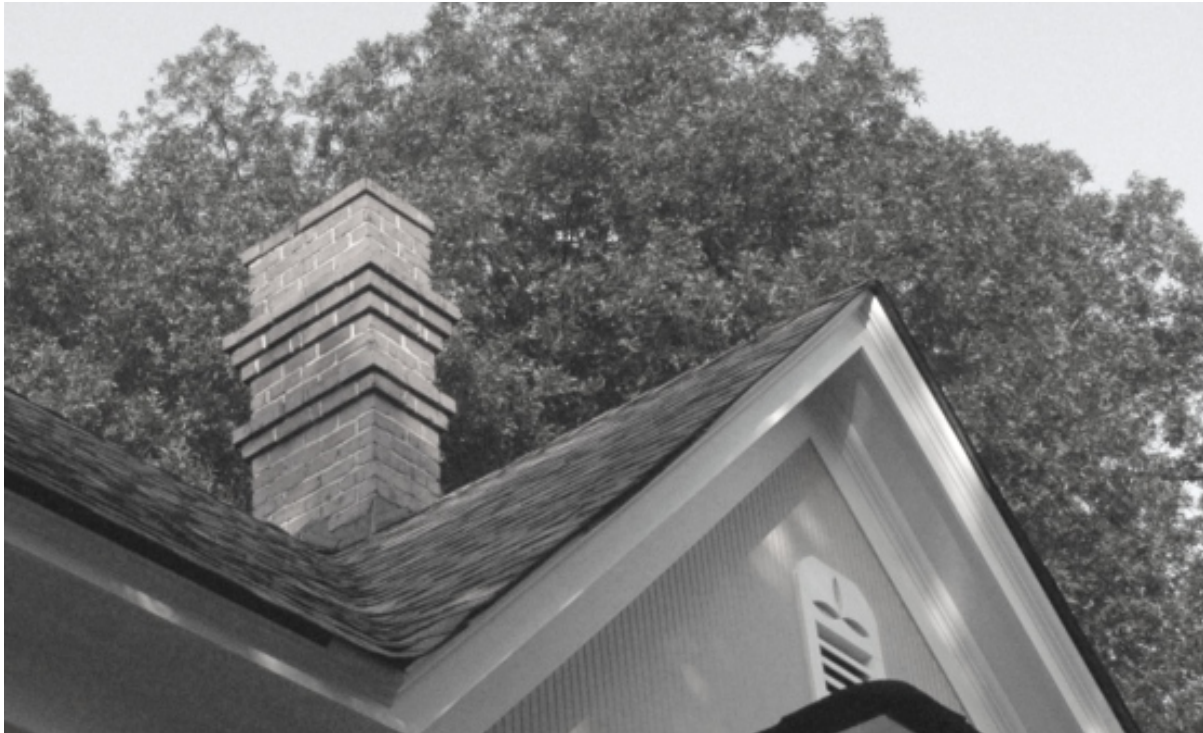
Chimney detail

The Sustare House features three decoratively corbelled internal chimneys. Each chimney is centered over one of the forward facing gables.

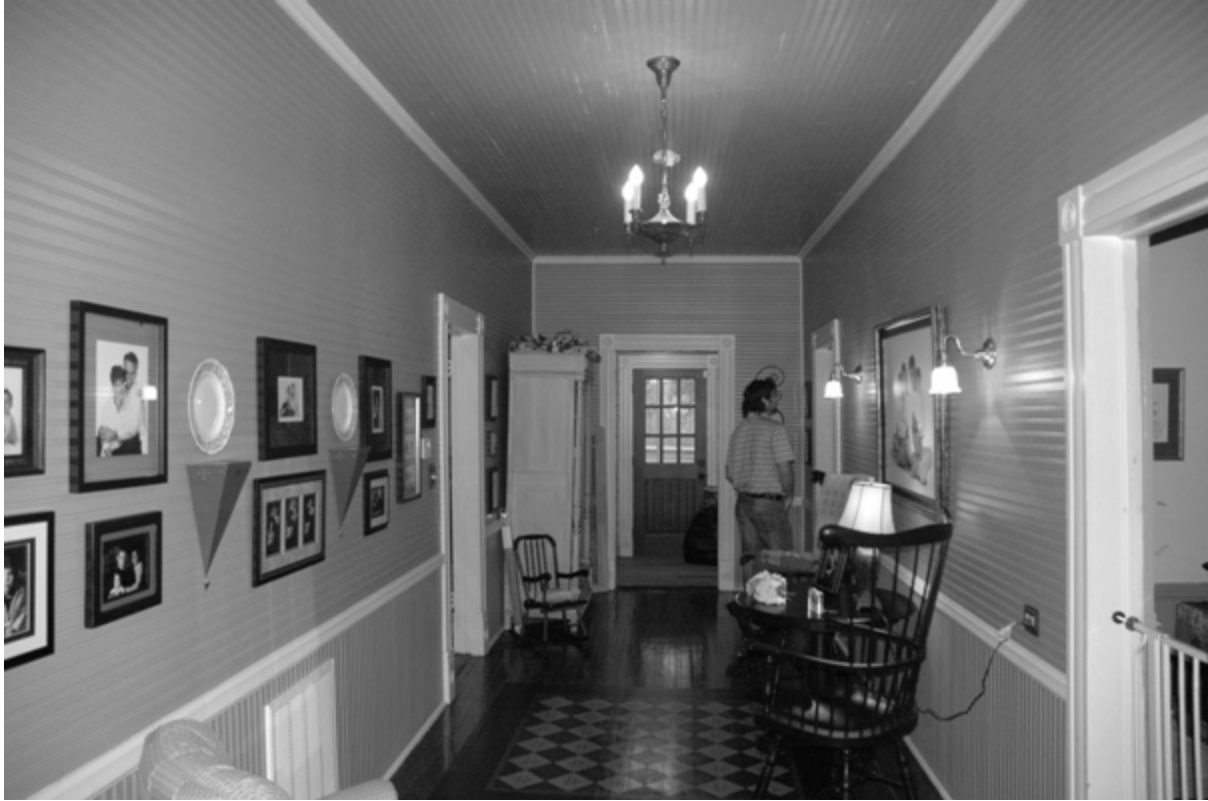
Hallway looking to the rear

Significant portions of the interior of the Sustare House have retained a high degree of integrity. The workmanship exhibited by the interior woodwork is exemplary. The five rooms that compose the principal section of the house have retained an impressive amount of the original woodwork. The principal section of the house is bisected by a hallway that runs the depth of the house. The hallway's ceiling and walls are covered with beaded boards. Boards on the wall are set vertically below a moulded chair rail, and horizontal above the rail. The six doorways that open onto the hallway are trimmed with moulded boards butted into rosette blocks at the upper corners, and into starter blocks also decorated with rosette at the floor. The walls are topped with simple moulded crown and the original pine floors are topped with wide quarter-round where they meet the walls. Interior doors have retained the original cast iron box locks and pressed steel knobs.

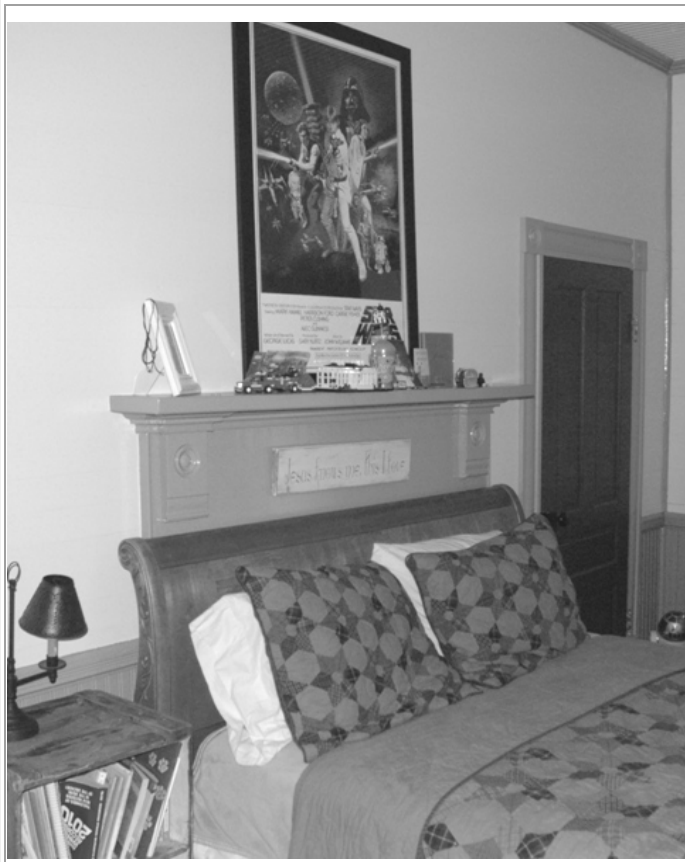
Front bedroom

To the north of the hallway are two bedrooms. The front bedroom features a beaded-board ceiling and vertical beaded boards below a moulded chair rail. Above the chair rail, the wall is sheathed with plain tongue-and-groove boards. The mantle features rosette starter blocks supporting a shelf. The rear bedroom has no chair rail and no beaded boards on the walls. The mantle in the back bedroom features sawn trim and rosette blocks and starter block, suggesting the the mantles were made by the builder using off-the-shelf millwork items. Both rooms feature moulded wood and rosette block trim around the doors and windows.

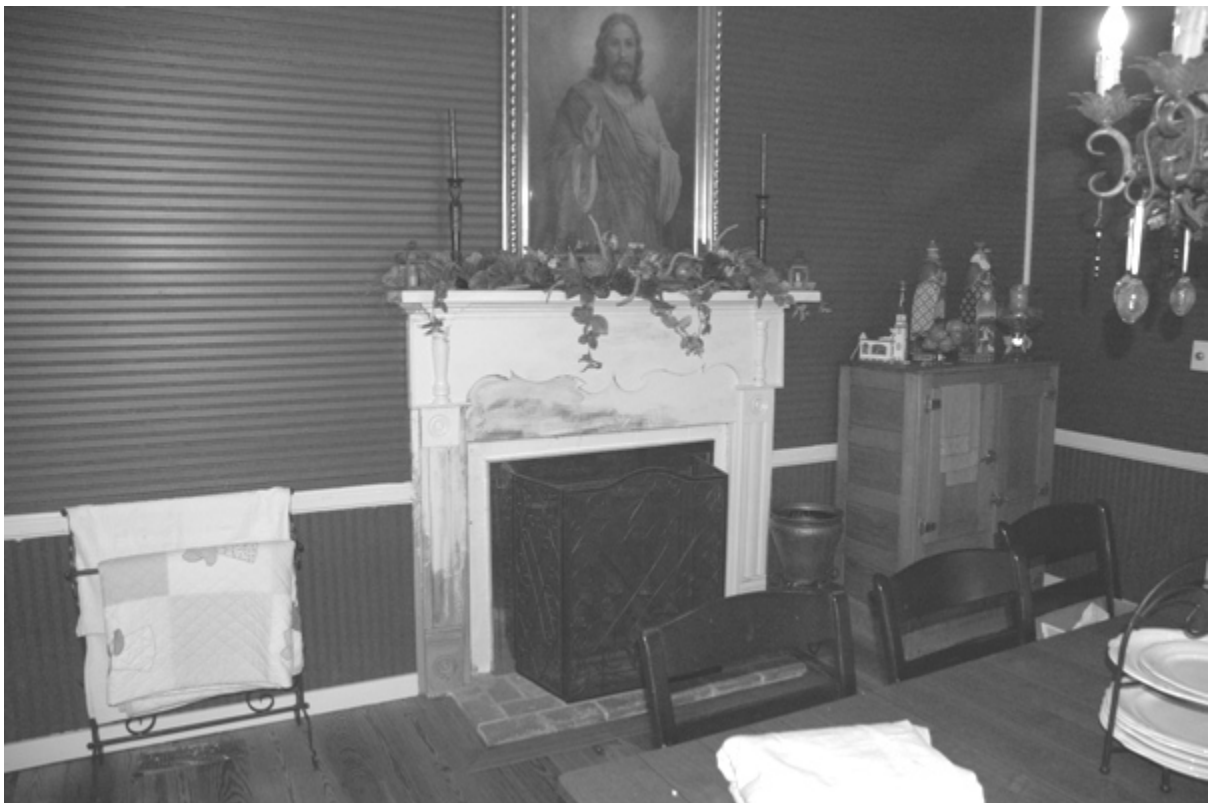
Parlor

The front room to the south of the hallway contains the cut-away bay, and originally served as a parlor. The tall mantle features ripped turned spindles, scroll saw trim, rosettes and moulded trim. In this room narrow moulded boards with a convex profile, like the siding used on the front porch, covers the walls below a moulded chair rail, with beaded boards above. The original floor has been replaced with similar pine flooring.

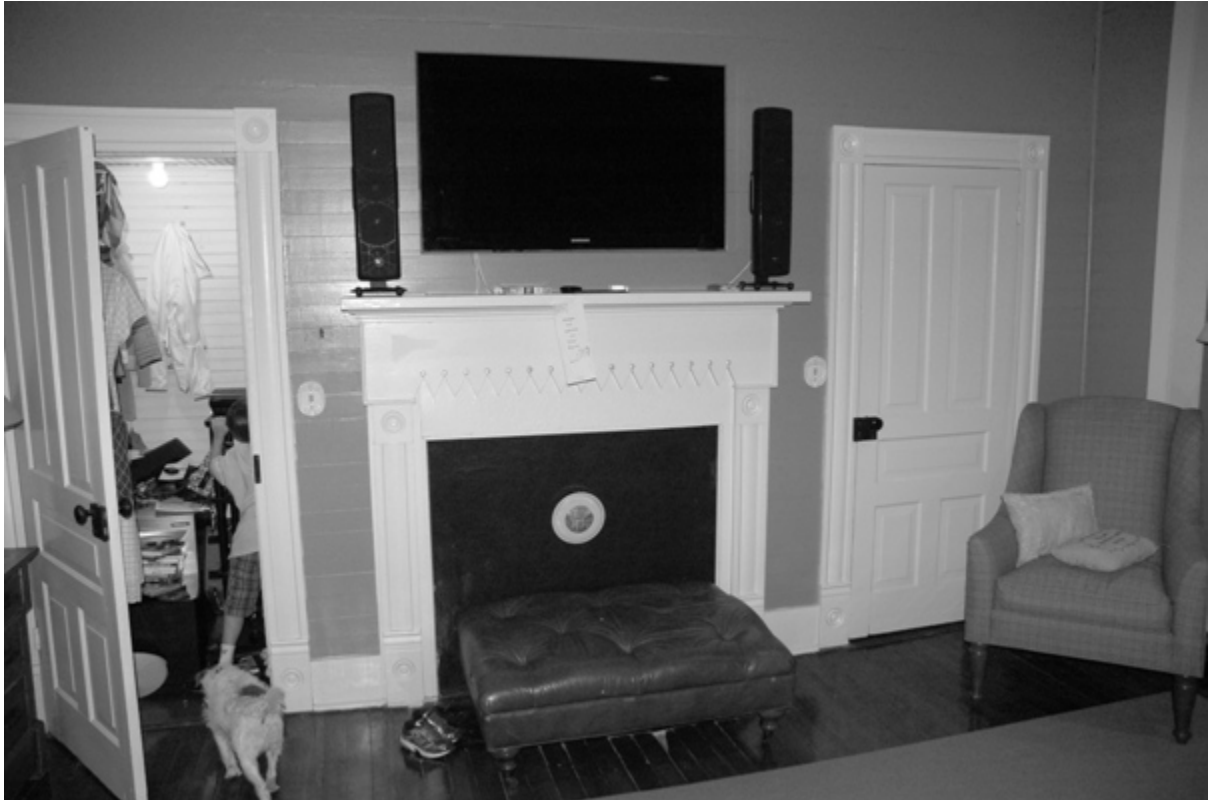
South rear bedroom

The back room to the south of the hallway, like all of the bedrooms, features two closets, one set on either side of the internal chimney. All of the bedrooms feature five panel doors. The mantle in this room features pendant-design sawn trim. A wall between this bedroom and the original dining room has been largely removed, replaced by a cased opening.

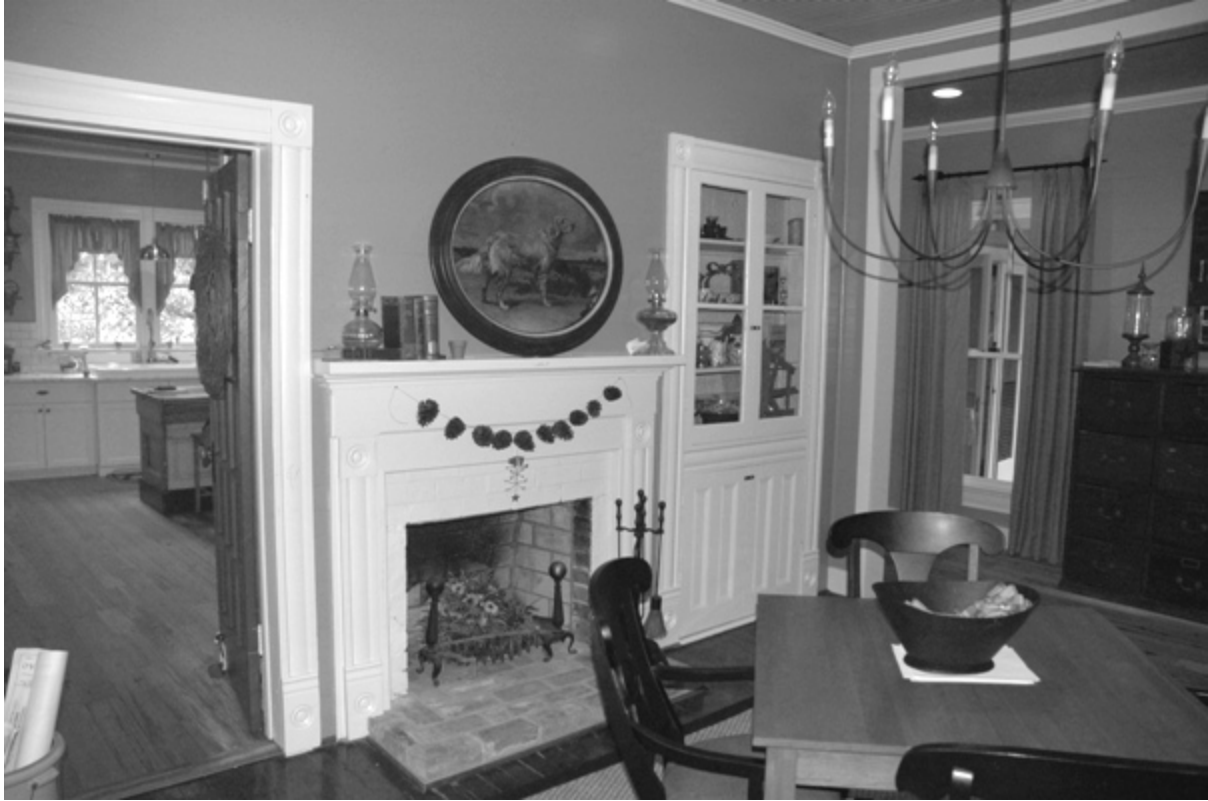
Dinning room

The dining room features a built-in china cabinet. The cabinet is either original to the house or an early addition. The room features a relatively simple mantle with moulded trim and rosettes. The brick hearth was recently rebuilt. A second cased opening was added to the rear of the room and open onto what originally was a rear porch. The walls are covered with tongue and groove boards. The floor is original. Portions of trim from an original window opening is still extant in the rear wall.

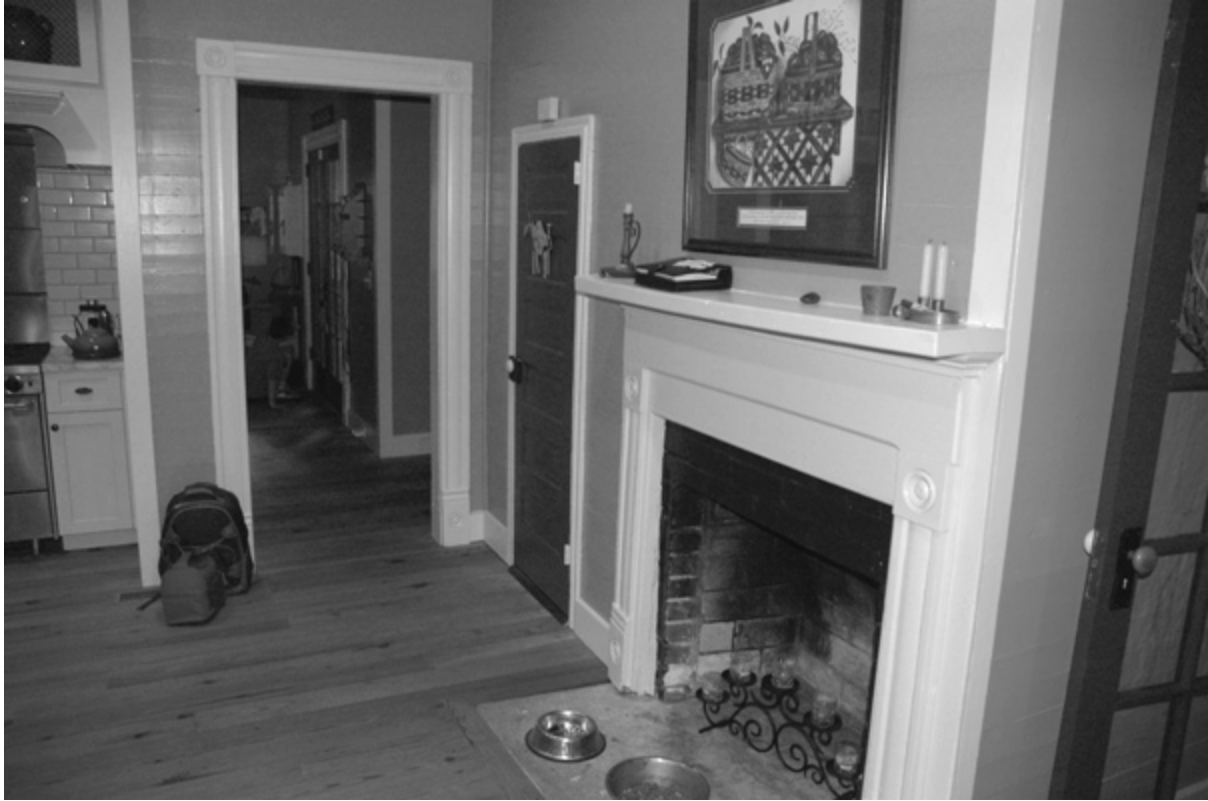
Kitchen

The kitchen was expanded in the middle part of the Twentieth Century and again in 2007, but many of the historic architectural elements remained in place, including a short six-panel closet door, and a mantle with moulded trim and rosettes similar to the mantle in the dining room. The room has a new pine floor, and boxed beams in the ceiling indicate the locations of the original exterior walls. A large bedroom wing was added to the house to the rear of the kitchen.
