Survey and Research Report On The Armature Winding Company Complex

Historical Background Statement

Architectural Description

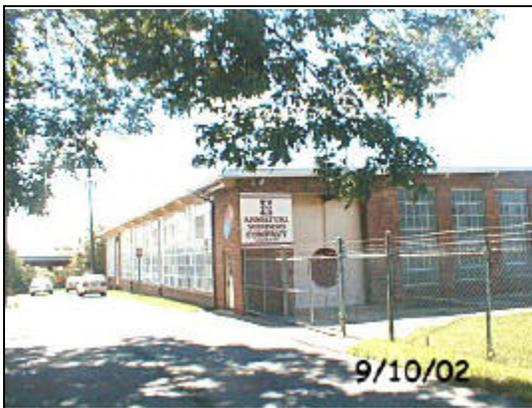
Armature Winding Co. Building, 1924

The complex's main building is a one-story red brick (common bond pattern with six course headers) structure with a low-pitch tarred gable roof, with a rectangular plan. Steel columns and heavy wood cross beams support the building throughout. The roof's overhanging eaves and exposed wood rafters evoke the bungalow-style—architect Fred L. Bonfoey's specialty. The building is constructed in the mill/industrial style, with large multi-pane windows with metal frames dominating the structure's architecture.

The north face of the main building is eight bays wide, with seven windows stretching from just under the roofline to about three feet above the ground. These apertures have metal mullions, brick sills, and are laid-out in a 7 pane high by five pane wide configuration, with hopper window insets. A large loading door is on the east (left when facing) side of this wall—this door once connected to a spray booth (adapted from one of the tenant houses)²⁰, but no doubt became an important point for deliveries, as trucks replaced trains as the principal means of receiving and distributing goods to the site. A three-story, non-corbelled, non-shouldered chimney also rises from the north side of the building.

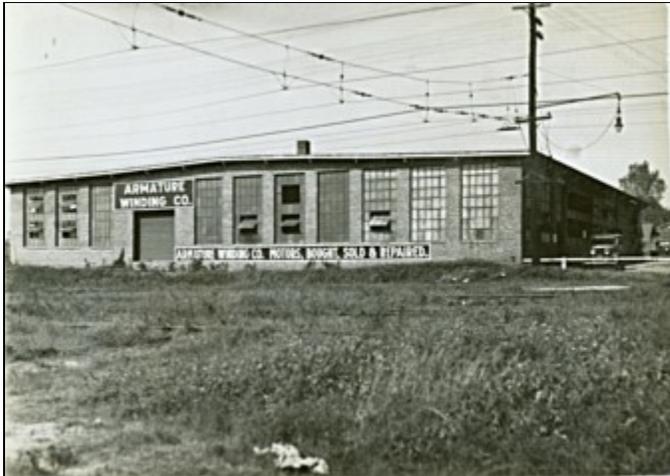
Armature Winding Company Building from across Piedmont and Northern Railroad tracks.

The south elevation looks out over the rail line and at the time of its design was likely considered the front of the building. Eleven bays wide, with ten window groups (five panes wide by seven tall), the words "ARMATURE WINDING CO." was boldly emblazoned above the loading dock door in white letters against a black background. Similarly, "ARMATURE WINDING CO. MOTORS BOUGHT SOLD AND REPAIRED," was painted underneath the band of windows to the right (east) of the loading door.

Today the south elevation has lost much of its former glory. The huge windows that defined this view of the building are bricked completely up. A hedge of thick foliage runs just a few feet parallel to the building face, and the area in between has become quite overgrown with plants. The view of the building is further obscured by several defunct train cars parked on the railroad track right in front of the building. Although greatly faded, it is still possible to read the two black and white painted signs on the building. The rollup loading dock door, which once allowed the passage of goods to and from waiting railroad cars, is closed and practically useless.

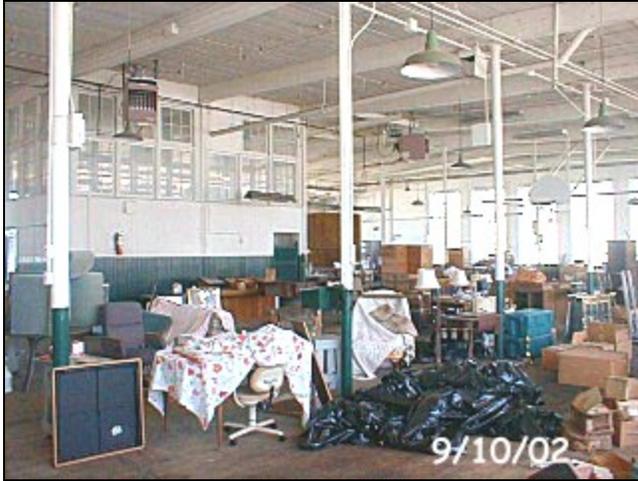
**Interior of Armature Winding Company
Building**

The steel column and heavy wood cross-beam construction of the Armature Winding Company Building not only allows the extensive use of large windows in non-load bearing walls, it also permits the interior of the building a great deal of openness. The interior of the building is essentially a shop space, the open plan of which is interrupted solely by the centrally located men's restroom. The flooring inside the space is concrete on the western half of the building, while maple boards are on the eastern side. An overhead crane system tracks below the ceiling in the space. Offices located in the southeast corner of the shop have been partitioned off from the main space by a new wall and have been extensively remodeled with carpet, refinished floors, dry-wall partitions, and modern lighting; however, there has been some efforts at preserving the integrity of the space, such as keeping the original windows and covering them with shades on the inside.

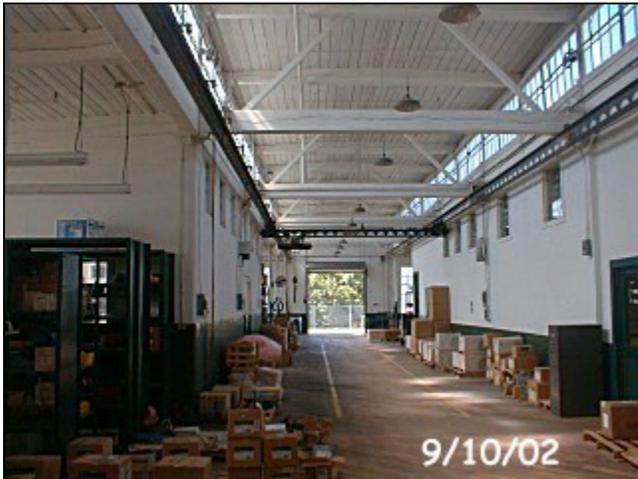
Interior of Southern Specialties Co. Building

The interior of the Southern Specialties Building is a curious mix of the extensively remodeled and well preserved. In the 1970s, the building underwent an extensive modernization. The owners added a storefront addition to the north elevation and gutted extensive portions of the northern and eastern sections of the building.²¹ Very little original material remains in these areas—even the windows are gone. However, a great deal of historic fabric is concentrated along the central spine of the building in an open space underneath the dramatic clerestory roof. Here the wood plank floor and ceiling are still in place, as are the hanging lights, elements of the overhead hoisting system, and the heavy wood beam and steel column support system. A cellar (inaccessible to this writer at the time of his visit) purportedly used by the Southern Specialties Company to store silkworm cocoons exists under the building and is reached via a centrally located interior staircase.
