## **The City House**

This report was written on September 12, 2005.

**1. Name and location of the property:** The property known as the City House is located at 500 East Kingston Avenue in Charlotte, NC. The UTM coordinates for the property are: 17 513351E 3896327N (WGS84/NAD83); USGS Charlotte East Quad.

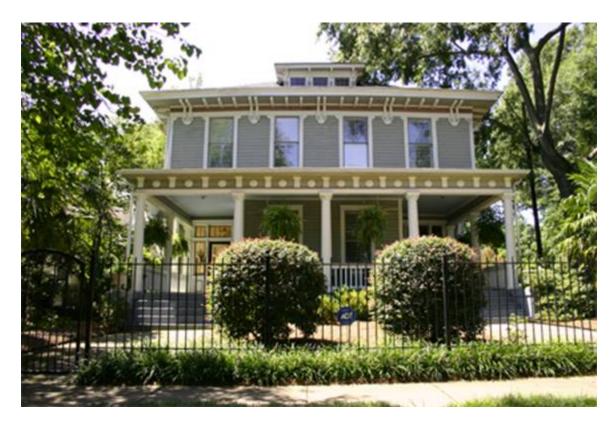
Front Elevation

The front northeast elevation is strongly characterized by a large one-story front porch with plain railing that spans the full front façade. Doric columns support a flat porch roof and a frieze ornamented with alternating triglyphs and rondels. Twin sets of steps lead from each front corner of the porch down to concrete sidewalks that cross the front yard connecting to the street. A four-foot high black painted steel fence with two gates, added in 1989 encloses the front and northwest side yards.

The main block of the structure has a low-pitched hip roof. Large brackets support the overhanging boxed eaves and dominate the cornice. Arranged in pairs, and separated by modillions, these brackets are placed on a trim band elaborated with sawn-work. A central dormer is perched on the roof and features three six-light windows.

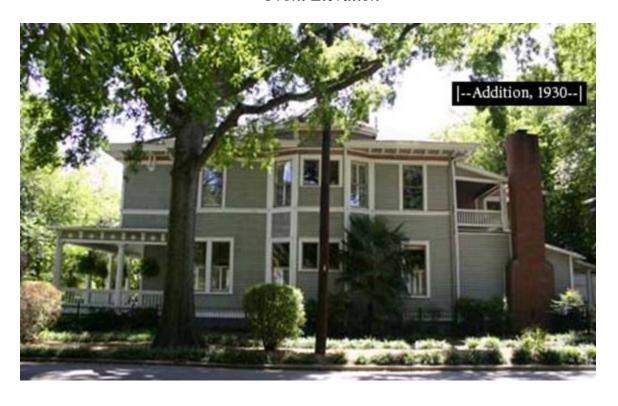
The northwest elevation

The northwest elevation fronts Lyndhurst and is seven bays in width, with the bracketed eaves and trim motifs continued from the front. The most defining element of this face is the two-story high bay window, itself four bays wide with its own hip roof. As with most in the City House, the windows are double-hung one-over-one sash. A chimney rises from the roof, visible just behind the bay window. An examination of the brick foundation along the northwest side makes apparent the division between the original portion of the house and the later 1930s addition, which includes a second story porch with simple railing. A single shouldered chimney abuts the wall near the west corner.

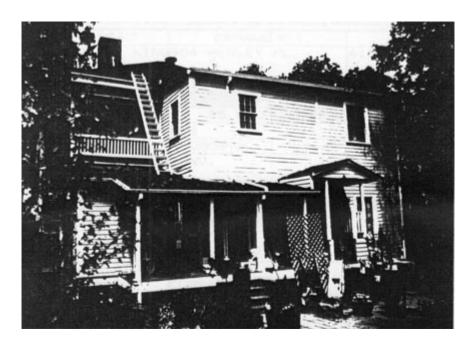
Rear Elevation, 1988

A rear addition extends the footprint of the City House to the southwest and has seen extensive modifications over the years. Nine bays wide, the addition was constructed around 1930-1931. The rear is asymmetrical, with a large mass extending from the second story from the southern (right) side of the building and spanning three-fourths of the elevation. Seven large single-pane windows replaced the original two small six-over-six double hung windows in 1988. A recessed sleeping porch, extends the remaining length. Popular additions in the 1930s, sleeping porches were especially favored in the South.

The rear porch has been rebuilt at least four times. The 1911 Sanborn Fire Insurance Map shows a fairly wide rear porch spanning three-fourths of the way across the rear elevation. By the time of the Sanborn's next addition in 1929, a new shorter porch

was in place, as were a set of external stairs descending below grade to what may have been a newly dug cellar beneath the rear of the foundation. The 1930-1931 rear addition necessitated the demolition of the second porch and the building of another, which stood until the late 1980s. Documentary photographs show the southeast side of the City House accessed from the rear by a stoop and single door entrance with a pedimented front-gabled porch-roof; these were demolished in 1988, the door clapboarded over and the porch's shed roof extended back to span three-fourths of the elevation. Ivan Beach, the current owner was required to replace the porch in 2002 because of decay, using vinyl planks atop a cinder-block foundation. The rear yard is shielded by a 7½-foot cypress privacy fence, constructed in 2002. In the back yard is non-contributing storage building of corrugated pressed metal siding of recent origin. The rear yard is beautifully landscaped and is dominated by a red brick patio and walkways.

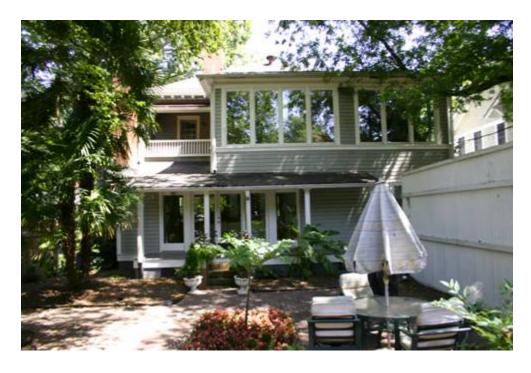
Rear elevation, 2005
