Delburg Cotton Mill House

The Delburg Cotton Mill House
303 Delburg Street
Davidson, North Carolina

The Delburg Cotton Mill House

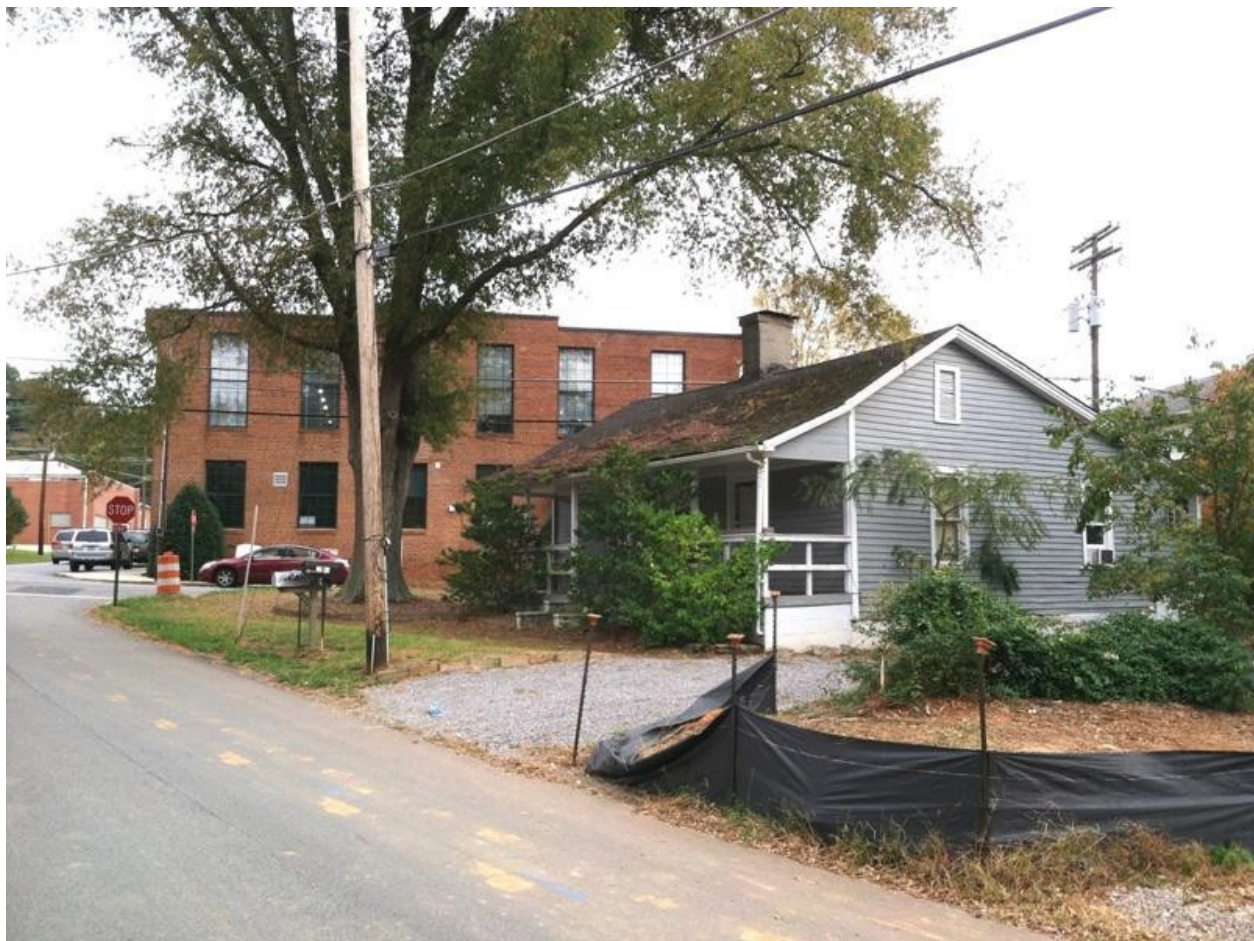
With the substantial loss of integrity for the 300 block of Delburg Street to what was until recently an intact mill village setting, the significance of the Delburg Cotton Mill House located at 303 Delburg has greatly increased. With its unique location adjacent to the mill, the Delburg Cotton Mill House still conveys the historic relationship of the mill to the mill houses.

The Delburg Cotton Mill House, with the mill in the background

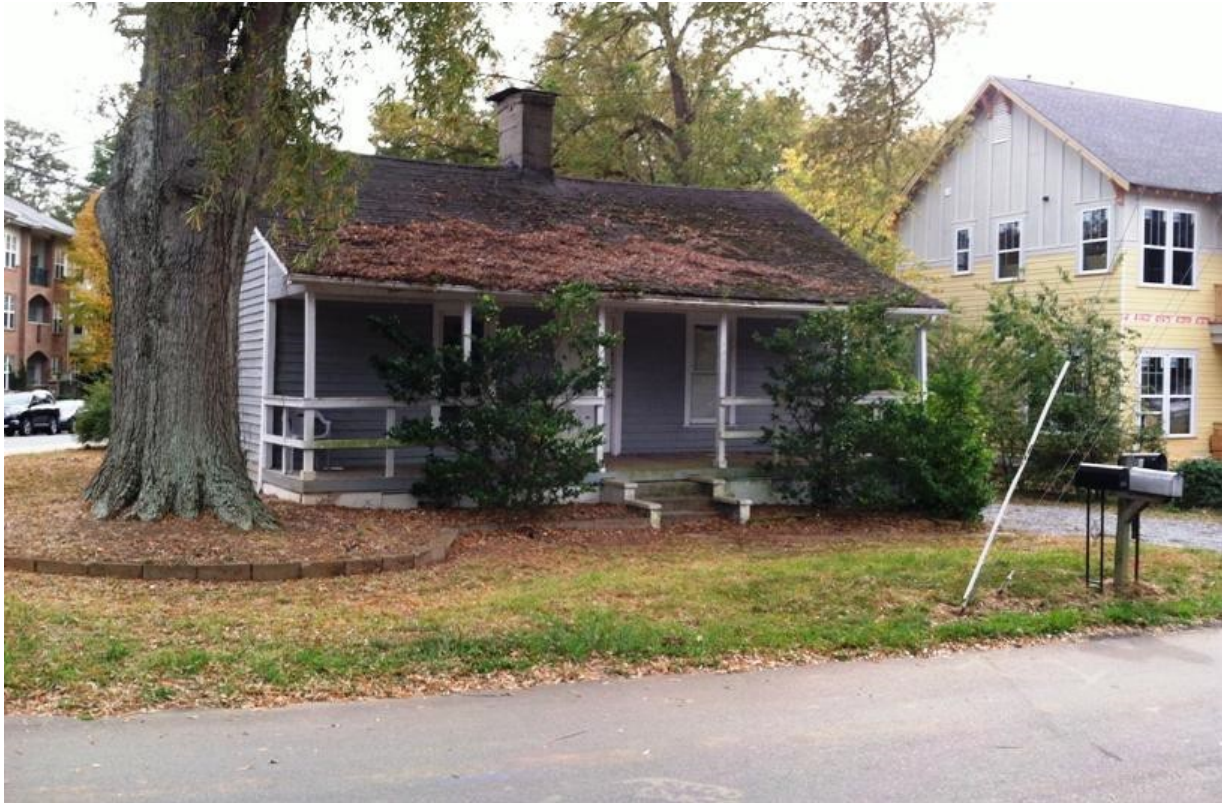
The Delburg Cotton Mill House at 303 Delburg Street is a one-story, frame, side-gabled house, typical of early-20th century Piedmont mill housing. The house faces north and sits on an irregularly shaped .10 corner lot. The house fronts on Delburg Street and is located approximately 21 feet from the pavement. The east side of the house faces Watson Street. Until recently, Delburg Street was populated by a fairly intact collection of one-story side-gabled and hipped-roof mill houses. Many of these houses have been demolished. The neighboring house to the west of the Delburg Cotton Mill House is a new two-story frame house. To the east, across Watson Street, is the two-story, brick Delburg Cotton Mill/Davidson Cotton Mill. A large water oak is located in the front yard.

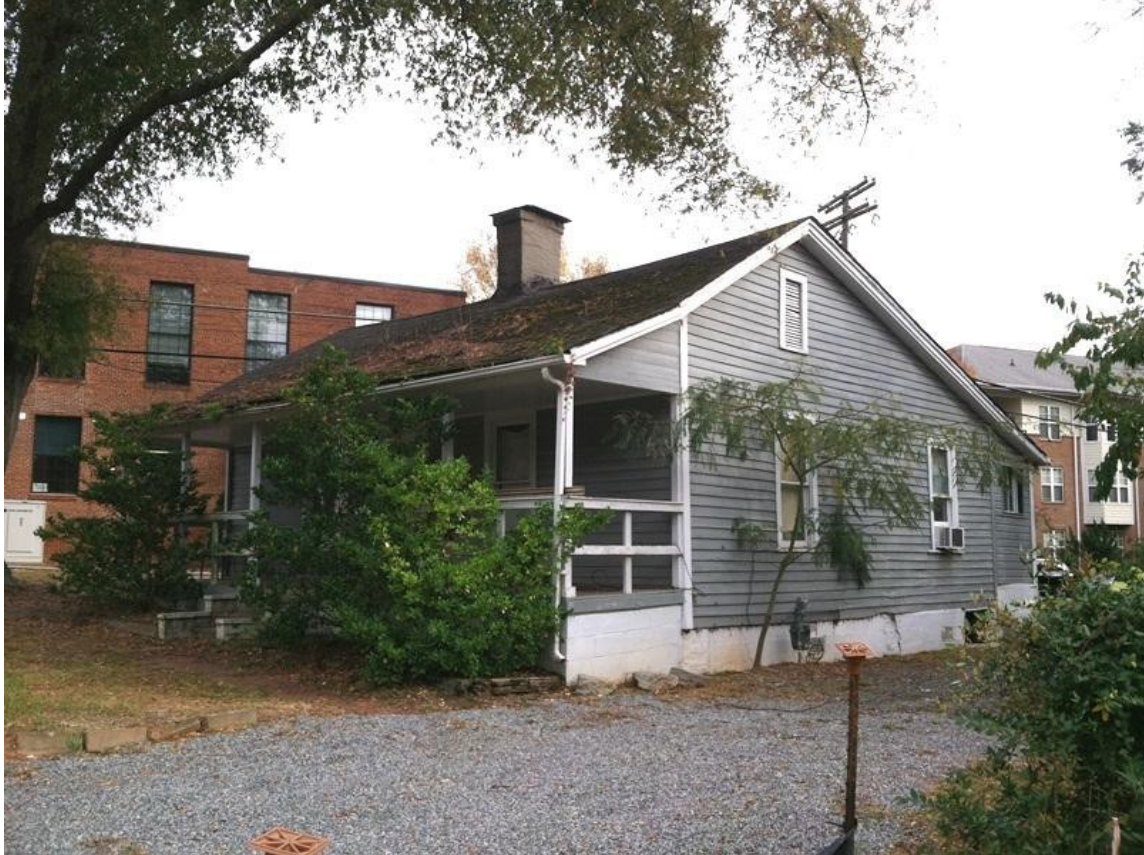
The front of the house is dominated by a full width engaged porch. The original porch floor has been replaced with pressure-treated boards supported by a block foundation. Block steps with block cheek walls lead to the porch. The porch roof is engaged with the principal roof, but has a slightly lower pitch. The porch roof is supported by six simple square posts. The porch ceiling is original tongue-and-groove boards. The front elevation fenestration is symmetrical with a replacement door centered between one-over-one windows. The double-hung windows contain replacement one-lite sash. Like the other elevations, the front elevation is covered with weatherboard that terminates at simple corner boards. Centered on the ridge is an internal chimney with a corbelled cap. The chimney has been parged.

It is likely that the house was originally a single-pile (one room deep) building. It appears that the roof was extended to cover additional rooms added to the rear of the house. On the west elevation, the original brick piers are exposed, and are now infilled with block. The principal section of the house is two bays wide. Each bay contains a single double-hung window with replacement single-light sash. An original rectangular louvered vent is located high in gable. The same siding found on the front was used on the side elevations. There is no transition in the siding on the side elevations indicating that the house was expanded to the rear.

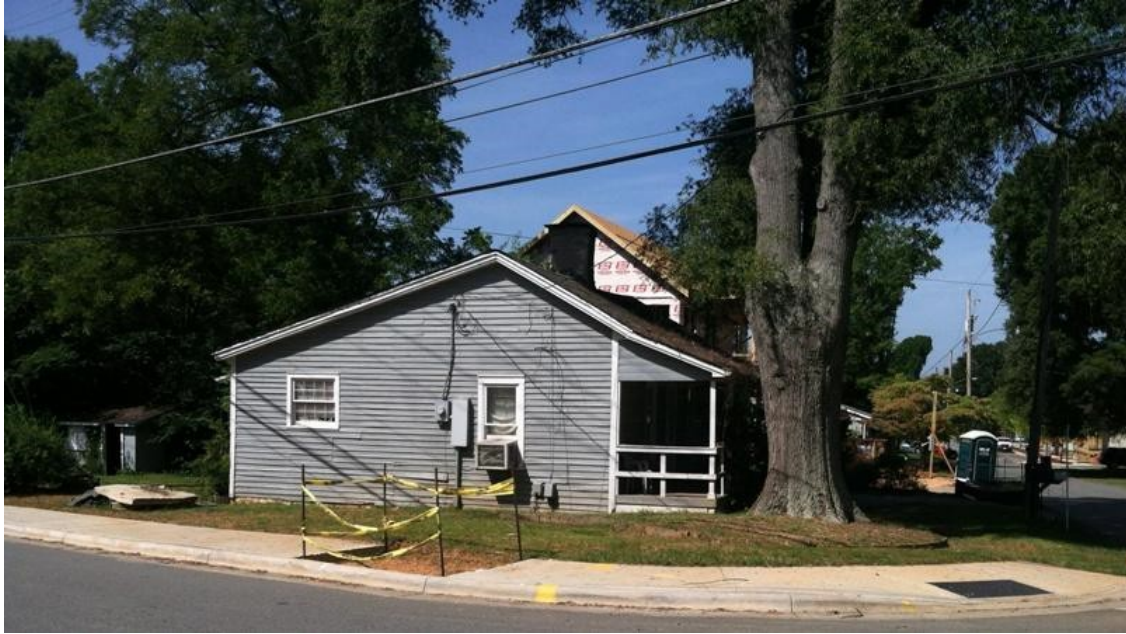
The east elevation is similar to the west elevation. The window in the rear bay was replaced with a shorter double-hung window to accommodate kitchen cabinetry. The lower section of the original window opening is patched with short pieces of siding. Unlike the west elevation there is no vent in the gable.

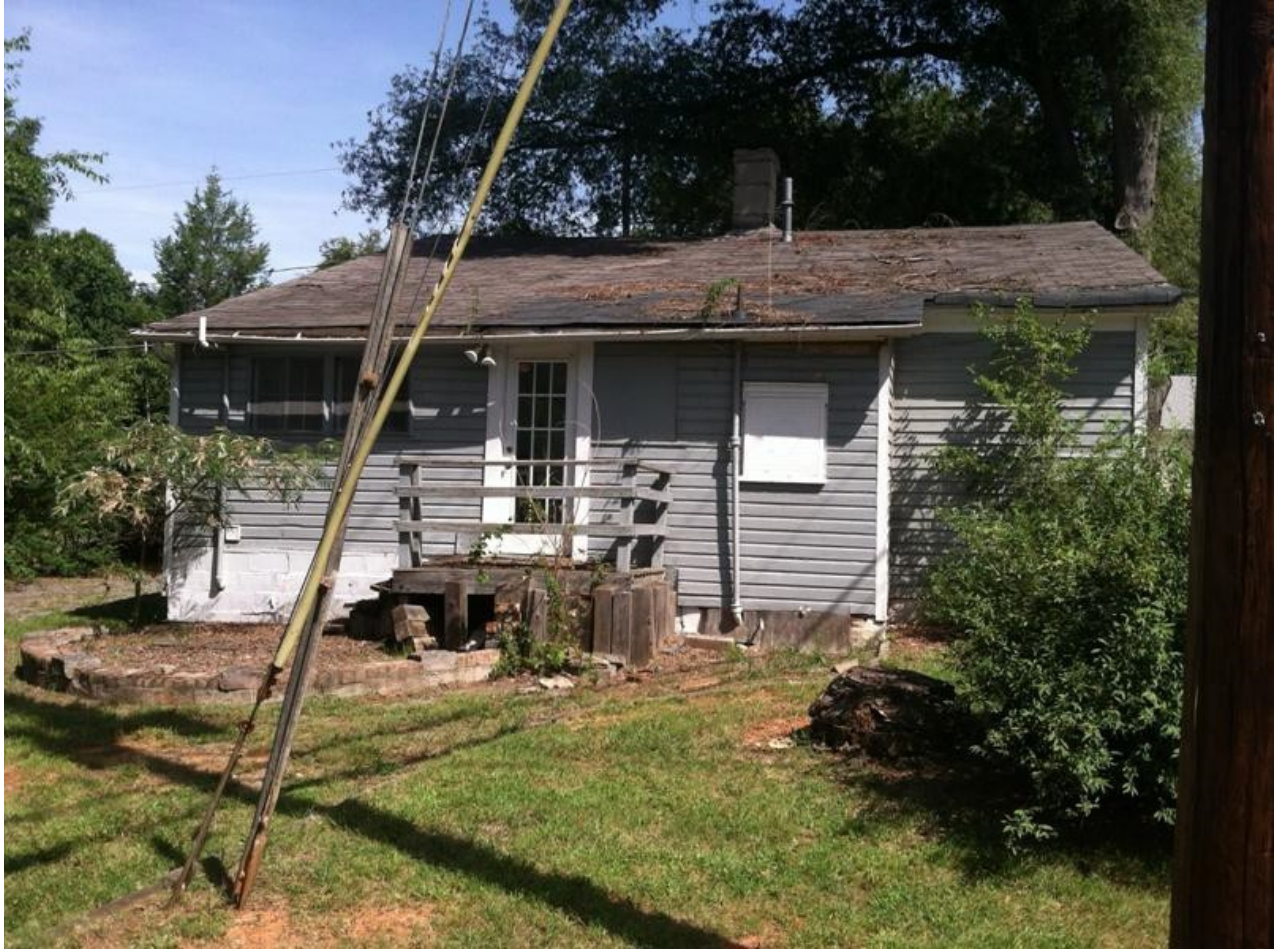
A shallow shed addition was added to the rear of the house and may incorporate portions of a rear porch. The addition is flush with the principal west elevation, and is set back approximately six feet from the principal east elevation. On the west side of the house, the weatherboard siding of the principal section is separated from the German siding of the addition by a vertical board. The west elevation of the addition is pierced with a six-light casement window. The rear of the addition is covered with German siding. A replacement door is roughly centered on the rear of the addition. To the west of the door, the rear elevation is pierced by a pair of six-light casement windows. To the east of the door are two covered window openings. The opening closest to the door is covered with a plywood panel. The second window opening is set low in the wall and is covered with beaded board. The west side of the addition is supported by a continuous block foundation. The east side of the addition features a brick pier at the corner. The siding on the west side of the addition stops at the level of the door threshold. The siding on the east side of the addition extends lower by four courses. The east elevation of the addition is blank and is covered with weatherboard, as is the only exposed section of the rear elevation of the principal section of the house.

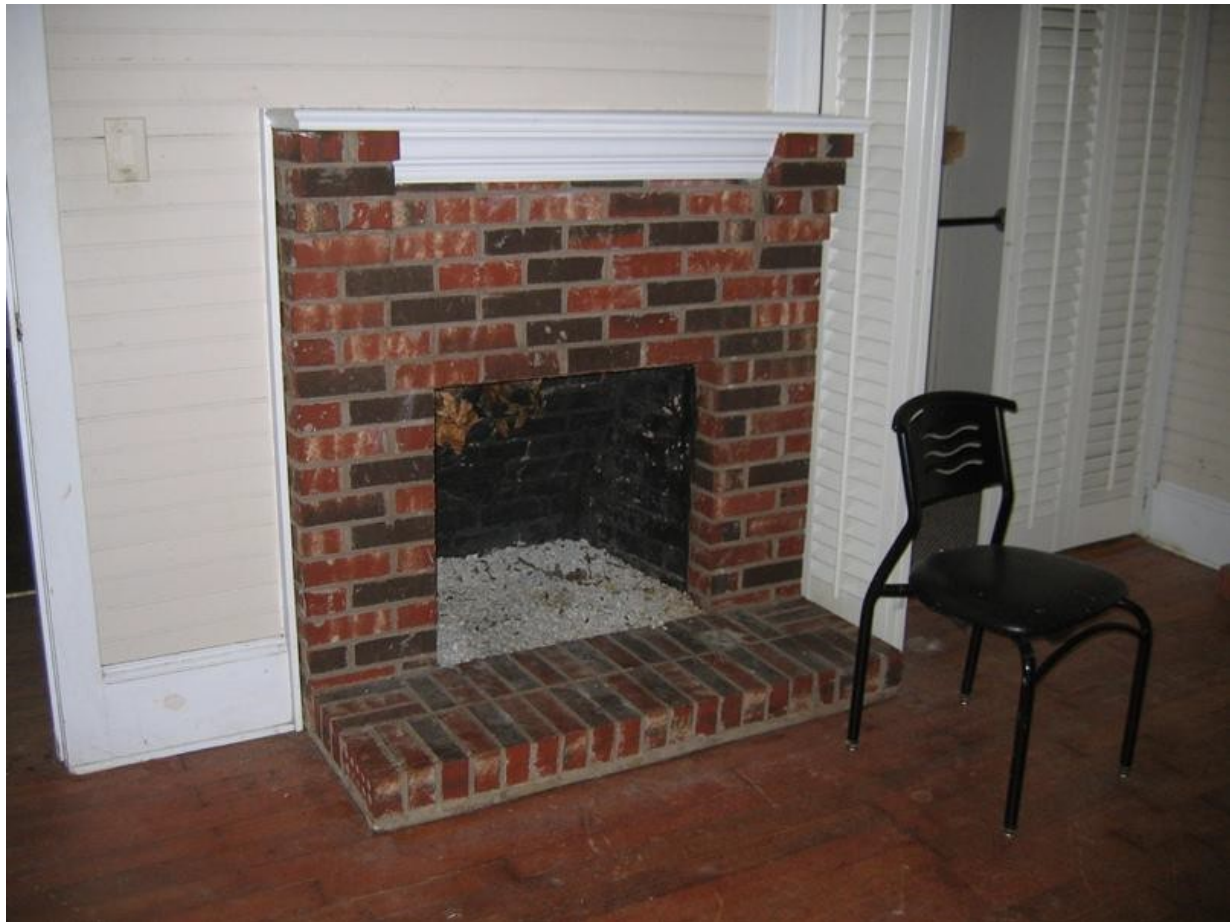
The interior of the Delburg Cotton Mill House has retained a good degree of integrity. The fourroom layout of the principal section of the house has been retained, and the interior of the principal four rooms should be included in any landmark designation. The original pine floors appears to have survived in all four rooms. The front two rooms feature tall (approximately 9'6") ceilings. Wallboard has been added over the original ceiling boards. The living room walls are also covered with wallboard. Original window and door trim is in place. Tall original baseboards have been topped with additional moulded trim. The front bedroom has also retained the original beaded-board wall covering. The central chimney services fireboxes in both front rooms. The brick fireplace surrounds and mantles are of recent construction. An original recessed space features recently added louvered doors.

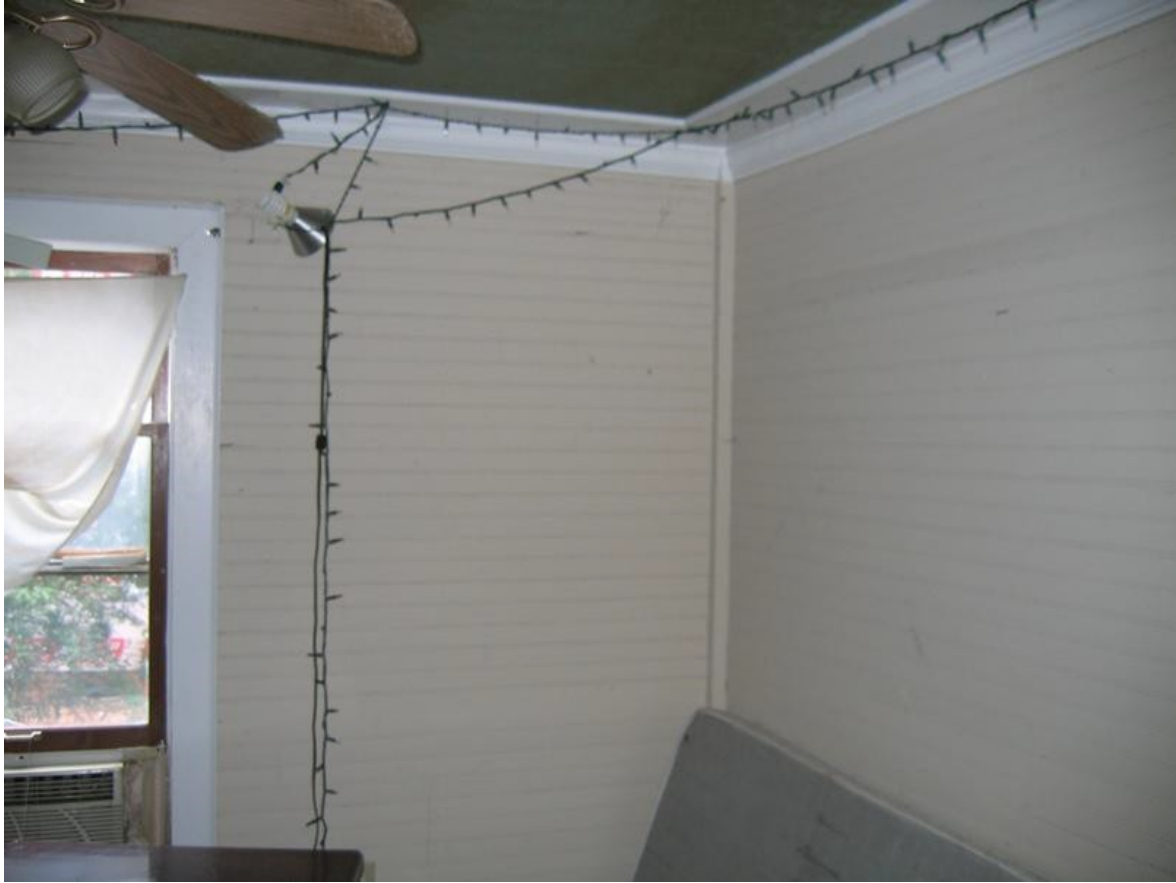
The rear two rooms feature lower ceilings. The rear bedroom features the original beaded-board wall covering, baseboard, and simple window trim. Recent trim has been added to juncture of the walls and ceiling. The ceiling has been covered with wallboard.

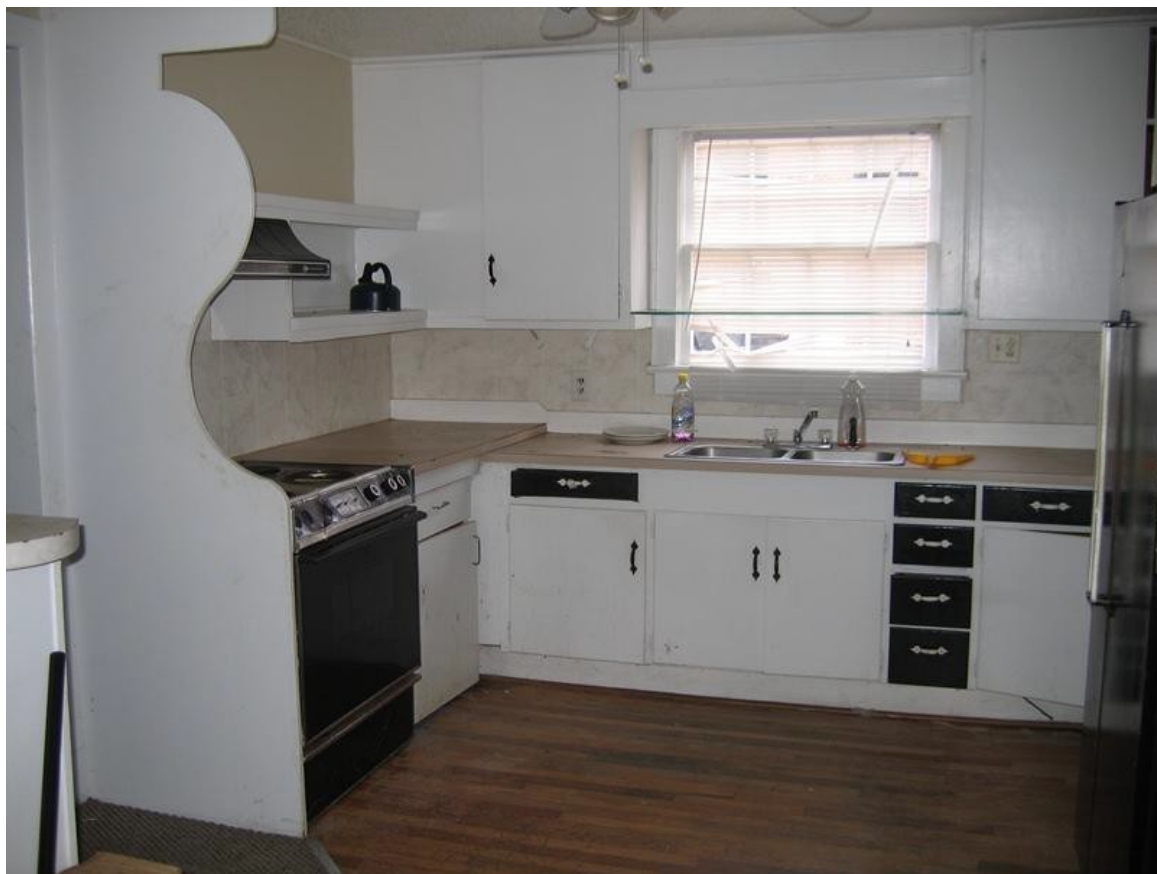
The kitchen has retained the original pine flooring. The ceiling is covered with wallboard, and the walls are covered with cabinetry and wallboard. The rear addition of house contains a bathroom and a mudroom/laundry room. The interior features of the rear addition are in poor condition and do not contribute to the significance of the property.

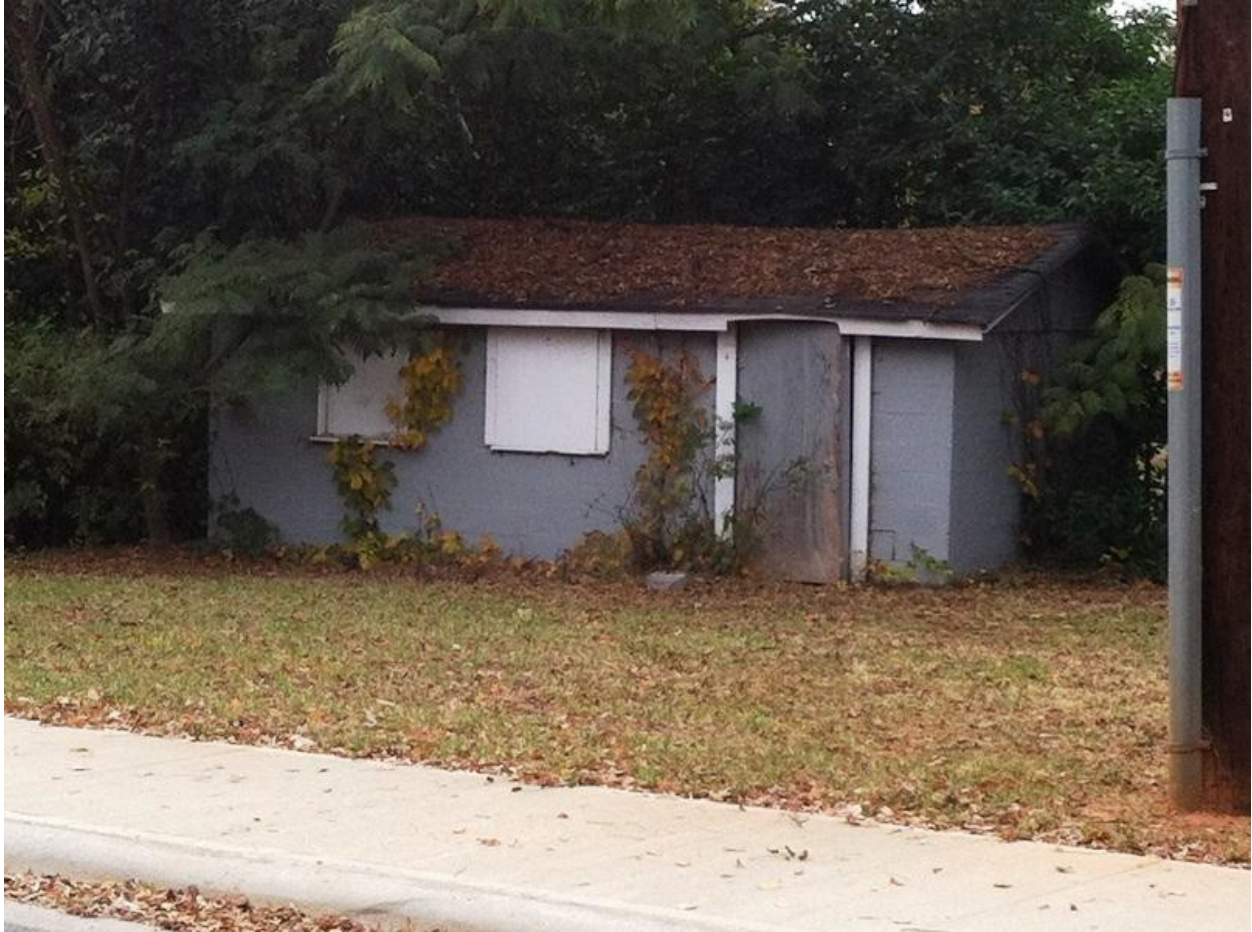
A small concrete block outbuilding with a gabled roof is located behind the house. The outbuilding dates from the second half of the 20th century, and does not contribute to the historical significance of the property.
