**RE:** Request for Certificate of Appropriateness (COA)  
**Project:** Johnston Mill, 3315 N. Davidson Street, NC

## Exhibit B: Structural Engineer SRO Report

RE: SRO, Building Johnston Mill Site – Preliminary Building Evaluation  
Charlotte, NC

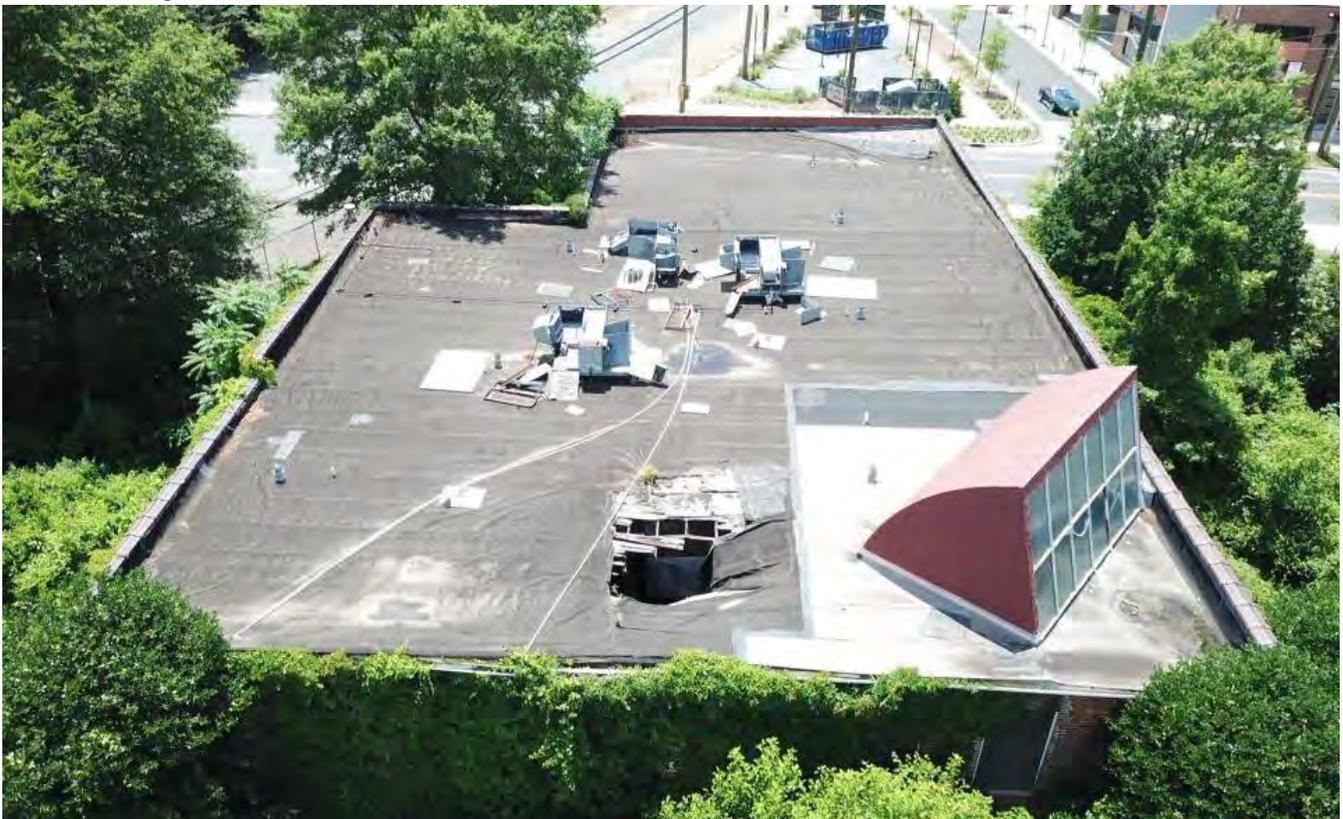
Photo 1 – Aerial of SRO Building Roof Damage (not taken by Stewart)

From the rear of the building, we observed a section of the 2-story building approximately 40'x40' that had fully collapsed. The framing supporting the opening we observed the collapse through was severely damaged. We also received aerial photography of the roof of the building. Several places can be observed with active leaks and further roof damage.

Photos of our visit are included with our report. We recommend the building be demolished as soon as possible to prevent further deterioration or the potential for the dangerous conditions to become a public safety danger. If you have any questions, please contact me.

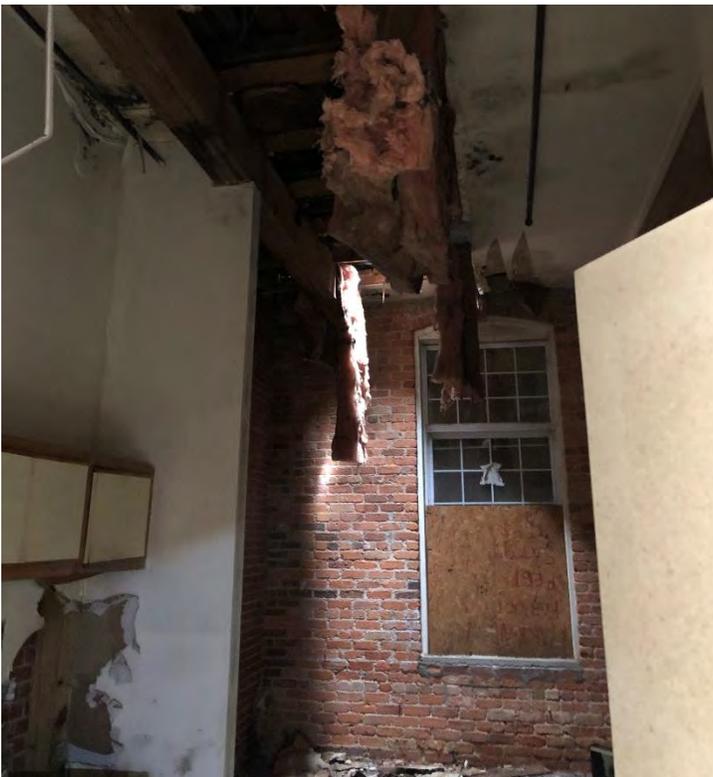
Photo 3 - Damage and water entry at the front of the building

From the front of the building, we were able to observe areas where active water leaking was observed around the perimeter of the building. It appeared some roof deck boards had failed and allowed light in through the structure. Our observation into this side of the building was limited to one open room.

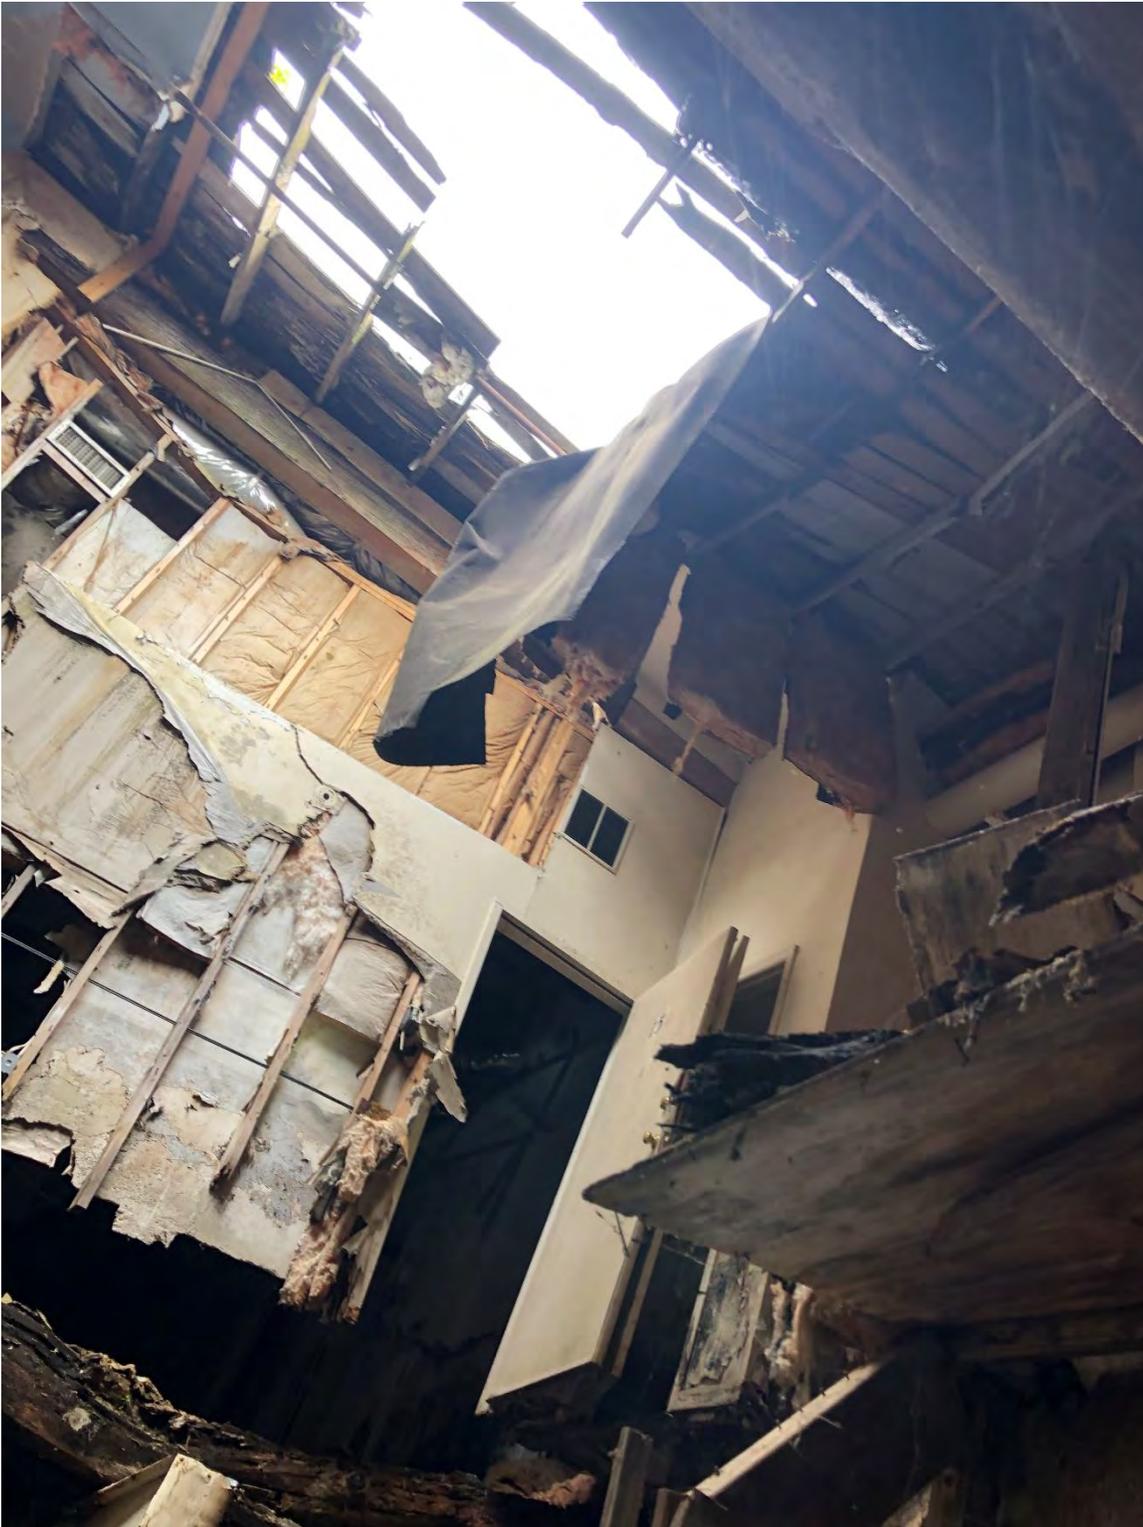
Photo 6 – Collapsed area looking at roof

- [6,924 SF / 106,934 SF]
- It is not technically feasible to retain the SRO Building:
  - A 40' x 40' section of the building experienced a full collapse of two stories, severely damaging the frame that once supported it (please see photos 6-8 on the previously referenced Exhibit B)

Based on our observations, the building is unsafe. A significant portion of the building experienced a full collapse of two stories. It is not safe to enter the building to determine the rest of the potential damage.

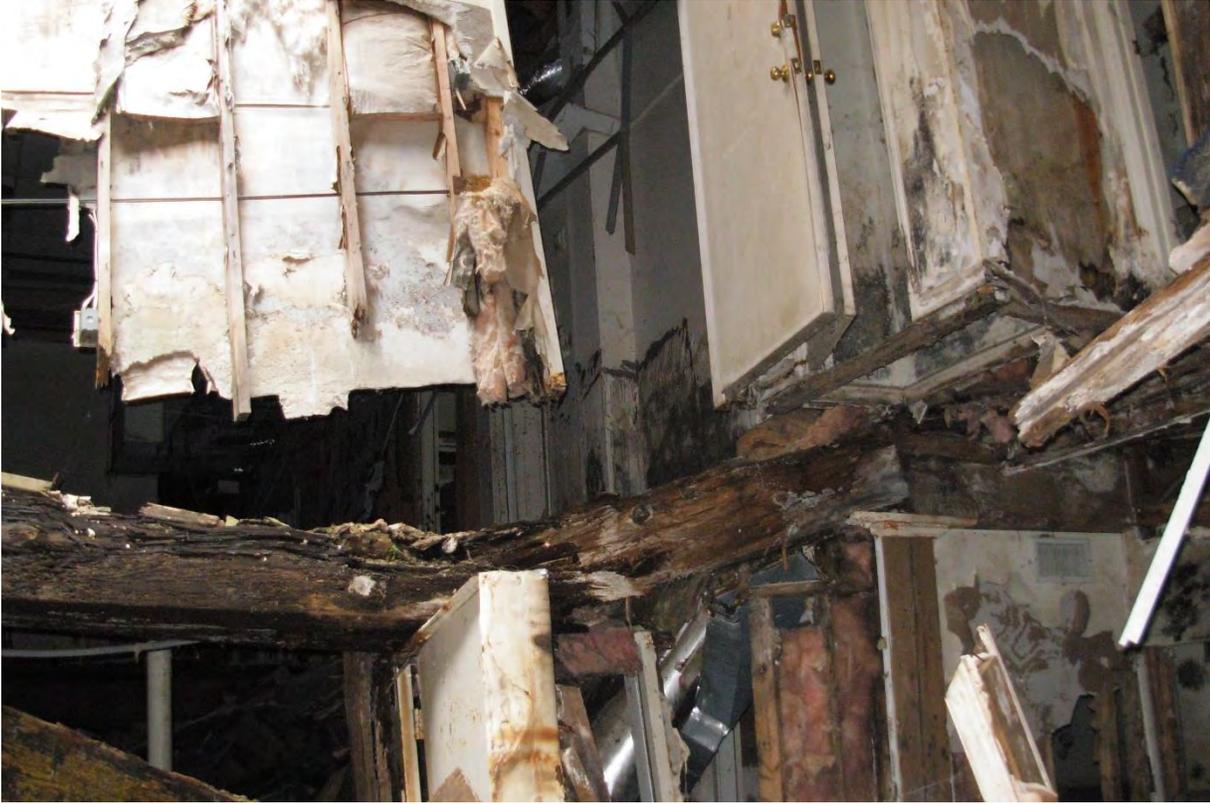
Photo 7 – Collapse of floor and wall framing

The portion of the exterior wall in the rear of the building adjacent to the collapsed area is not supported and presents a dangerous condition. This portion of the exterior wall is a two-story wall without any support to the floor or ceiling. The existing walls were not designed to cantilever two-stories. Without the ability to determine the remaining condition of the building there are likely other dangerous conditions that exist. We believe the building has very little structural integrity or the previous structural integrity has been severely compromised due to the large portion of collapse and damage observed.

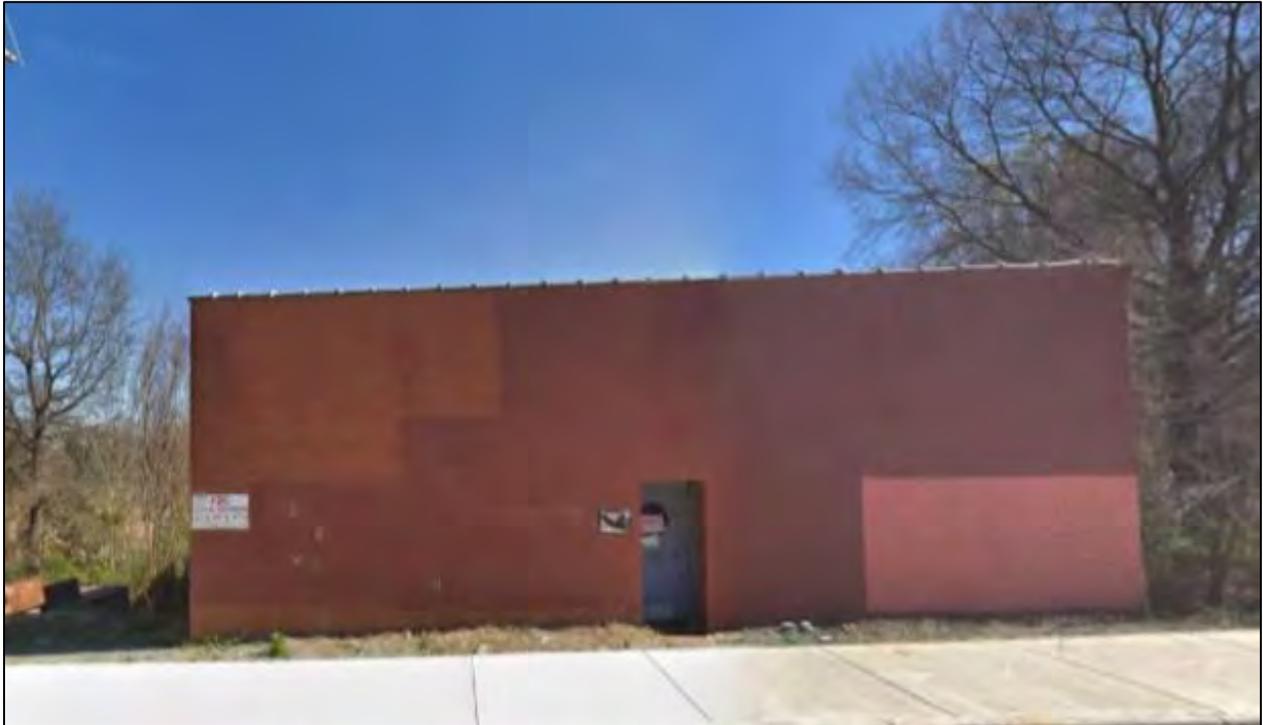
Exhibit E: Lacking Historical / Architectural Significance

- The SRO Building lacks architectural significance in that its street-facing elevation (36<sup>th</sup> Street façade) has been replaced in post-period of significance (post-1939) by a blank wall of modern brick laid in common bond one-to-six (please see Exhibit E);
