Survey and Research Report on the Helper-Walley House

1. **Name and location of property:** The property known as the Helper-Walley House is located at 603 North Main Street in Davidson, North Carolina.
2. **Name, address, and telephone number of the current owner of the property:**

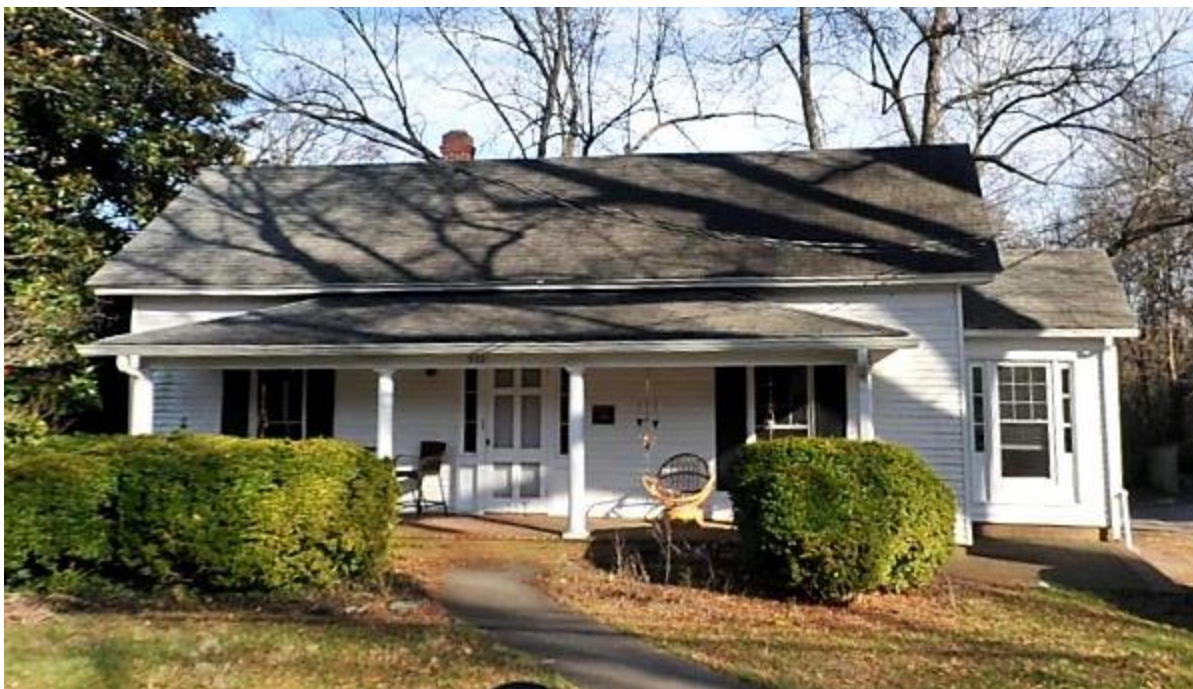
Figure 1 The Isaac Johnston House, just down the street from the Helper-Walley House at 532 North Main Street, is the oldest extant (and only other known) hall-and-parlor house in Davidson.

Pre-1900s houses in Davidson fall under two categories—either they have remained relatively unchanged from their original style of construction, or the houses have been so altered from their original state that they no longer retain architectural integrity. The antebellum Isaac Johnston House, as seen above, appears from the street much like it did a century ago. The same may be said for the ca. 1898 Currie-Adams House, an I-house at 525 North Main Street. In comparison, the ca. 1890 Cranford-Kneedler House next door to the Helper-Walley House at 609 North Main Street was bricked with a new full-height front porch added to the original frame house ca. 1950.

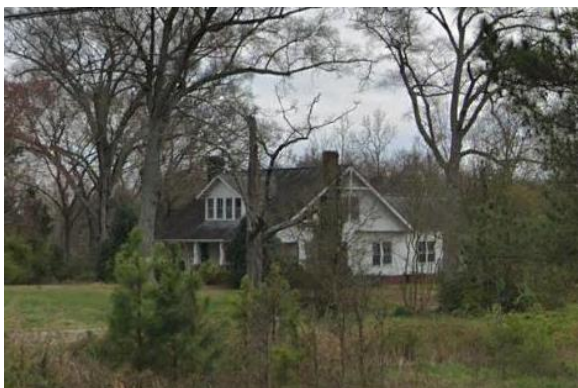
Figure 2 The Jesse and Martha K. Washam Farmhouse was originally built as a hall-and-parlor tenant house. In the 1920s, the Washams remodeled it to the Craftsman style. The original portion of the house is visible in the bay behind the chimney.³

The Helper-Walley House was not the only residence around Davidson remodeled in the Craftsman style. The Jesse and Mary K. Washam Farmhouse on rural Davidson-Concord Road also serves as an example of this transition in architectural style. Built as a hall-and-parlor tenant house, the Washam Farmhouse was renovated and expanded in 1922 to a Craftsman bungalow that practically obscured the original house. The Helper-Walley House is a much less extreme renovation, as the hall-and-parlor form was retained while architectural detailing reflective of the Craftsman style was applied. When Harlan remodeled the house sometime in the early 1920s, he made many changes to the original house as evidenced by the extant details and compared to hall-and-parlor houses contemporary to the Helper-Walley House. The roofline was altered. Most 19th-century hall-and-parlor houses in Mecklenburg County have a front porch independent from the roof structure over the house, whereas the Helper-Walley House features an engaged porch. While the paired porch columns are not common in the Craftsman style, this detail may also be seen in houses of this period, such as the Ralph Johnson House at 115 Mock Circle in Davidson.

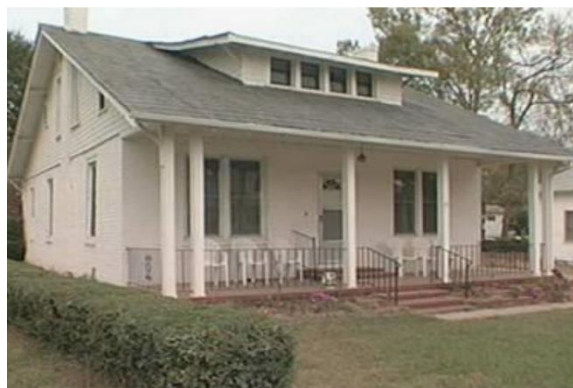
Figure 3 The Ralph Johnson House as it appeared in 2006. Today, the Craftsman-style duplex appears even more like the Helper-Walley House, as the middle columns are now paired, and the railing is wood rather than wrought iron.⁴

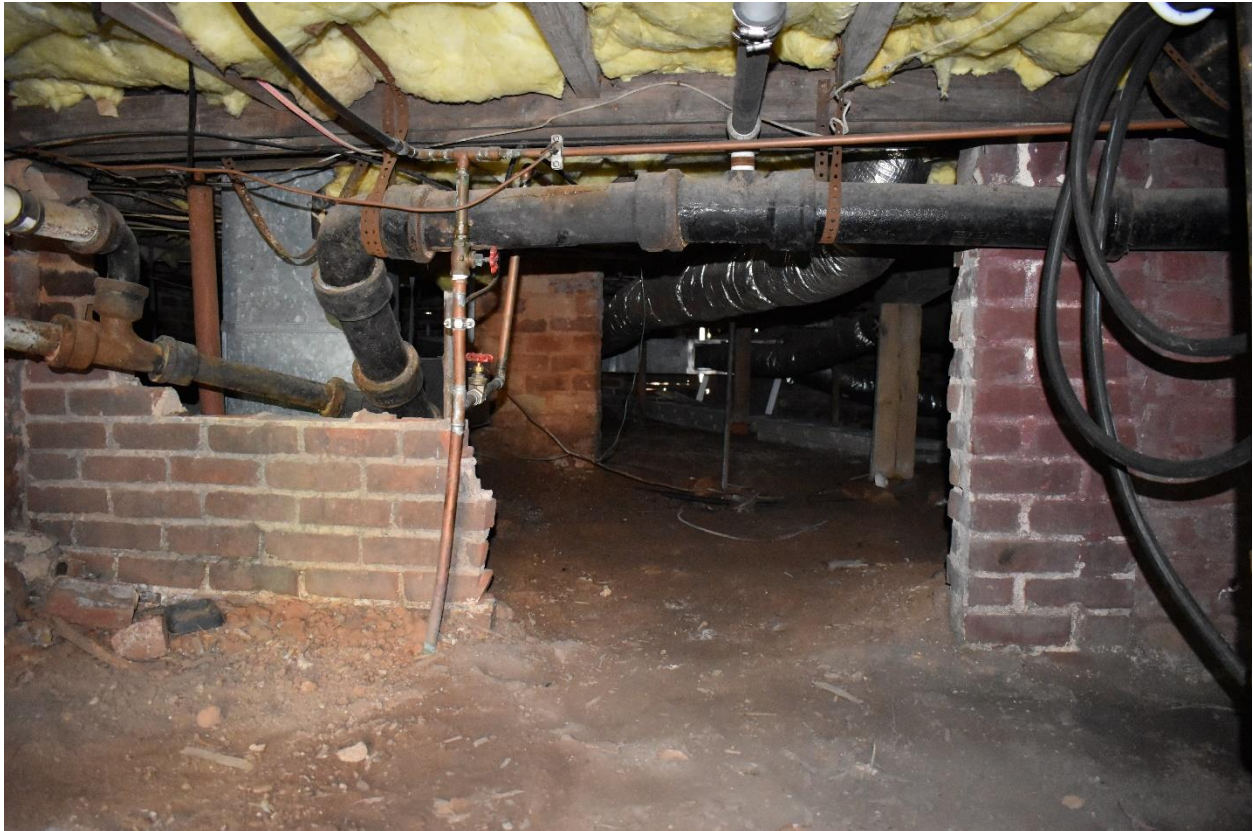
Figure 6 Under the Helper-Walley House, the various phases of construction are visible. In the background, you can see the foundation of a chimney that was formerly in the current dining room. In the foreground are the brick piers and remaining walls from the ca. 1925 addition.

Many materials and architectural details are featured consistently throughout the house. The entirety of the house, excepting the wood shake gables of the original hall-and-parlor house, is covered in overlapping wood siding. All windows are 1-over-1 double-hung wood sash. The foundation of the Helper-Walley House consists of masonry piers with an exterior wall. The ca. 1896-1897 and ca. 1925 portions are brick, and the ca. 1950

addition utilizes concrete masonry units (CMU), all painted white on the exterior with regularly spaced grille vents. Gutters have been installed on the eaves.

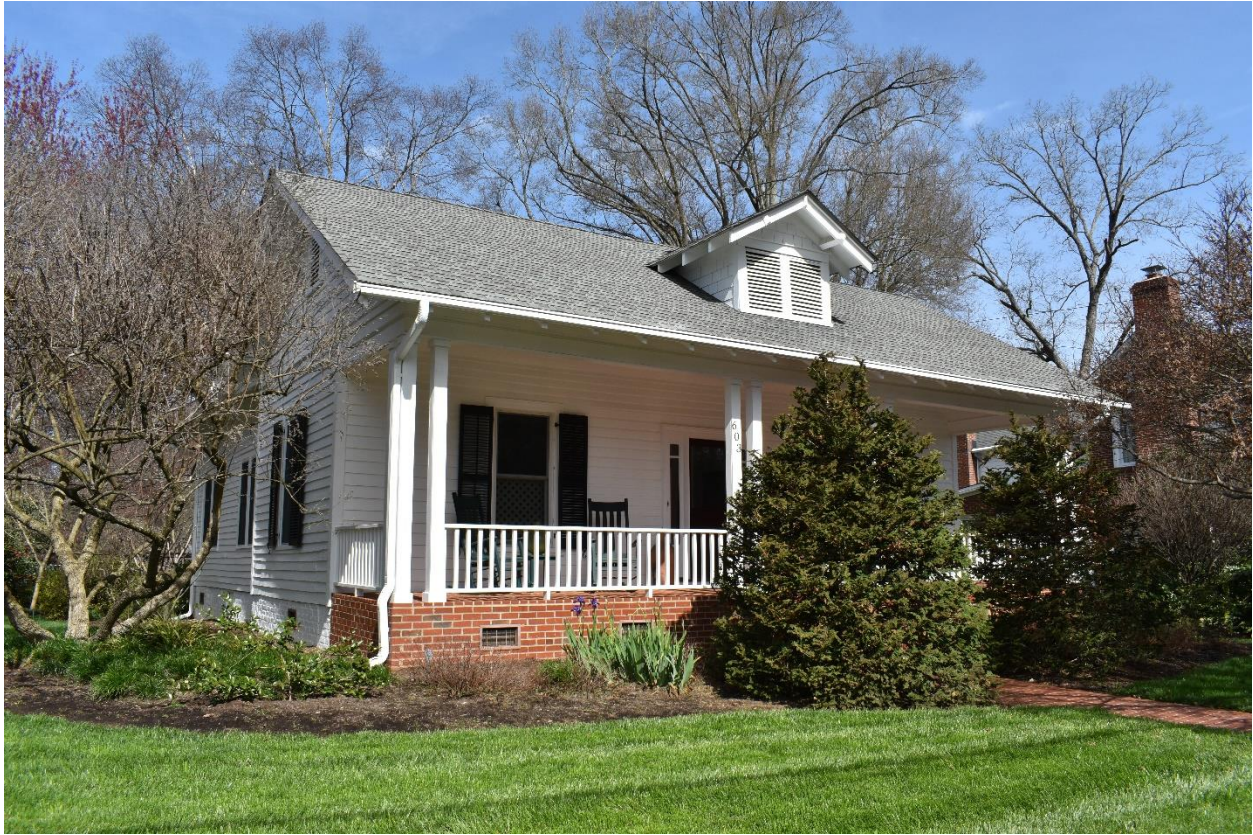
The front elevation of the Helper-Walley House faces east toward North Main Street and is three bays wide, with an engaged full-width front porch with paired columns and simple vertical railing dominating the elevation. Brick steps lead up to a raised brick porch with regularly-spaced metal grille vents—the previous wood porch was replaced around 2010 due to age and deterioration. A gabled dormer, added in 1925, with exposed rafter tails, paired louvered panels, and wood shake shingle siding is centered on the elevation. The half-light wood front door and sidelights are flanked by 1-over-1 double-hung wood sash windows, which feature louvered wood shutters. Exposed rafter tails extend under the eaves, and the ceiling of the front porch is bead board.

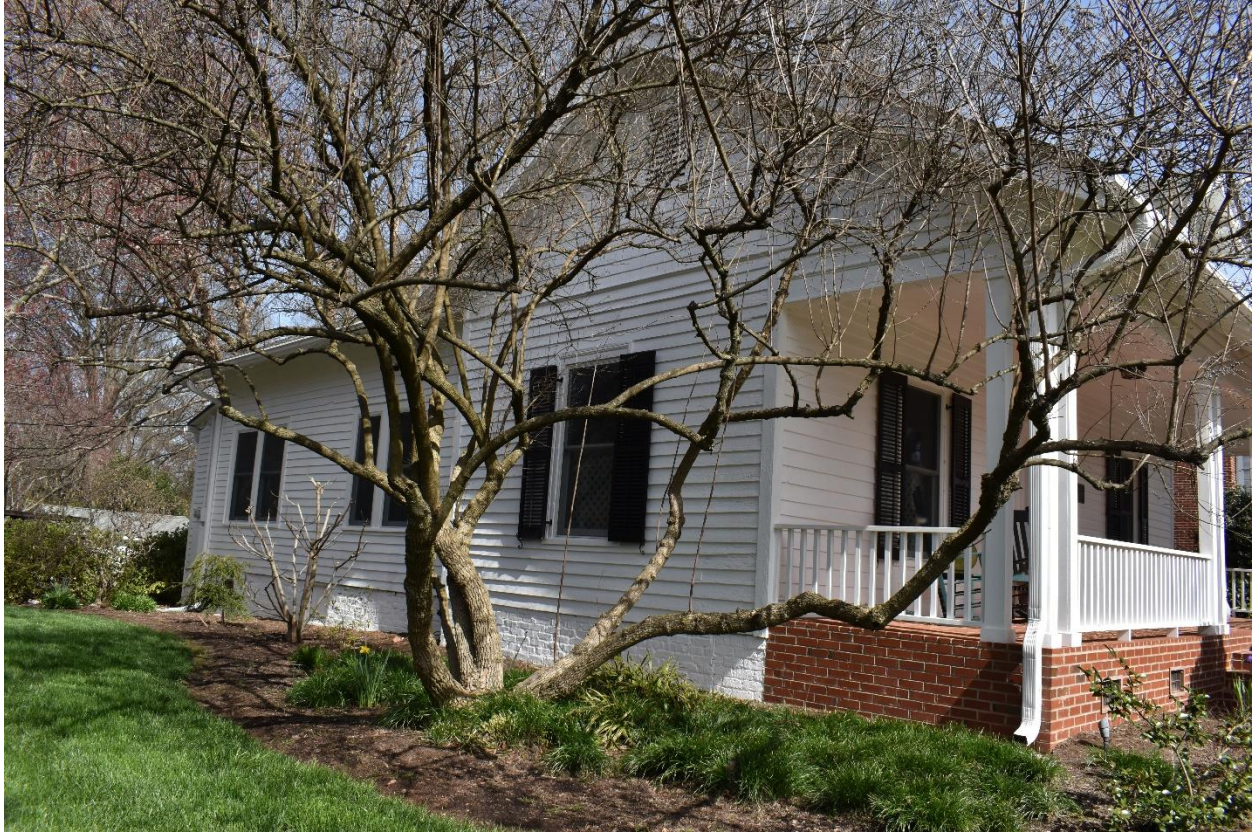
The south elevation of the Helper-Walley House is five bays wide and reveals the various expansions made to the house over the years. The second bay is the original portion of the hall-and-parlor house, with the front bay being the engaged porch built around 1925. A rectangular wood louver is centered in the gable. Also added at this time was a gabled wing extending back from the left side of the house, which comprises the third and fourth bays. The fifth bay is the small shed addition made ca. 1950.

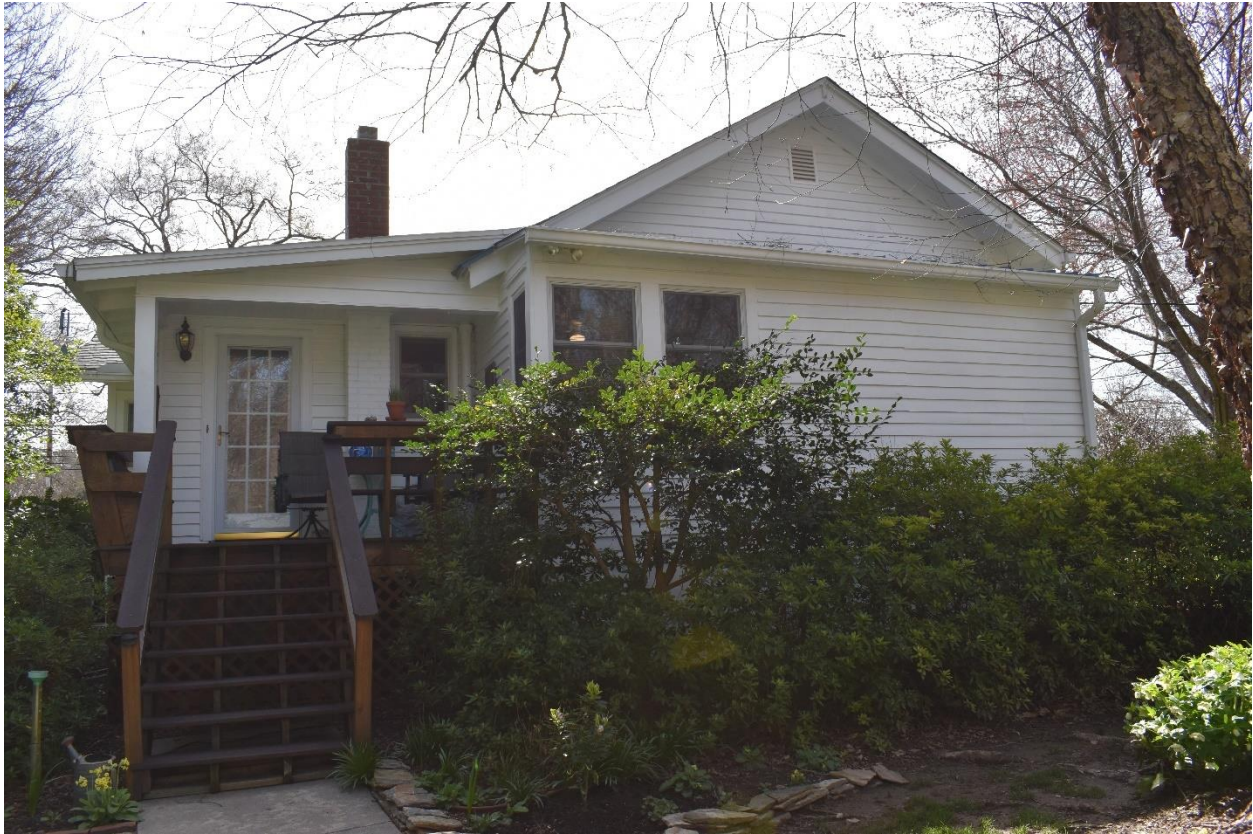
The rear elevation of the house is comprised of the additions made to the original hall-and-parlor portion of the house. This elevation is two bays wide and one bay deep. Since the property slopes downward from the street, this portion of the house sits higher from the ground than the front elevation. The first bay is a shed addition made ca. 1950 which includes a French door, an extant narrow brick chimney no longer in use, and a small 1-over-1 window. A shallow porch is ceilinged with bead board wood paneling. A wood deck with seating built into the railing fills the width and depth of this bay. The gabled ca. 1925 addition and a small shed addition from ca. 1950 comprise the second bay. Corner 1-over-1 windows are placed at the left side of the shed portion, with a single window on the side facing the porch and a pair of windows on the back elevation. The eave of the ca. 1950

shed addition continues the exposed rafter tail detailing of the older portion of the house. The gable, which is sheathed in wood siding, has a centered rectangular wood louver.

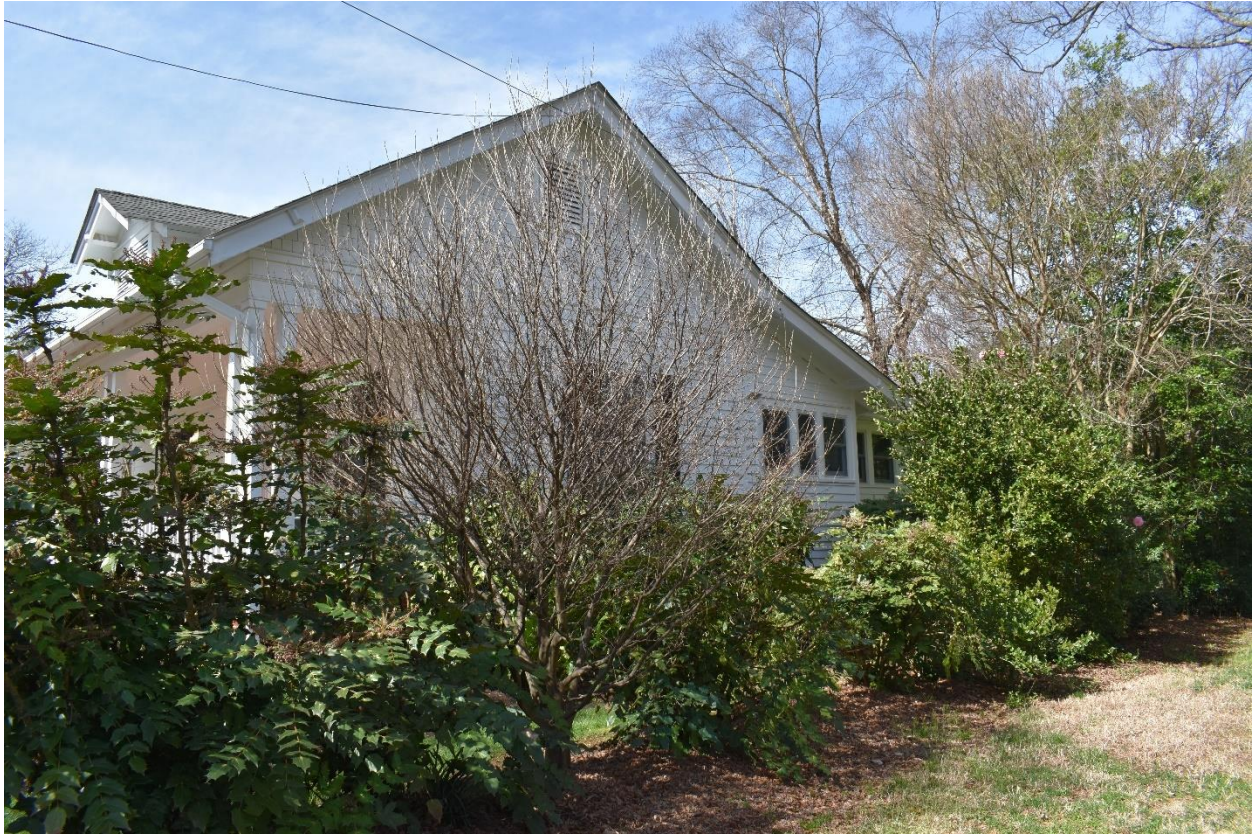
The north elevation of the Helper-Walley House is four bays wide and one bay deep. The front two bays are identical to that of the south elevation, with the first bay being the porch and the second a single 1-over-1 window flanked by wood shutters; the gable also is sheathed in wood shake shingles with a centered rectangular wood louver. The third bay is the former porch which was enclosed ca. 1950 to make the kitchen. It features three grouped windows which fill the space. These three front bays are built atop brick piers filled in between with brick, whereas the fourth bay rests upon CMU walls. This bay, which steps back from main mass of the house, has a pair of windows centered in the elevation.
