ELMER H. GARINGER HIGH SCHOOL HISTORIC CAMPUS

The proposed project focuses solely on the 300 Classroom Building, and is very limited in scope. The primary aim of the project will center on life-safety renovations and the addition of a new fire sprinkler system. Limited additional renovations will provide refurbishment of classroom finishes and equipment, replacement storefront windows, and restroom upgrades in specified areas of the building.

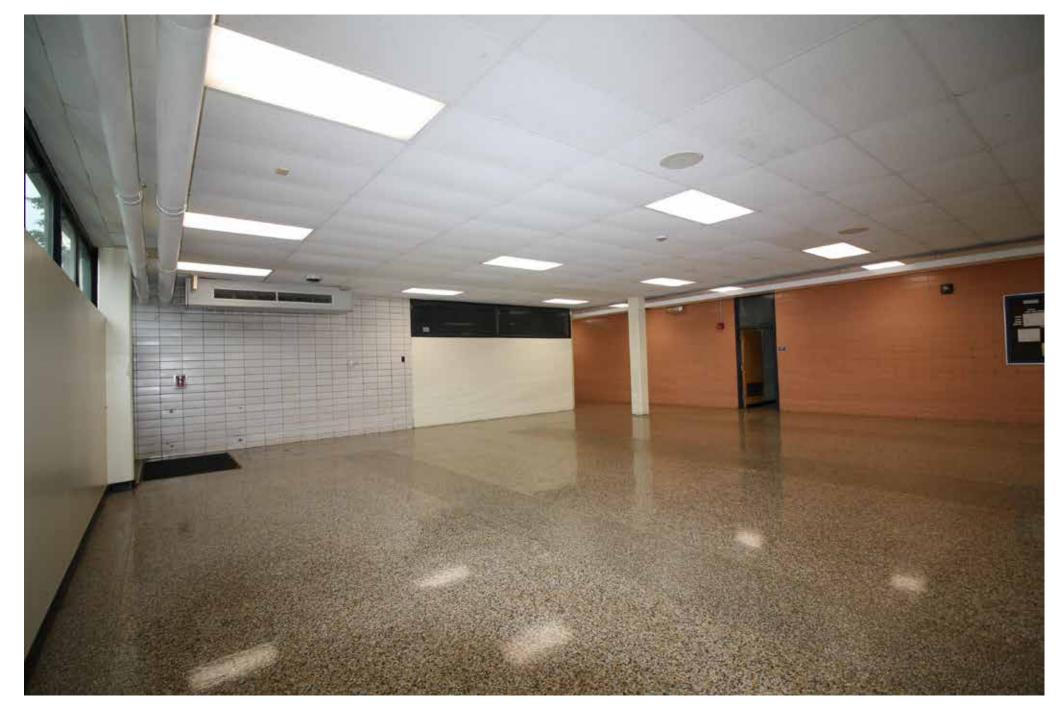
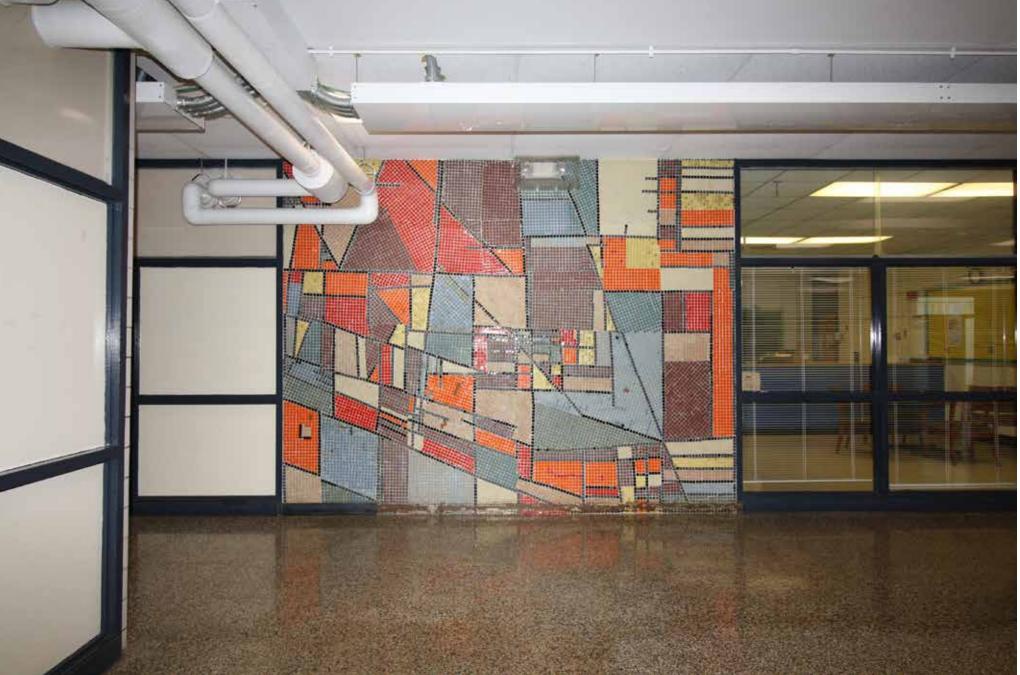
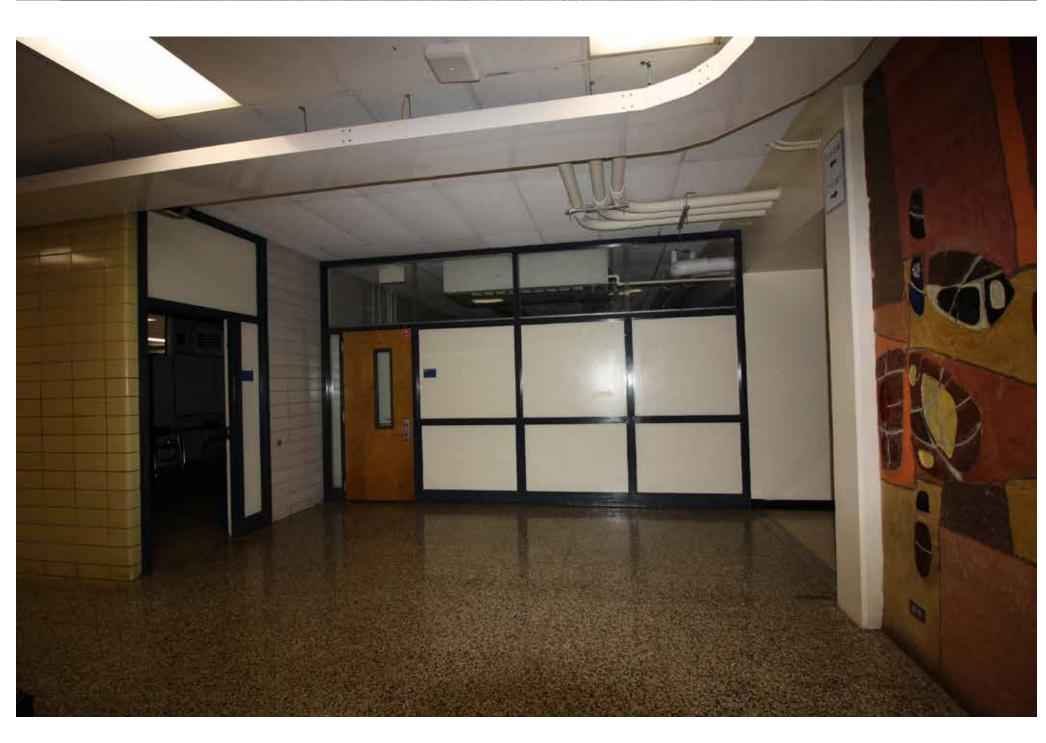
EXISTING CORRIDOR CONDITIONS

Due to the low overhead clearances of the existing precast concrete structure, building services and utilities are exposed below the ceiling plane within corridors and classrooms. All existing corridor murals & art walls will be maintained with the proposed renovation work. Existing HVAC piping will remain for re-use.

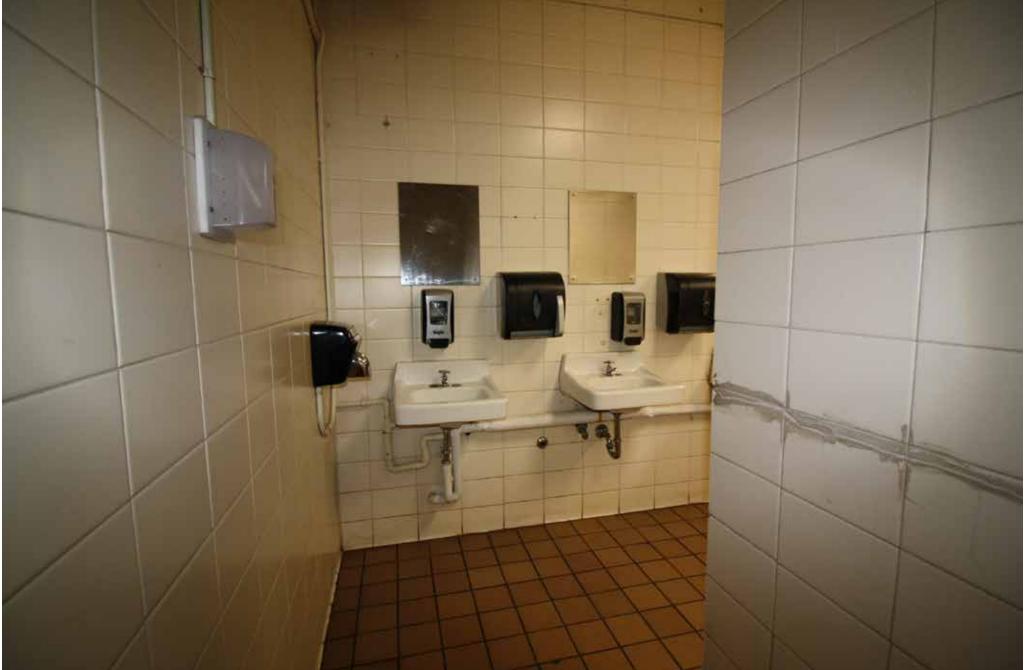
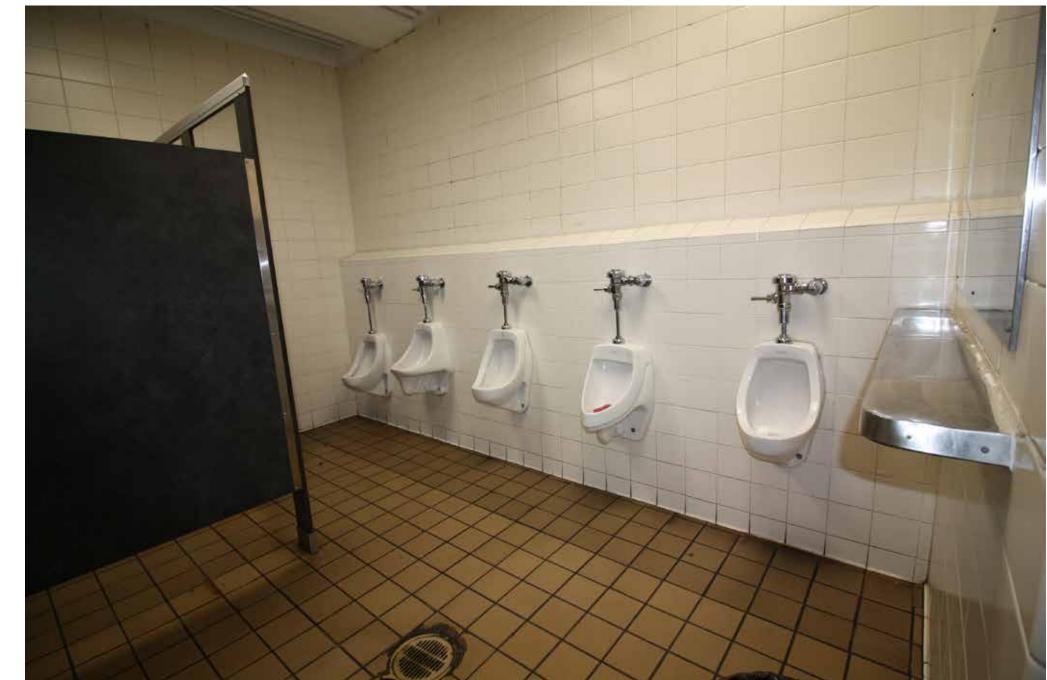
EXISTING RESTROOM CONDITIONS

Existing conditions for the four (4) group toilet rooms within the 300 building evidence various eras of fixtures, equipment, and finishes. Installation of fixtures often occured with exposed plumbing or vent piping. Existing surface finishes exhibit cracking, discoloration, and wear, and are beyond their useful lifespan. Renovations will address fixtures, finishes, and accessibility.

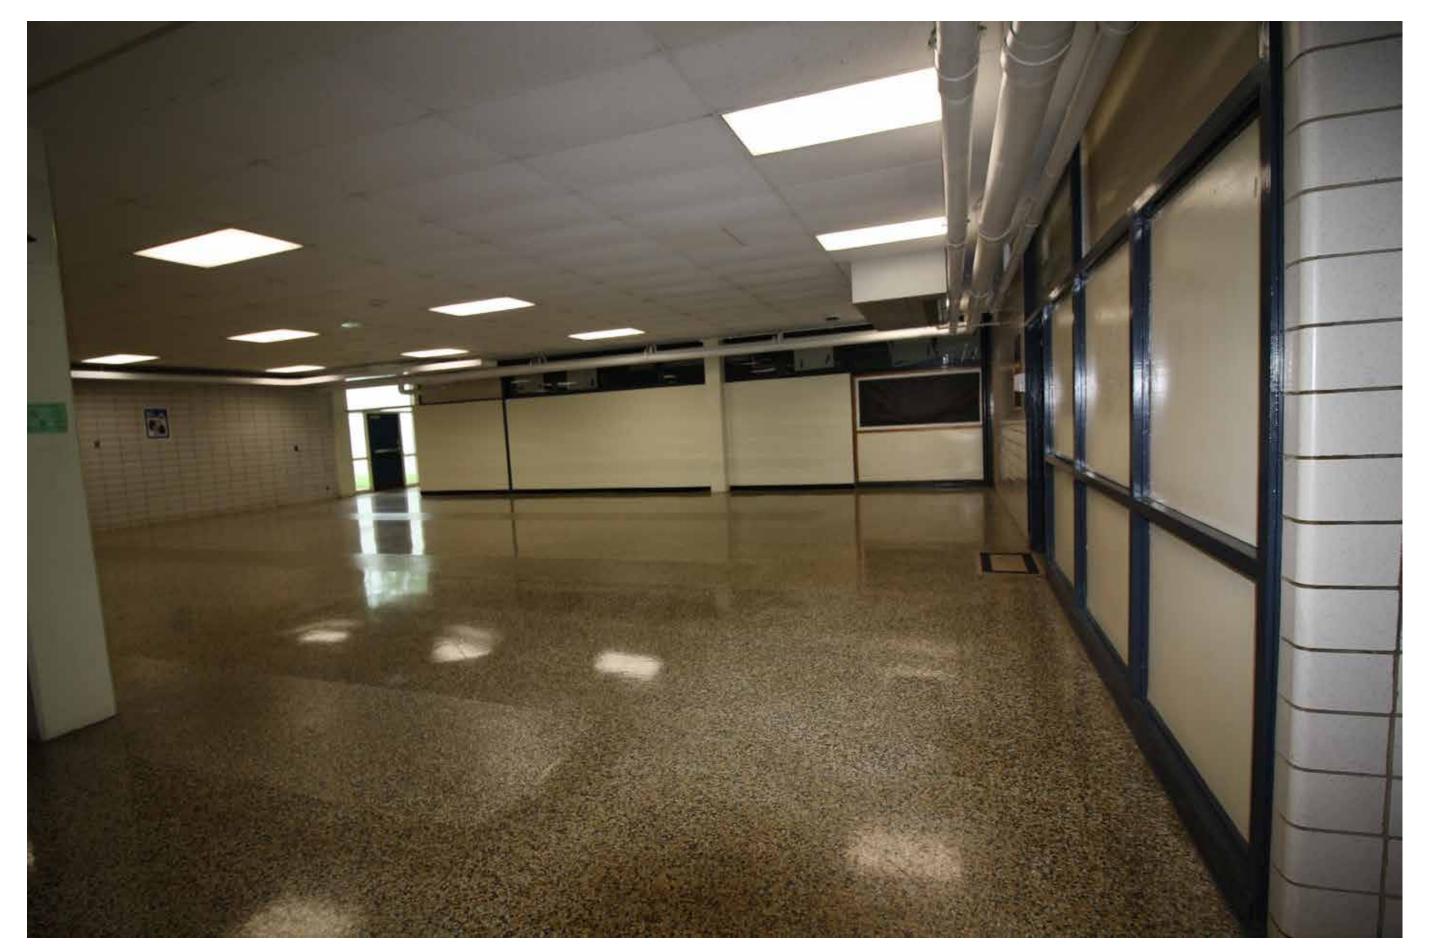
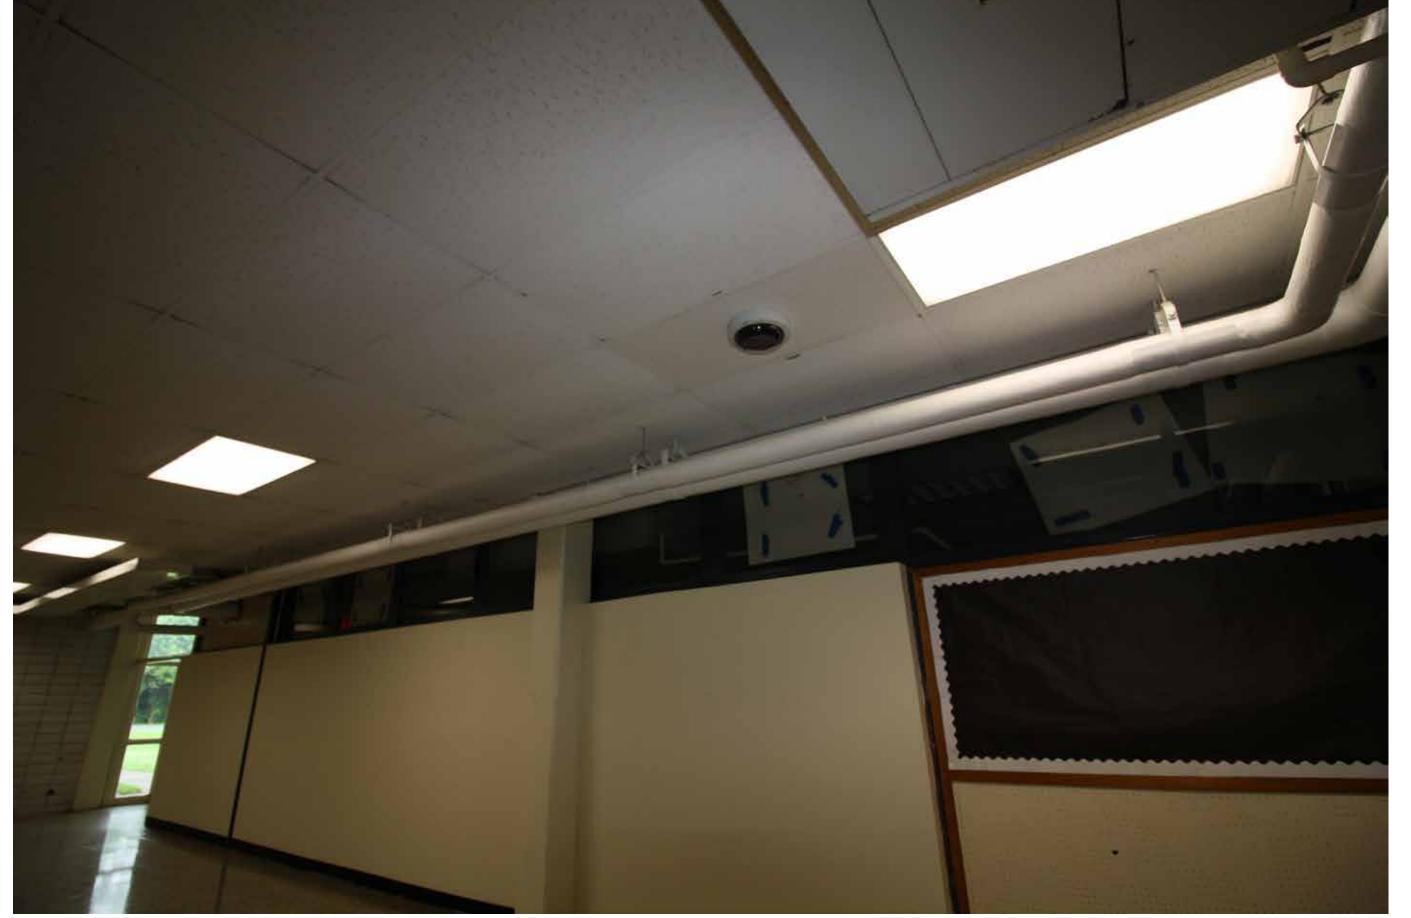
PROPOSED FIRE WALL

The existing classroom partition wall will be replaced with a solid, fire-rated wall to provide separation between the 300 Building and the adjacent structures. This will bring the building into code compliance for fire area limitations.

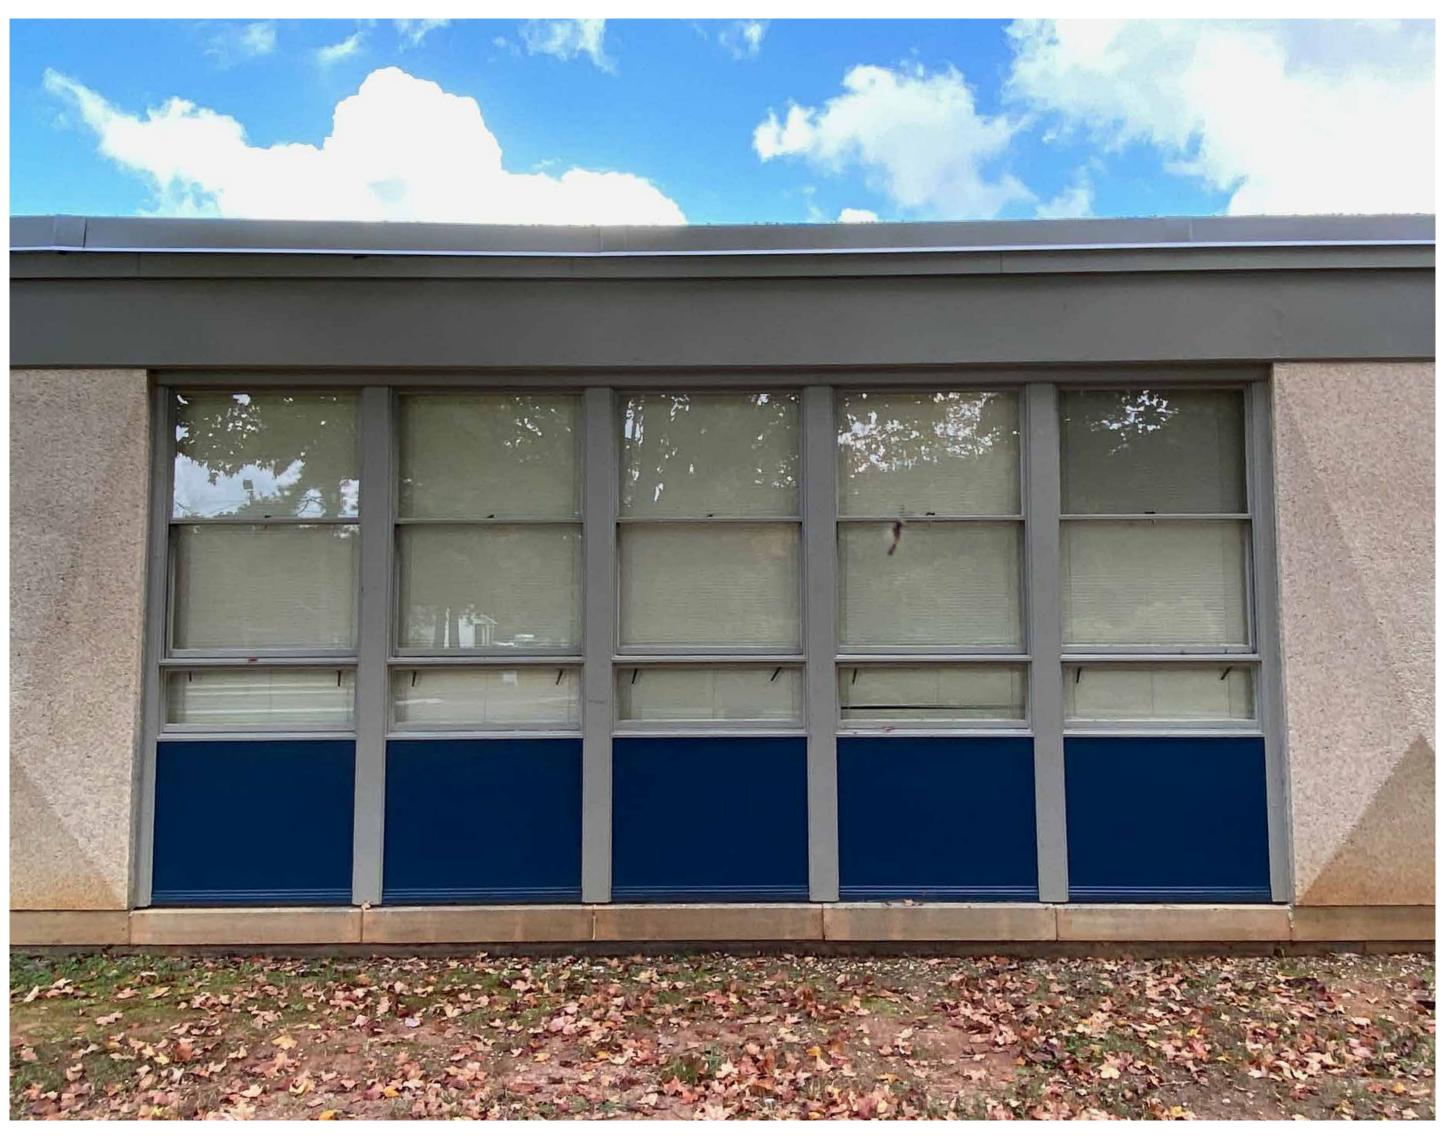
TYPICAL EXISTING UNIT

Each of the renovated classrooms within the 300 Building will recieve a replacement, in-kind, of the existing storefront window system. In keeping with previous replacement work on the 200 Building (see figures, above) replacement units will match the size, rhythm, and configuration of existing lites and solid panels. The new units will have advanced thermal properties to provide improved performance within these areas.
