William H. Peeps Home
831 East Worthington Avenue
Charlotte, NC 28203

Report prepared 07 December 2020

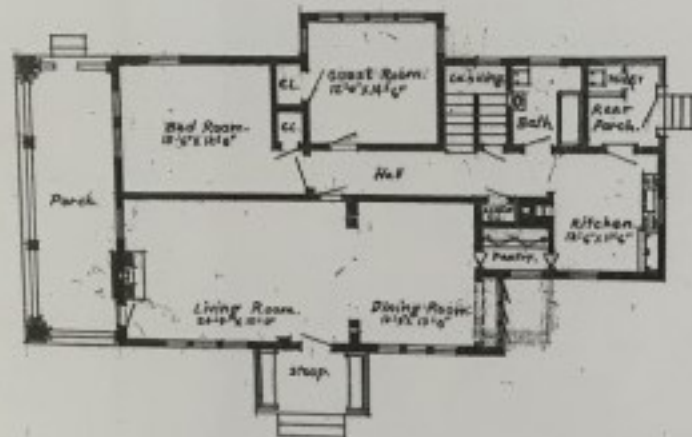
PLAN OF FIRST FLOOR.

The interior plan divides the main block nearly in half from front to back. The wider formal side faces Avondale with the deeper front room as the living including the public entry door and the shallower dining to the rear. A wide and tall cased opening separates the otherwise elongated room. The public front entry door along the living room wall is entered from the open but roof and side walled covered stoop. Directly across is the door entering into the hallway to the private quarters. The fireplace is centered on the front wall of the living with the private porch entry door on the left and a window on the right. Triple double hung windows front onto Avondale from living and dining either side of stoop. A Window bay feature is at the east corner of the dining room. The triple elongated casement windows are two over two with square panes at the top similar in configuration to the double hung square panes in their upper sash. The walls and ceiling are in plaster and floor in oak. The flat casing of windows and doors run vertically from the flat board ceiling band to the floor interrupting the flush baseboard. At the ceiling there is also a flat trim board with intersecting small crown. Picture mould below the ceiling band and a moulded cap and shoe mould at the floor base. (This treatment most likely extended into the dining room, but later removed. The fireplace in living projects with full wall into the room. The shelf mantle has a stock classical appearance. Paneled pilasters with base trim have appliqués at the architrave face plate with a panel at the center with also an appliqué. The firebox surround is in buff color glazing with rectangular tile set in running bond as is the flush floor hearth.

The dining room connects to the kitchen through a butler's pantry with by-pass doors. All flooring, beyond formal rooms throughout house, is in pine. In the pantry wood cabinetry flanks the northwest side. Below counter is a bank of drawers and a pair of flush wood doors. Above are full glass pane cupboards supported by large scroll brackets. Projecting above are triple sliding storage doors supported by small scroll brackets. The interior treatment is vertical v-groove paneling. There is a separate corner unit recessed in the wall with upper and lower glass pane doors matching the design of the pantry.

There are drawings of the house done by Peeps, labeled *Residence of Mr. William H. Peeps, William H Peeps, Architect* housed at the Archives Collection at the University of North Carolina at Charlotte, for the extant structure; however, one never knows exactly what was built especially with a probability of the architect there to make improvements or tweaks during the construction, undetectable changes or complete alterations. There are obvious changes made through the years with photographs and records such as those in the *National Register of Historic Places Report for Dilworth in Charlotte of circa 1986* that show those changes. The interior dining room features a window bay in the corner with three casements on the rear wall; however, as cryptically sketched over Peep's hard lined drawings and as the foundations suggest, a full sunroom bay with a pair of casements on each the rear and side walls was built originally.

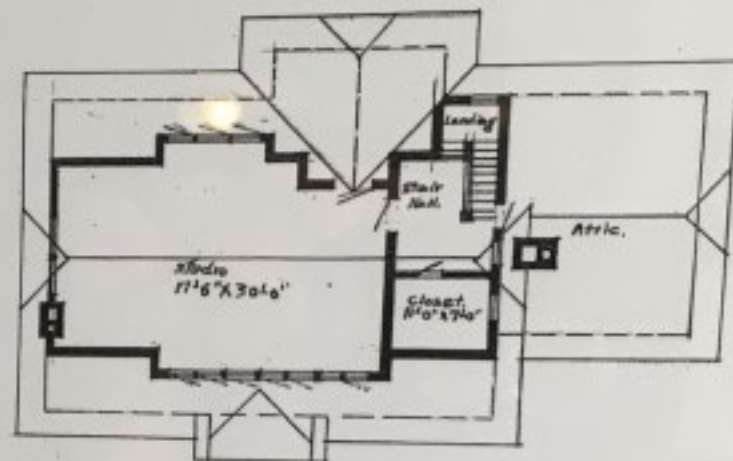
PLAN OF SECOND FLOOR & ROOF.

Ascending the stairs, there is an upper landing with a closet across at southeast side, a door to attic to the left and a door to the studio on the right. The studio has a bank of seven casement windows at the southeast, a bank of three casements at the northwest and a pair of double hung over the front porch avail the studio space with abundant lighting and a sense of openness. The walls trace the confines of an optimized enlarged attic-like space with some sloped ceilings, and are uninterrupted except for a door to attic at northwest wall.
