**LOCAL HISTORIC DISTRICT:** Wilmore

**PROPERTY ADDRESS:** 1544 Merriman Avenue

**SUMMARY OF REQUEST:** Demolition

# HDCRDEMO 2021-00019

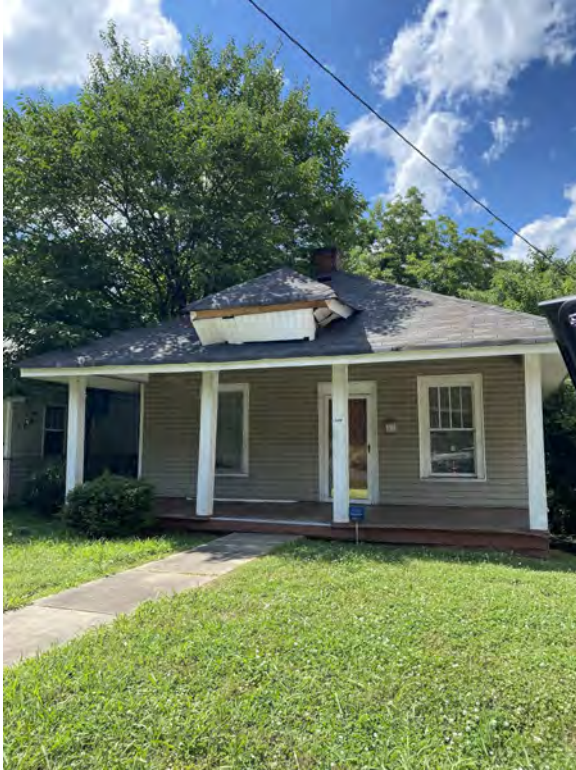
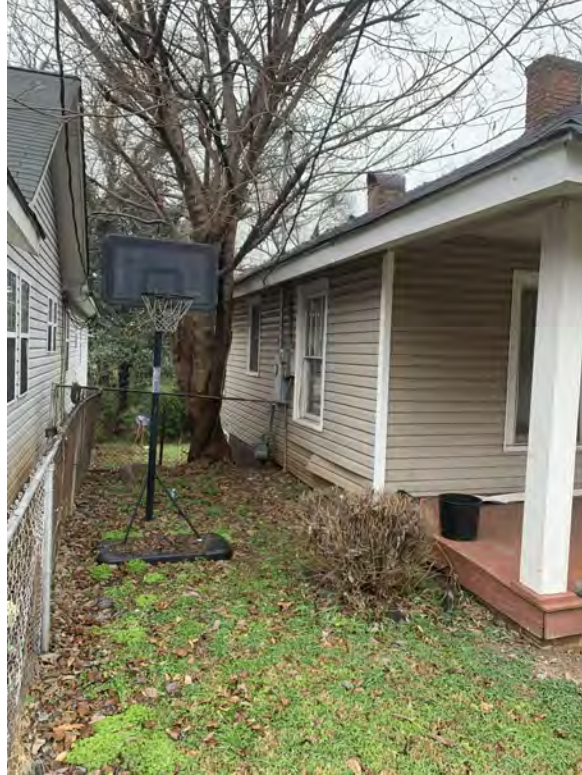
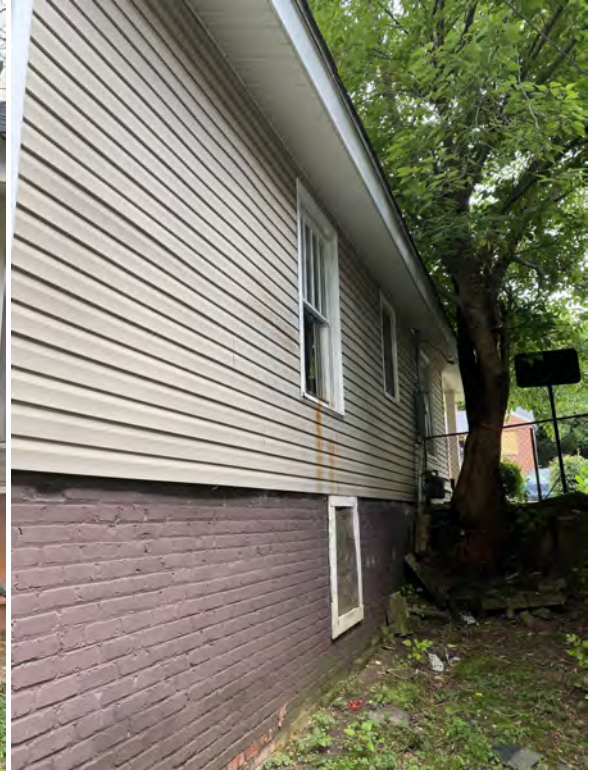
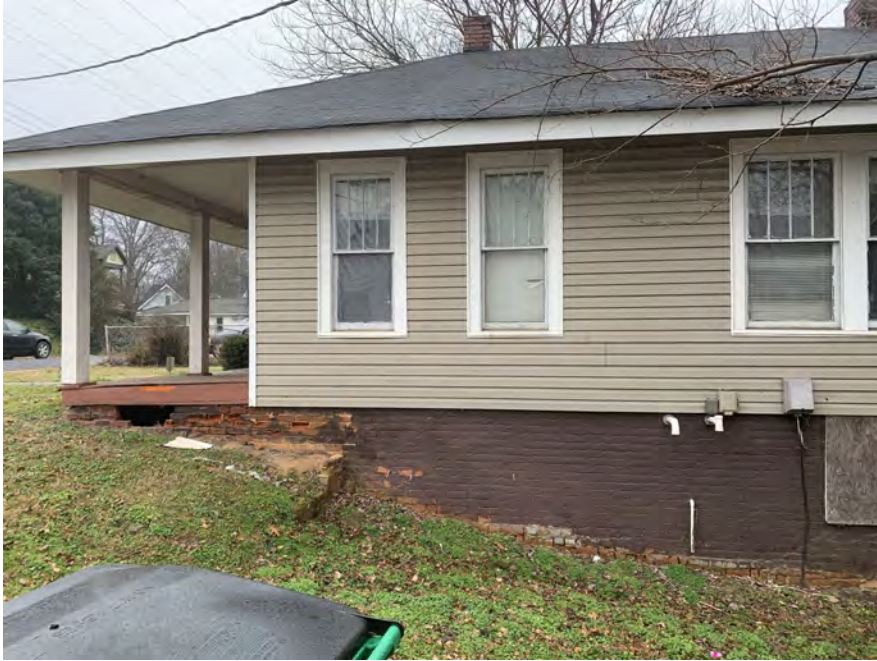
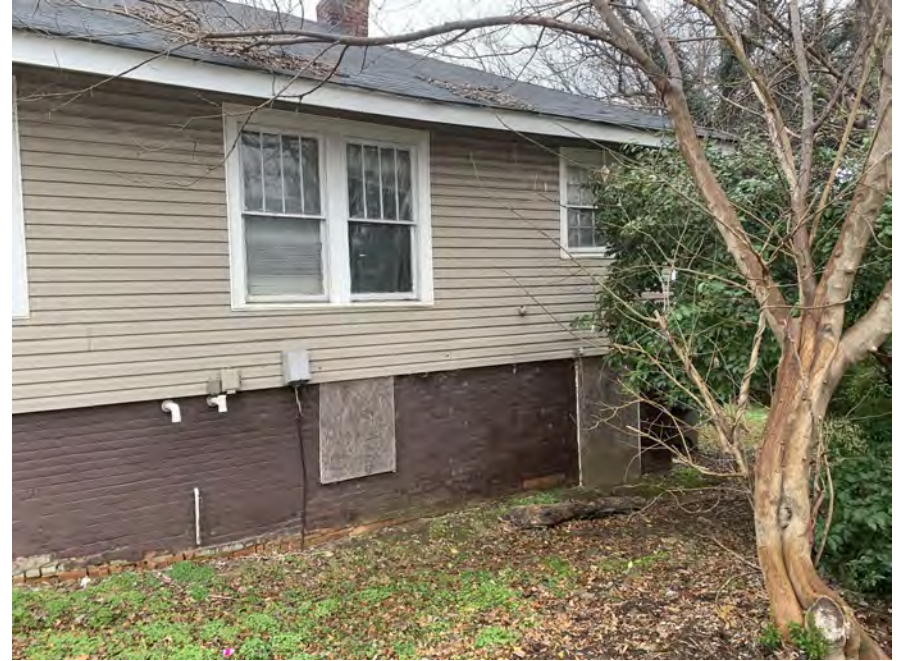
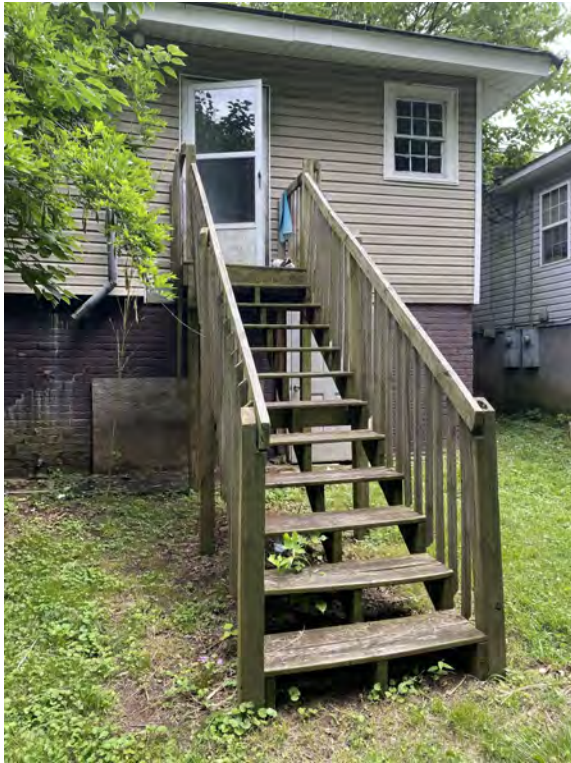
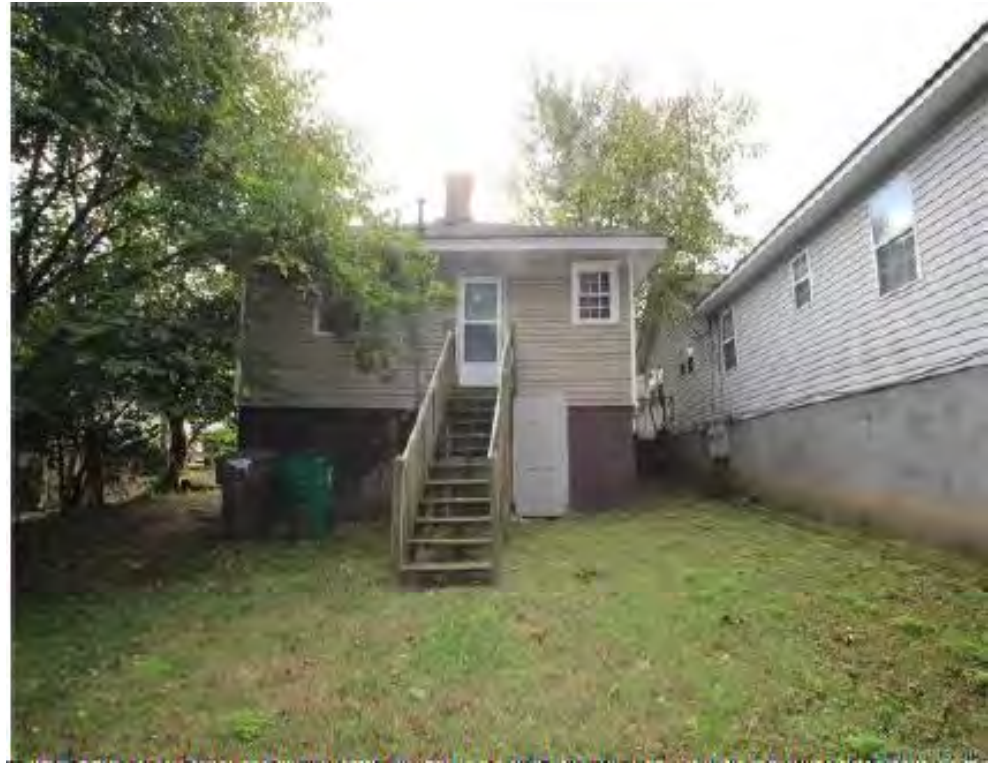
All sides of the building

The existing structure is a one-story bungalow constructed in the 1930s. It is a 2 bedroom, 1 bathroom house with apx 900 sq ft. It has an asphalt roof (multiple layers), vinyl siding and wooden plank front patio. It sits on a rear sloping lot, providing a walk in “crawl space” in the rear of the house.

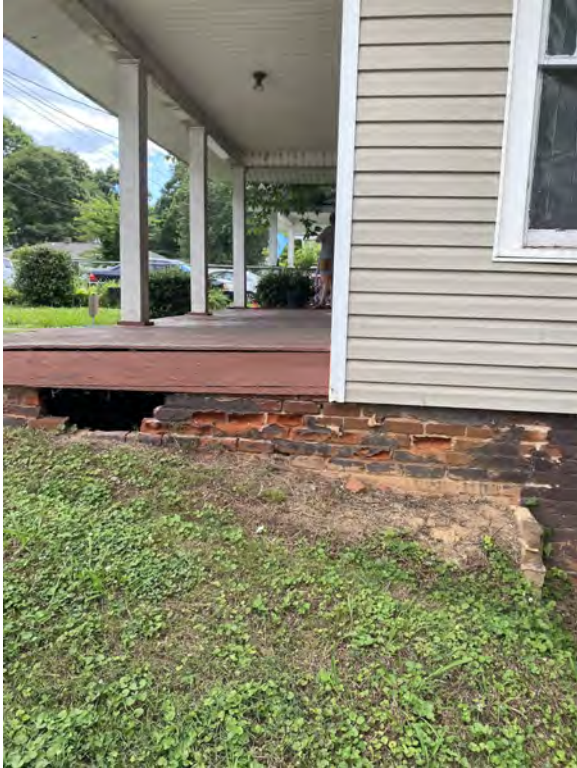
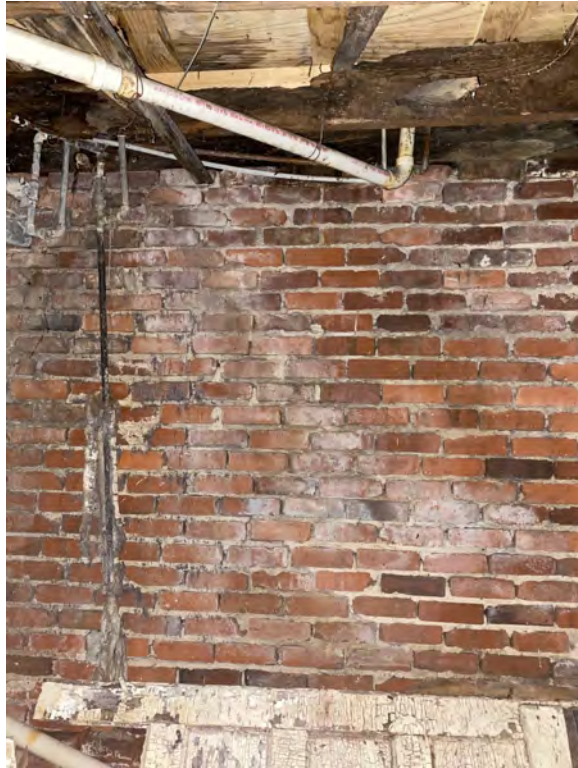
Due to the age of the house, the lot and neglect over the years, the house is suffering from severe structural damage including collapse of the rear structural foundation wall and deterioration of other areas of the foundation.

Side Foundation Deterioration

After consultation and much thought, it was determined that the structure has too many compromised components to save. The number one issue being them current state of the foundation. As such, the applicant is requesting approval for immediate demolition of the subject property. The applicant intends to build a single family dwelling in accordance with HDC design guidelines to replace the existing structure.

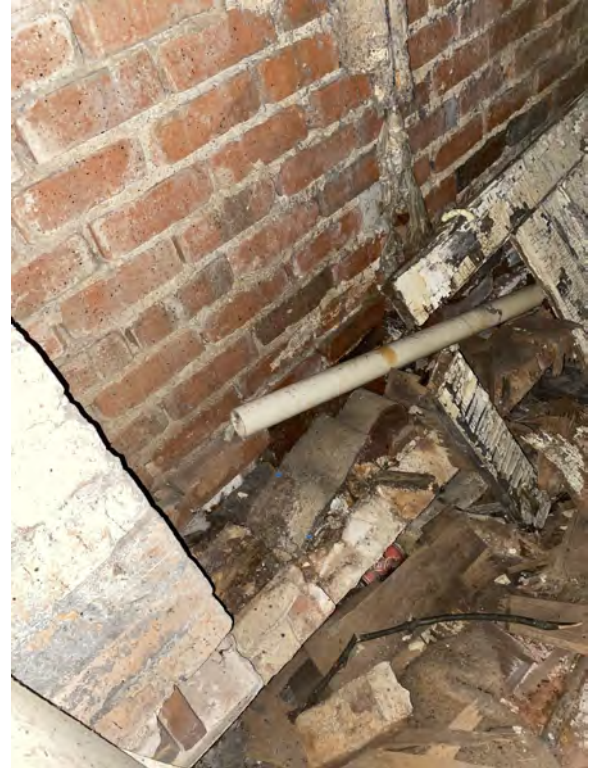
Rear Foundation Deterioration

Rear Foundation Buckle
