**Staff Report and Comments
Atherton Mill House
2005 Cleveland Ave, Charlotte
Application for COA HLC313**

RUGGLES ENGINEERING PC

Re: Residence - 2005 Cleveland Avenue

Ruggles Engineering PC has completed a structural evaluation of the residence at the above referenced address. On November 18, 2015 a visit was made to the site to observe the condition of the existing structure.

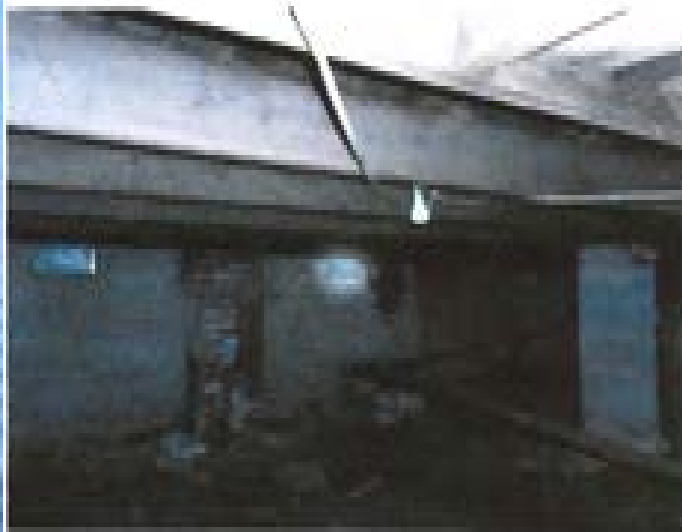
SAM 3749

1. The original foundations for the piers supporting the home were constructed from brick masonry laid on the subgrade, which vary in height between two and one half feet up to eight feet. The foundations have settled differentially in multiple locations resulting in rotation of the piers (see photo SAM 3749). Several of the piers have been repaired, utilizing materials and methods that do not meet the current code. Due to its age, the mortar in the piers is in poor condition (see photo SAM 3752).

The residence is in poor condition and would need extensive repairs to bring it up to a habitable condition. The cost of the repairs would likely exceed the cost of new construction and in our opinion are not economically feasible.

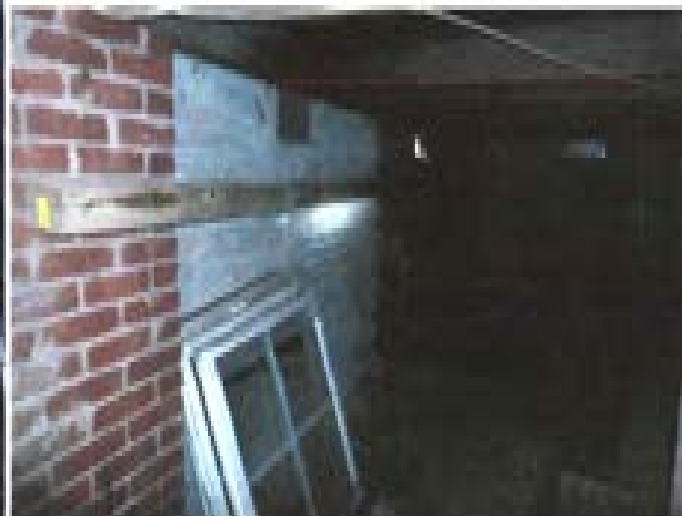
SAM 3748

2. The single wythe brick walls that infilled between the piers are supported on a masonry foundation constructed from four inch by eight inch bricks, turned perpendicular to the wall and stood on edge. The brick foundation has been laid on top of the ground and is not down below the frost line. Consequently, the wall will move with the freeze thaw cycle. The infill walls that are up to seven feet in height are not tied to the piers or to the floor structure for lateral support. In numerous locations, the walls are leaning due to settlement of the foundations. In several locations, a 4x4 wood member has been bolted through the infill wall and connected to the back of the piers to keep the wall from leaning out (see photo SAM 3748). The foundations and foundation walls do not meet the current code requirements.

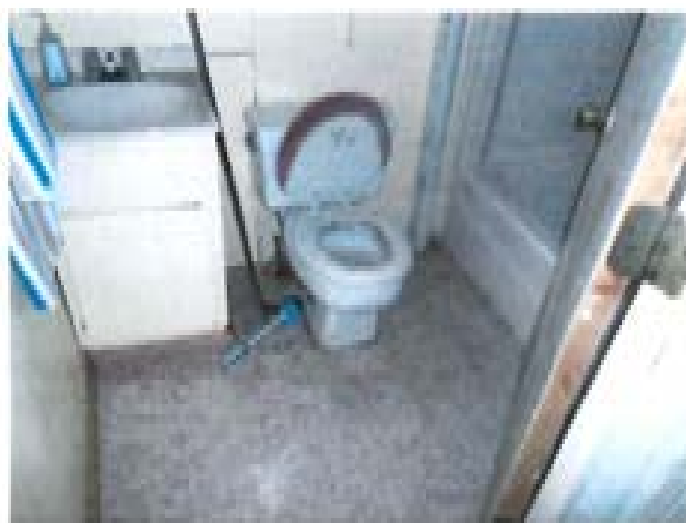
SAM 3774

5. The floor in the bathroom has settled approximately 2 1/2" across the length of the room (see photo SAM 3774).
6. The passage from the front rooms to the rear of the house is through a two foot wide door that is approximately six feet in height. There is also a dropped down soffit with six foot of headroom clearance (see photo SAM 3756). The low headroom clearances do not meet current building code requirements for egress.

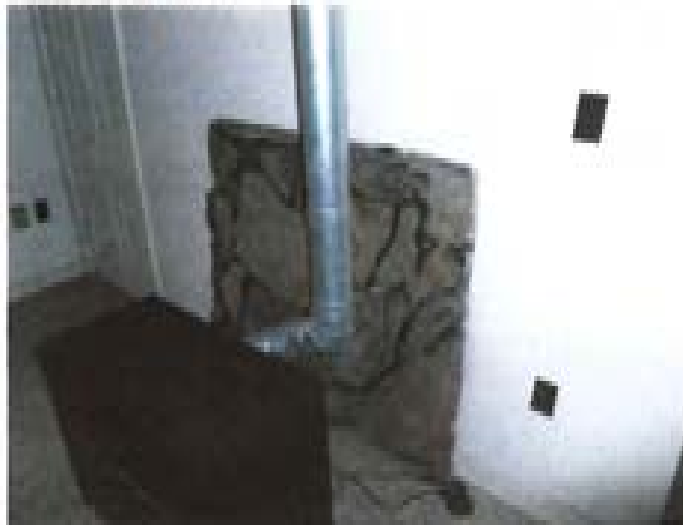
SAM 3760

7. The house does not have a ducted heating and cooling system. There is no cooling and the only heat is provided by a gas floor furnace located in the kitchen (see photo SAM 3760).

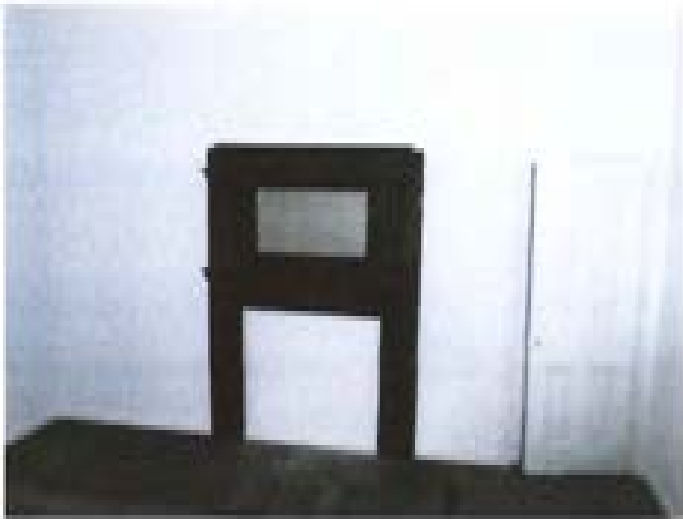
SAM 3768

8. There is a fireplace in all four of the main rooms of the house and they have all been closed off (see photo SAM 3768). The chimneys and flues in the fireplaces are in poor condition and are unsafe to use because of the poor condition of the mortar. The chimney above the roof has been parged with mortar to keep the bricks from falling out (see photo SAM 3780). It should be noted the chimney on the right side of the house is being used for the gas furnace.

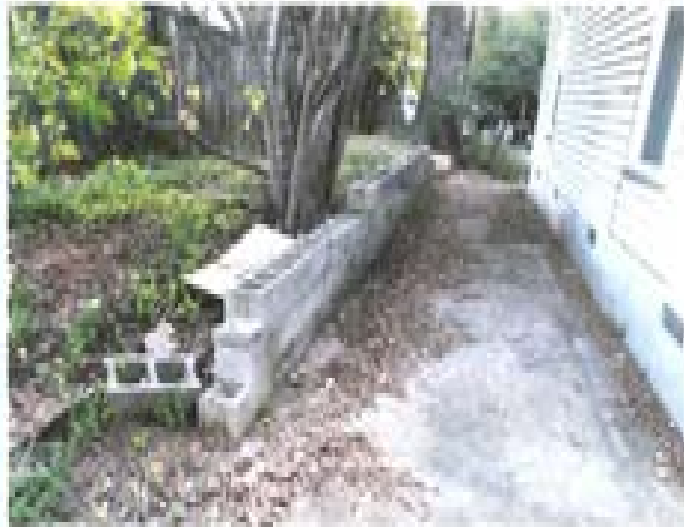
SAM 3777

9. The roof framing was observed to have water damage that has occurred over the years.
10. There is a concrete block retaining wall on the right side of the house that is constructed with dry stacked units. The wall has lateral movement and has failed (see photo SAM 3777).

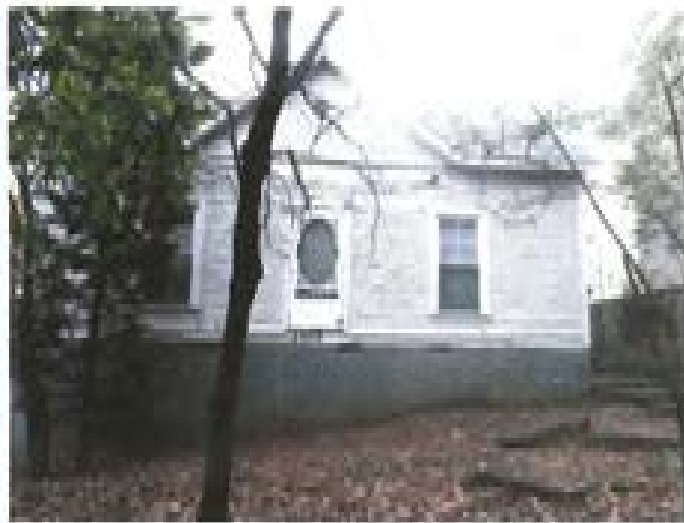
SAM 3787

11. The home originally had a front porch and stairs, which have been removed. There is currently no access to the front door (see photo SAM 3787). The front wall of the residence is built on the twenty foot setback line. In order to reconstruct the front porch and the stairs, a variance would be required.
