Historic Structure #1

| 1. | Name | Spratt-Grier House |
| | Location | 8006 Robbie Circle; Charlotte, North Carolina; Mecklenburg County |

MK1875, Spratt-Grier Farm, 8006 Robbie Circle, V.W., March 2020

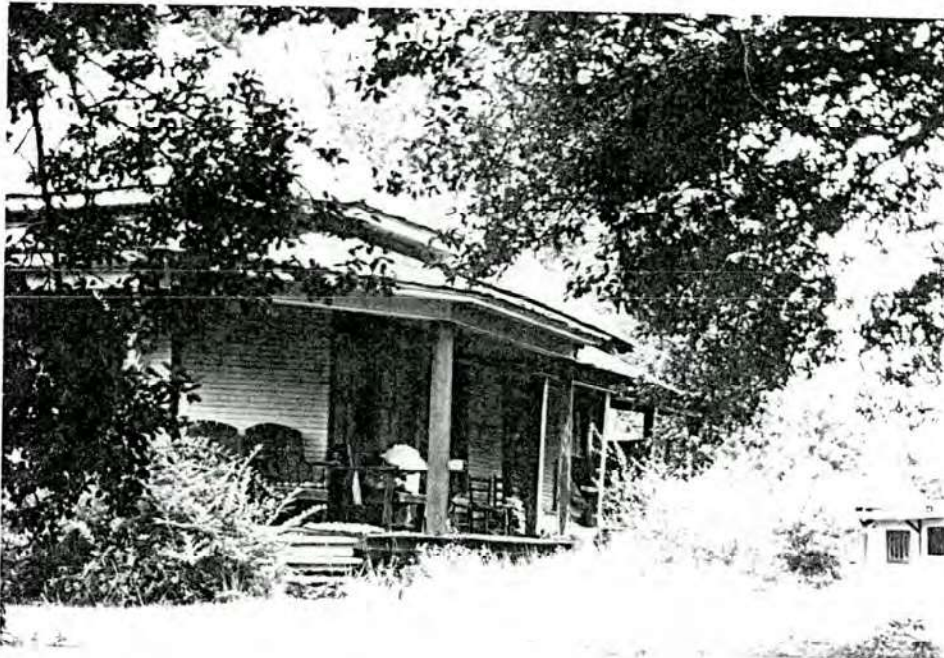
| 3. | Photographs | |

The historic core of the previously-mentioned Spratt-Grier House is a mid-19th century hall-parlor dwelling that stands one story high and three bays wide under a side-gabled tin roof. A slope-shouldered brick chimney, resting on a foundation of corbeled brick, anchors the north gable end. The house was expanded in the late 19th or early 20th century and the original hall-parlor block now serves as a side wing.

The Spratt-Grier House, built as a hall-parlor dwelling, was expanded to center passage form during the late Victorian era. The addition, made to the south end of the original block, is polygonal in shape with a low, hipped roof of complex form, and an encircling veranda. The main doorway, likely dating from the same building campaign, contains twin arched lights. Windows are 6/6 or 2/2 sash. The exterior of the house is sheathed in beaded siding. Inside, one of the partitions of the central passage has been removed. Walls are flush-sheathed or covered with tongue-and-groove siding. Several late 19th century mantelpieces, of carved hardwood, remain in place. An ell was appended to the rear in the 1930s; it is covered in clapboard and, unlike the rest of the house, is in poor condition with holes in floor and roof.

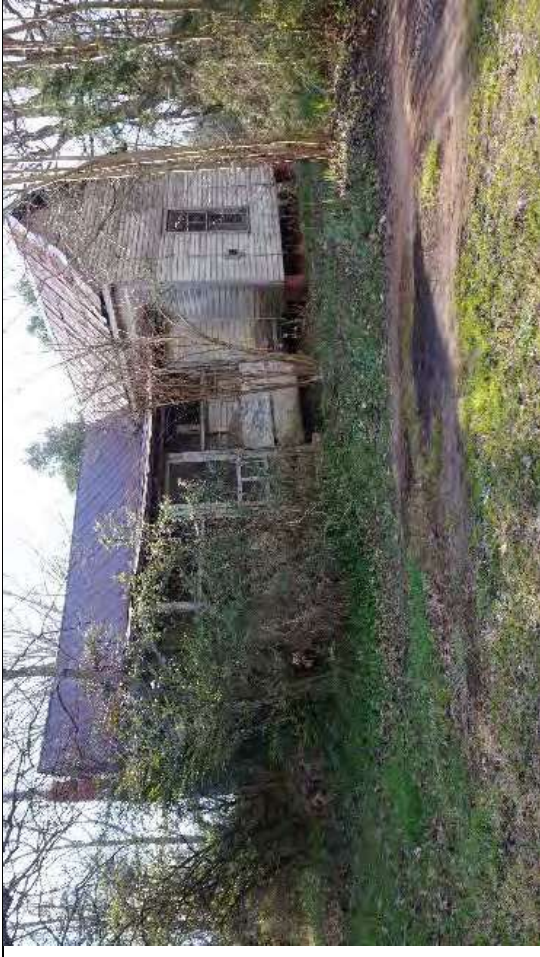
MK1875_SprattGrierFarm_03 20_V.W._01

Front View

This one-story frame L-plan residence was previously determined eligible for Register listing by the North Carolina SHPO in 1998 (Figure 5 and Figure 6). It represents a variation on a popular late-19th-century house type, the L- or T-plan cottage. Little altered on the exterior, it retains numerous historic features including a distinctive wrap-around porch with raised-seam metal shed/pyramidal roof, supported by wood posts; wood siding; front door with arched glazed panels; and original 2/2 and 6/6 wood windows. The brick porch piers are replacements of the originals. At the same time, however, the long-vacant house is suffering serious deterioration that threatens its material integrity, including brick chimney collapse, a failing porch with warped and patched metal roofing and collapsing ceiling, and a porch enclosure in poor condition (Photo Proof Set 2).

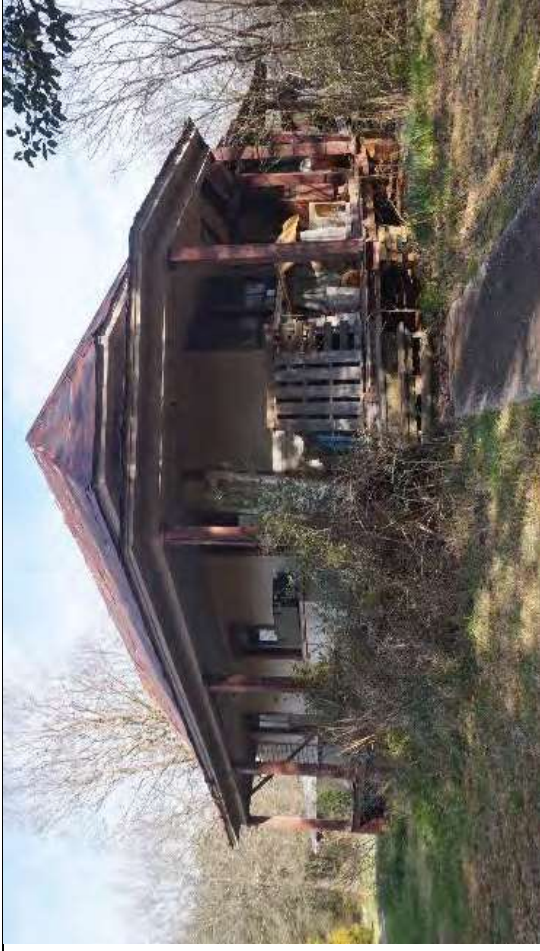
MK1875_SprattGrierFarm_03 20_V.W._02

Back View

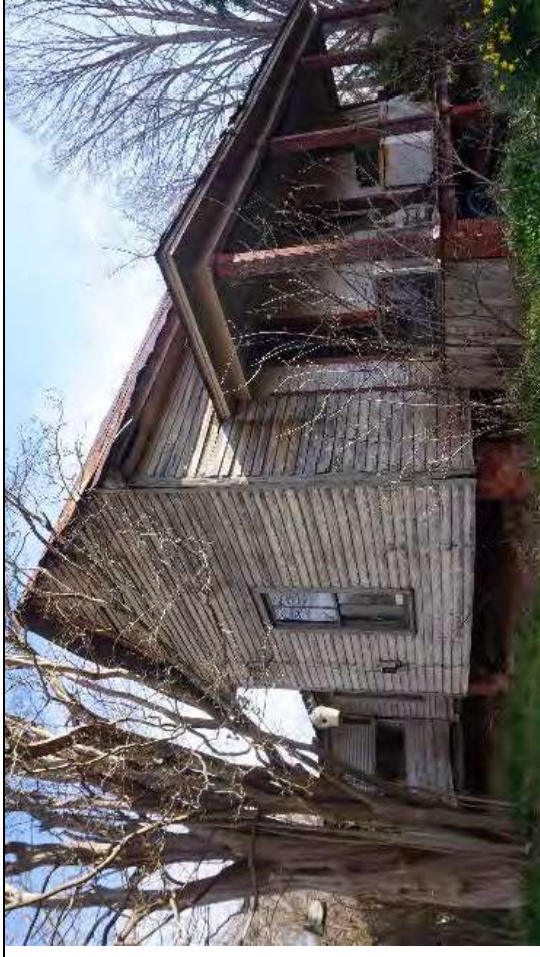
MK1875_SprattGrierFarm_03 20_V.W._03

Right View

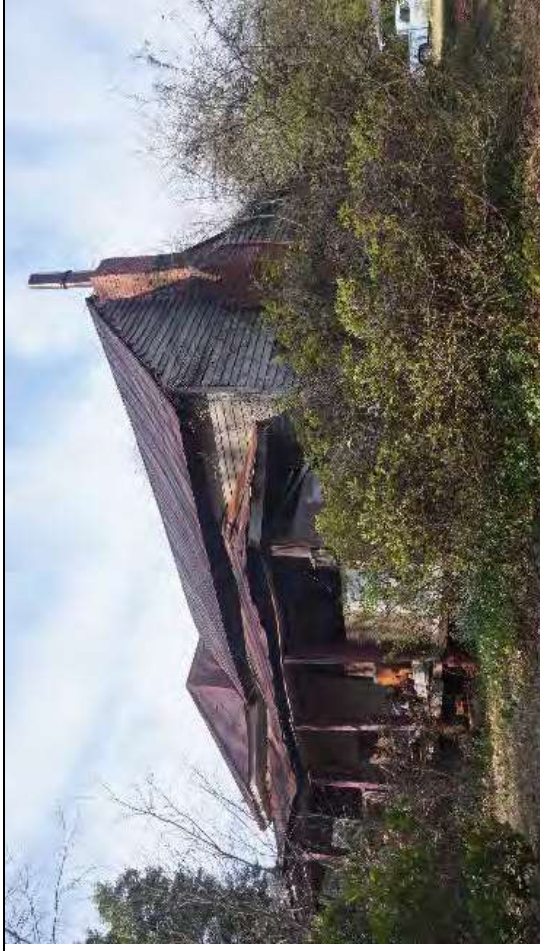
MK1875_SprattGrierFarm_03 20_V.W._04

Left View
