Staff Report and Comments

Name **Quartermaster Depot-Gama Goat Building**
Address **1801 N. Graham St.**
City State Zip **Charlotte, NC 28206**

Item: Application for COA HLC454

1. Modification of the exterior truss system.

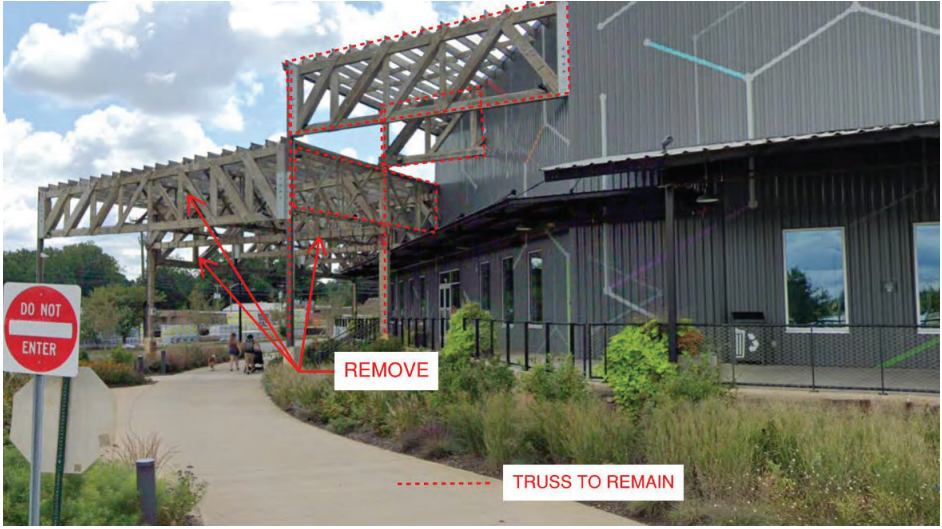
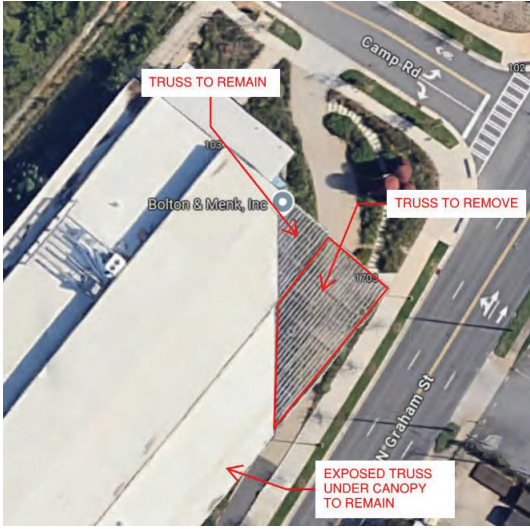
Gama Goat Building Proposal Scope Of Work

- Remove sections of the exterior timber frame structure over the road.
- Leave two king truss and lateral trusses closest to the building and replace two wood columns with steel columns.

While the retention of original materials is preferred, partial removal of the truss system, which was originally an interior feature, is appropriate due to deterioration and subsequent safety concerns.

Exposed wood truss was previously enclosed in the building. During base building renovation, we needed to remove that corner of the building to accommodate for Camp Road and the adjacent city sidewalk. As a design decision, we decided to leave the once interior timber truss exposed on the exterior of the building. Over the last 6 years we have been chasing ways to keep the wood intact- including in recent months working with a structural engineer to devise solutions. At this point, the only two options to ensure the safety of both drivers and pedestrians is to completely rebuild the trusses over the road or demo portions of the trusses that have been deemed unsalvageable. To rebuild would be too costly and we are requesting the HLC review the alternate proposal.

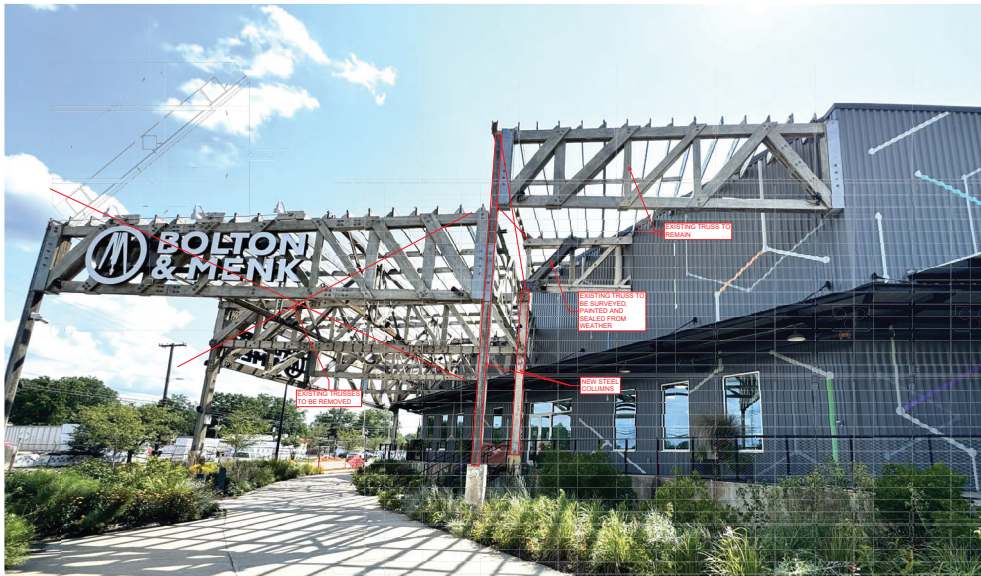
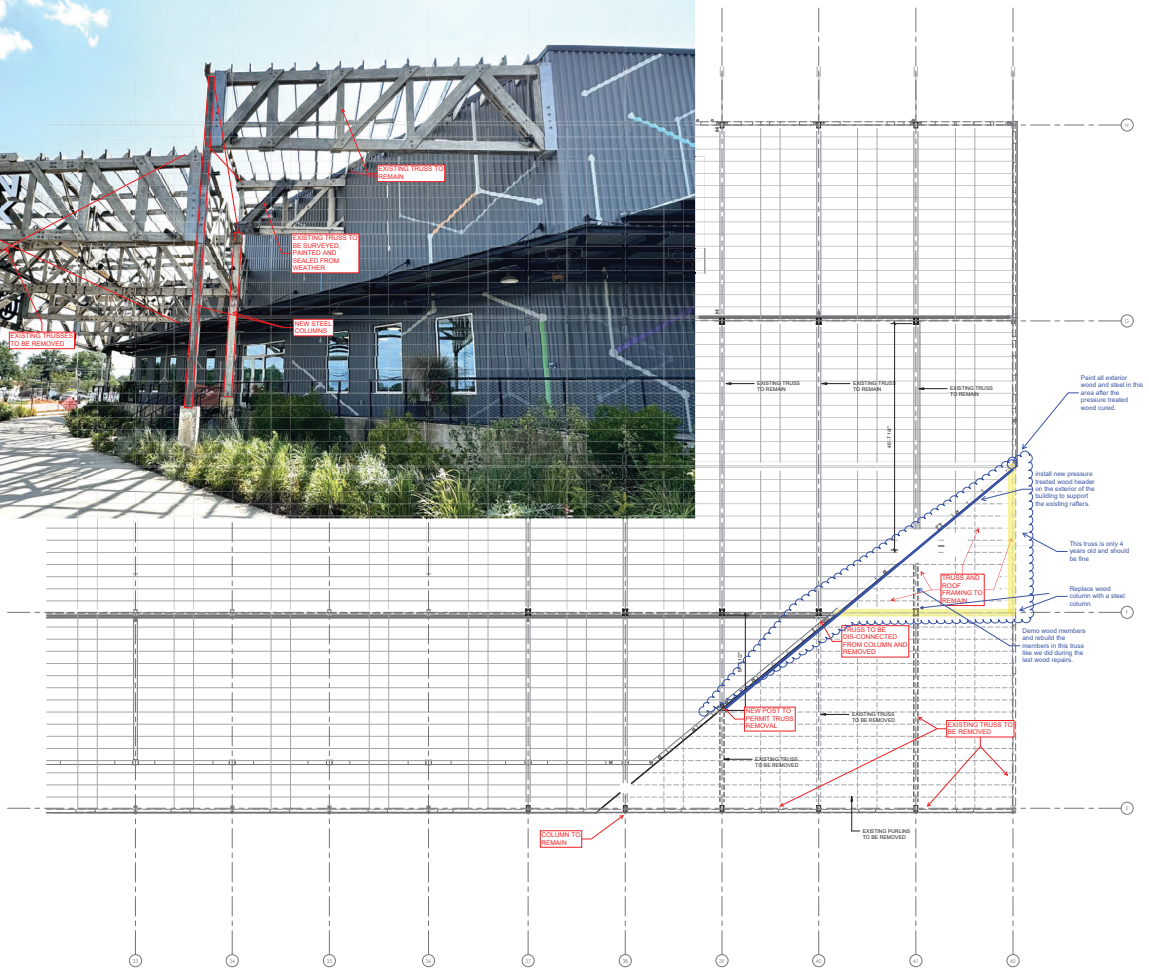
1 ROOF FRAMING PLAN
SCALE: 1/8" = 1'-0"

EXISTING ROOF FRAMING PLAN

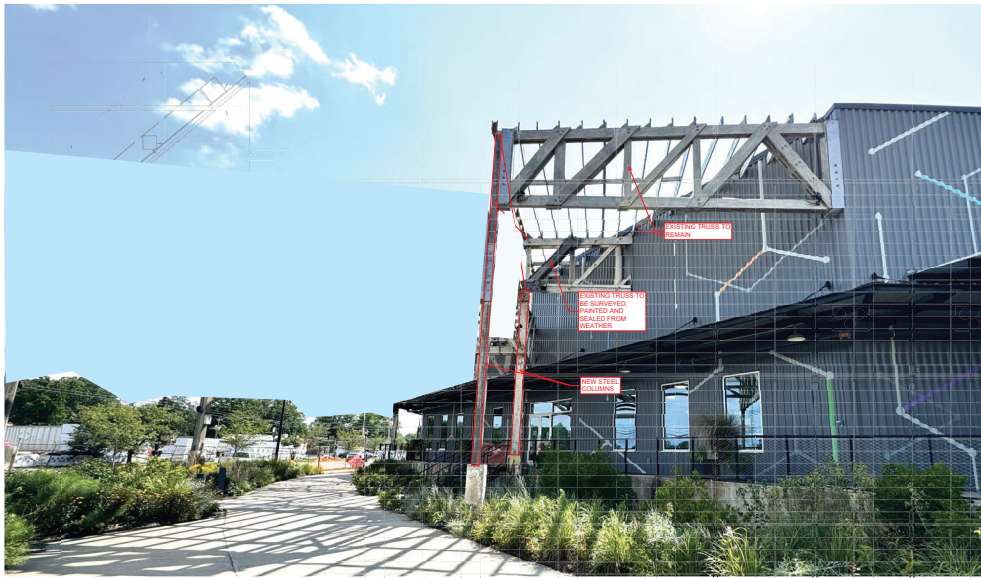
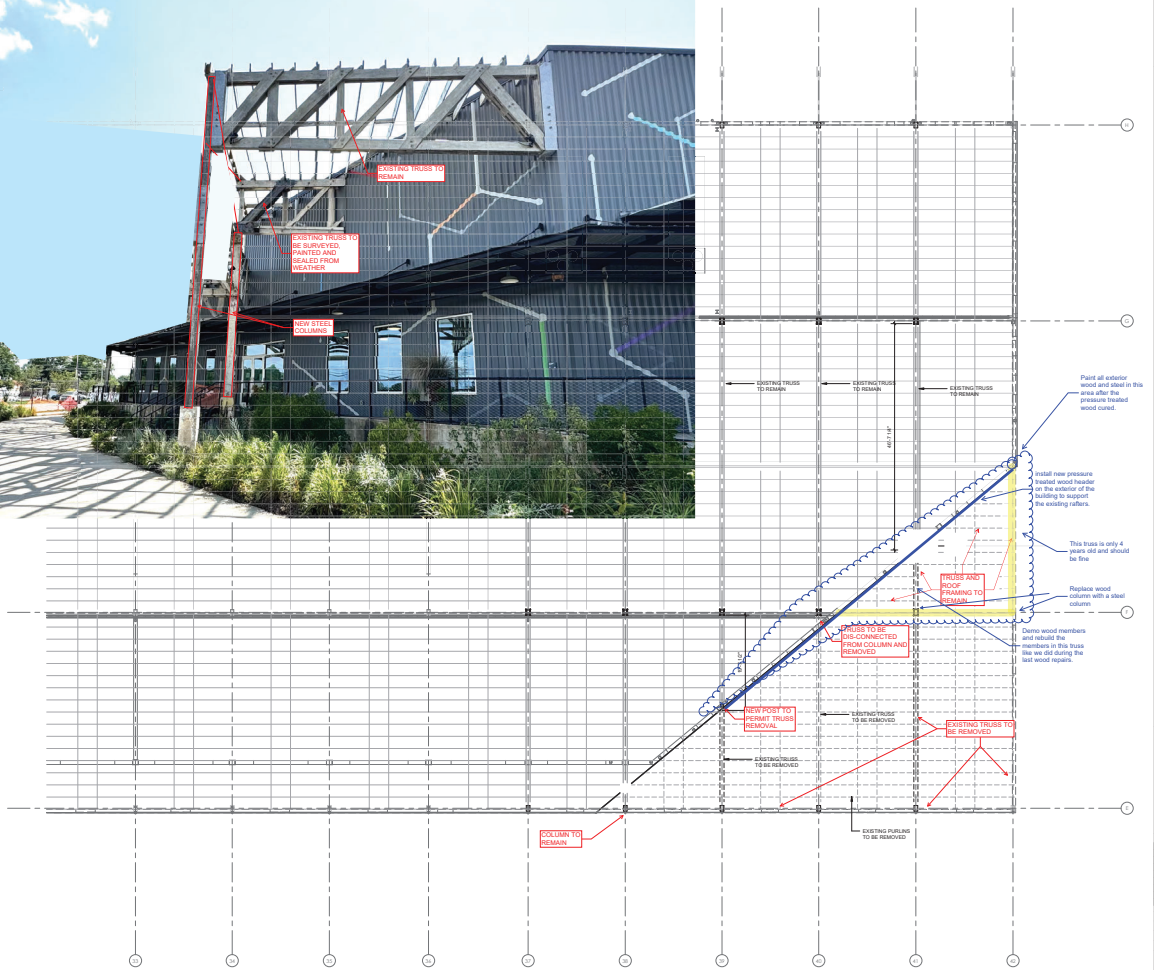
1 ROOF FRAMING PLAN
SCALE: 1/8" = 1'-0"

SHEET TITLE
EXISTING ROOF FRAMING PLAN
