# HISTORIC LANDMARK COMISSION

## DUE DILLIGENCE REPORT

Property Name: **Charles E. Barnhardt House**- 2733 Country Club Lane, Charlotte, NC.

**Project:** 2733 Country Club Lane  
Barnhardt -Cramer House  
Charlotte, NC

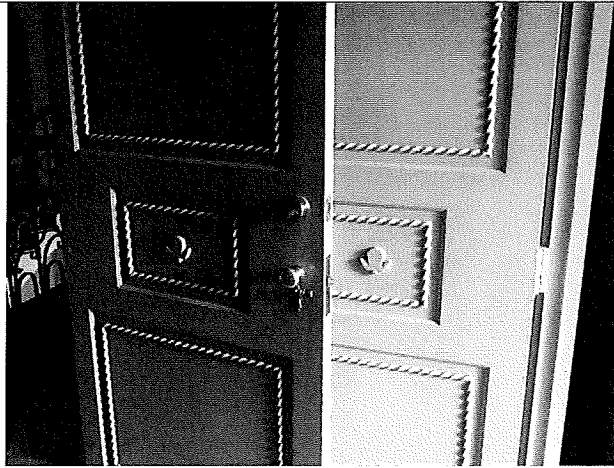
**Photo #19:**

Interior details on wood work, and metal hardware on doors and windows are in excellent condition.

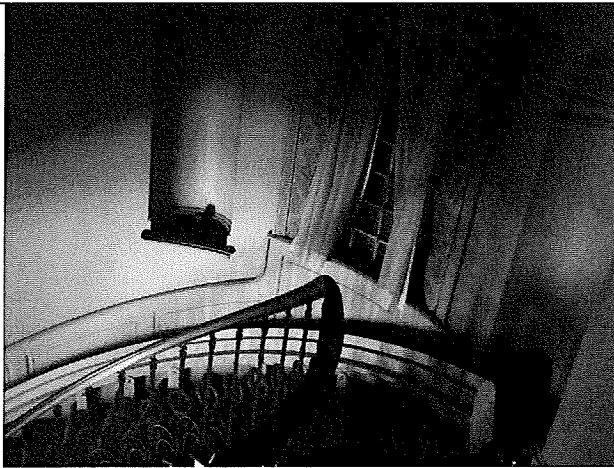
**Photo #20:**

A curved staircase with wood and metal railing at the rear of the main entrance hall are in excellent condition. The stairwell has a powered lift attached to the outside of the stairwell wall. Plaster niches within the walls of the stairwell have small sections of wood flooring at the base.

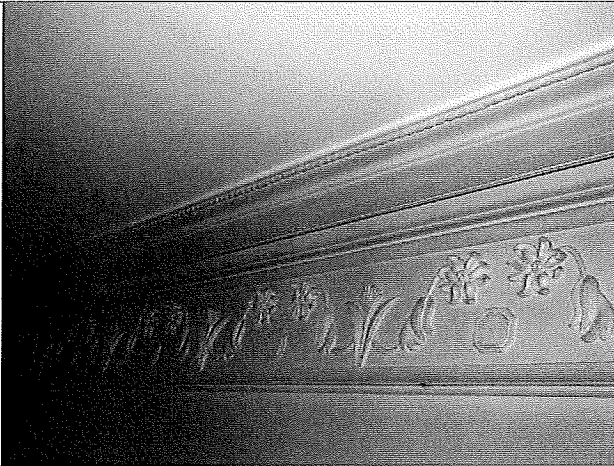
**Photo #21:**

Interior plaster details such as at this cornice appear within most of the larger rooms and are in good condition.

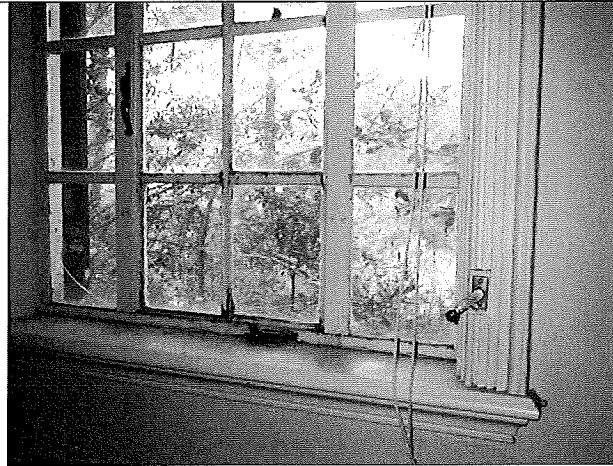
**Photo #22:**

Metal-frame windows have heavy brass locks and cranks. Brass cranks located in the side casing open and close the exterior wooden shutters. In most cases this hardware operates smoothly.

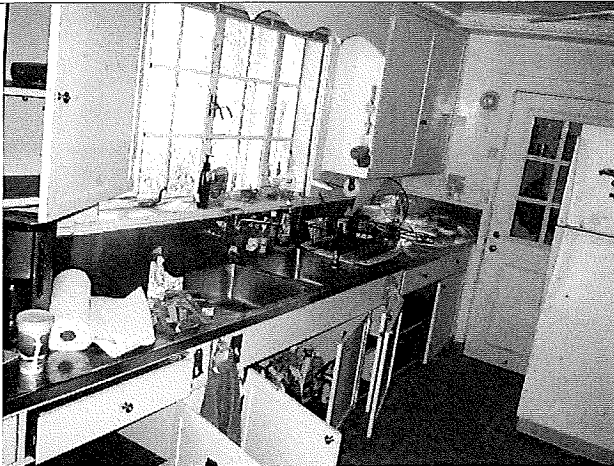
**Photo #27:**

The relatively small kitchen located on the right-side within the main level of the home has stainless-steel sinks, countertops, and backsplashes. A similarly appointed butler's pantry separates the kitchen from the dining room.
