Reginald Armistice Hawkins House

1703 Madison Avenue, Charlotte, NC

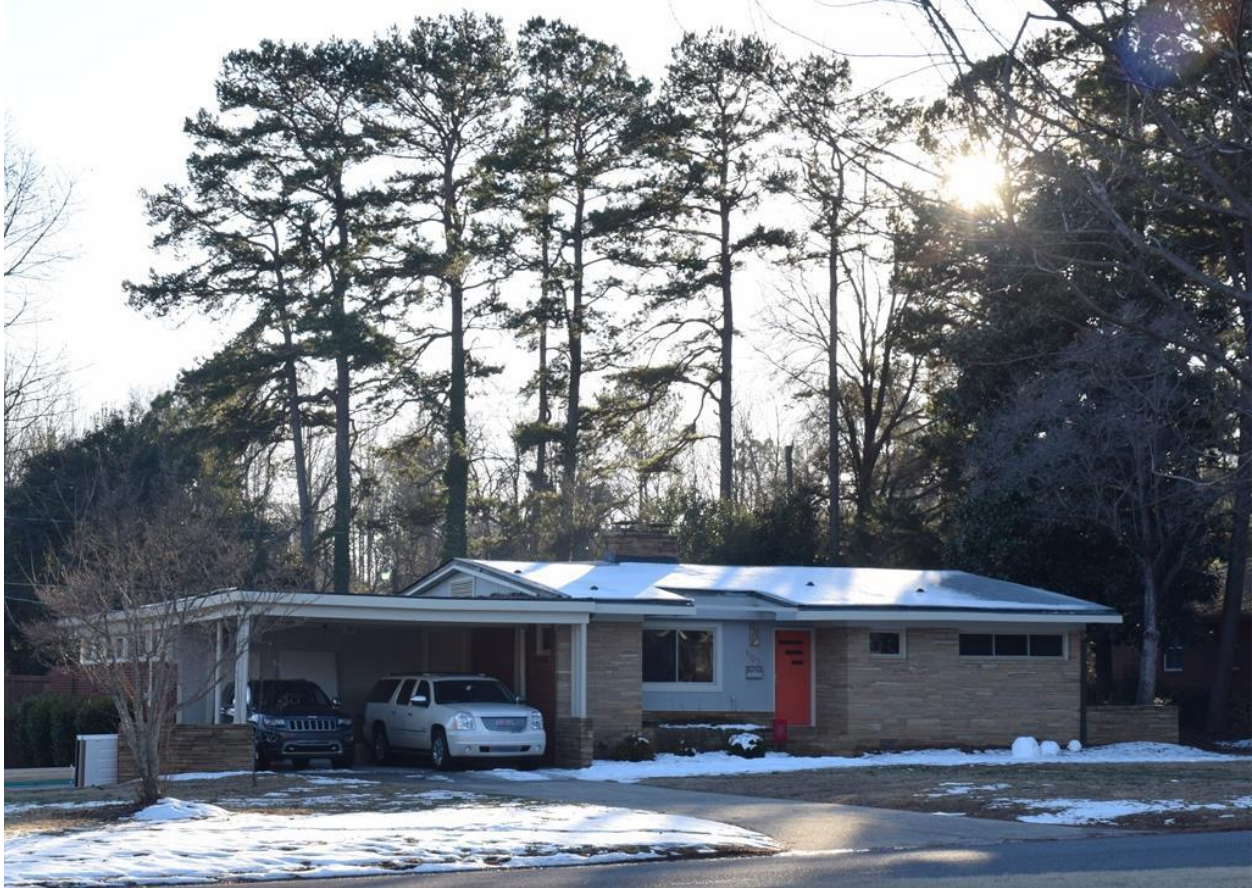
The 1954 Reginald Armistice Hawkins House faces roughly north and occupies a relatively flat, approximately .4-acre corner lot at the intersection of Madison Avenue and Clifton Street in the McCrory Heights neighborhood. The modernist-style, side-gabled house is set back from Madison Avenue approximately 65 feet. The majority of the façade is veneered with rough-cut, irregularly-coursed sandstone. The western portion of the façade is pierced by a short tripart window set high in the wall, and a short shingle-sash window also set high in the wall. The house's entrance is set in a recessed, two-bay-wide section of the facade. The stone on the façade wraps the blank side walls of the recessed bay. The recessed bay is composed of a low, partial-height sandstone wall, topped by T1-11 siding. The wall is pierced by a

replacement slab door and a large, two-sash sliding window. A sandstone planter, and a concrete and sandstone stoop extend across the recessed bay. The stone sections of the façade are topped with a wide wooden band. The façade features a deep overhang with a soffit composed of T1-11. A significant portion of the roof is cut away over the engaged stone planter in the recessed bay. Two stone steps lead to the stoop.

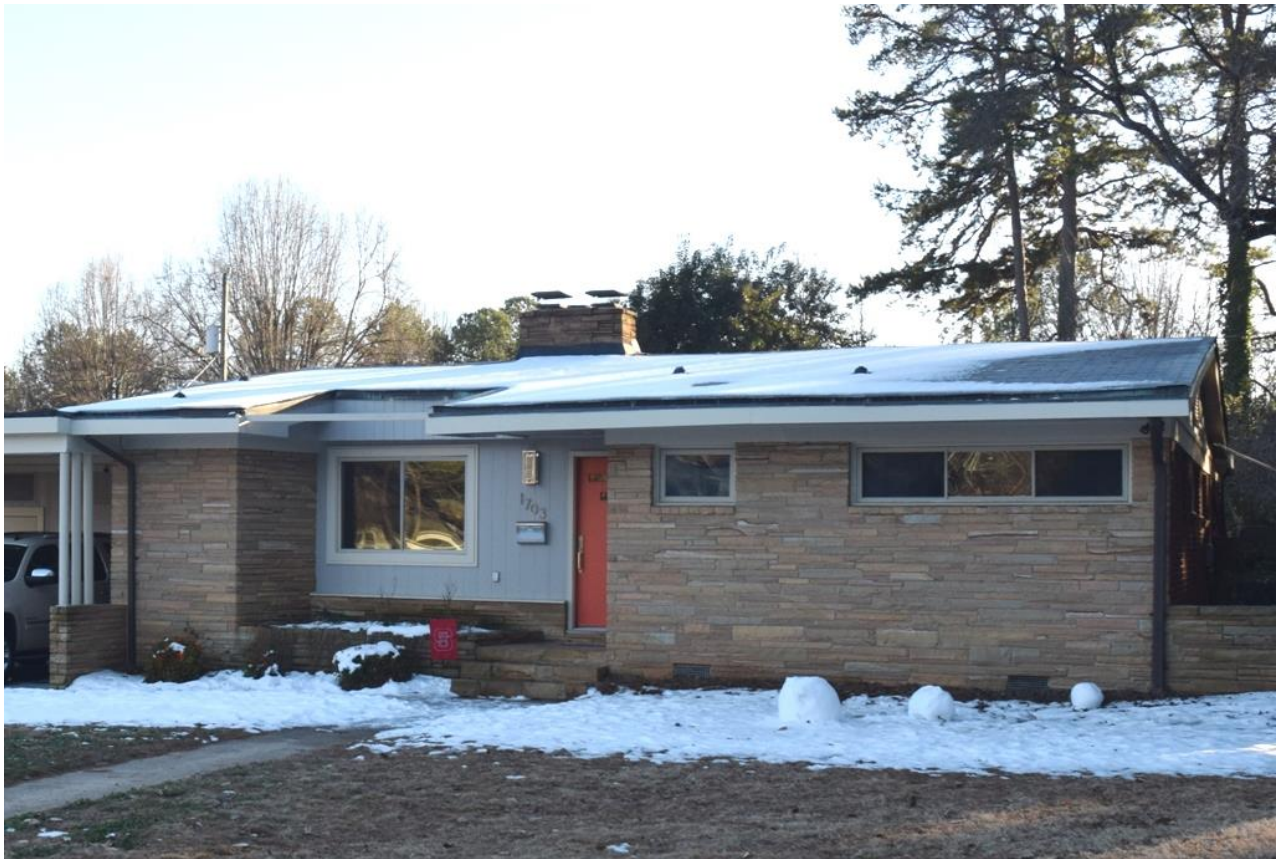
The low-pitched roof is topped with a short stone chimney, and features integrated gutters. The sandstone found on the façade extends uninterrupted to the west as a partial-height wall.

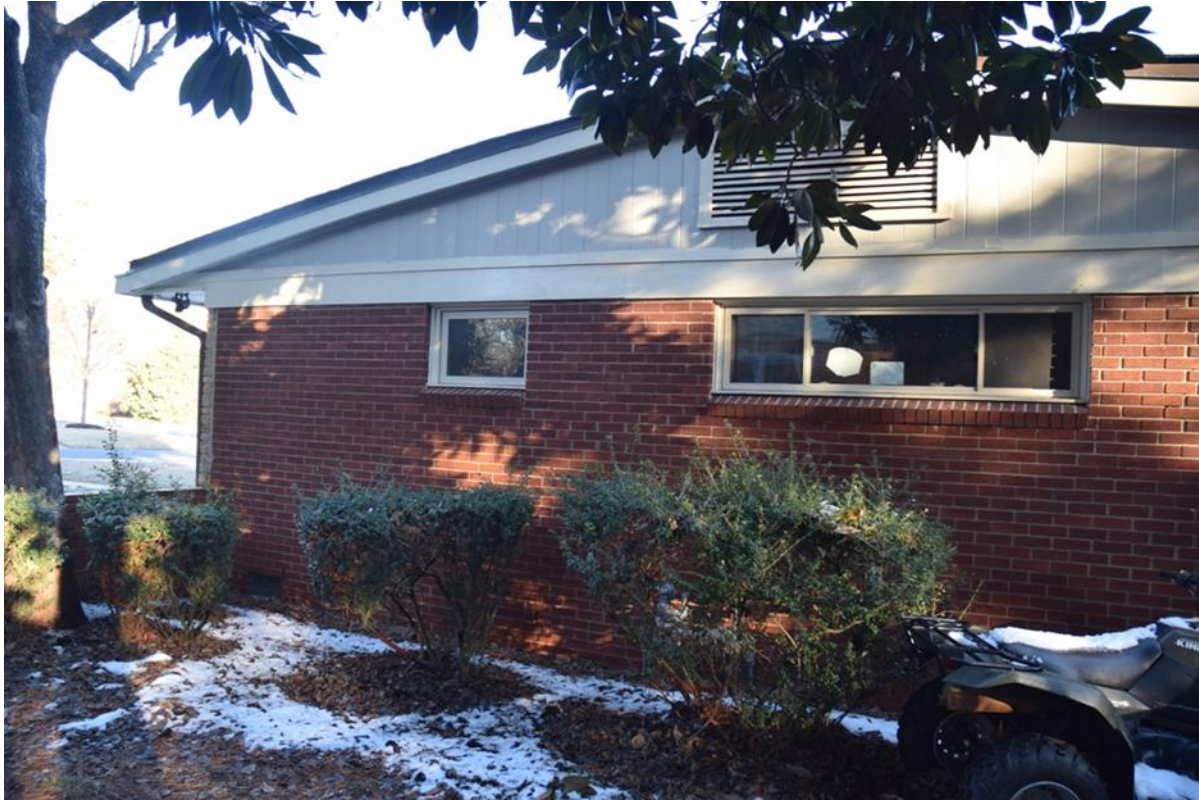
The masonry veneer transitions to brick, laid in a running bond, on the three-bay-wide west elevation. The elevation is asymmetrical and is pierced by three original window openings set high in the wall. The window closest to the façade is a single sash, the middle window is a triple sliding window, and the rearmost original window is a two-sash slider. The windows sit on angled brick sills. The short gable is sheathed with T1-1,1 and features a wide louvered vent. The overhang is very shallow. A shallow gabled addition was added to the rear of the house in 1961. The addition is flush with the west elevation. A single-sash, short window pierces the west elevation of the addition.

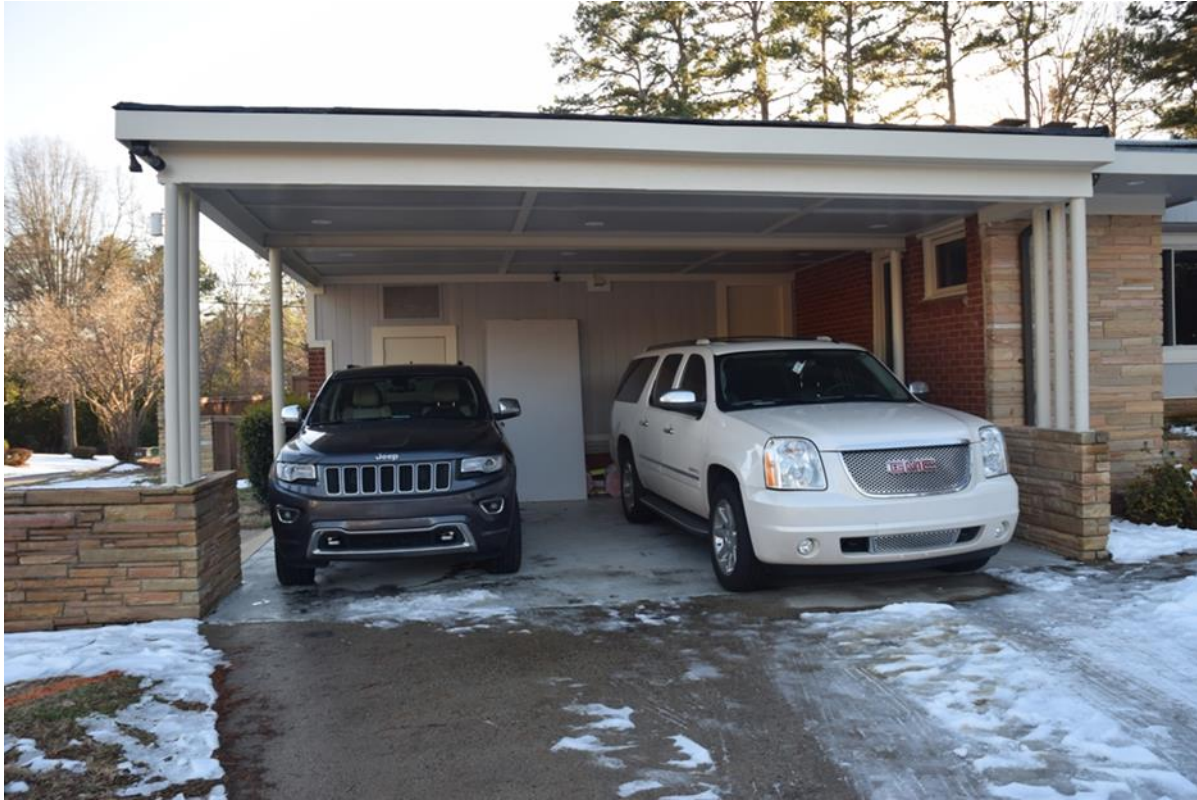
A carport and flat-roofed wing were added in 1958 to the east elevation of the house. The carport extends past the façade. The carport's roof is supported on the west by three metal columns that rest on a partial-height sandstone wall that projects from the east edge of the façade. On the east, the carport is supported by three metal columns that rest on a freestanding stone wall. The east wall of the principal section of the house is sheltered by the carport and is veneered with brick. The brick wall is pierced by a single-sash window set high in the wall and a door opening, now infilled with a tall, single-light sash window. The east side of the carport is open and features a single metal post supporting a shallow I-beam. The rear wall of the carport is sheathed with T1-11, and is pierced by a single slab door.

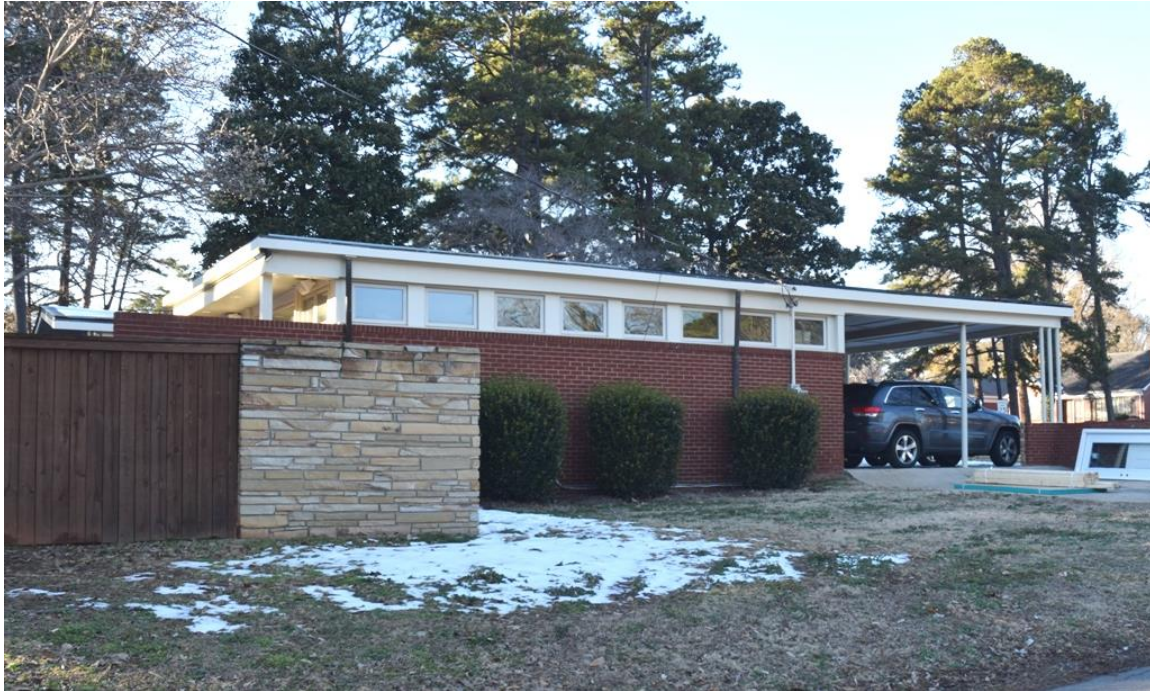
The carport is engaged with the flat-roofed wing, which extends past the rear elevation of the principal section of the house. The east elevation of the wing is composed of a blank, partial-height brick wall topped with a full-width, eight-sash ribbon window.

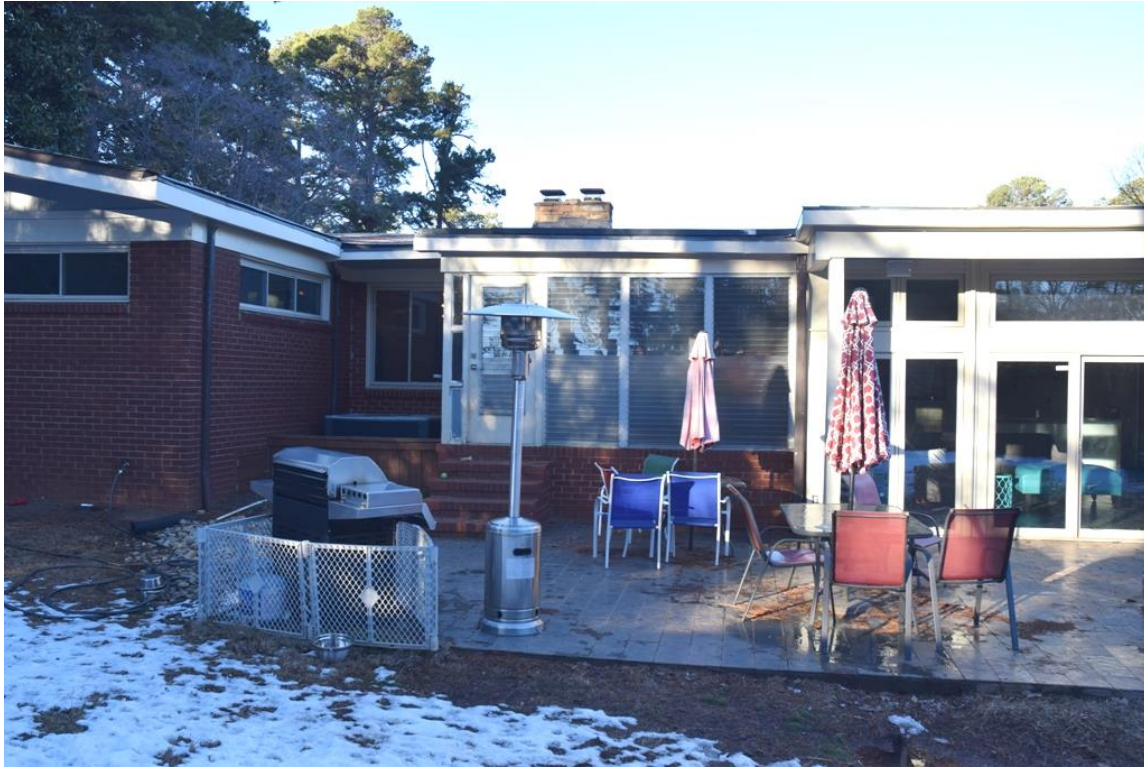
The only exposed portion of the rear elevation of the principal section of the house is a single bay that contain a large two-vertical-light window. To the east of the exposed bay is a flat-roofed porch with jalousie windows. The porch features a tall brick foundation and a concrete floor embedded with roughly broken pieces of quarry tile. The porch shelters a replacement one-light door and a window opening now in-filled with shelving.

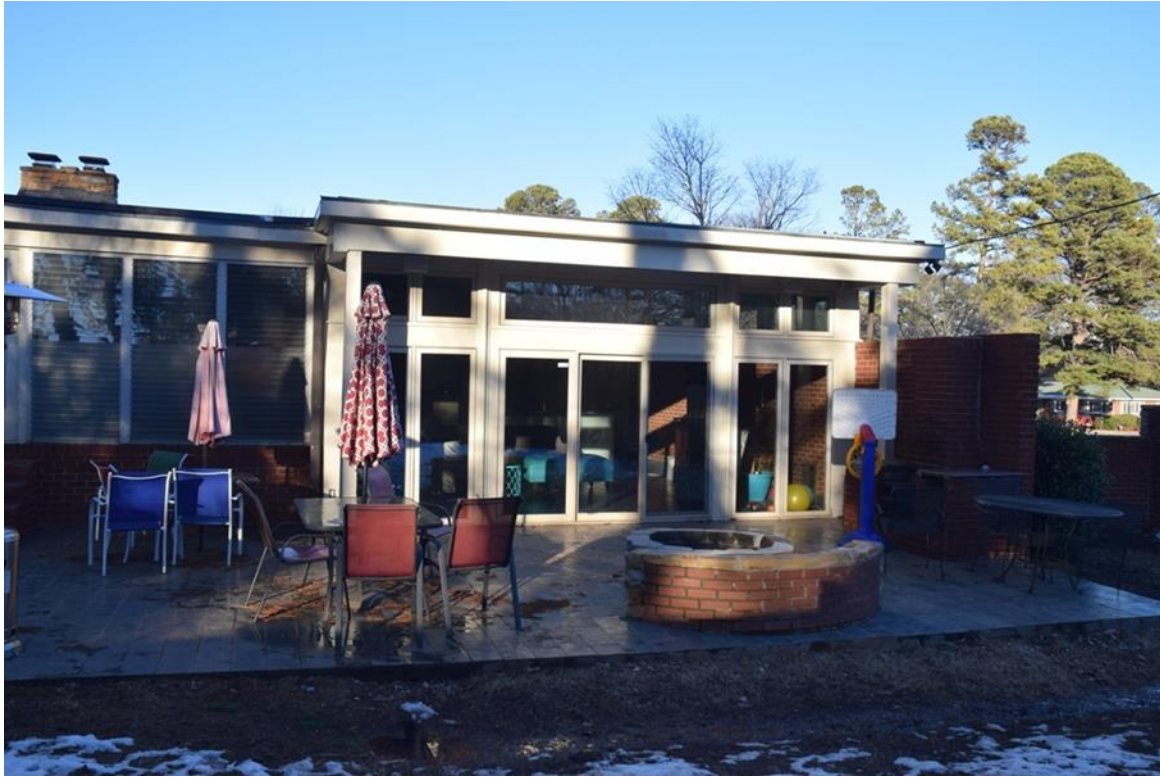
The flat-roofed rear wing aligns with the rear elevation of the porch, but the roof of the wing extends to the rear to form a shallow porch supported by two posts. The rear elevation of the wing is composed of a tripart glazed sliding door and four tall single-light sash at grade, all separated by minimal framing. The sliding door is topped with a large transom, and the sash are each topped a single-light square sash. The partial-height brick wall of the wing's east elevation extends past the shallow porch, and helps to define a patio paved with cut blue stones. A brick fireplace/grill is built against the projecting wall.

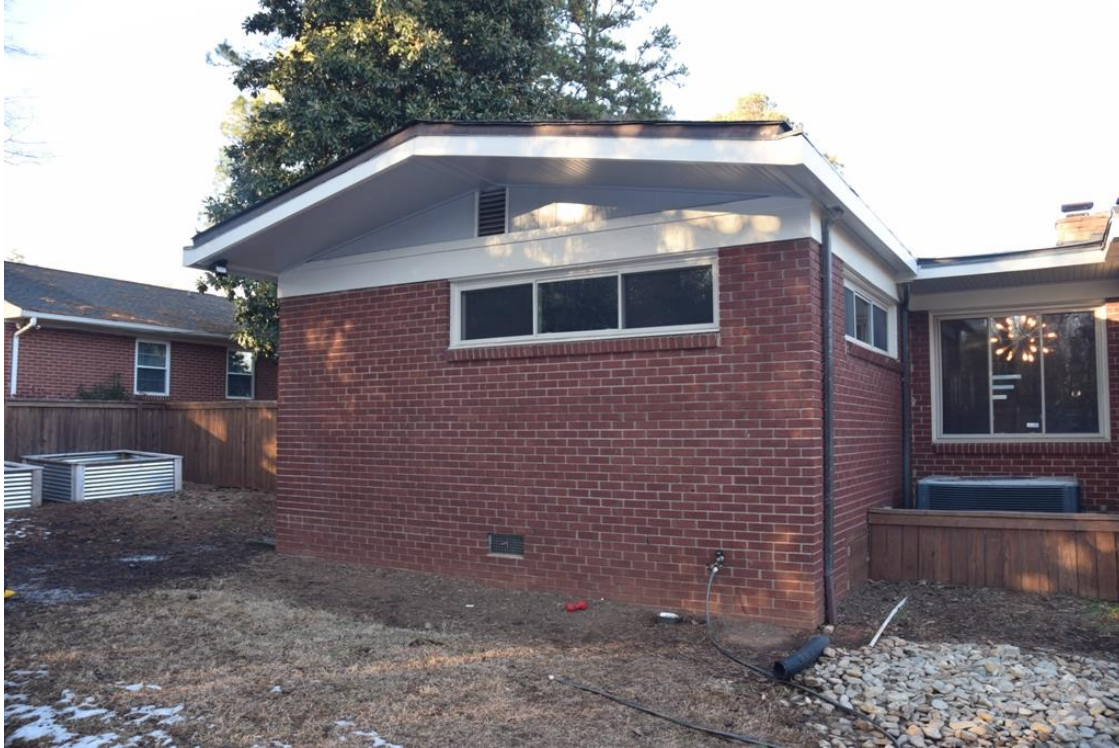
The asymmetrical rear elevation of the gabled addition is pierced by a tripart sliding windows set high in the wall and resting on an angled brick sill. The wall is topped with a wide simple band. The low-pitched roof features a deep overhang. The gable is sheathed with T1-11 and features a center louvered vent.

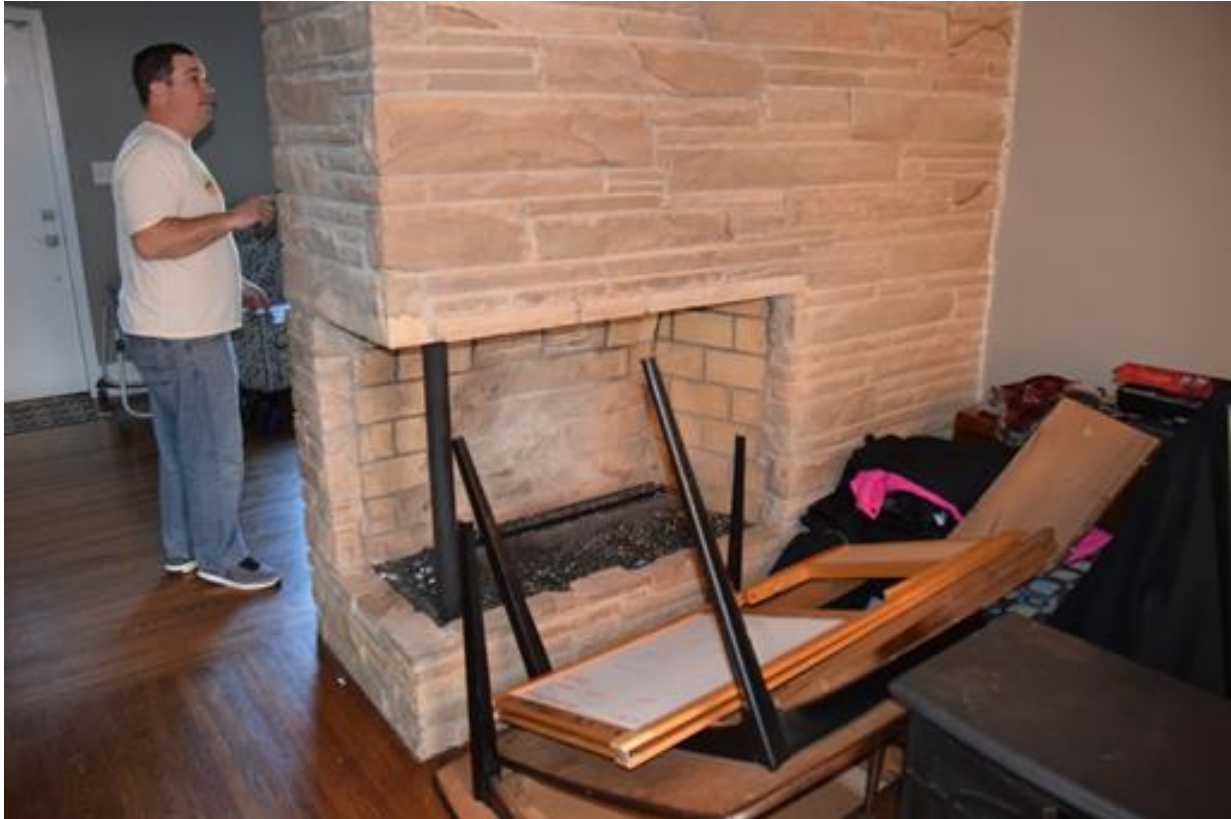
The interior of the Reginald Armistice Hawkins House has retained a good degree of integrity. The room layouts, minimalist trim, and original floors (including the oak flooring in the principal section of the house and the bluestone in the 1958 addition) have survived. Of especially note is the central sandstone fireplace that matches the masonry on the façade. The modernist-style firebox is open on two sides and features a steel corner-support post. The firebox opens onto a rear den, but the sandstone masonry extends into the front living room.
