Survey and Research Report
on the
1015 West Fourth Street

1. **Name and location of the property:** The property known as the Woodlawn Bungalow is located at 1015 West Fourth Street, Charlotte, North Carolina.

ARCHITECTURAL DESCRIPTION

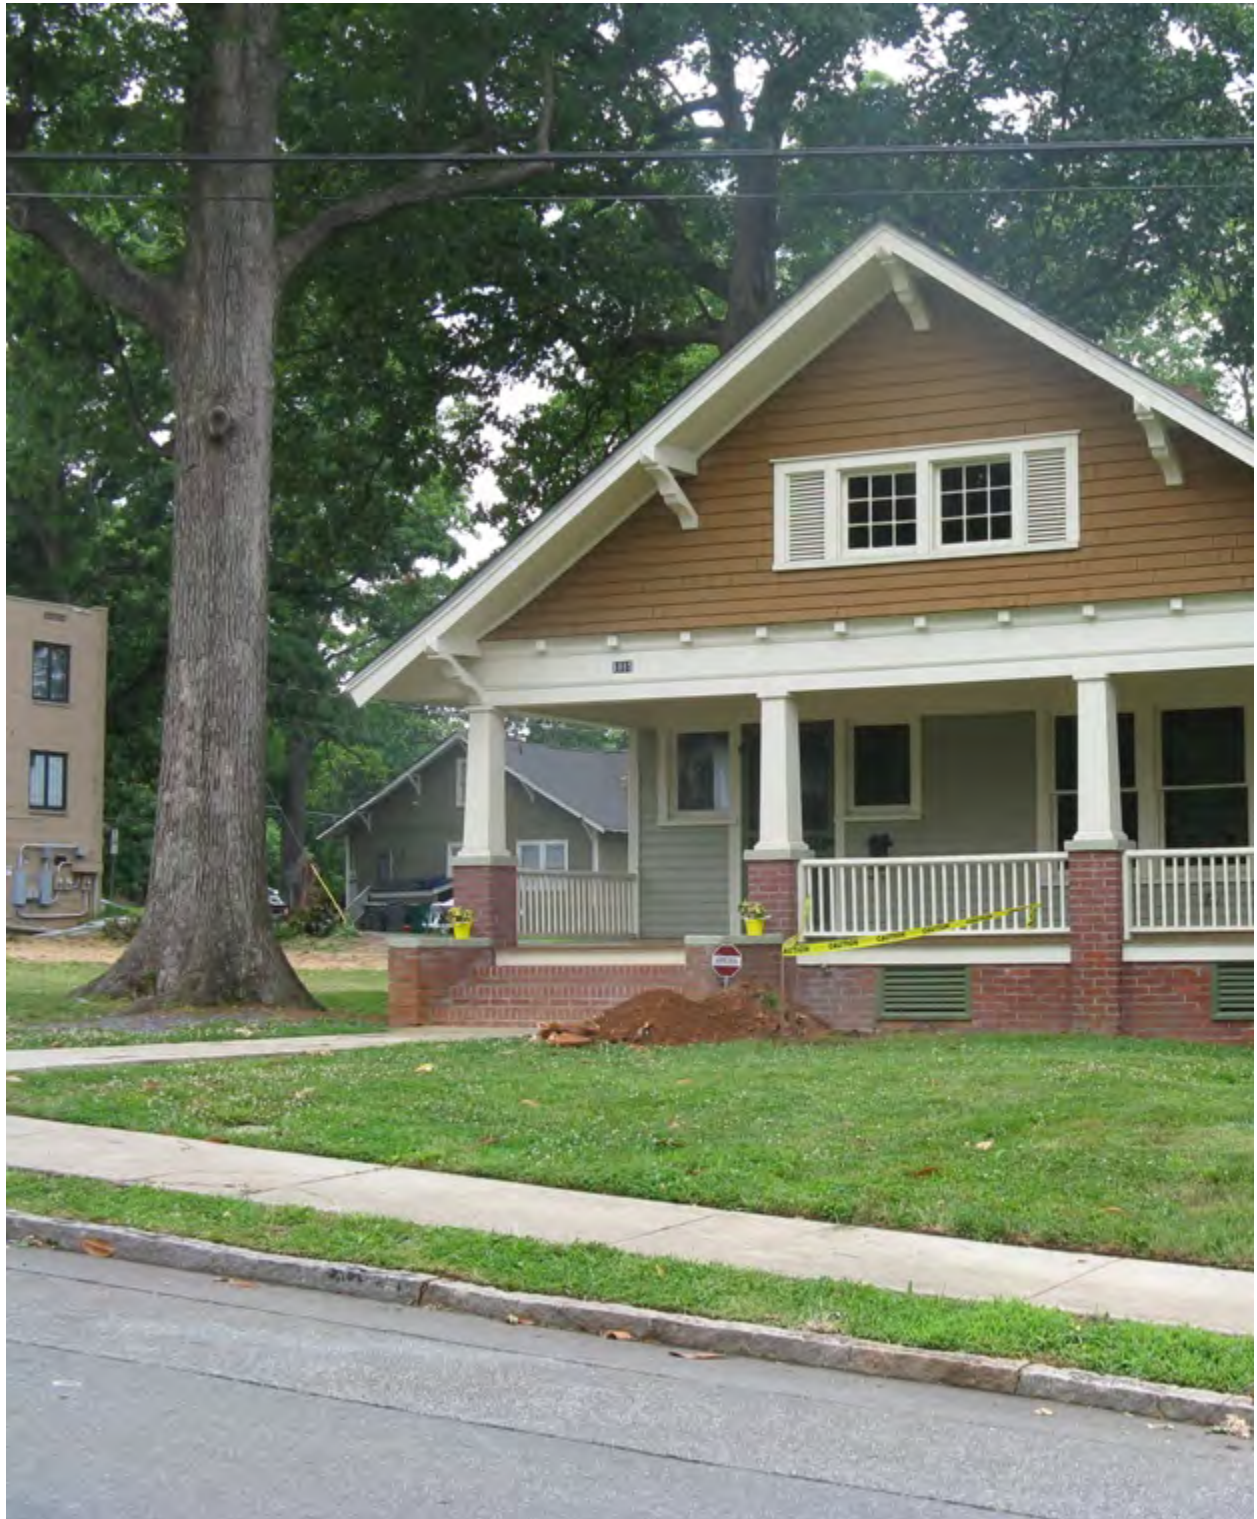
1015 West Fourth Street is a ca. 1909 one-story front-gabled Craftsman Style bungalow that faces north and is set back approximately 30' from the granite curbed street. The neighborhood is a mix of single family houses and small multi-family residential buildings. Like 1015, most of the buildings in the neighborhood date from the first half of the 20th century. This portion of West Fourth Street slopes steeply to the west, following the contour of the land which leads down to Irwin creek. Along this street and in much of the neighborhood all of the houses are set close to the street and close to the neighboring houses. In some instances the houses are separated by as little as 10'. The neighborhood is dominated by mature oak trees. Sidewalks line most of the streets, and alleys run behind many of the lots.

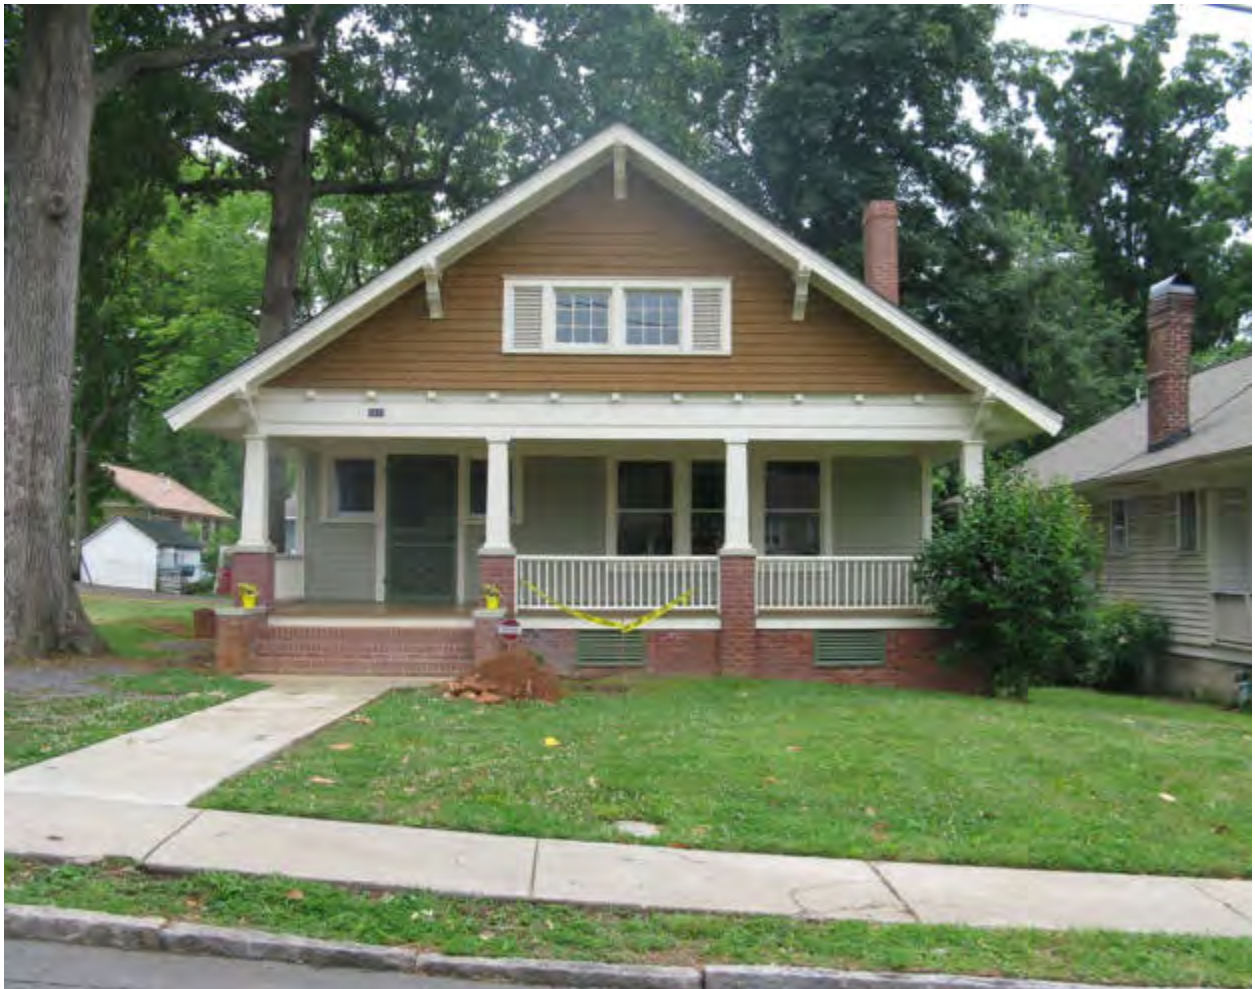
The front elevation is dominated by a substantial front gable that projects over a recessed porch. A rebuilt continuous brick foundation is interrupted by four tall

brick piers topped with simple concrete caps. The piers are spaced evenly across the front elevation. Between the easternmost piers, a wide set of brick steps is flanked by cheek walls topped by simple concrete caps. Between the other front piers, the foundation is pierced by large wood louvered vents. A wooden floor with a simple wood band is supported by the masonry porch foundation. The tall piers are connected by balustrades composed of original chamfered top rails and simple original narrow balusters.

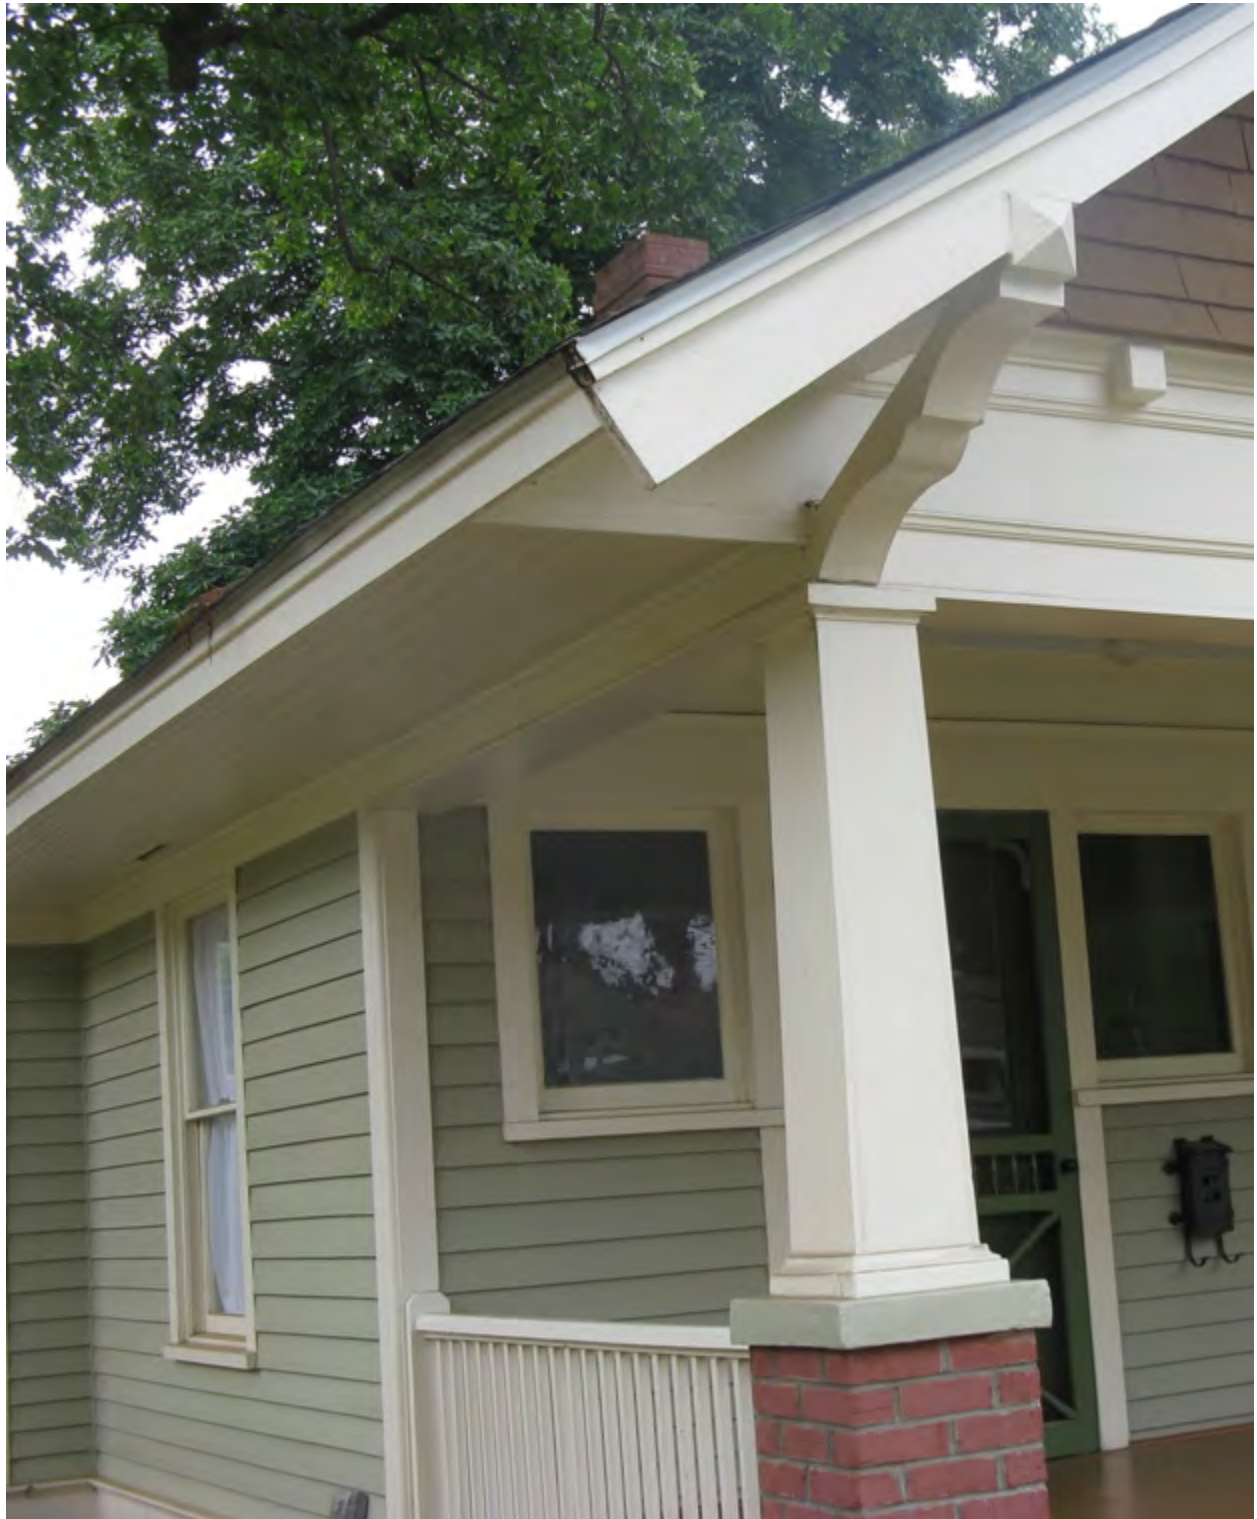
The piers are topped by Craftsman Style tapered posts. The posts rest on simple wooden bases with cavetto trim. The posts are topped with simple wooden caps with cavetto trim. The posts support a boxed beam with a narrow band of cyma

recta moulded trim. Above the boxed beam are a row of simple modillions bordered on the bottom by cyma trim. The modillions are separated by deep cyma trim. The modillions and trim project slightly forming a shallow pent. The gable is covered with wood shingles that angle out to cover the pent, giving the gable wall a bell-cast shape.

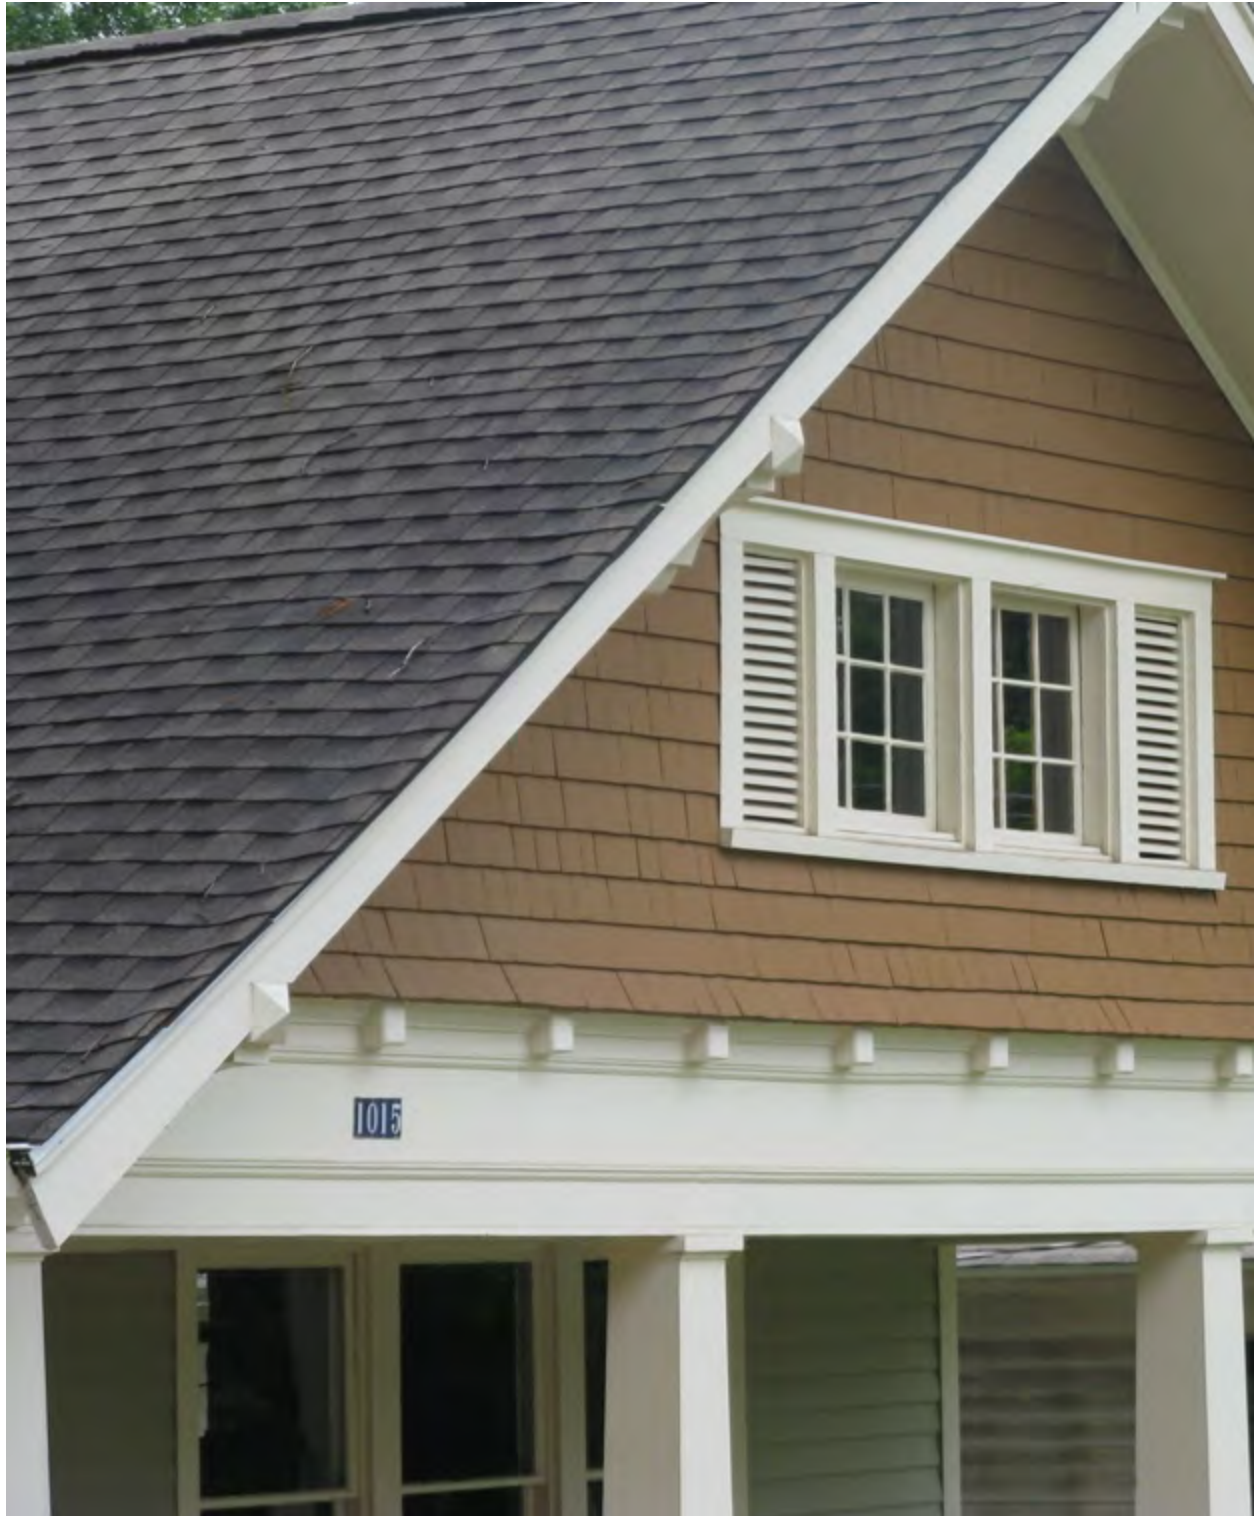
The gable is pierced by a window opening that contains a pair of fixed nine-light sash bordered on each side by louvered vents. The gable is sheltered by a deep roof overhang supported by decoratively sawn brackets. The soffit is sheathed with beaded boards. Although compromised over the years as roof sheathing

has been replaced, the original profile of the gable included a bell-cast design over the eaves.

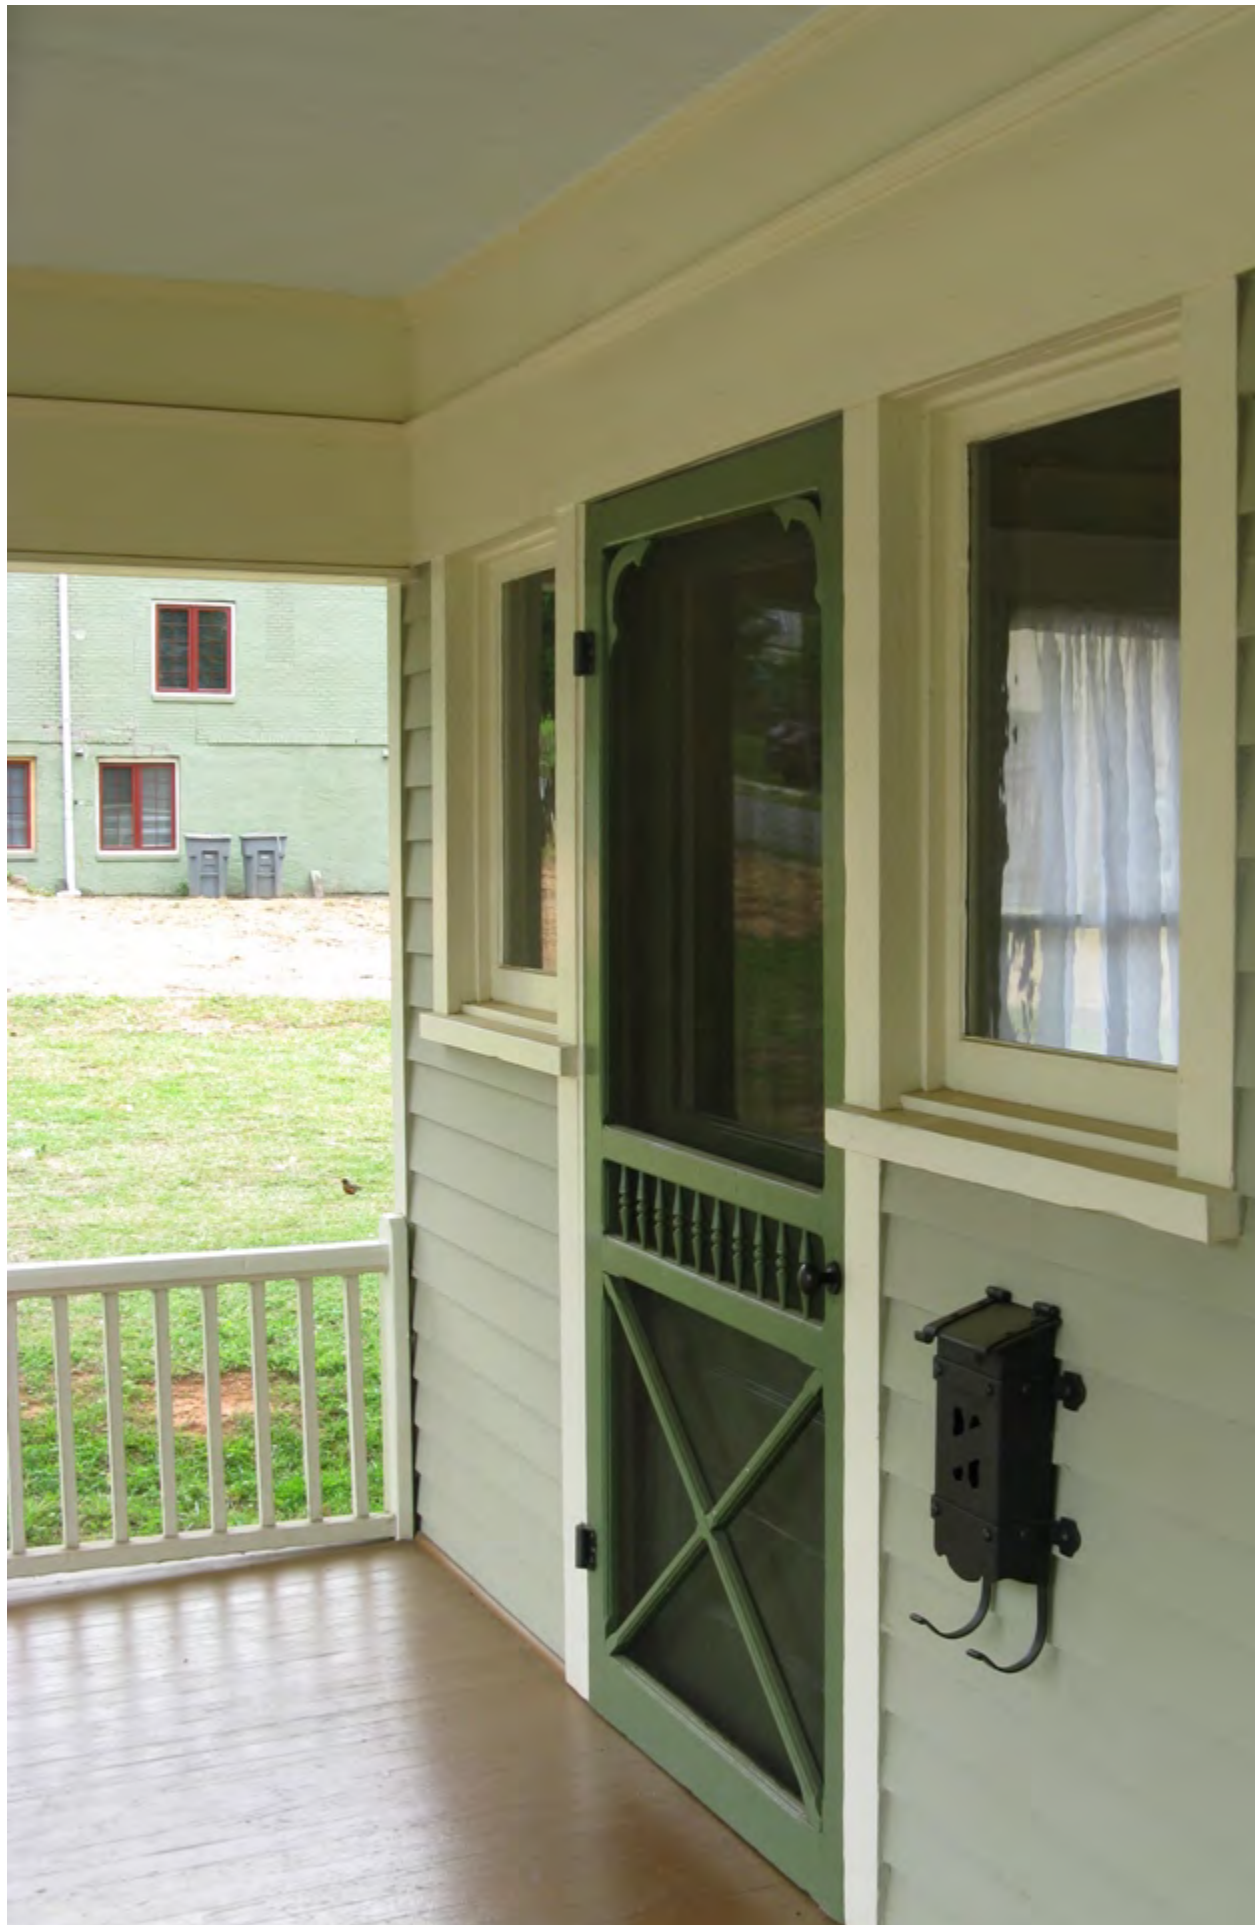
Sheltered by the deep overhangs, all of the architectural elements of the front porch, with the exception of the wood flooring, have survived intact. The porch elevation contains two bays. The east bay contains a wide single-light door. The door also features two horizontal raised panels. The door opening features an early, if not original, screen door. The door is bordered on each side by fixed single-light windows. The relatively short windows are set flush with the top of the door. The other bay contains a set of three one-over-one windows. The original windows feature simple trim and sills. The porch features simple clapboards used on all of the exterior walls. The courses of clapboards terminate in corner boards with a moulded round-over detail. The clapboards on the porch are topped by two-wide wide frieze boards. The horizontal joint between the boards is covered by narrow cyma trim. The porch wall is topped with more narrow cyma trim. The porch ceiling is beaded board.

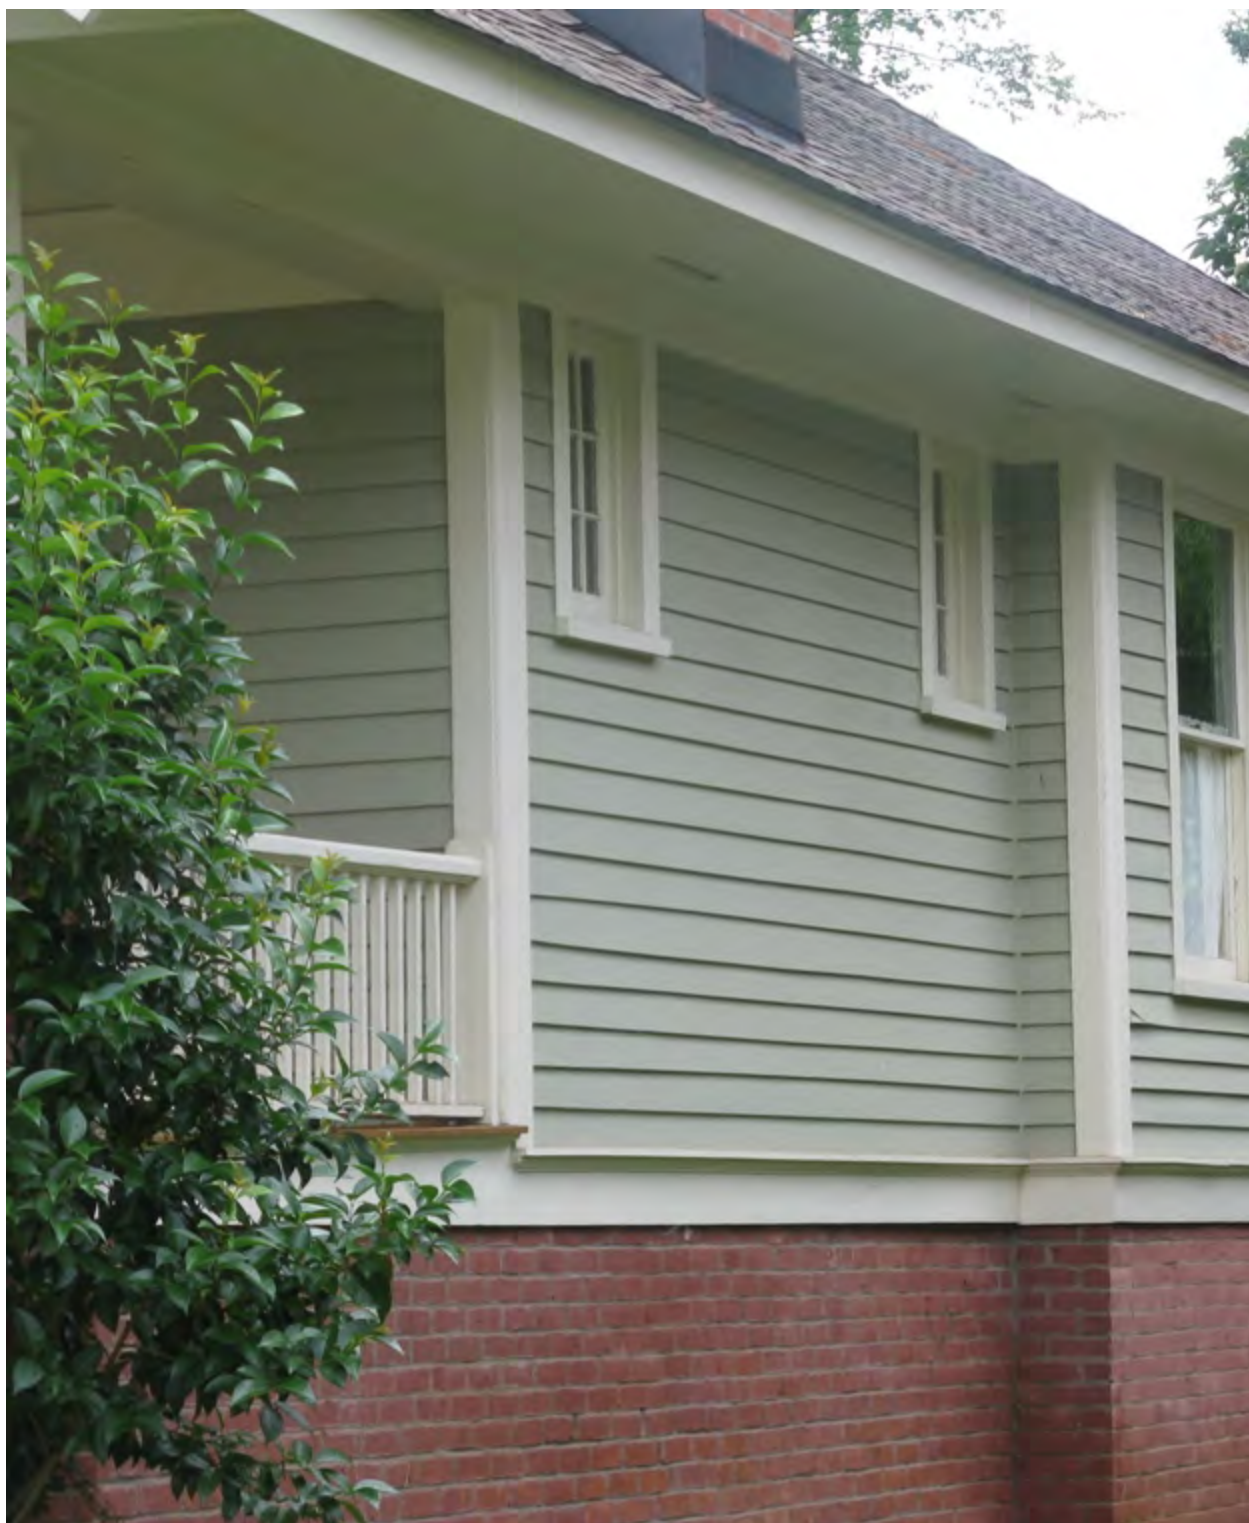
The west elevation contains six window openings. From the front, the first two bays are small nine-light fixed sash set high in the wall. These windows border an interior fireplace, and this design element was common in Craftsman Style houses. A simple bay roughly centered on the west elevation projects slightly

and contains two tall one-over-one windows. The projecting bay features corner boards. To the rear of the projecting bay, two one-over-one windows are ganged together. The rearmost section of the west elevation appears to be a rear porch that has been enclosed. On this section the drip cap angles down to the rear, indicating a sloping porch floor. A single small nine-light window is set high in the wall, and may have been moved there from another location on the house. The clapboards on the east, west and rear elevations rise from a drip cap that rests on a simple water table board. The eaves on the east, west and rear elevations feature a beaded-board soffit, now retrofitted with small vents.

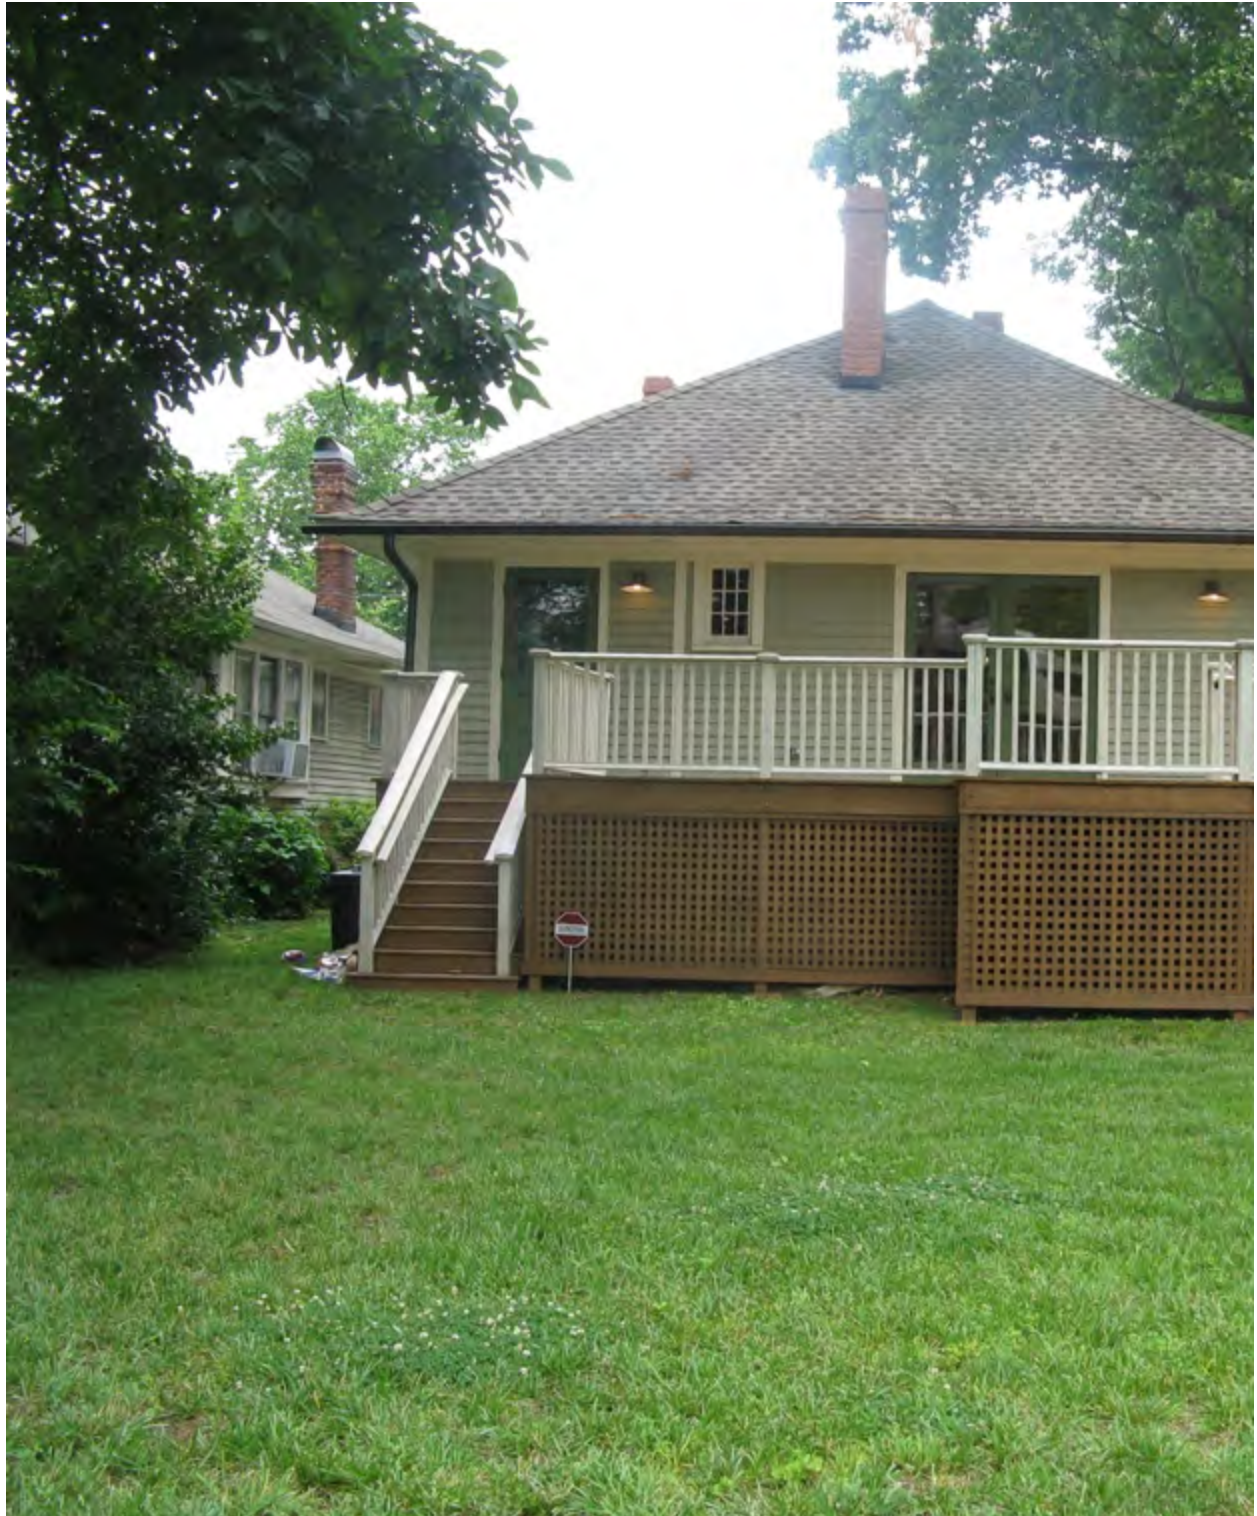
While 1015 exhibits a very high overall degree of integrity, the rear is the most altered elevation. Original fenestration is limited to a single small nine-light window set high in the wall. To the east of the original window, a modern wooden

double-door has been added. The rear wall of the enclosed porch features a modern wooden glazed panel door. A large recent wooden deck with an integrated accessible ramp extends from the rear elevation. The rear elevation is topped with a hipped roof. The bell-cast element is more distinct on the rear sections of the roof. The roof is pierced by three thin and simply corbelled internal chimneys, all of which have been rebuilt to some extent. Though rebuilt, they match the style and scale of the chimneys on the neighboring houses.

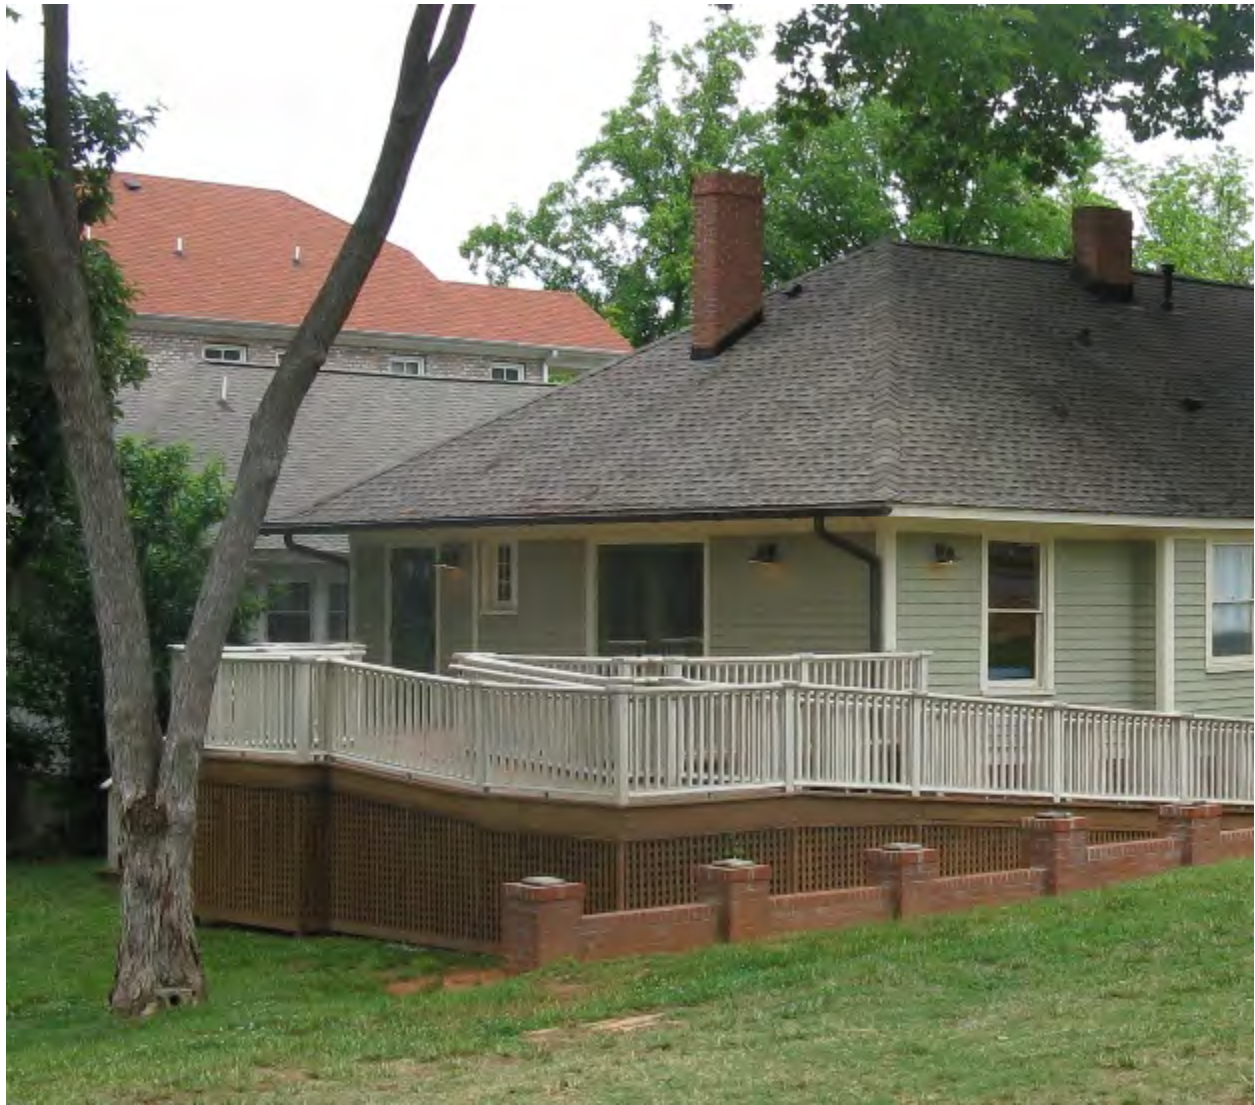
The east elevation features a shallow projecting bay containing three one-over-one windows. The rearmost is slightly shorter than the others on the elevation, but appears to be original. To the rear and to the front of the projecting bay the east elevation is pierced by single one-over-one windows.

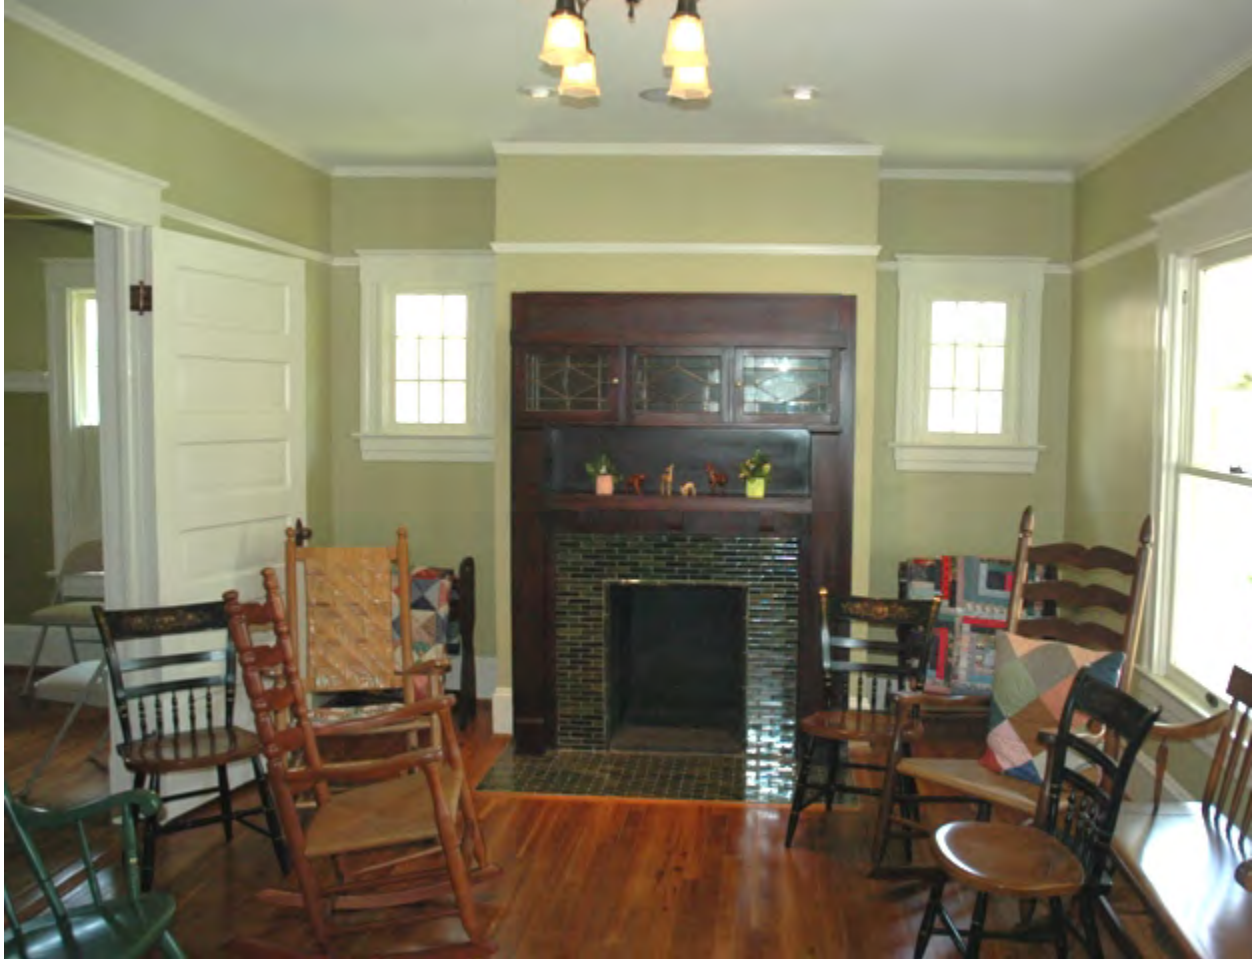
The interior of 1015 West Fourth Street is remarkably well preserved. The interior has retained an exemplary degree of integrity and is in good condition. The ca. 1905 layout of the interior remains virtually intact. All of the original significant interior architectural features have survived intact, and no significant interior alterations have occurred. 1015 West Fourth Street may very well contain the most complete and best preserved Craftsman Style home interior in the City of Charlotte.

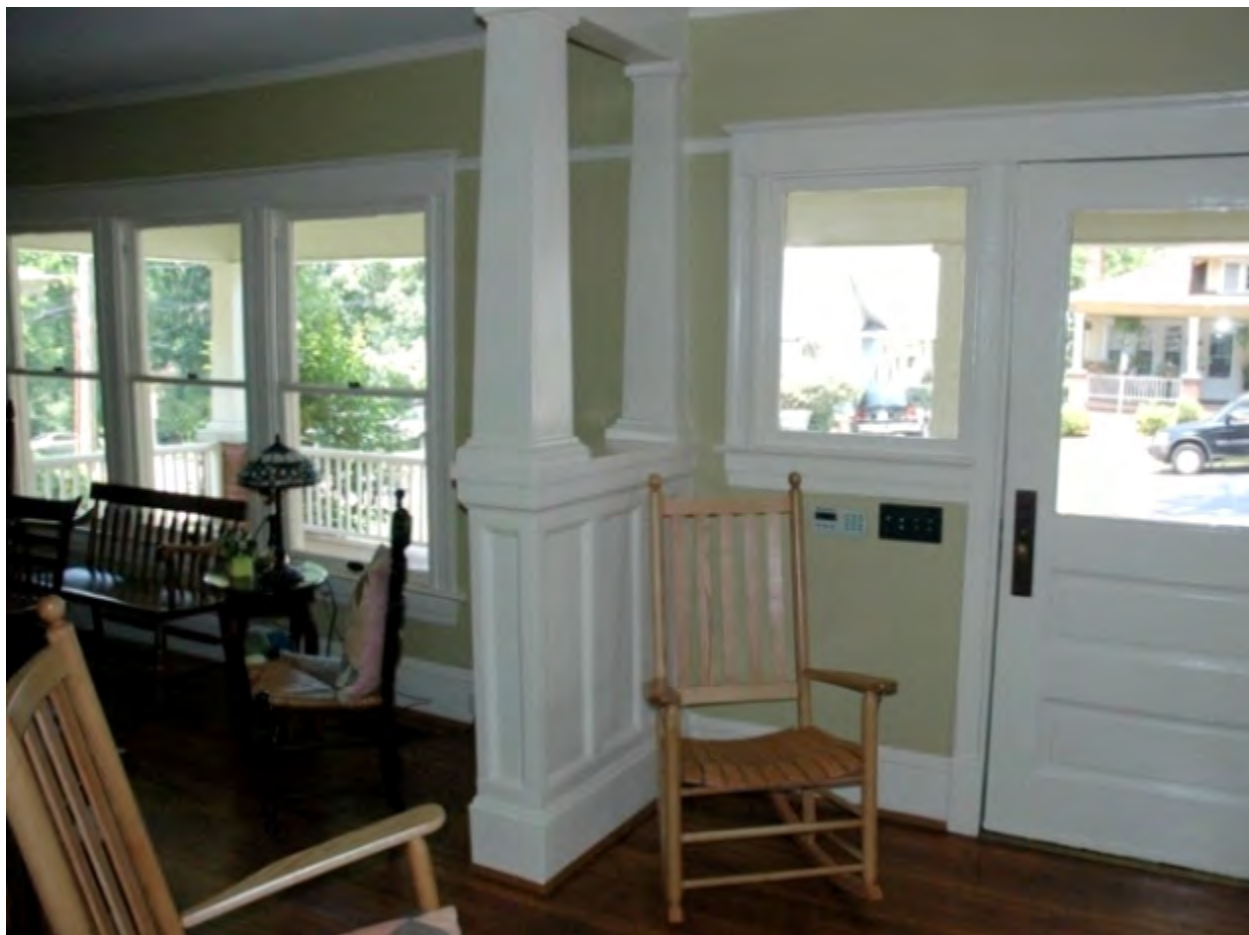
The interior of 1015 features a foyer separated from a front living room by portions of a wood panel half-height wall topped with tapered post and pilasters. The living room features a stained oak mantle surround that incorporates a three-door stained glass cabinet and a recessed mantle shelf supported by modillion brackets. The firebox surround and hearth are covered with original green glazed tile. The living room and foyer feature picture molding. All of the original rooms feature plaster walls and ceilings, narrow-board pine floors, tall baseboards with a molded cap, and molded crown trim. All windows and doors are bordered by fluted jam trim, and feature moulded casing caps. Door trim features starter blocks. The living room, foyer, and the house's two bedrooms all feature picture moulding.

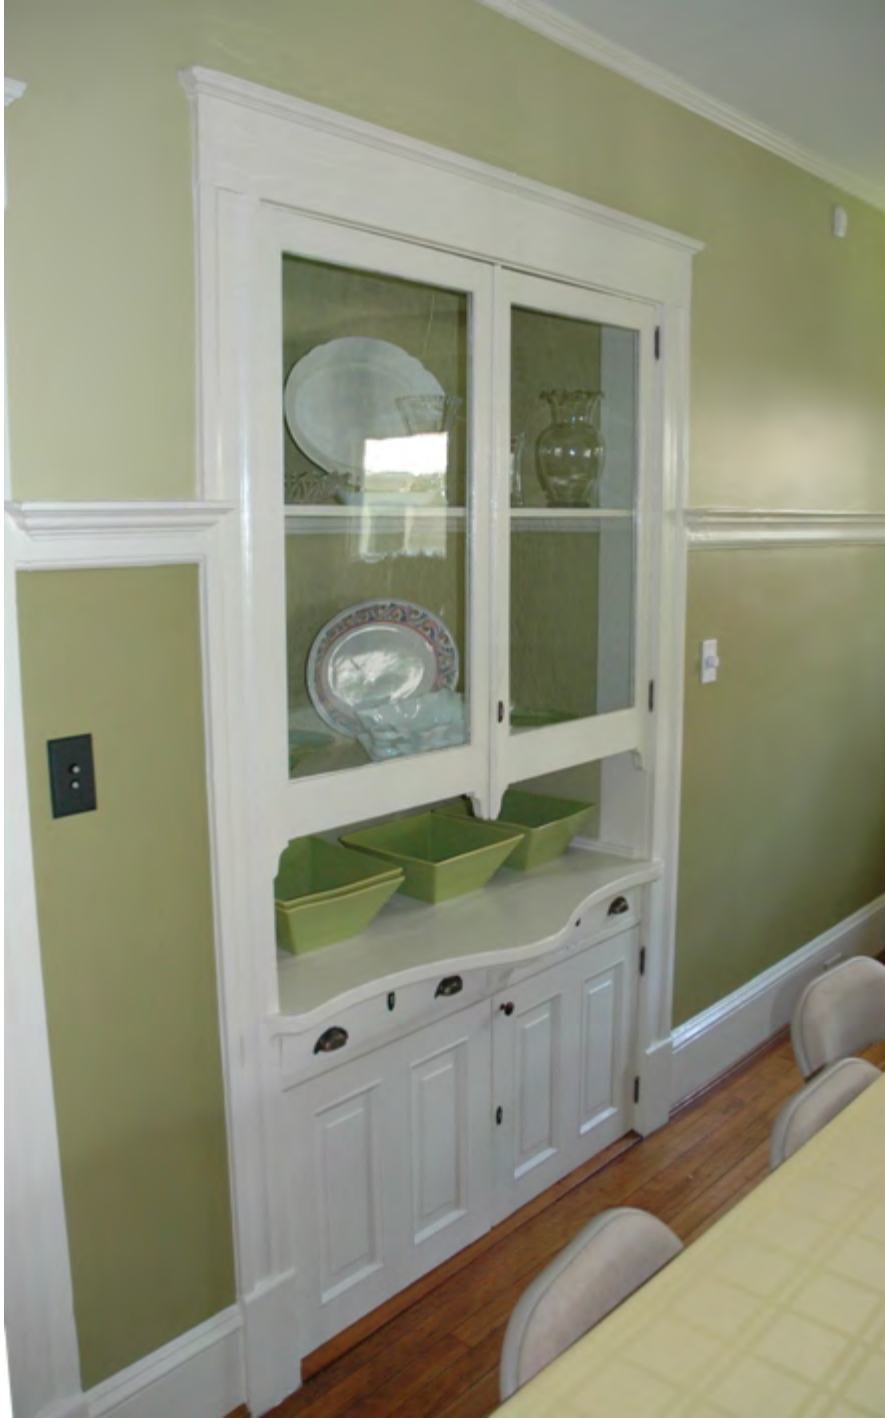
The dining room is accessed from the living via a pair of six-horizontal-panel doors. The house features numerous built-in cabinets. The largest is a built-in china cabinet in the dining room. It features a curved-sawn shelf, two raised panel doors and two glazed doors, and two drawers with original pulls. The cabinet is bordered by the same trim used around the doors. The dining room also features a plate rail that runs the perimeter of the room.
