# HVAC RENOVATIONS TO LIFT ACADEMY

Charlotte Mecklenburg Schools

Professional Engineering Associates, PA  
6451 B Morehead Rd  
Harrisburg, NC  
980-258-8035

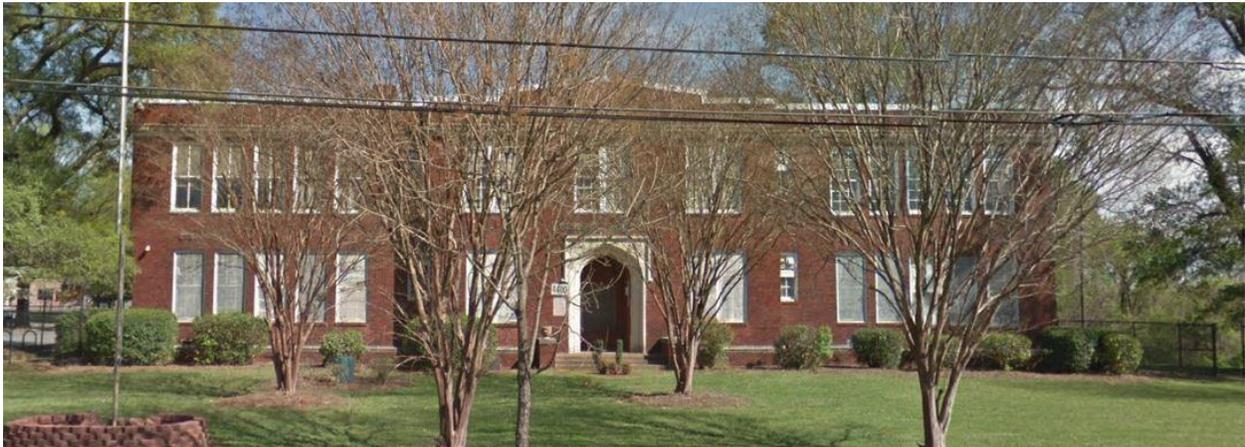
Existing Front Elevation

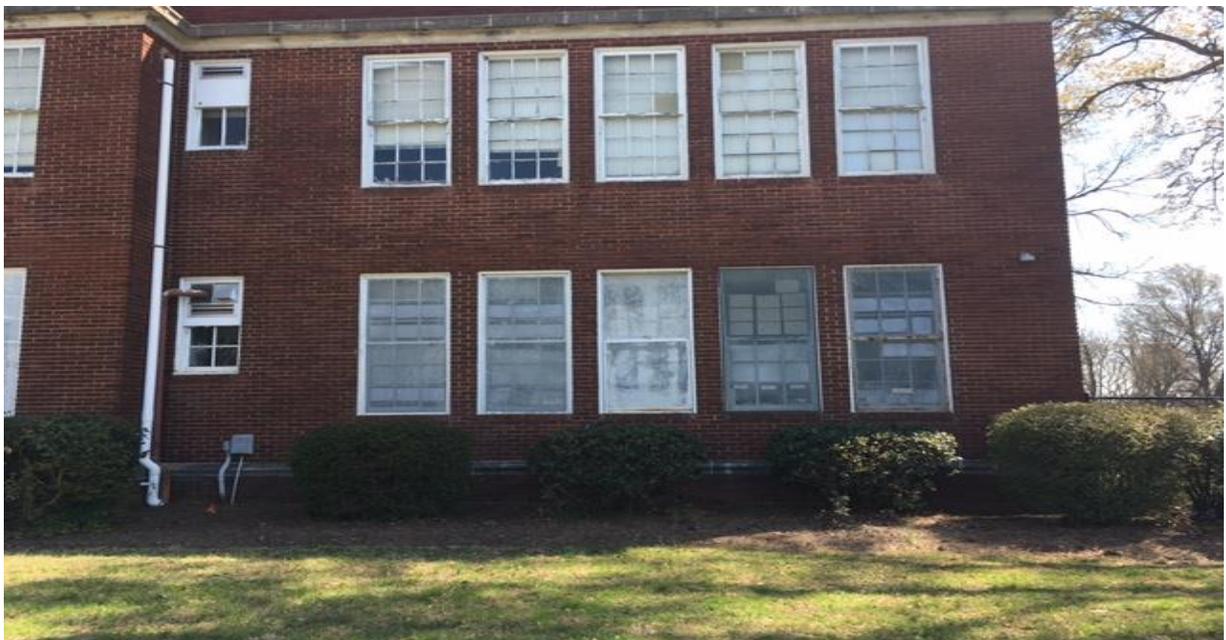
Existing First and Second Floor Windows (notice security screens on the first floor)

Our original design (and any currently shown on the plans) includes replacing a single exterior window in each classroom with a custom sized louver to match the existing openings. The louvers are to be white to match the existing window colors.

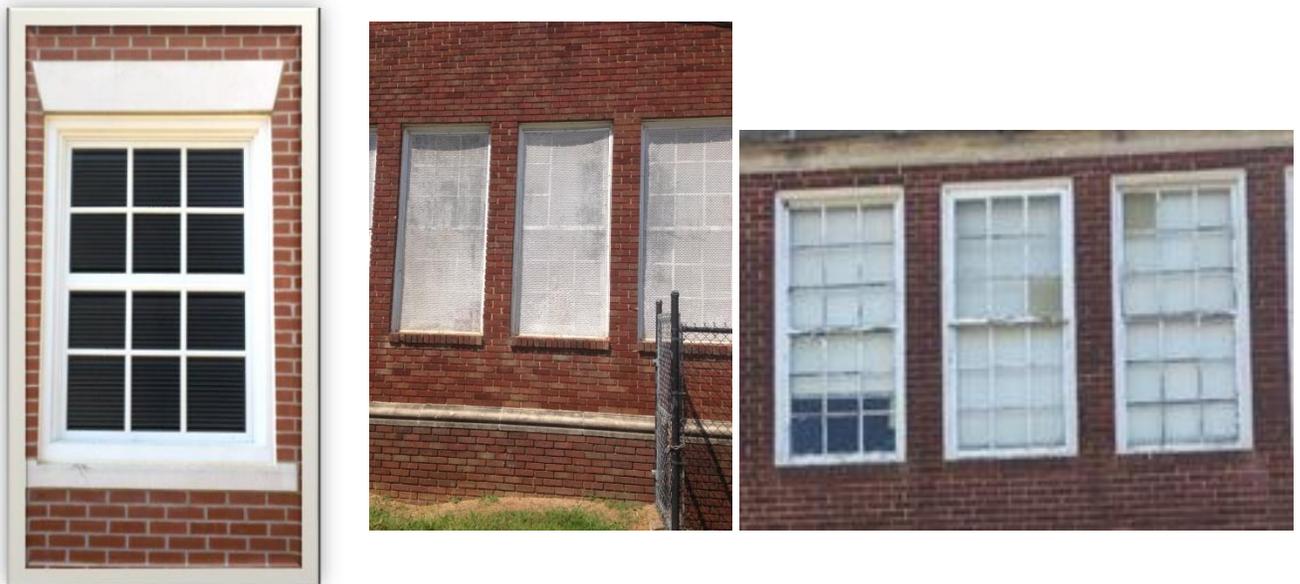
Example of Custom Window (Frame Only-No Glass) on left with Louver in Rear Compared to Existing First Floor Security Window (center) and Second Floor Window (right)

We are now proposing an alternative for review and approval that will more closely match the existing exterior. We can provide new custom aluminum window frames to match the existing windows, without glass and locate the louvers behind the frames; please see the accompanying pictures. The louver shown is bronze but can be white to simulate blinds.

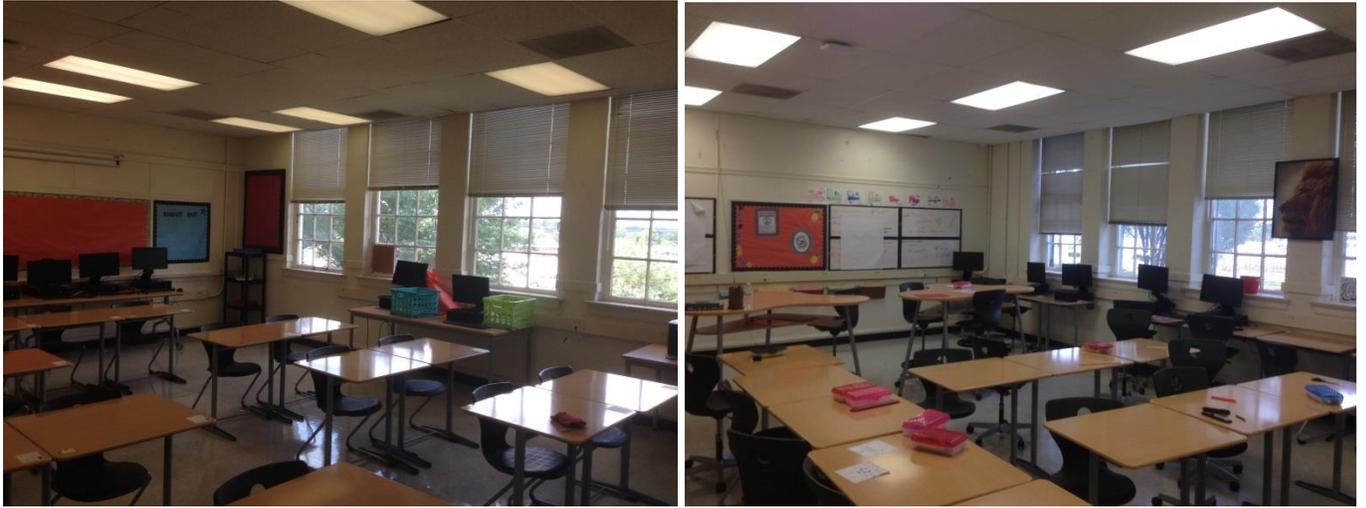
Typical Existing Classroom Interiors

Typical Existing Classrooms are very similar to most recent School designs, with the exception of the exterior windows. All existing classrooms have tile floors and acoustical tile ceilings.
