## Survey and Research Report on the Helper-Walley House

1. **Name and location of property:** The property known as the Helper-Walley House is located at 603 North Main Street in Davidson, North Carolina.
2. **Name, address, and telephone number of the current owner of the property:**

10. **Portion of the Property Recommended for Designation:** The exterior of the house, and the land associated with tax parcel.
11. **Prepared By:** Susan V. Mayer/September 13, 2019

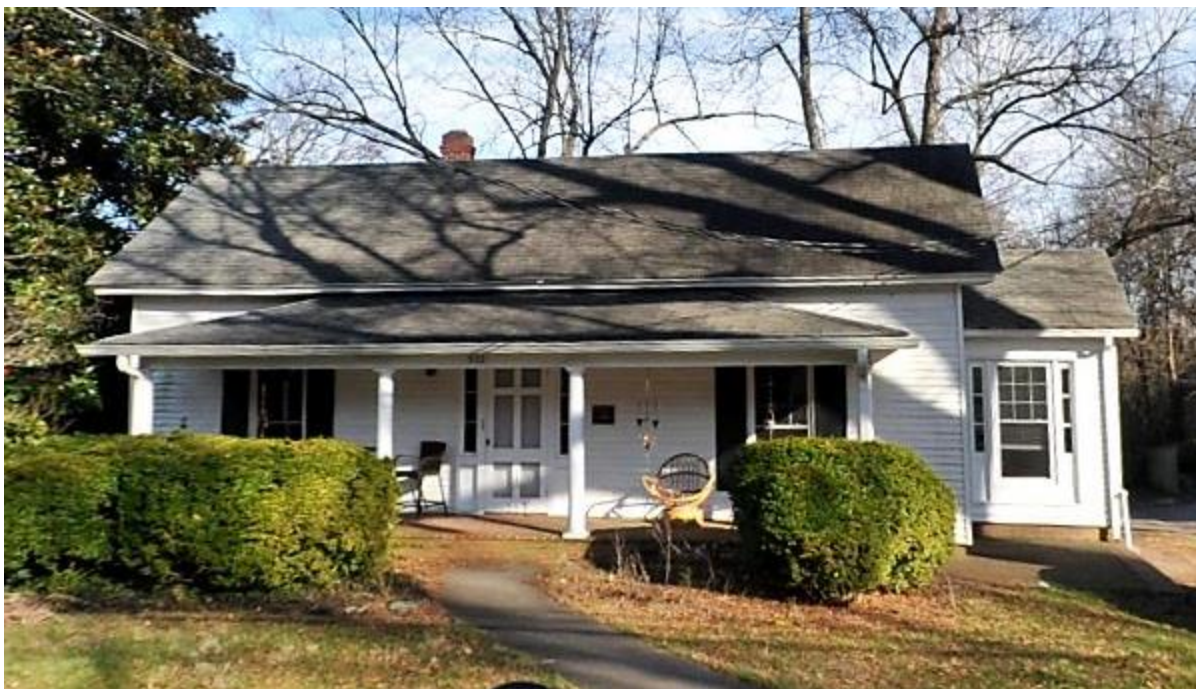
**Figure 1** The Isaac Johnston House, just down the street from the Helper-Walley House at 532 North Main Street, is the oldest extant (and only other known) hall-and-parlor house in Davidson.

Pre-1900s houses in Davidson fall under two categories—either they have remained relatively unchanged from their original style of construction, or the houses have been so altered from their original state that they no longer retain architectural integrity. The antebellum Isaac Johnston House, as seen above, appears from the street much like it did a century ago. The same may be said for the ca. 1898 Currie-Adams House, an I-house at 525 North Main Street. In comparison, the ca. 1890 Cranford-Kneedler House next door to the Helper-Walley House at 609 North Main Street was bricked with a new full-height front porch added to the original frame house ca. 1950.

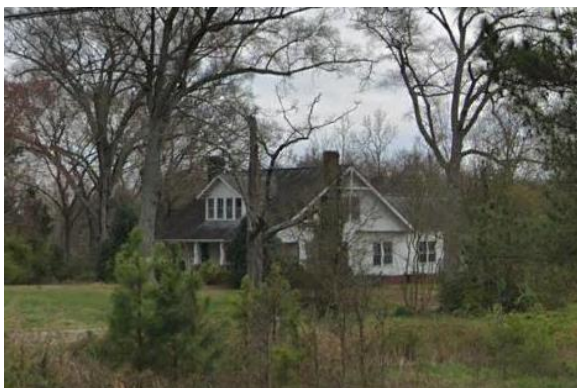
**Figure 2** The Jesse and Martha K. Washam Farmhouse was originally built as a hall-and-parlor tenant house. In the 1920s, the Washams remodeled it to the Craftsman style. The original portion of the house is visible in the bay behind the chimney.<sup>3</sup>

The Helper-Walley House was not the only residence around Davidson remodeled in the Craftsman style. The Jesse and Mary K. Washam Farmhouse on rural Davidson-Concord Road also serves as an example of this transition in architectural style. Built as a hall-and-parlor tenant house, the Washam Farmhouse was renovated and expanded in 1922 to a Craftsman bungalow that practically obscured the original house. The Helper-Walley House is a much less extreme renovation, as the hall-and-parlor form was retained while architectural detailing reflective of the Craftsman style was applied. When Harlan remodeled the house sometime in the early 1920s, he made many changes to the original house as evidenced by the extant details and compared to hall-and-parlor houses contemporary to the Helper-Walley House. The roofline was altered—hall-and-parlor houses have a front porch independent from the roof structure over the house, whereas the Helper-Walley House features an engaged porch. While the paired porch columns are not

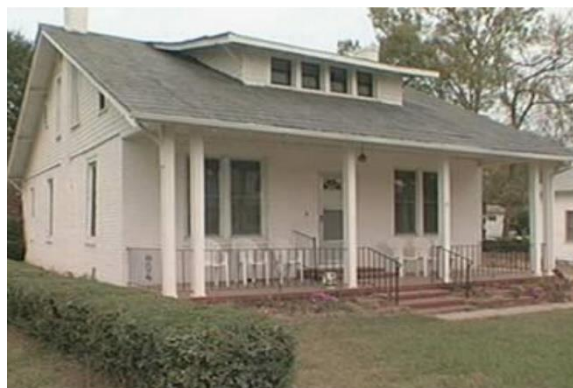
**Figure 3** The Ralph Johnson House as it appeared in 2006. Today, the Craftsman-style duplex appears even more like the Helper-Walley House, as the middle columns are now paired, and the railing is wood rather than wrought iron.<sup>4</sup>

common in the Craftsman style, this detail may also be seen in houses of this period, such as the Ralph Johnson House at 115 Mock Circle in Davidson.

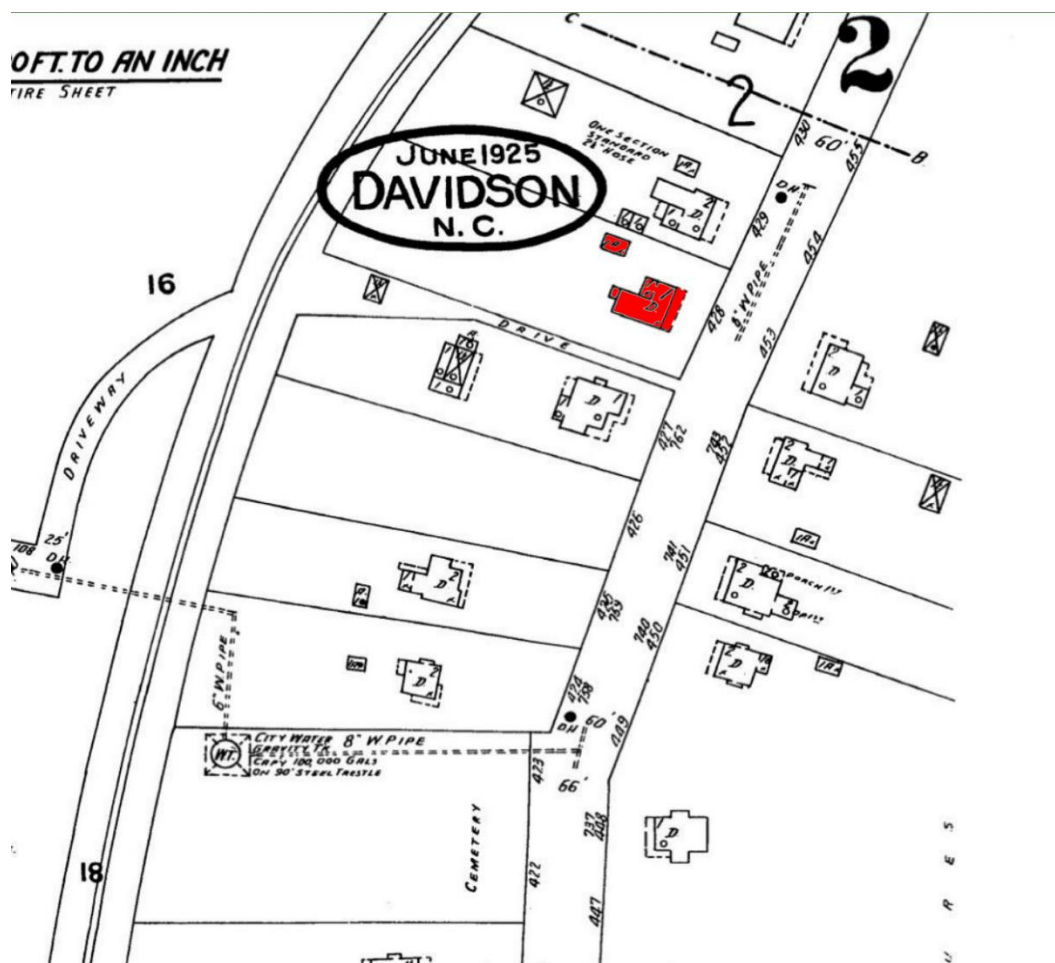
**Figure 4** The Helper-Walley House (red) on a 1925 Sanborn map of Davidson. By this point, the back wing addition was completed. Sanborn Fire Insurance Map Company, Davidson, Mecklenburg County, North Carolina, June 1925 (New York: Sanborn Map & Publishing Company, 1925), <http://sanborn1.proquest.com/map.php?m=330537>, accessed July 10, 2019.

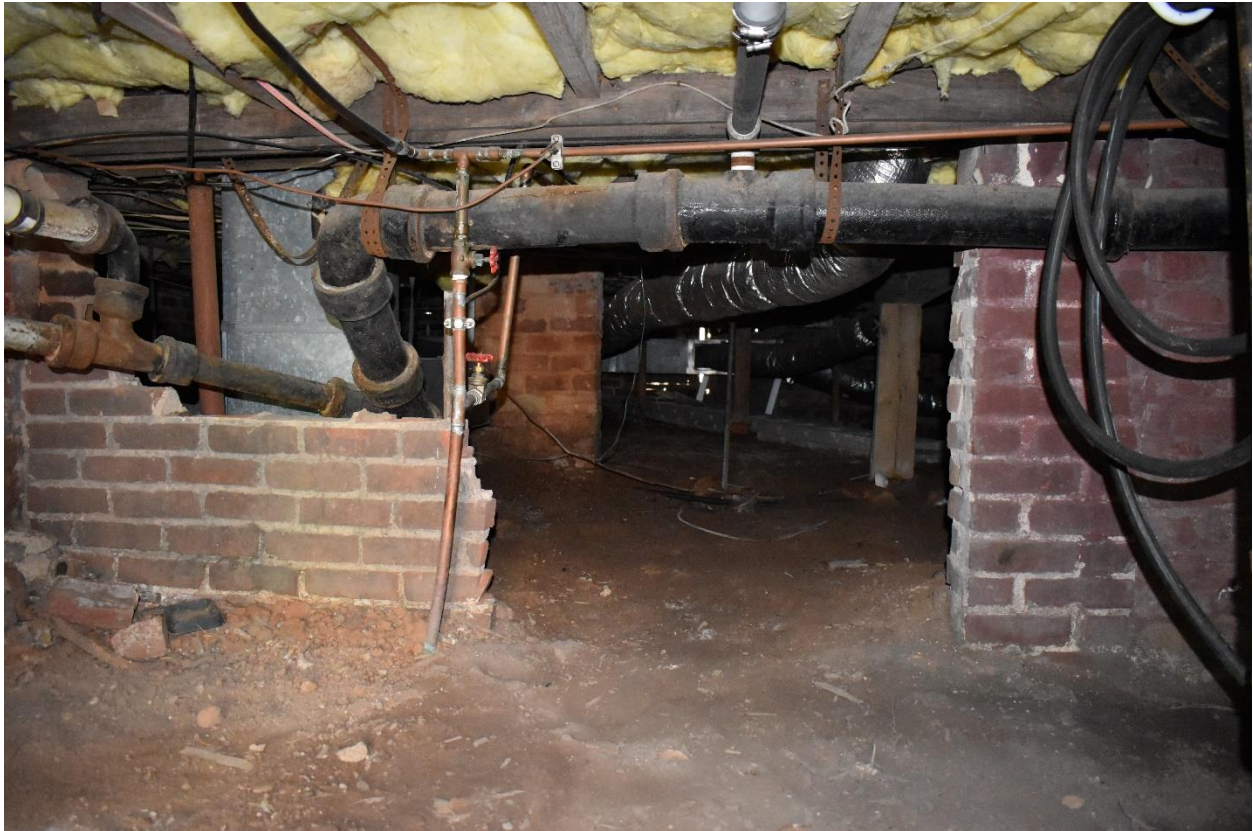
**Figure 6** Under the Helper-Walley House, the various phases of construction are visible. In the background, you can see the foundation of a chimney that was formerly in the current dining room. In the foreground are the brick piers and remaining walls from the ca. 1925 addition.

Many materials and architectural details are featured consistently throughout the house. The entirety of the house, excepting the wood shake gables of the original hall-and-parlor house, is covered in overlapping wood siding. All windows are 1-over-1 double-hung wood sash. The foundation of the Helper-Walley House consists of masonry piers with an exterior wall. The ca. 1896-1897 and ca. 1925 portions are brick, and the ca. 1950

addition utilizes concrete masonry units (CMU), all painted white on the exterior with regularly spaced grille vents. Gutters have been installed on the eaves.

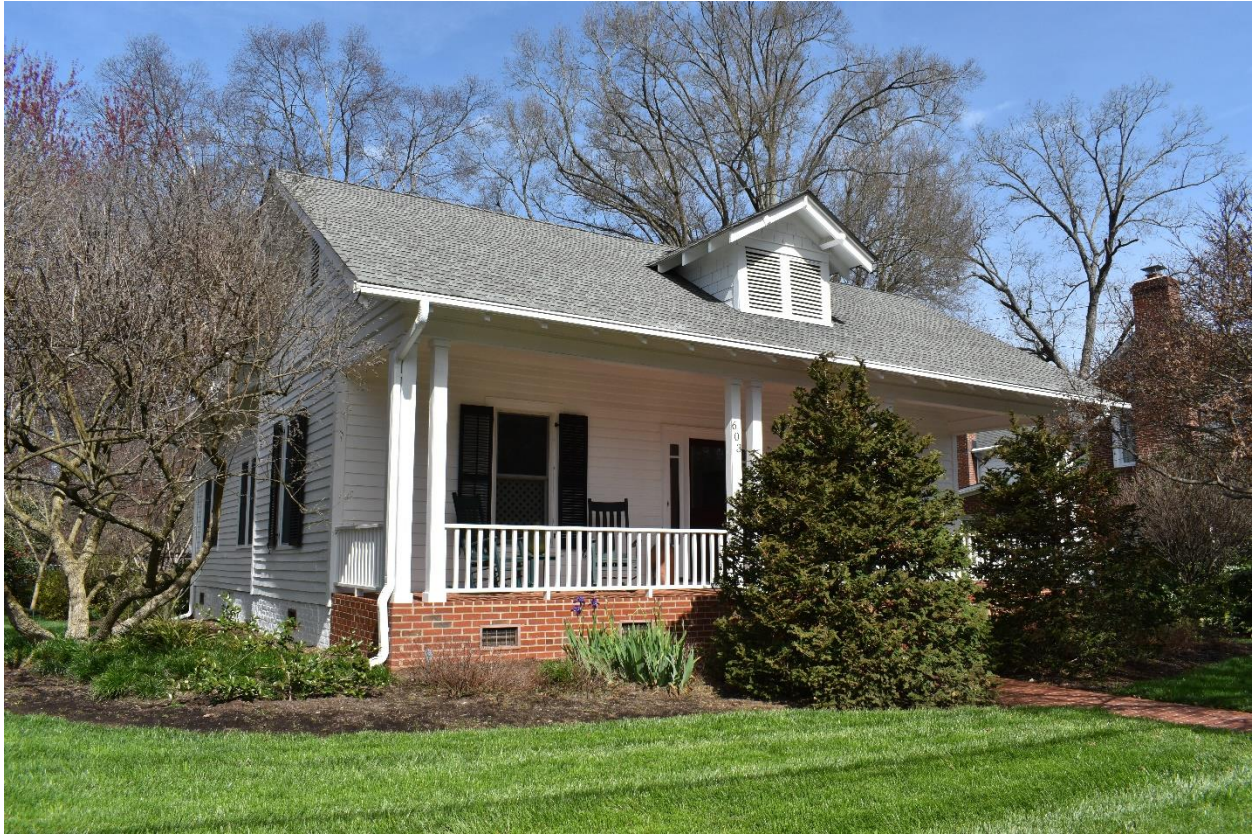
The front elevation of the Helper-Walley House faces east toward North Main Street and is three bays wide, with an engaged full-width front porch with paired columns and simple vertical railing dominating the elevation. Brick steps lead up to a raised brick porch with regularly-spaced metal grille vents—the previous wood porch was replaced around 2010 due to age and deterioration. A gabled dormer, added in 1925, with exposed rafter tails, paired louvered panels, and wood shake shingle siding is centered on the elevation. The half-light wood front door and sidelights are flanked by 1-over-1 double-hung wood sash windows, which feature louvered wood shutters. Exposed rafter tails extend under the eaves, and the ceiling of the front porch is bead board.

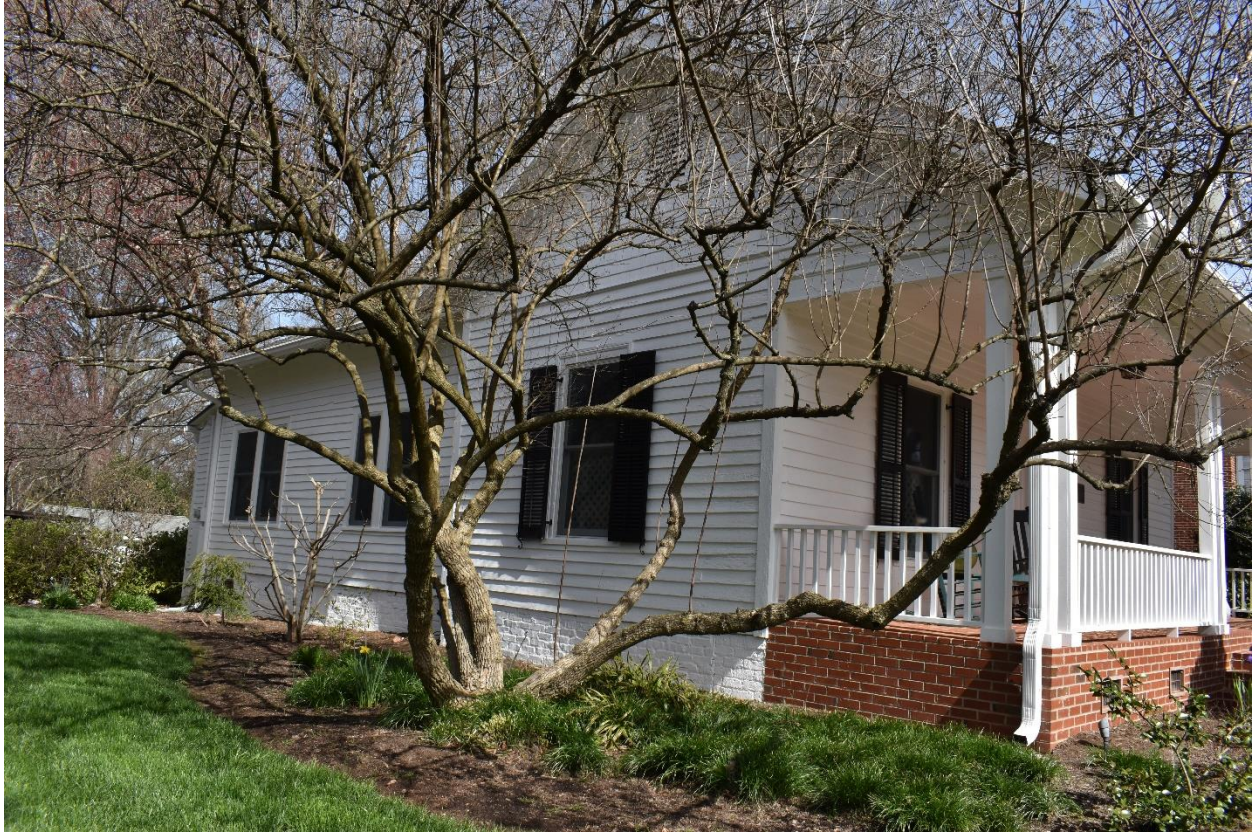
The south elevation of the Helper-Walley House is five bays wide and reveals the various expansions made to the house over the years. The second bay is the original portion of the hall-and-parlor house, with the front bay being the engaged porch built around 1925. A rectangular wood louver is centered in the gable. Also added at this time was a gabled wing extending back from the left side of the house, which comprises the third and fourth bays. The fifth bay is the small shed addition made ca. 1950.

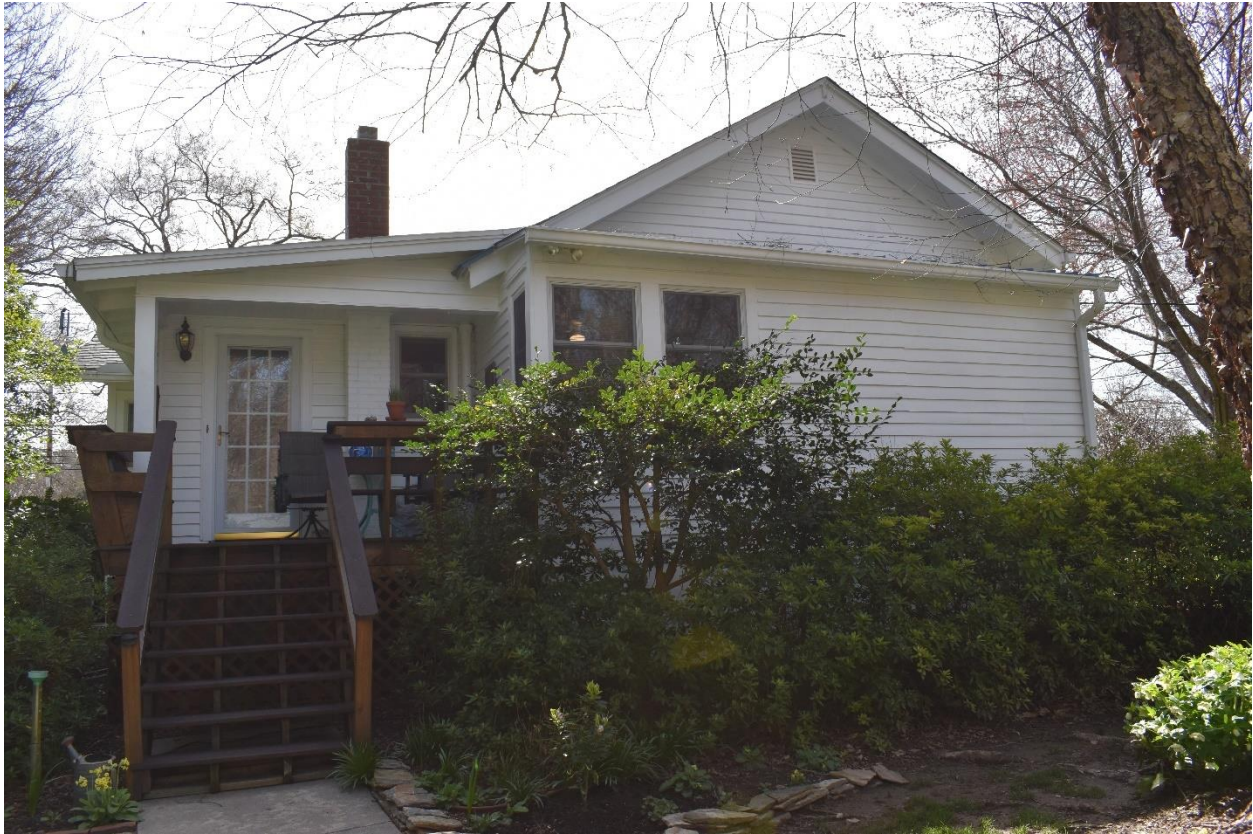
The rear elevation of the house is comprised of the additions made to the original hall-and-parlor portion of the house. This elevation is two bays wide and one bay deep. Since the property slopes downward from the street, this portion of the house sits higher from the ground than the front elevation. The first bay is a shed addition made ca. 1950 which includes a French door, an extant narrow brick chimney no longer in use, and a small 1-over-1 window. A shallow porch is ceilinged with bead board wood paneling. A wood deck with seating built into the railing fills the width and depth of this bay. The gabled ca. 1925 addition and a small shed addition from ca. 1950 comprise the second bay. Corner 1-over-1 windows are placed at the left side of the shed portion, with a single window on the side facing the porch and a pair of windows on the back elevation. The eave of the ca. 1950

shed addition continues the exposed rafter tail detailing of the older portion of the house.

The gable, which is sheathed in wood siding, has a centered rectangular wood louver.

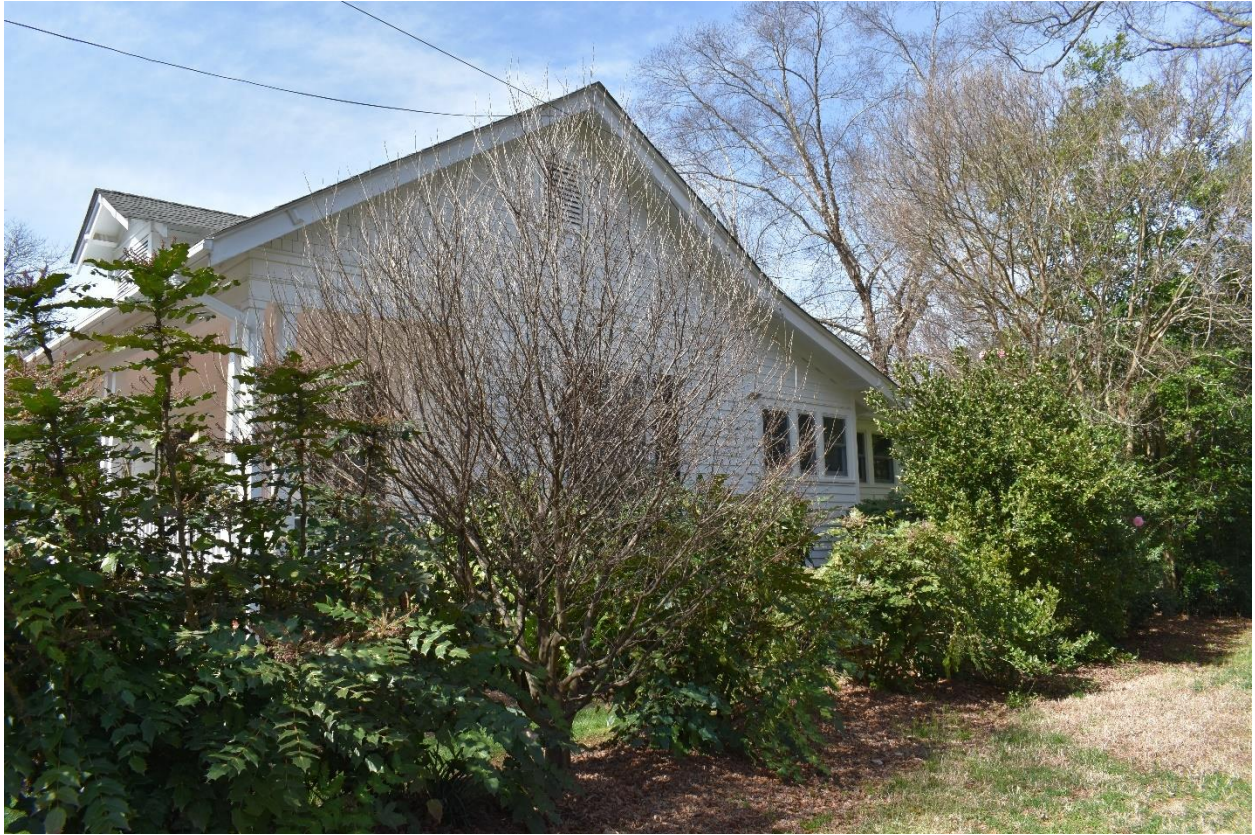
The north elevation of the Helper-Walley House is four bays wide and one bay deep. The front two bays are identical to that of the south elevation, with the first bay being the porch and the second a single 1-over-1 window flanked by wood shutters; the gable also is sheathed in wood shake shingles with a centered rectangular wood louver. The third bay is the former porch which was enclosed ca. 1950 to make the kitchen. It features three grouped windows which fill the space. These three front bays are built atop brick piers filled in between with brick, whereas the fourth bay rests upon CMU walls. This bay, which steps back from main mass of the house, has a pair of windows centered in the elevation.
