## **Charlotte-Mecklenburg Historic Landmarks Commission**

### **Historic Landmarks Department Staff Report – January 12, 2026**

| <b>Landmark Name:</b> | <b>The Fidler House</b> |

**FIDLER HOUSE ADDITION / RENOVATION**  
**21112 Catawba Ave**  
**Cornelius, NC 28031**

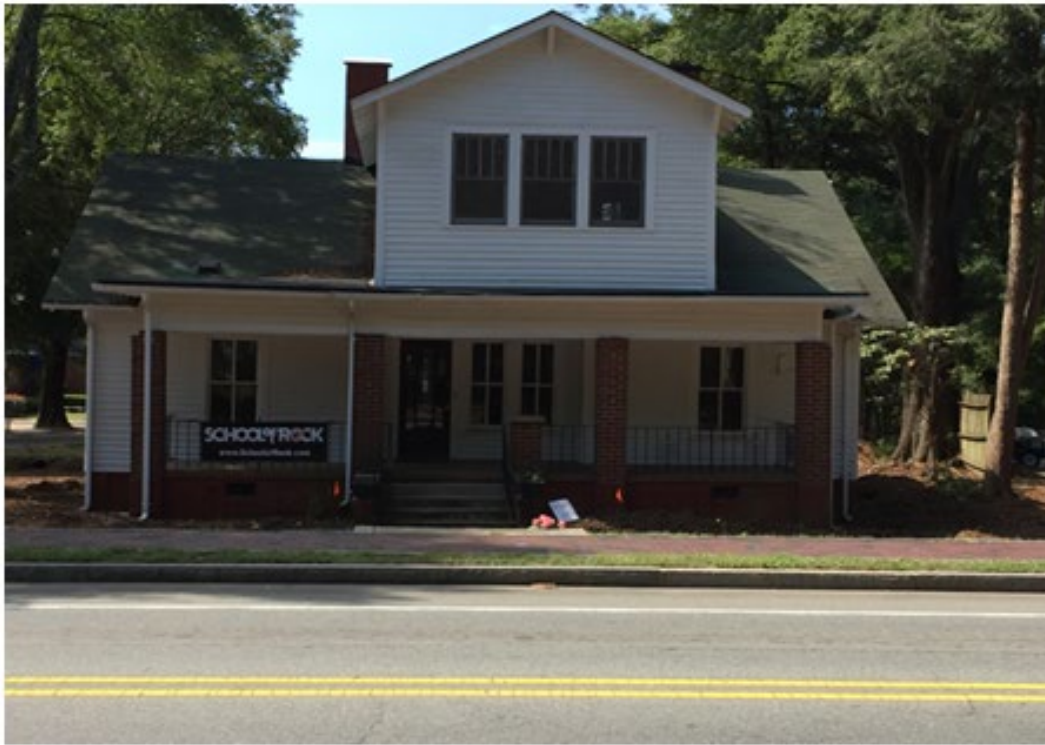
EXISTING FRONT - DOMINANT FEATURE OF OVERSIZED DORMER

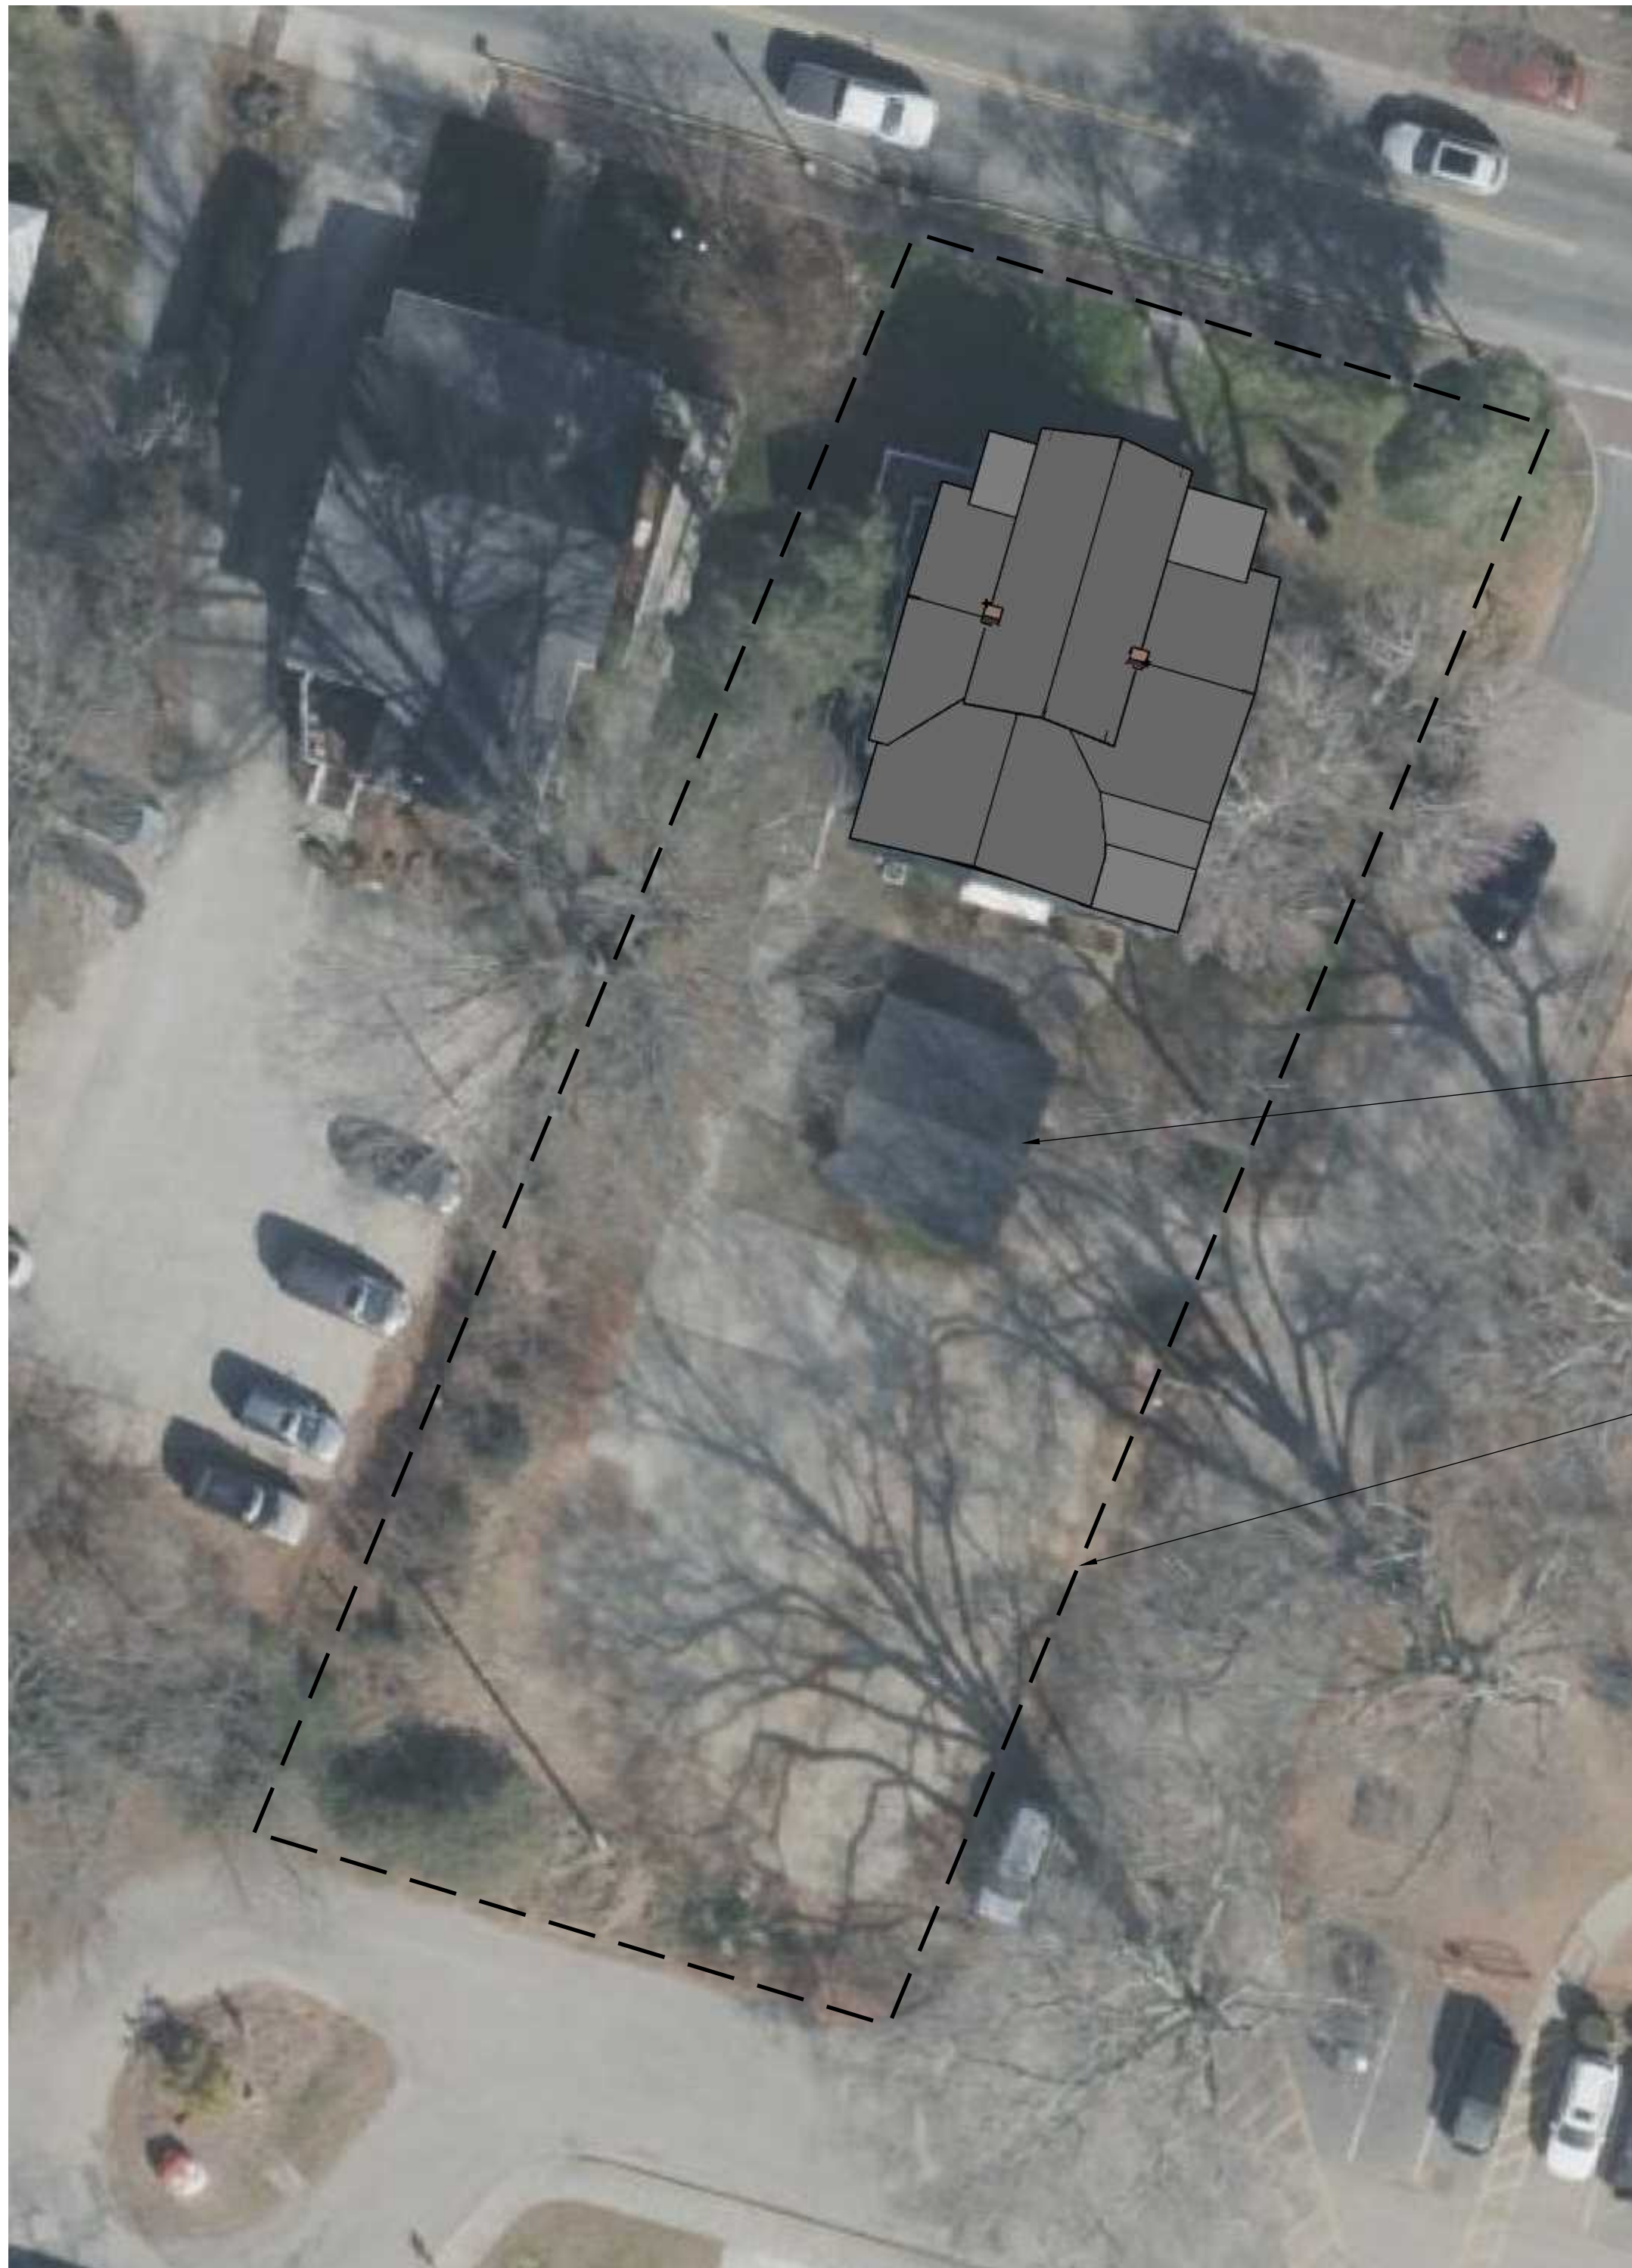
1  
A.01  
EXIST. SITE PLAN AERIAL  
NTS

EXISTING GARAGE TO  
BE REMOVED

SITE BOUNDARY

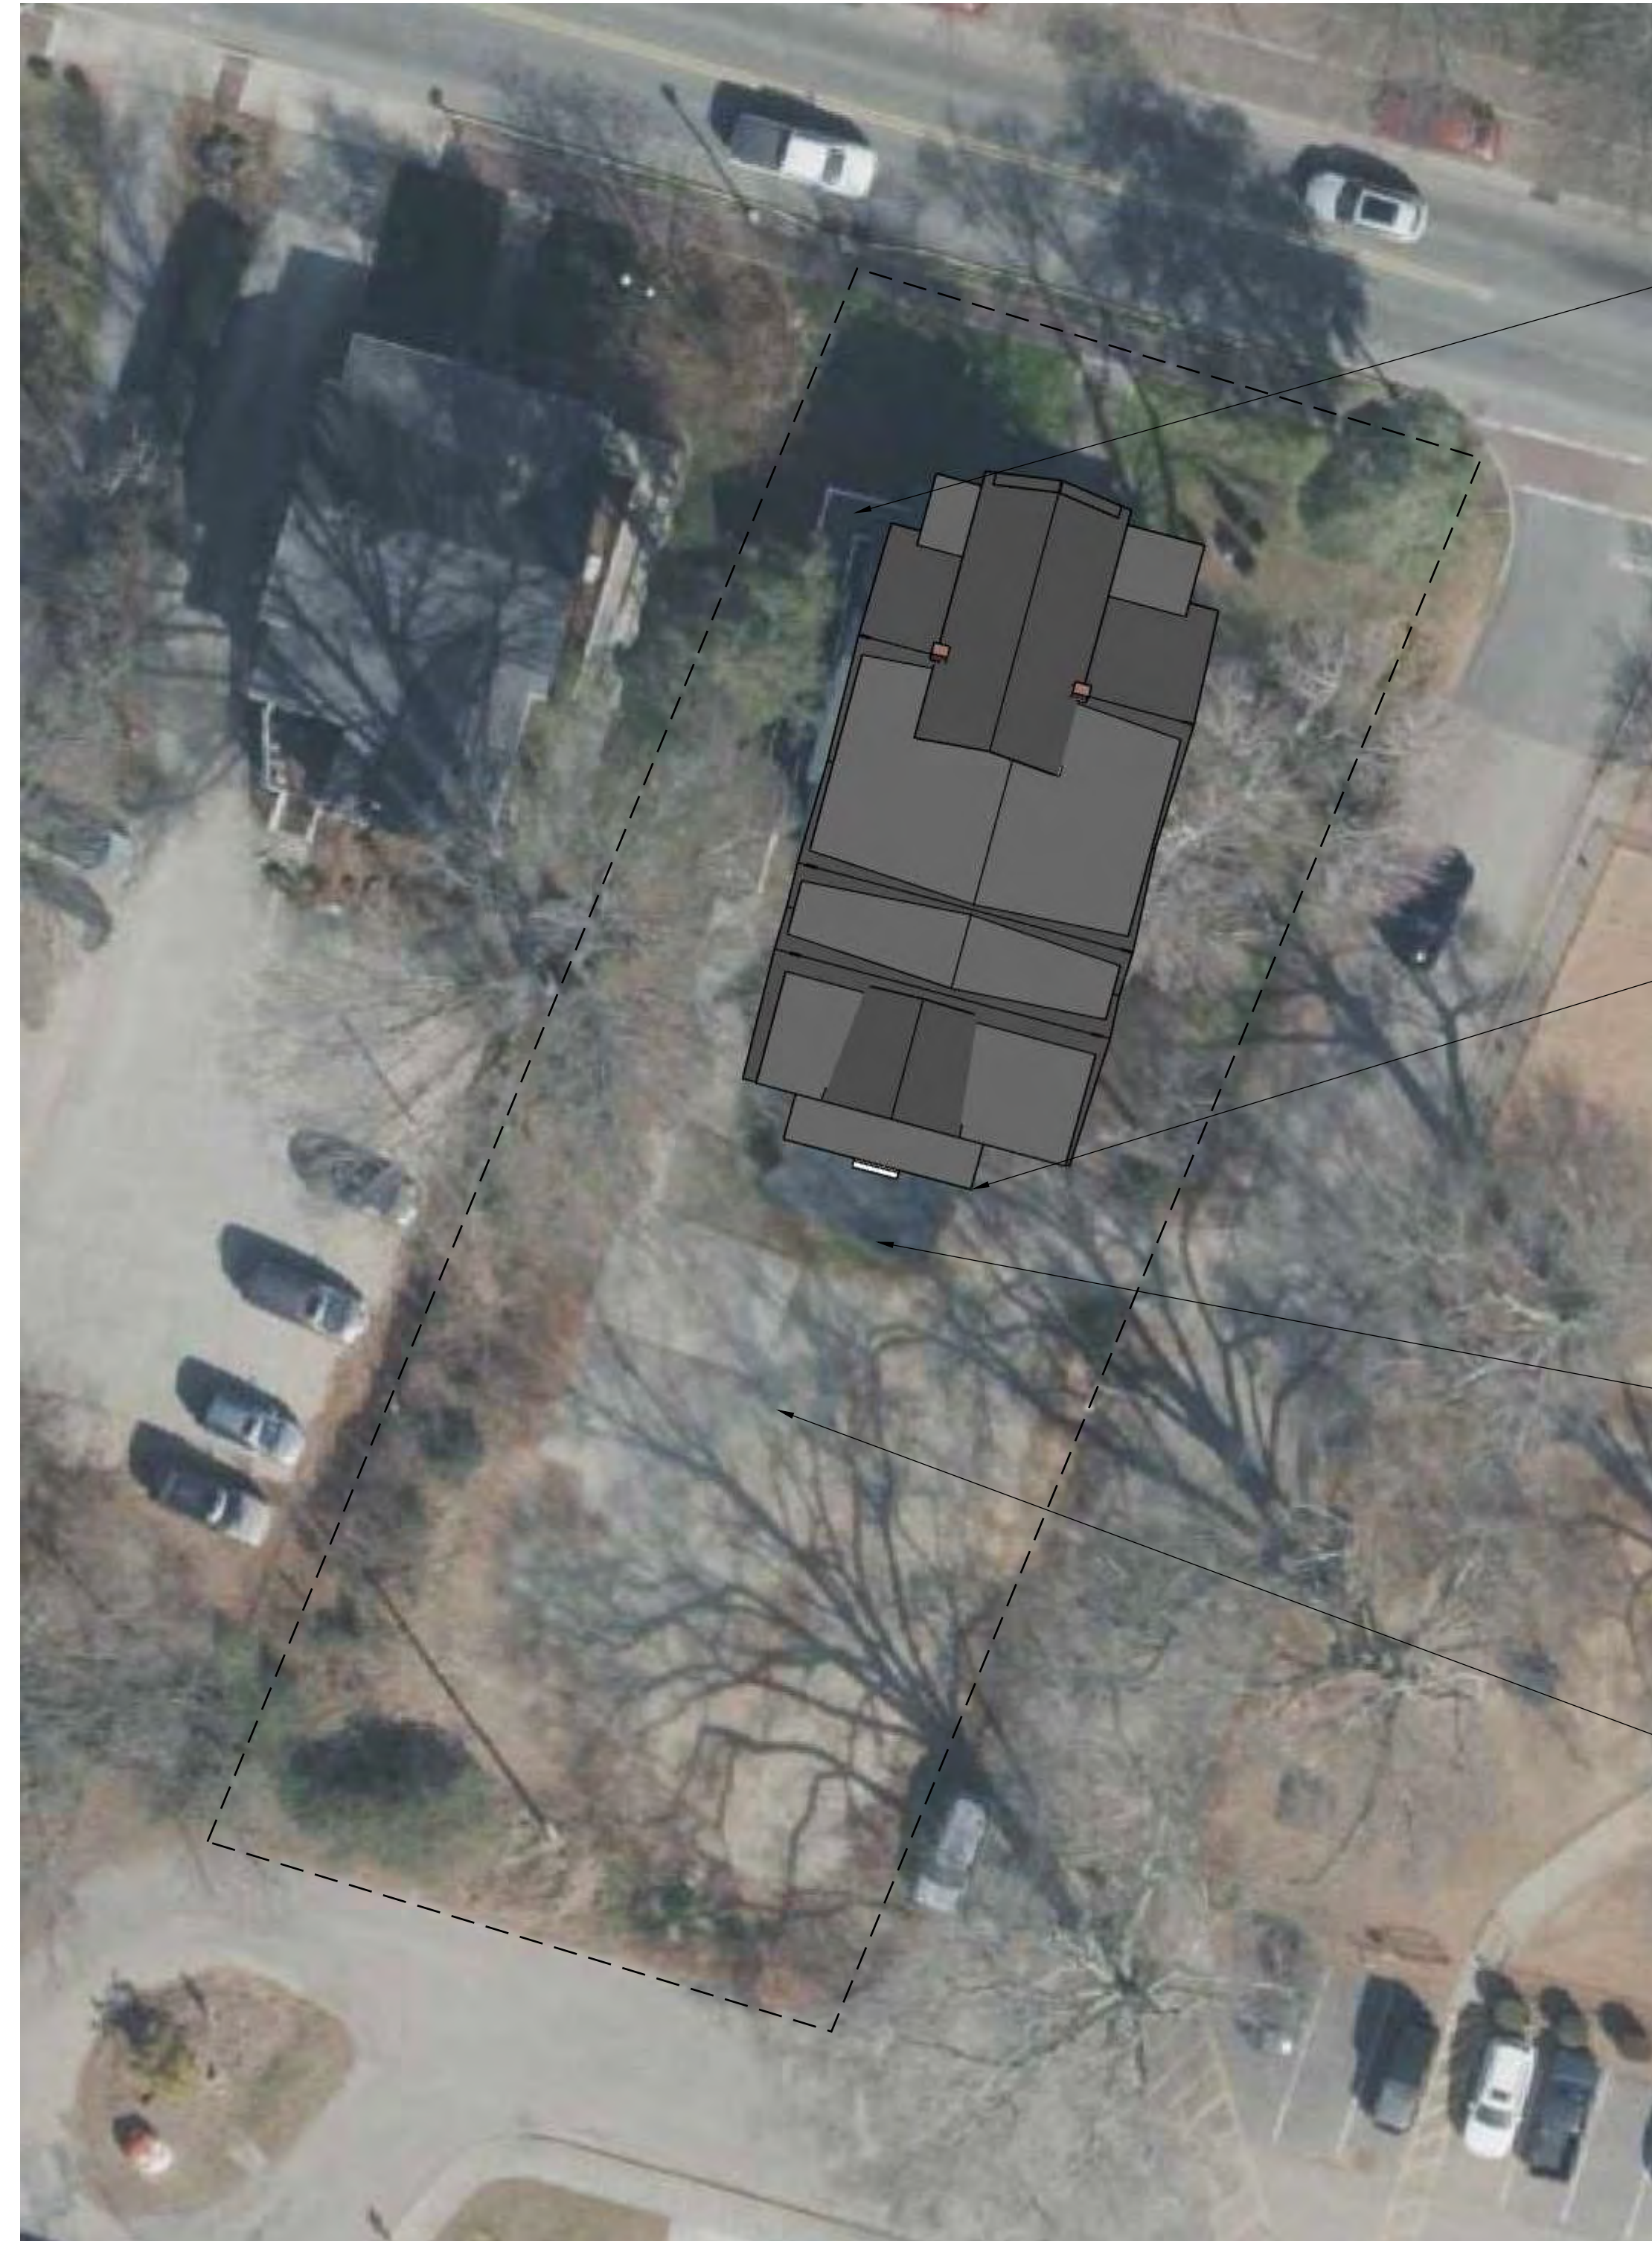
2  
A.01  
PROPOSED SITE PLAN AERIAL  
NTS

EXISTING RAMP TO BE  
REMOVED

NOTE: ADDITION DOES NOT  
EXTEND BEYOND WHERE THE  
EXISTING GARAGE IS LOCATED

REMOVAL OF THE  
GARAGE ALLOWS FOR  
EASIER ACCESS TO THE  
SOUTH ENTRY

EXISTING PARKING WILL  
NOT BE IMPACTED  
BY THE ADDITION

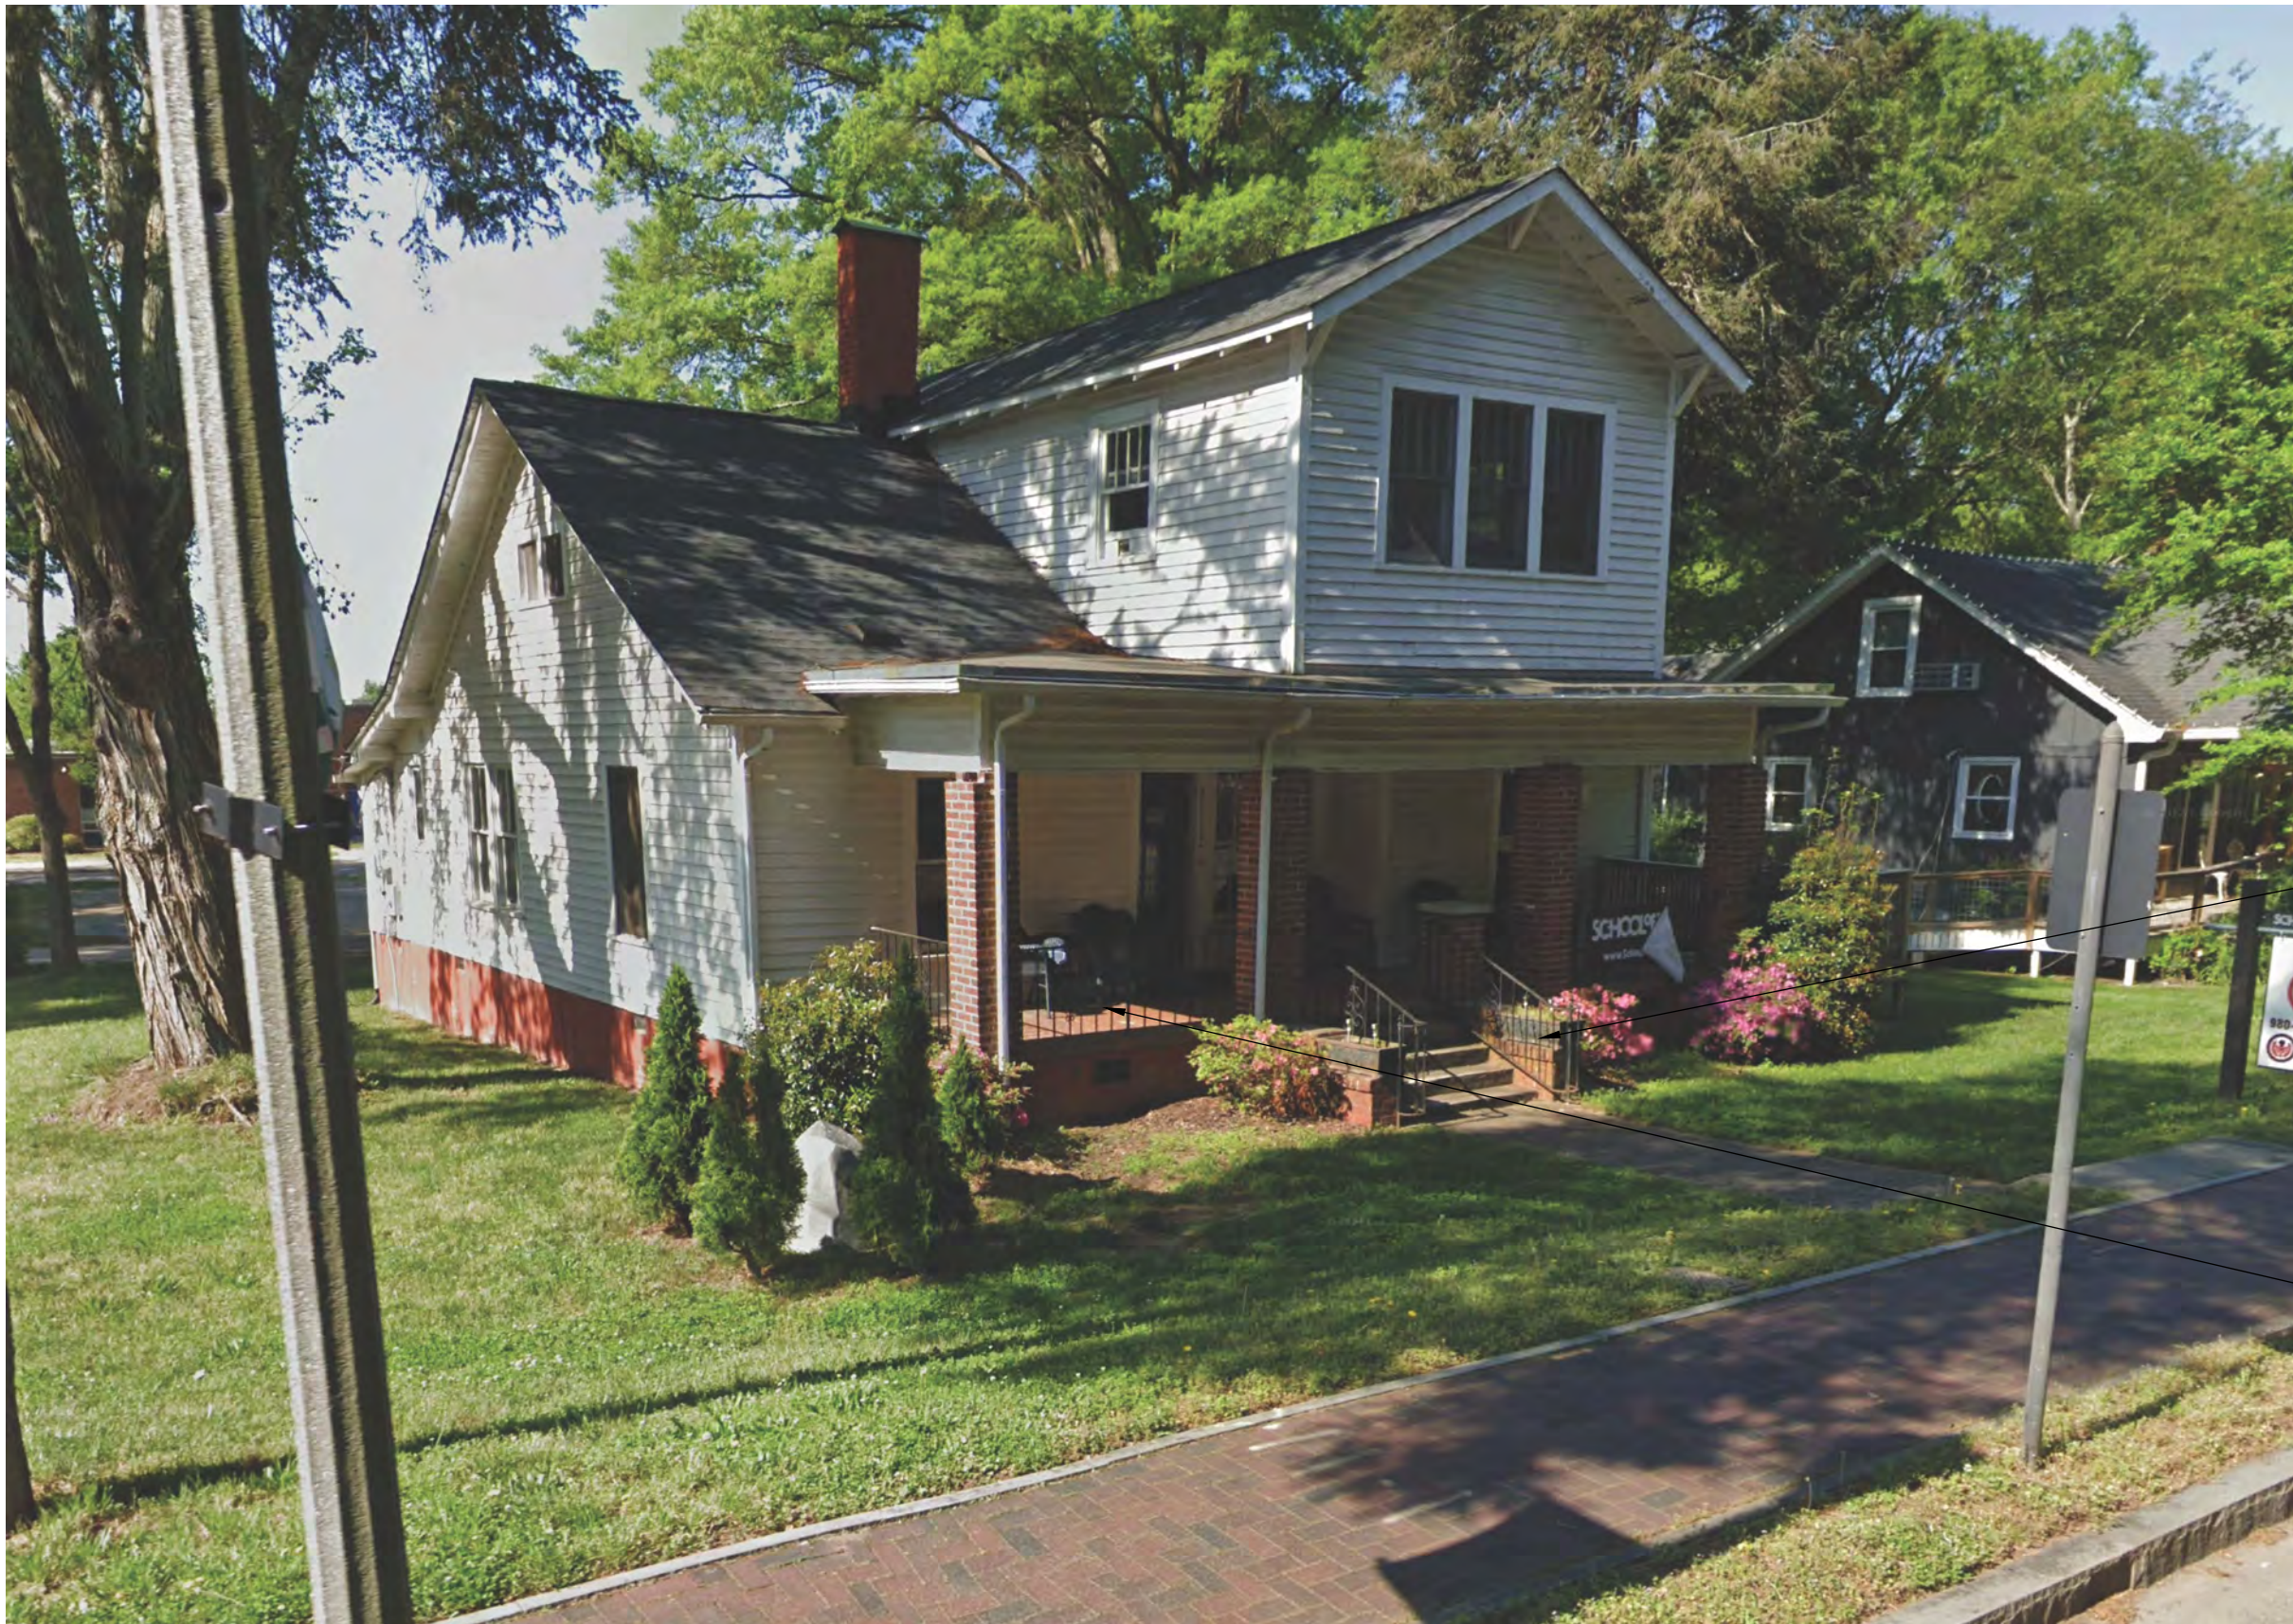
GOOGLE IMAGE - NE VIEW

STAIR RAILINGS AND WING WALLS TO REMAIN

PORCH RAILINGS TO REMAIN AS IS

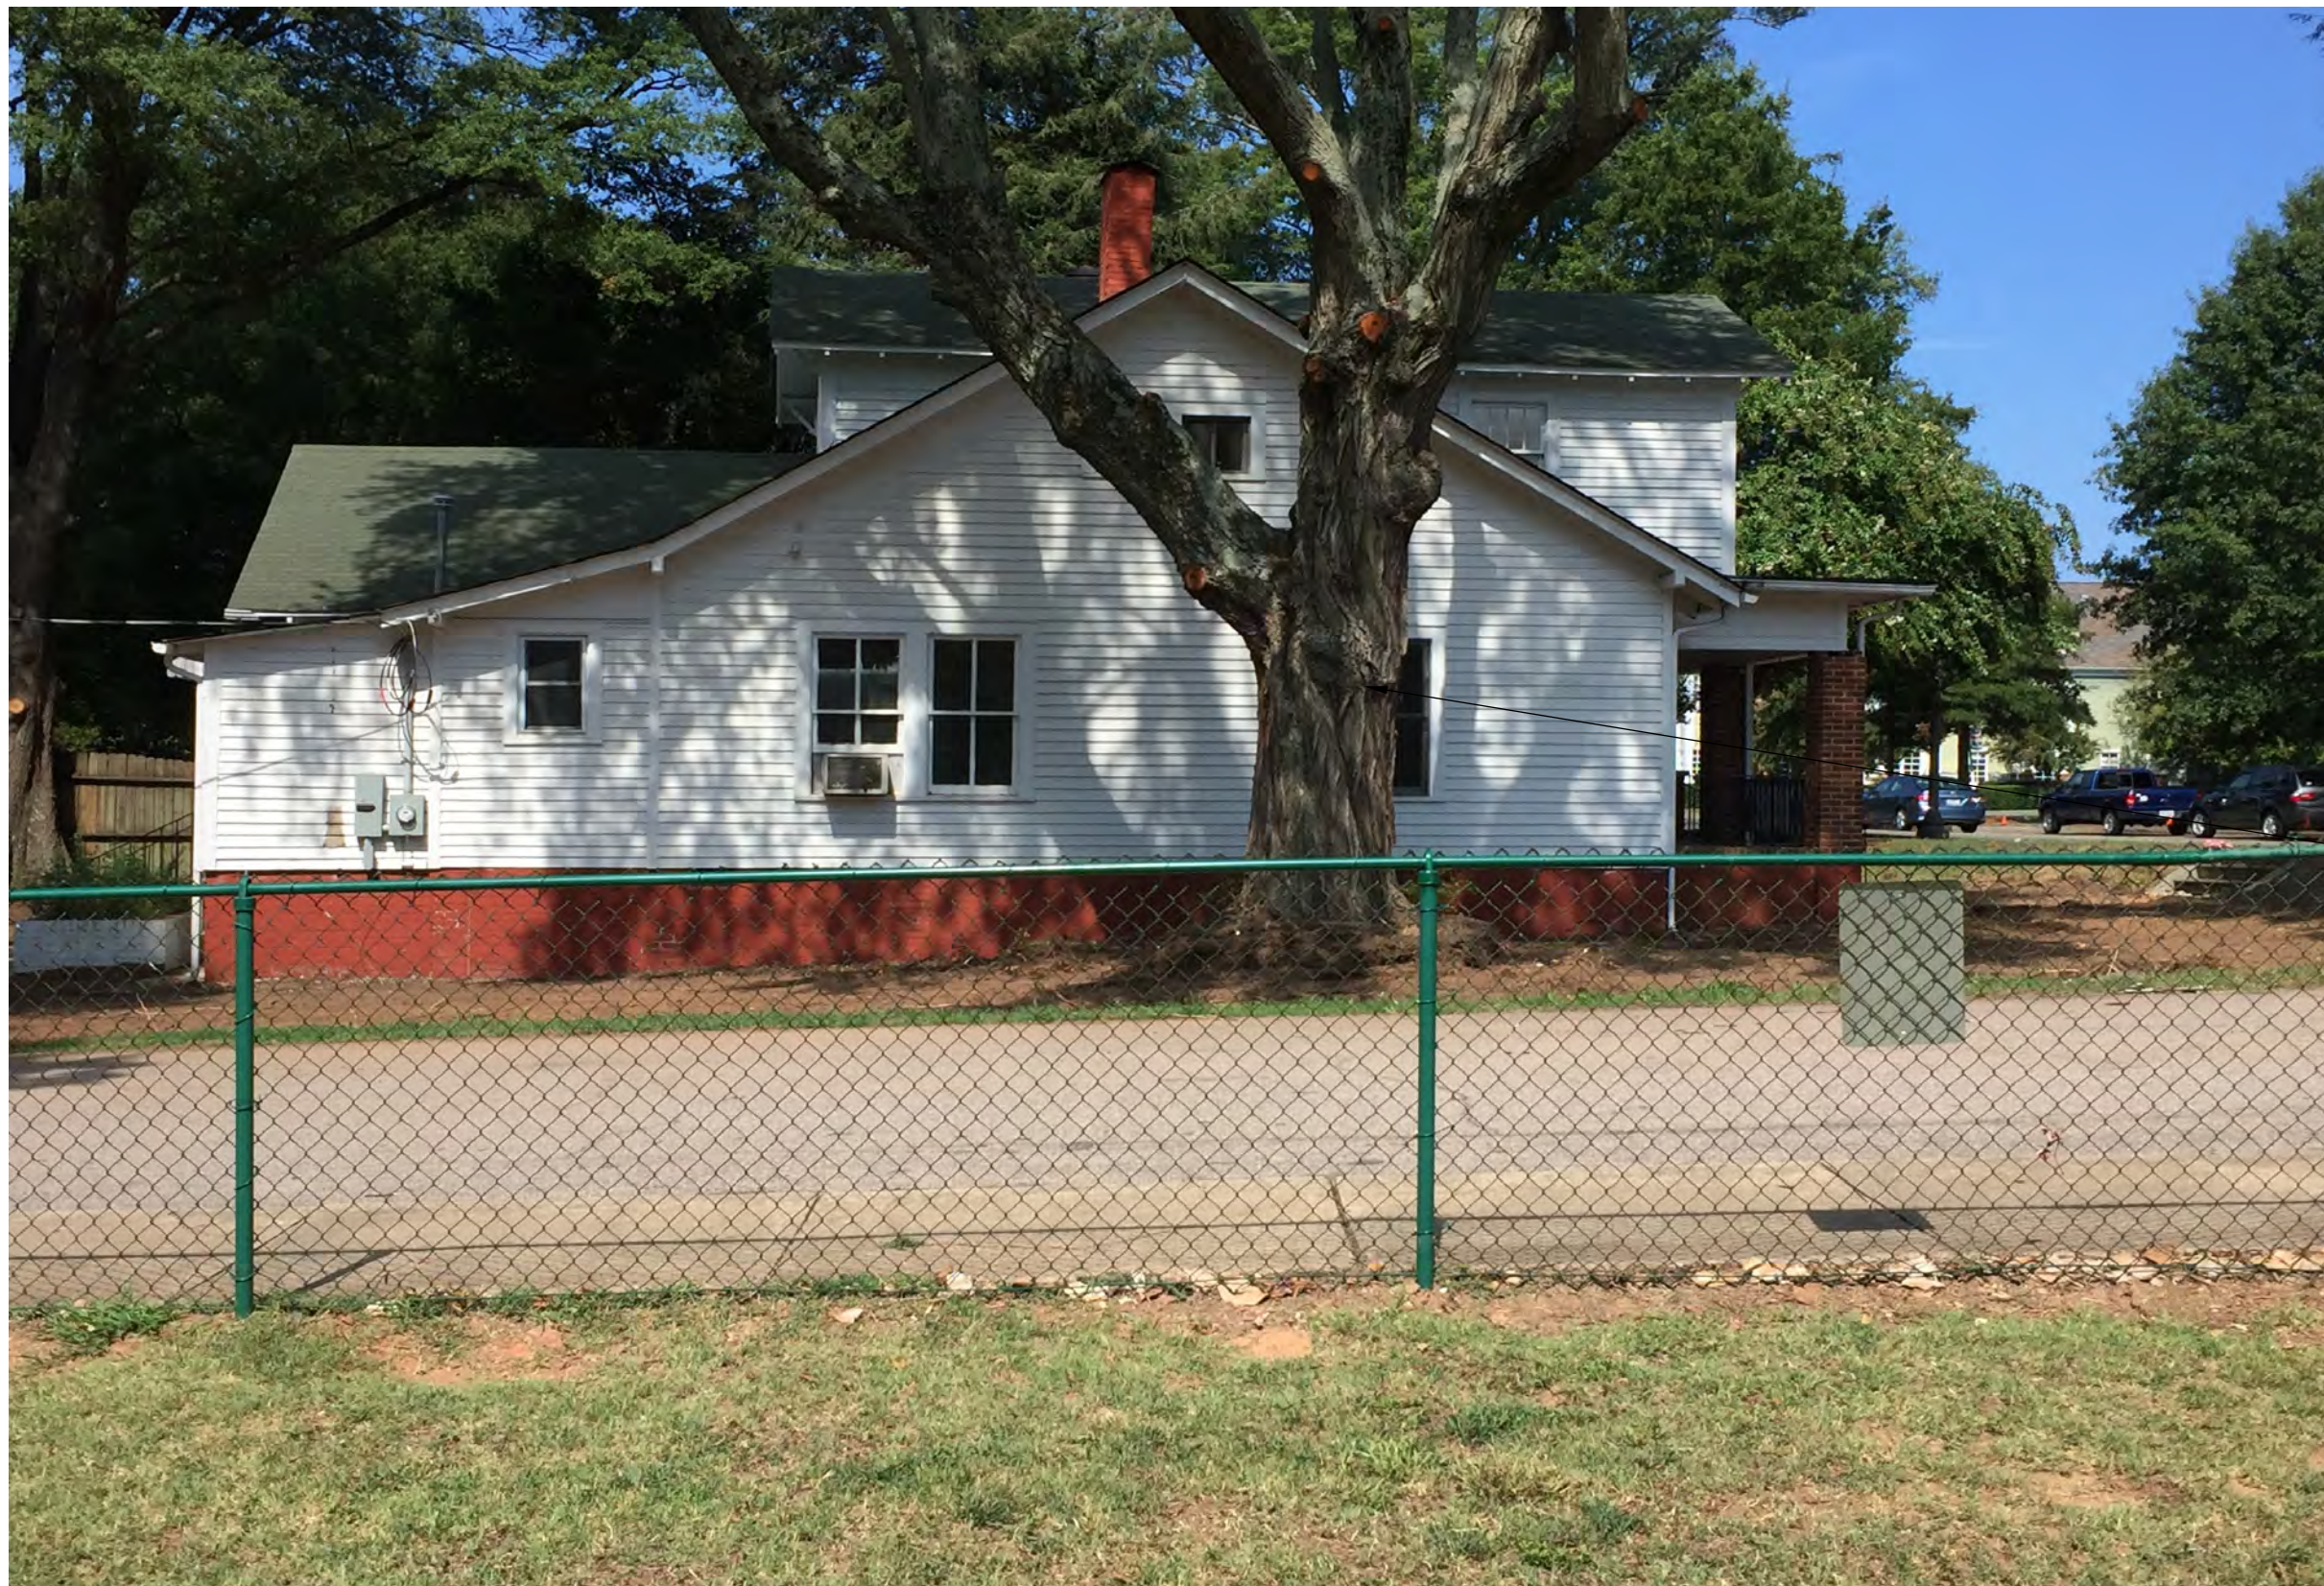
EAST ELEVATION

GARAGE TO BE REMOVED

EXISTING TREE WILL REMAIN

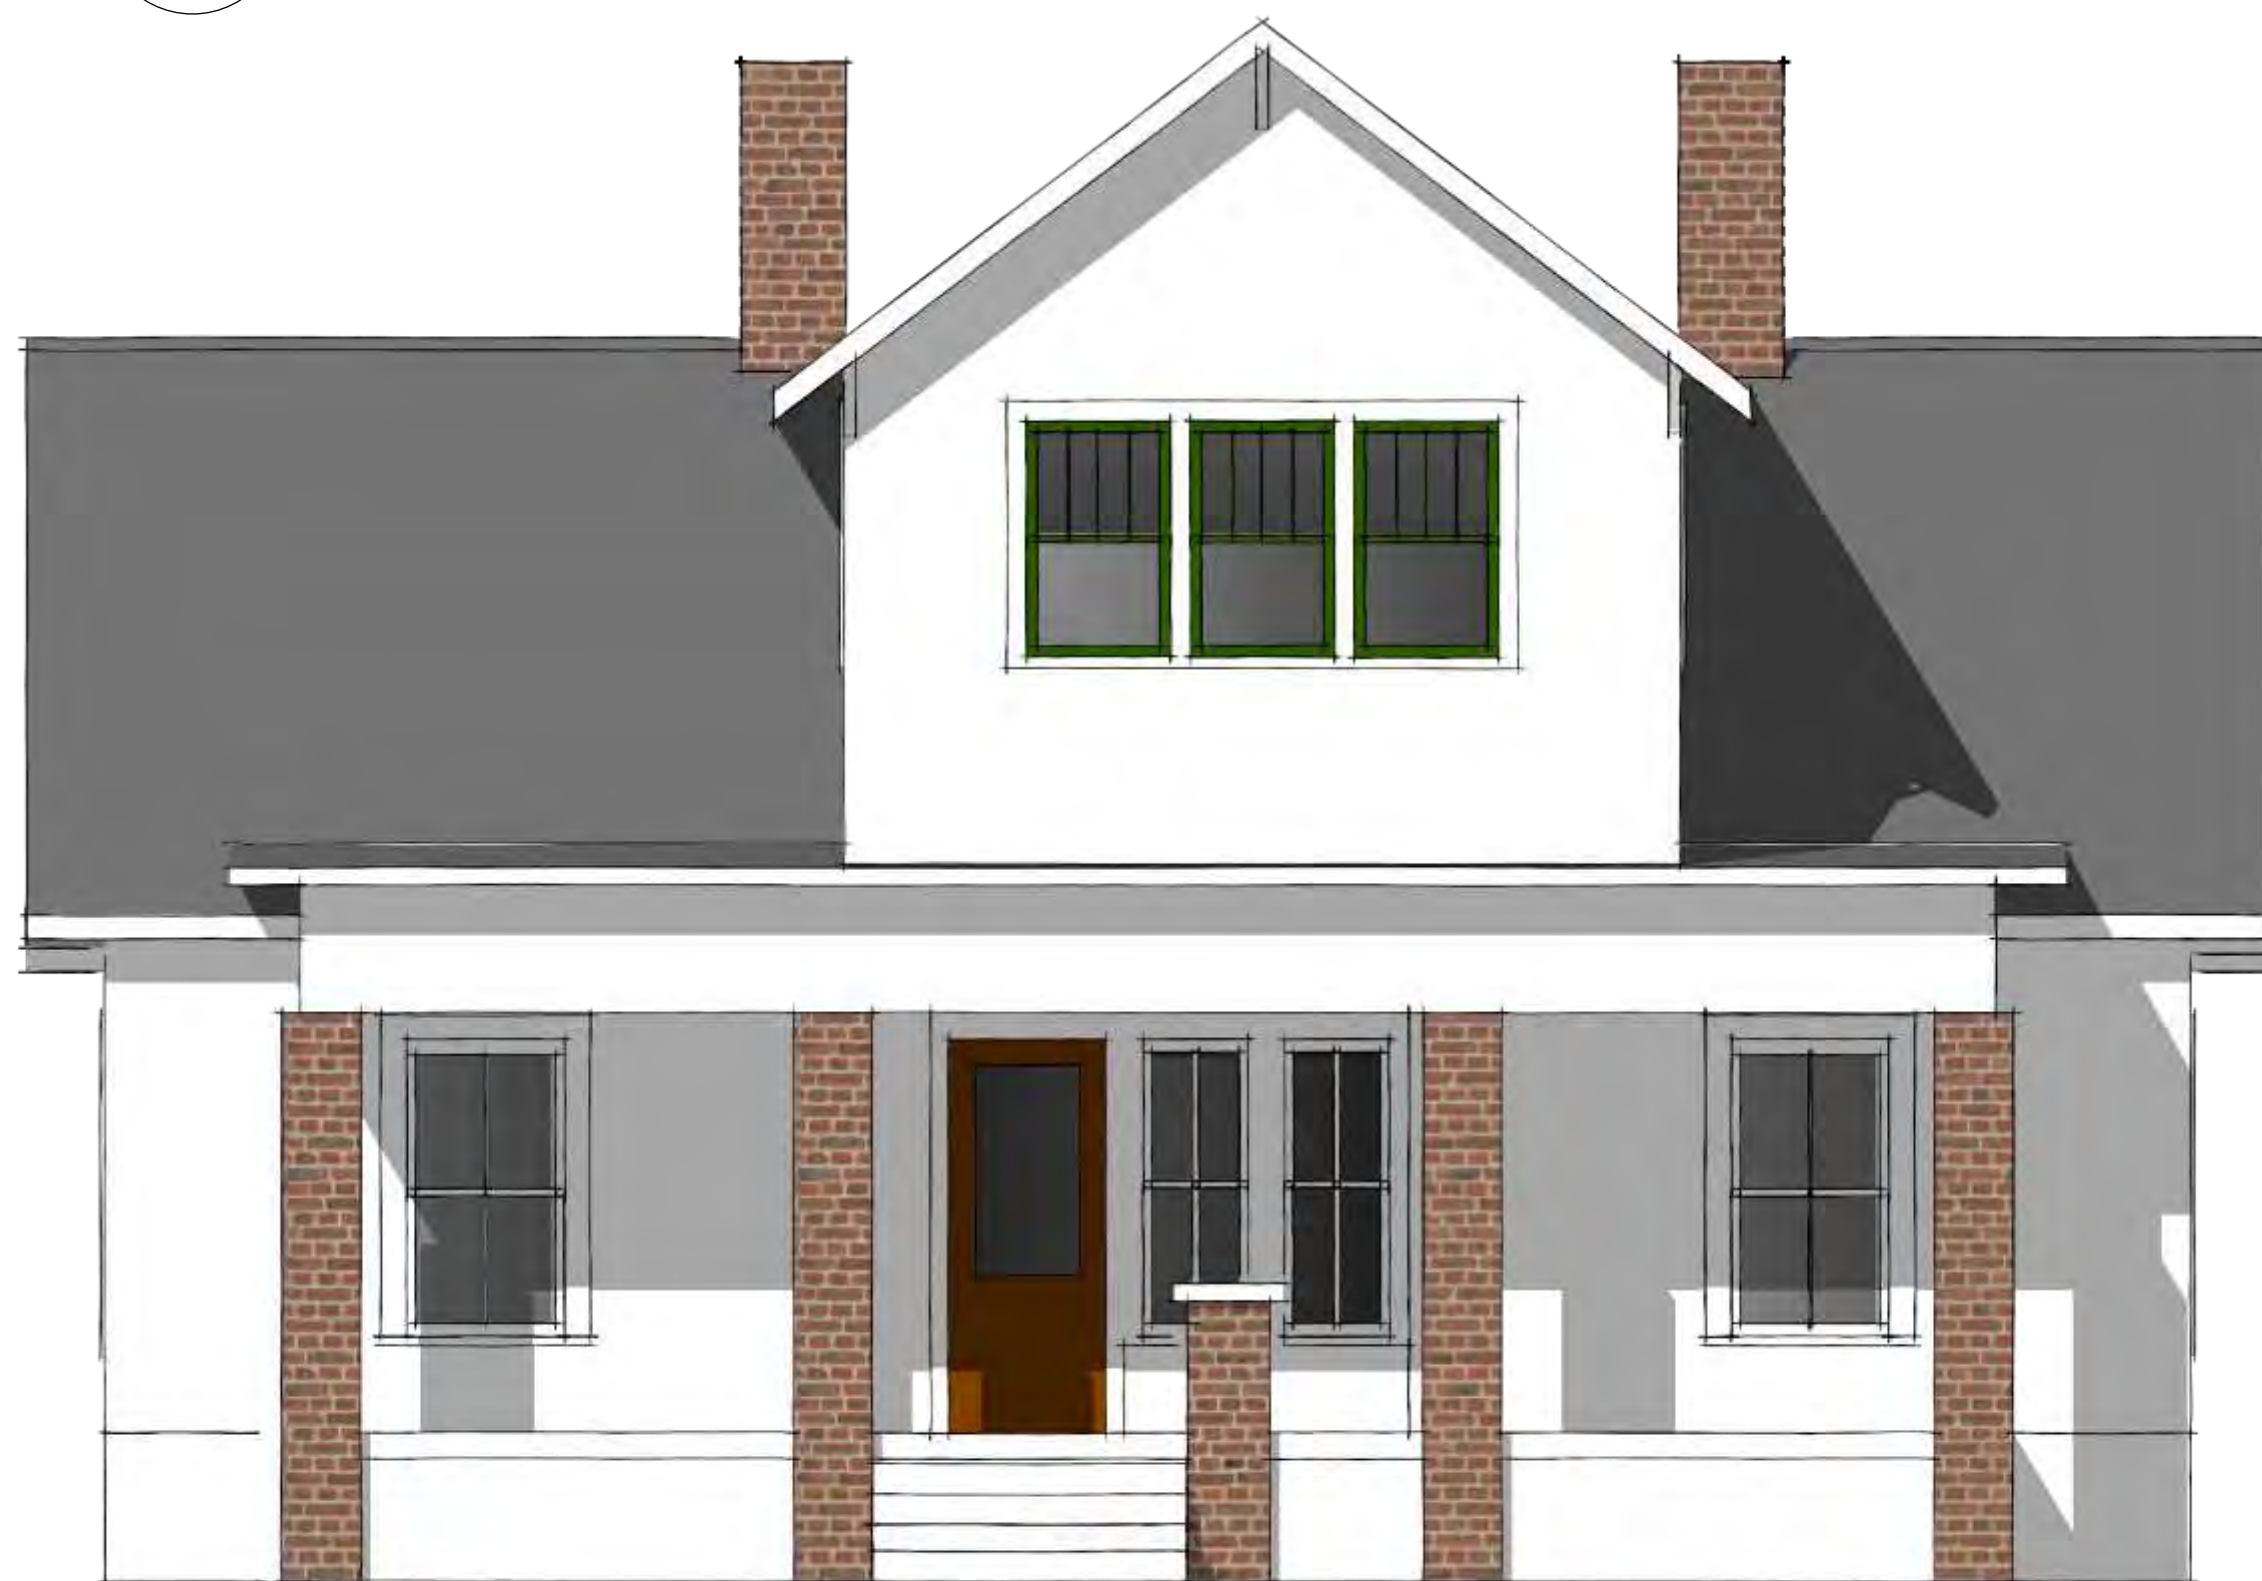
2  
A1.1  
PROPOSED FRONT ELEVATION  
NTS

WINDOW NOT ATRICULTAED  
WILL BE REMOVED AS PART  
OF THE ADDITION

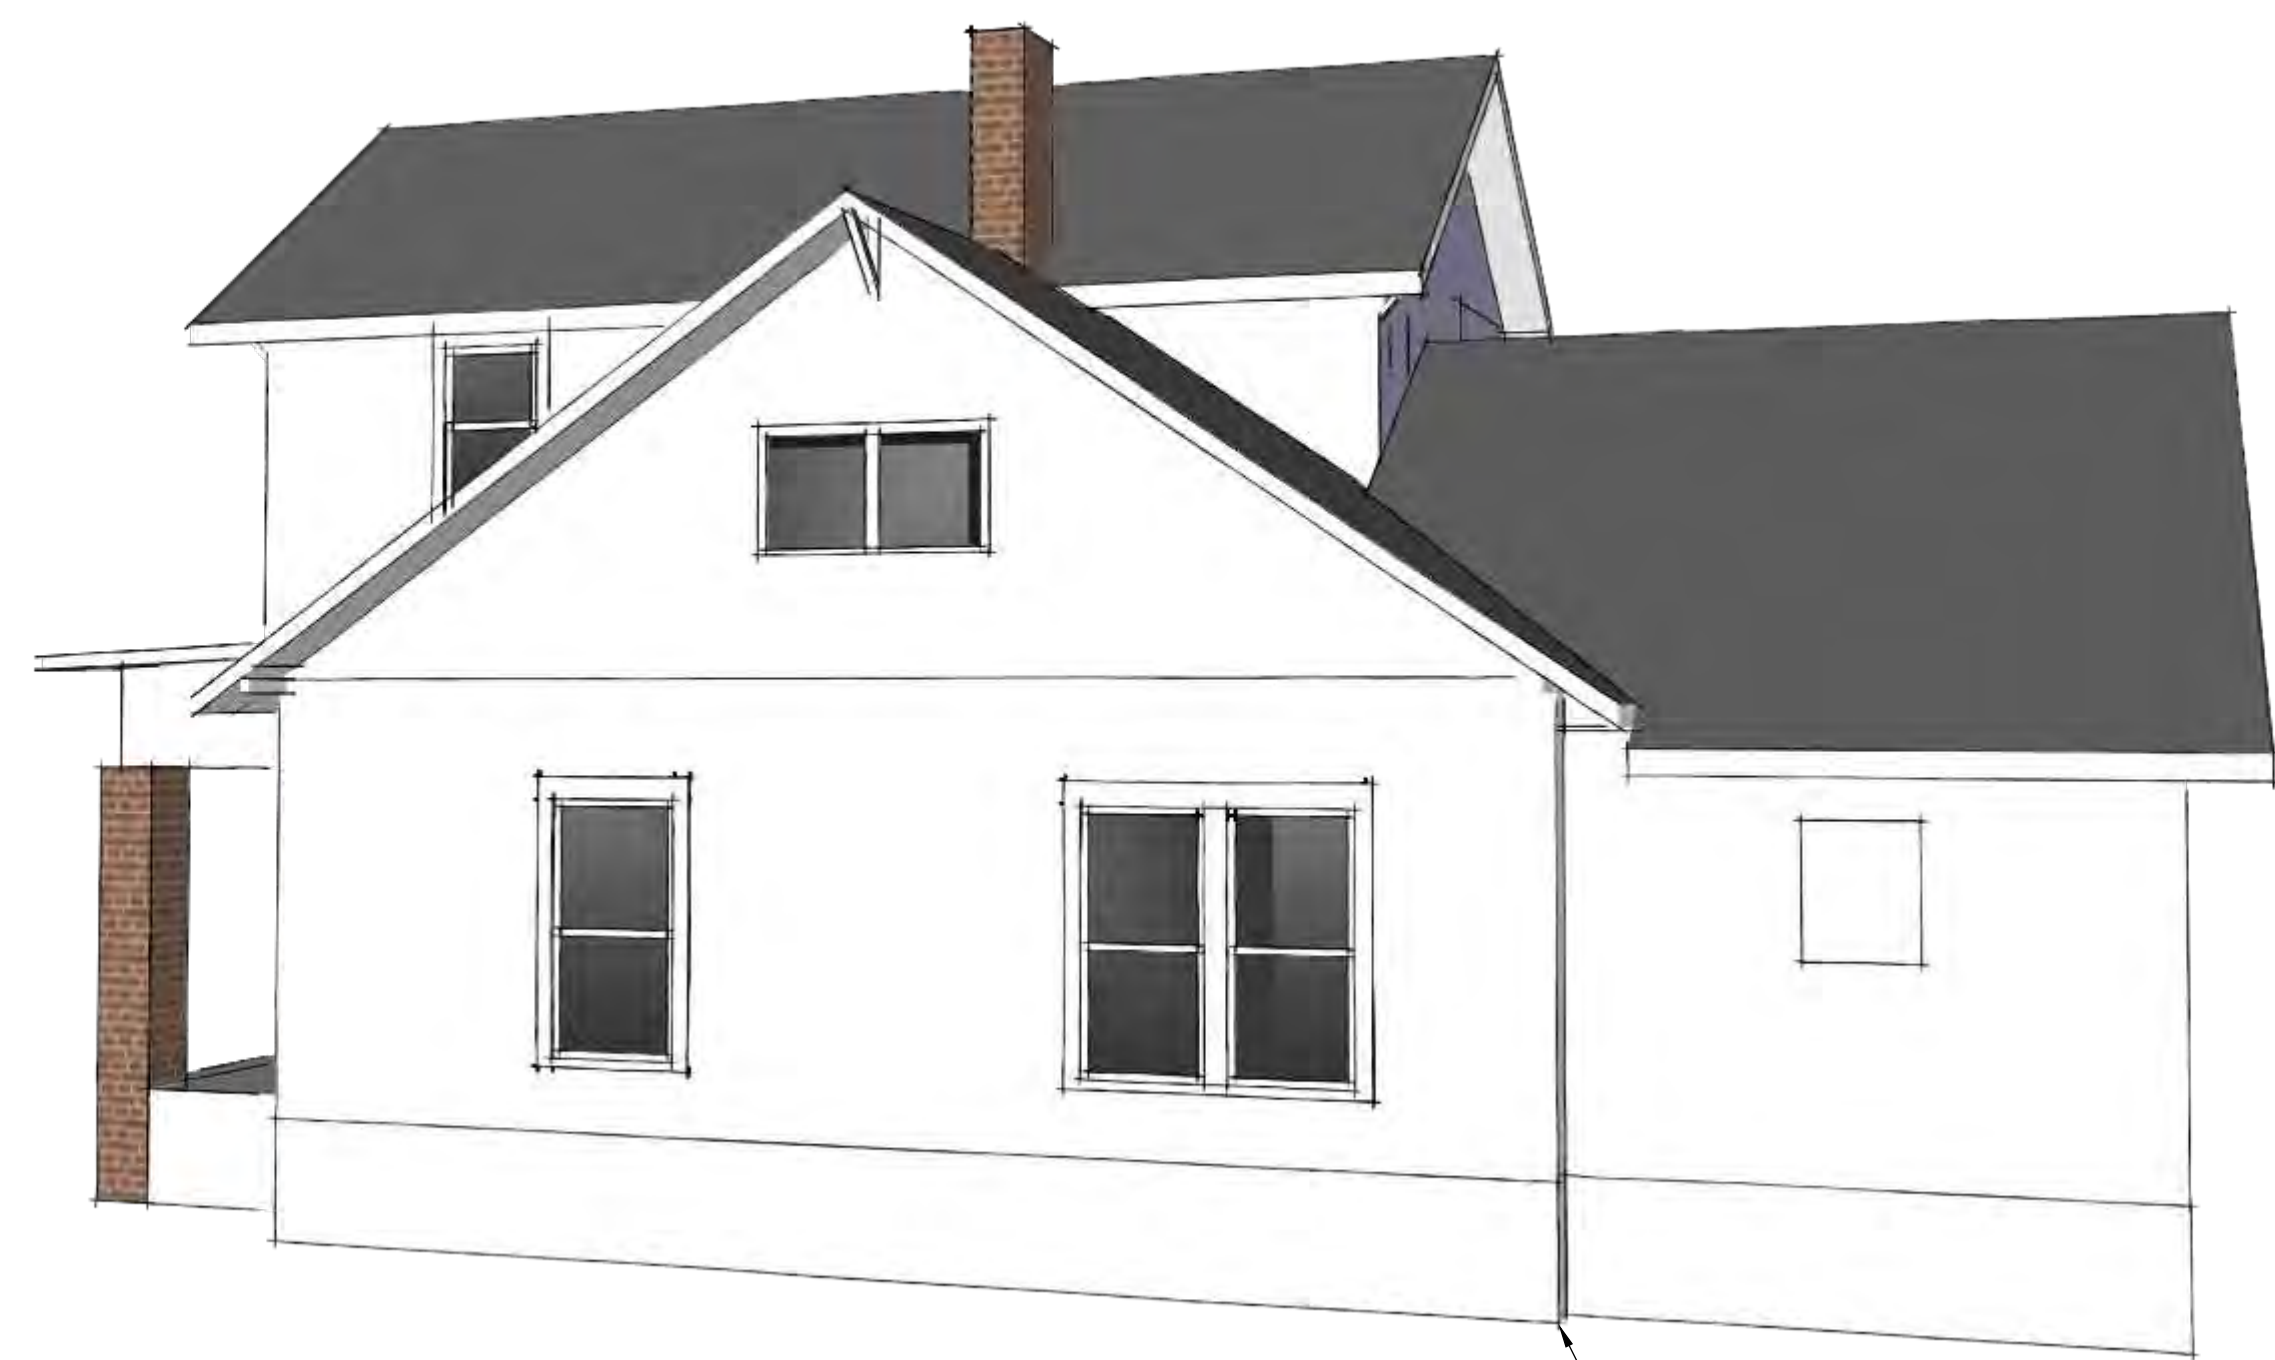
1  
A1.3  
EXIST. WEST 3D VIEW  
NTS

NOTE: THIS IS AN EXISTING JOG  
IN THE FACADE
