## **Charlotte-Mecklenburg Historic Landmarks Commission**

### **Historic Landmarks Department Staff Report – January 12, 2026**

| <b>Landmark Name:</b> | <b>The Fidler House</b> |

**FIDLER HOUSE ADDITION / RENOVATION**  
**21112 Catawba Ave**  
**Cornelius, NC 28031**

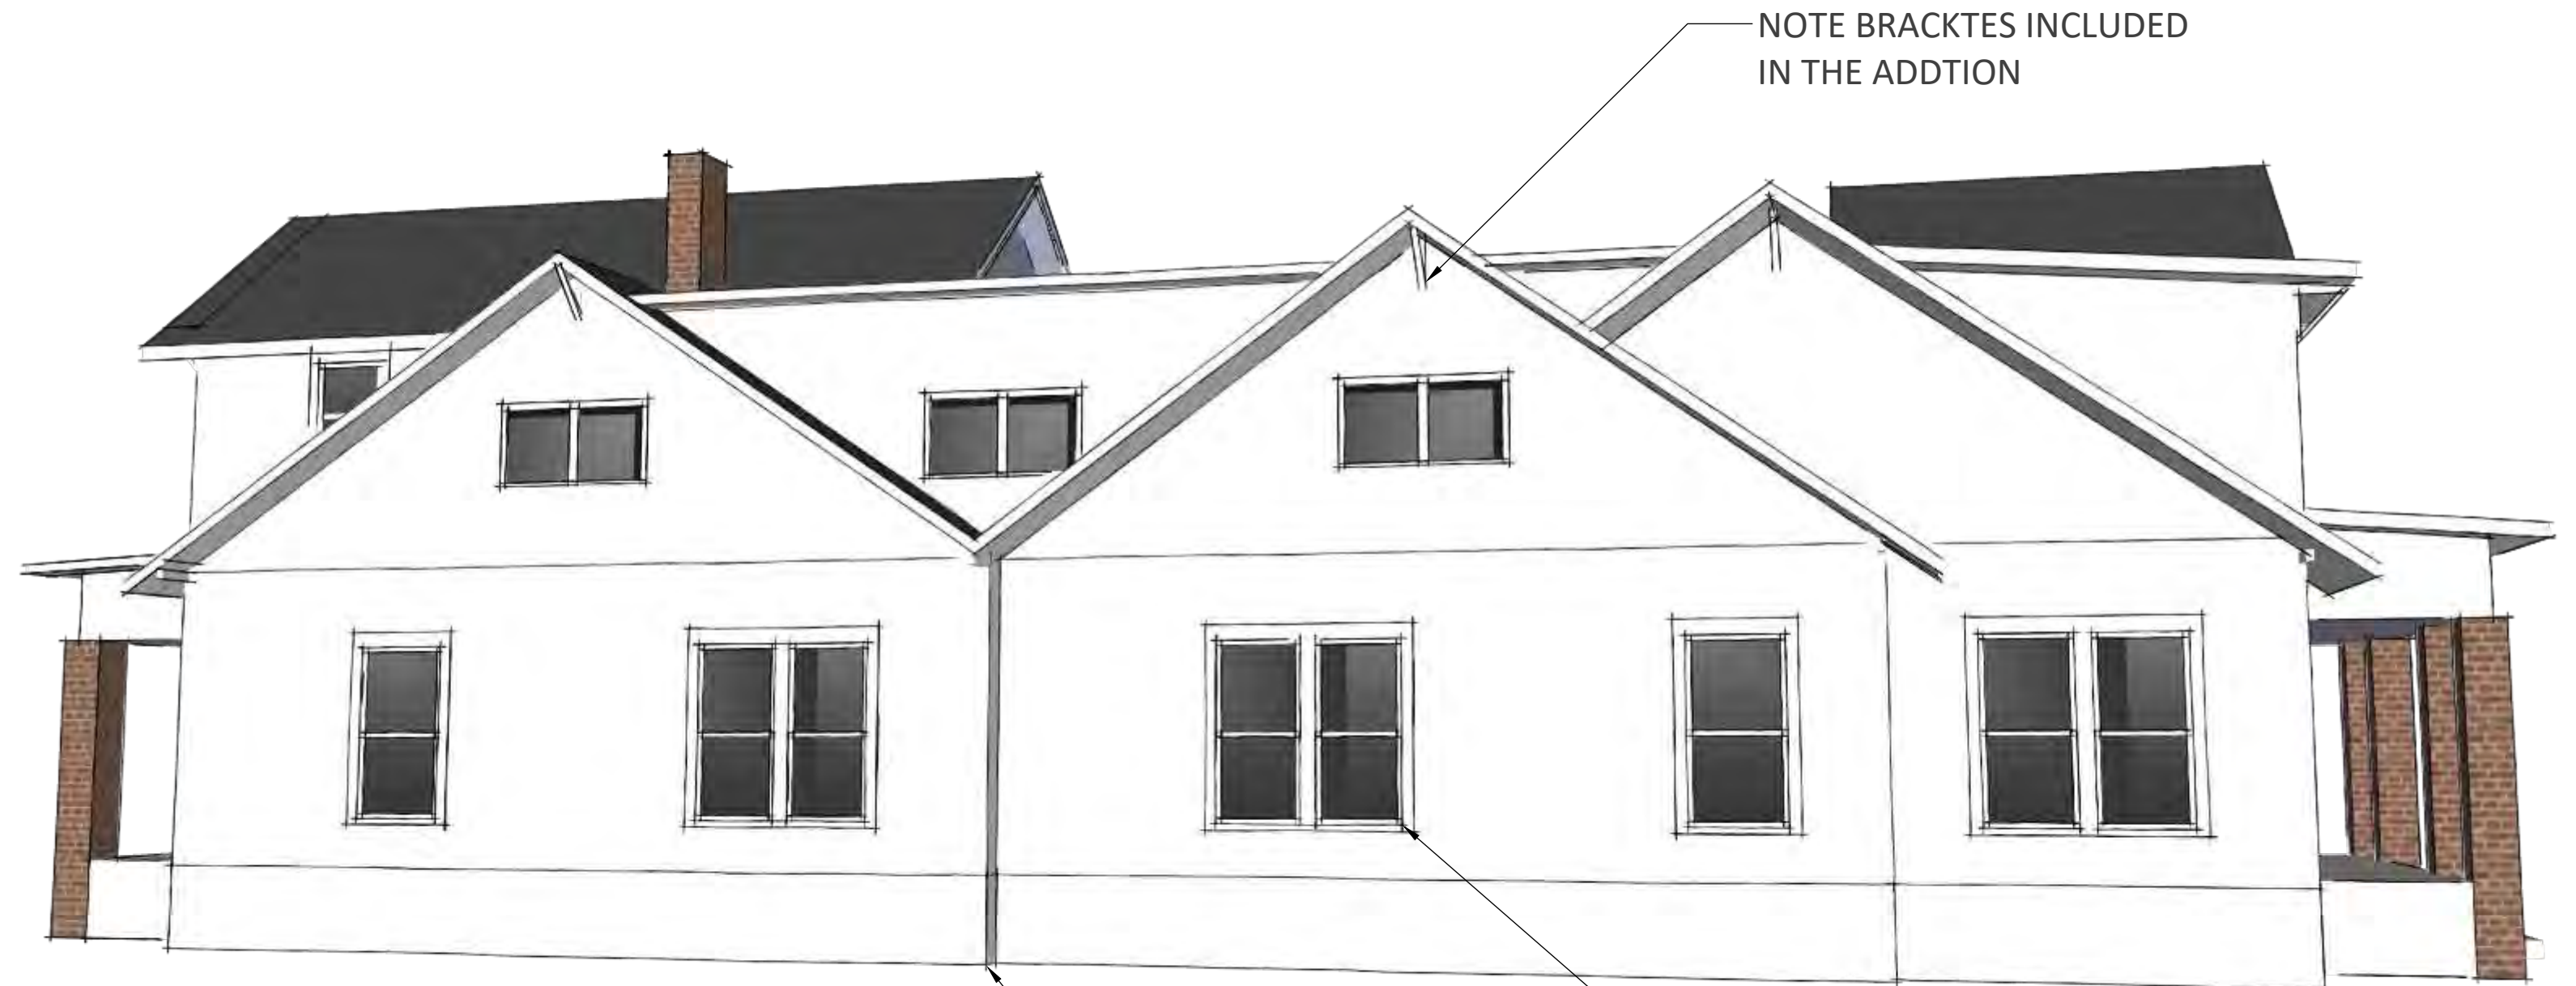
3  
A1.3  
PROPOSED WEST 3D VIEW  
NTS

EXISTING JOG REMAINS  
WITH THE ADDITION

NOTE BRACKTES INCLUDED  
IN THE ADDITION

REPEATING WINDOWS TO  
MATCH EXISTING

FRONT DORMER WINDOW  
REPLICATED AT REAR

EAVE BRACKETS  
REPLICATED IN  
NEW ADDITION

The proposal meets the Standards for height, width, and materials. However, the new addition directly behind the original building is coplanar and the rhythm of the side elevation is disrupted by the rear dormer over the porch. The twin side gable roofs and wall planes are flush with the original building making it difficult to differentiate new construction from the original side elevations.

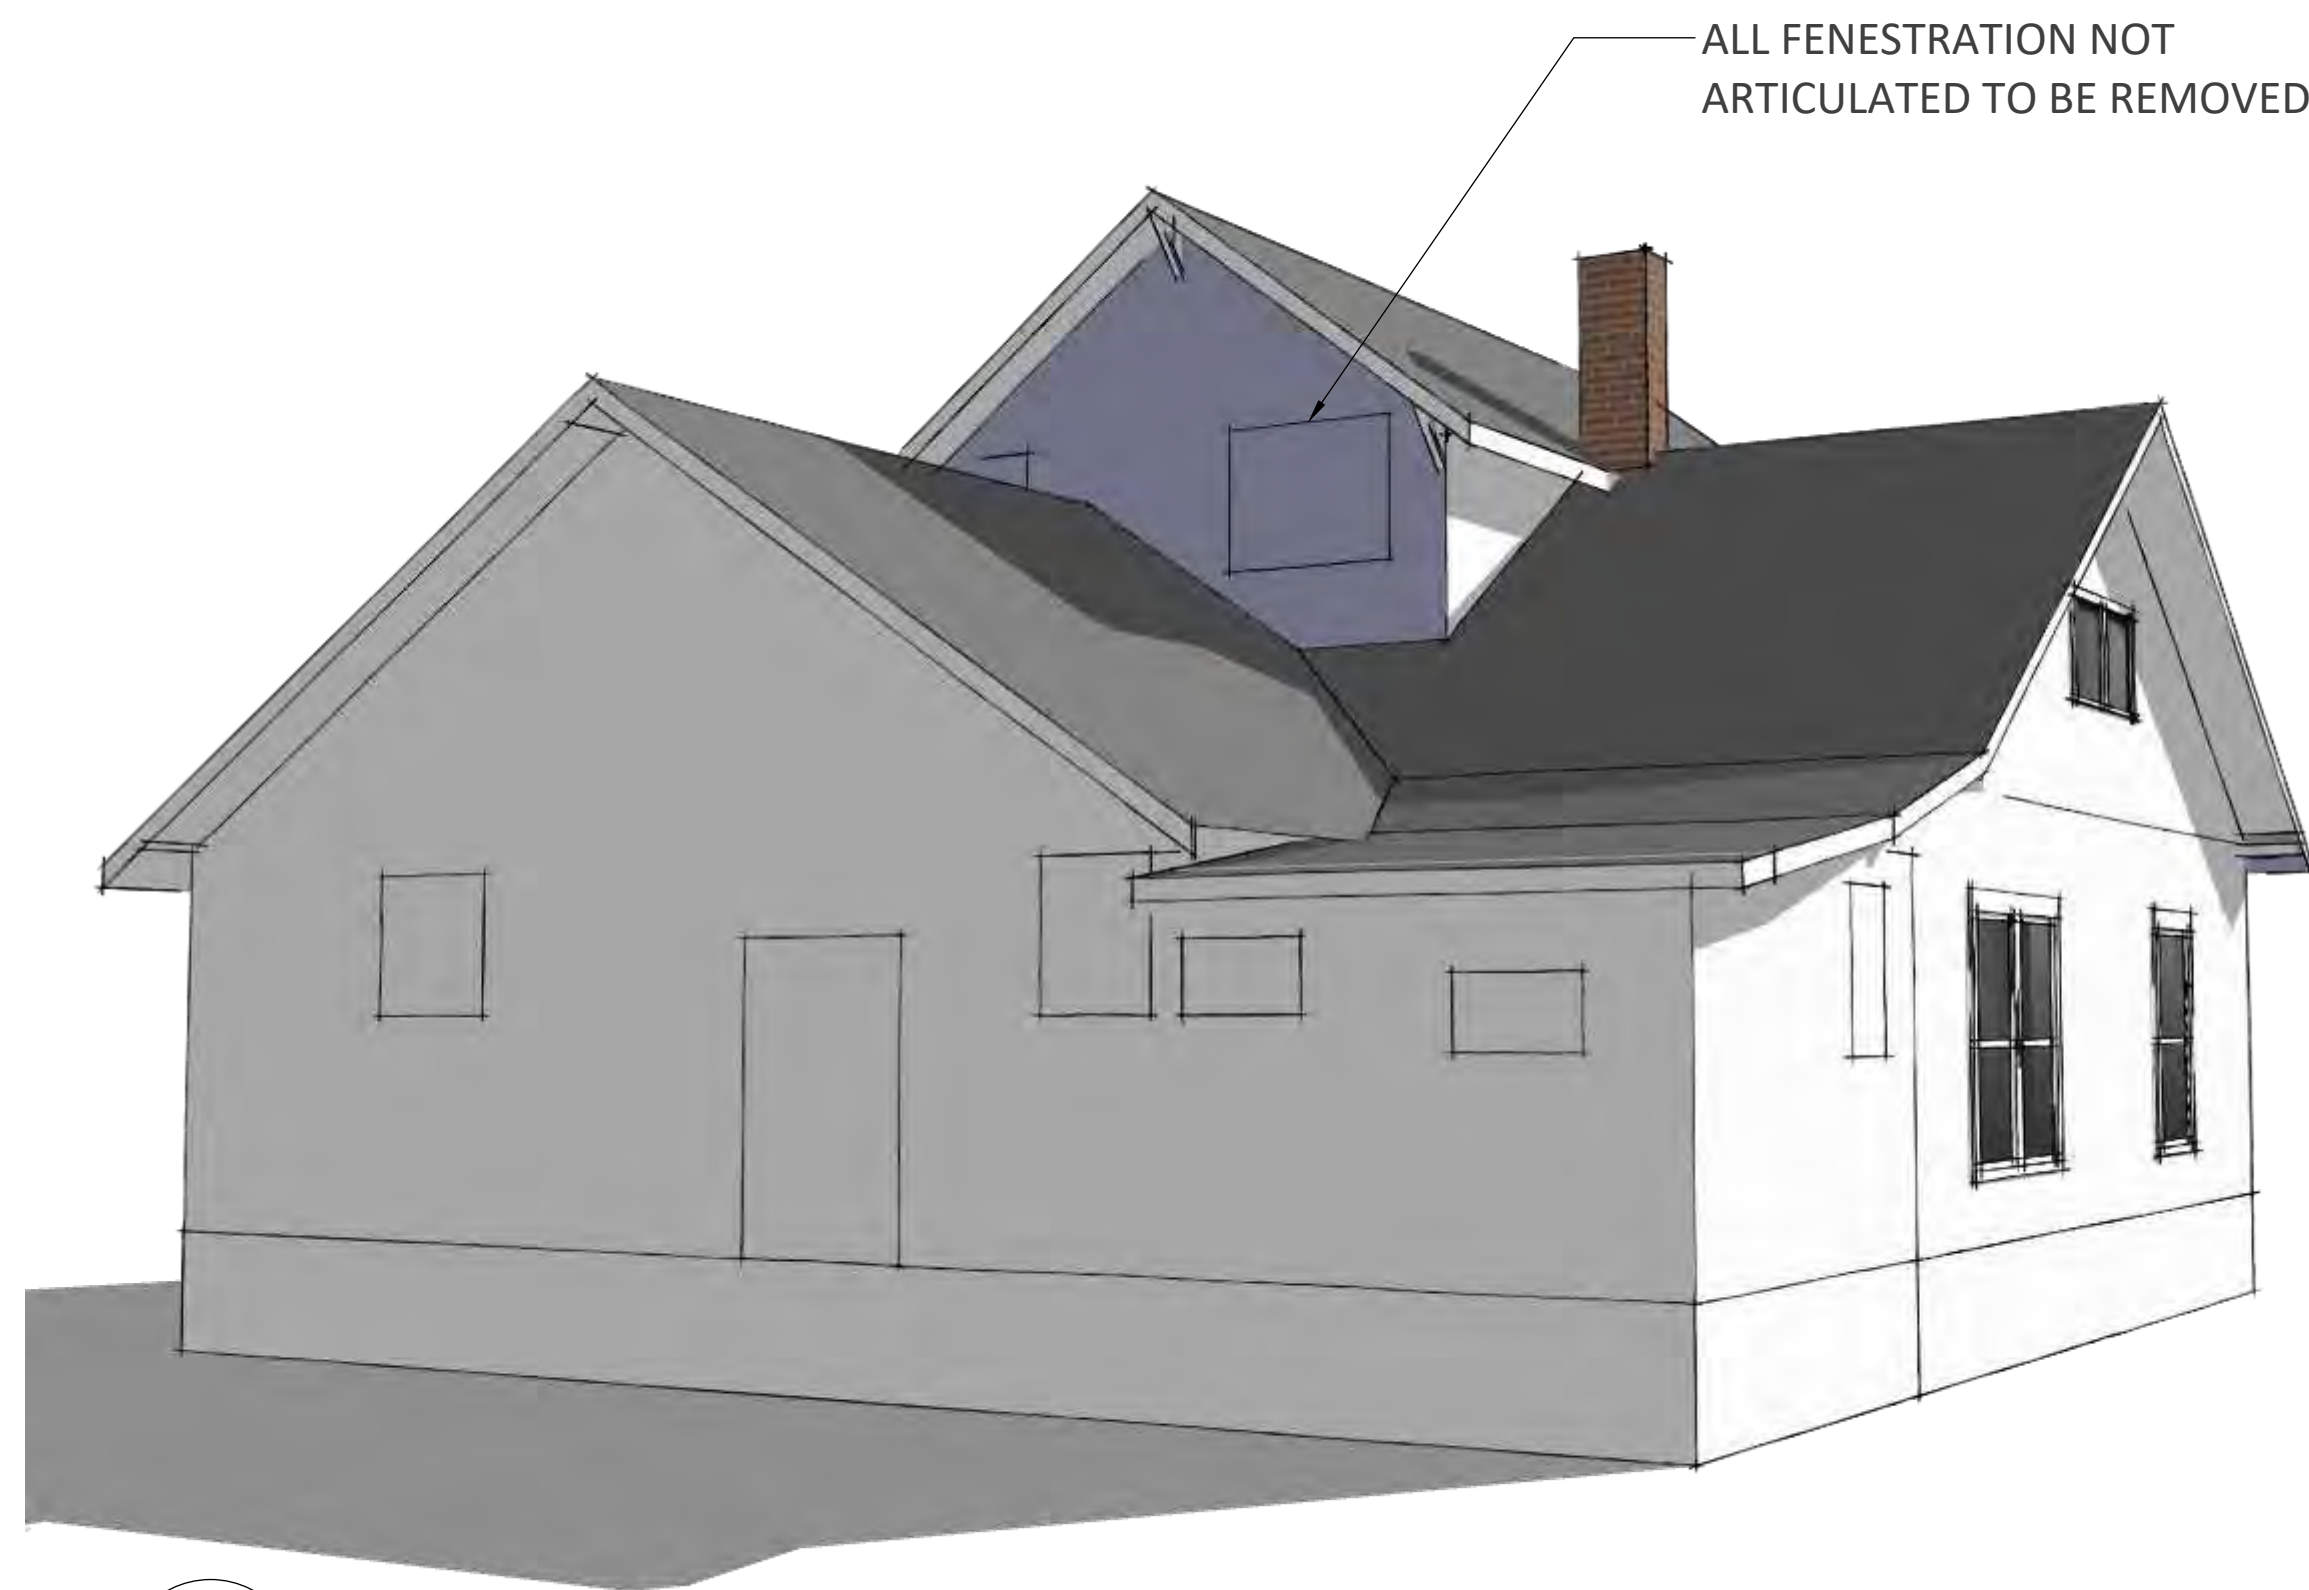
2  
A1.3  
EXIST. SOUTHWEST 3D VIEW  
NTS

ALL FENESTRATION NOT  
ARTICULATED TO BE REMOVED

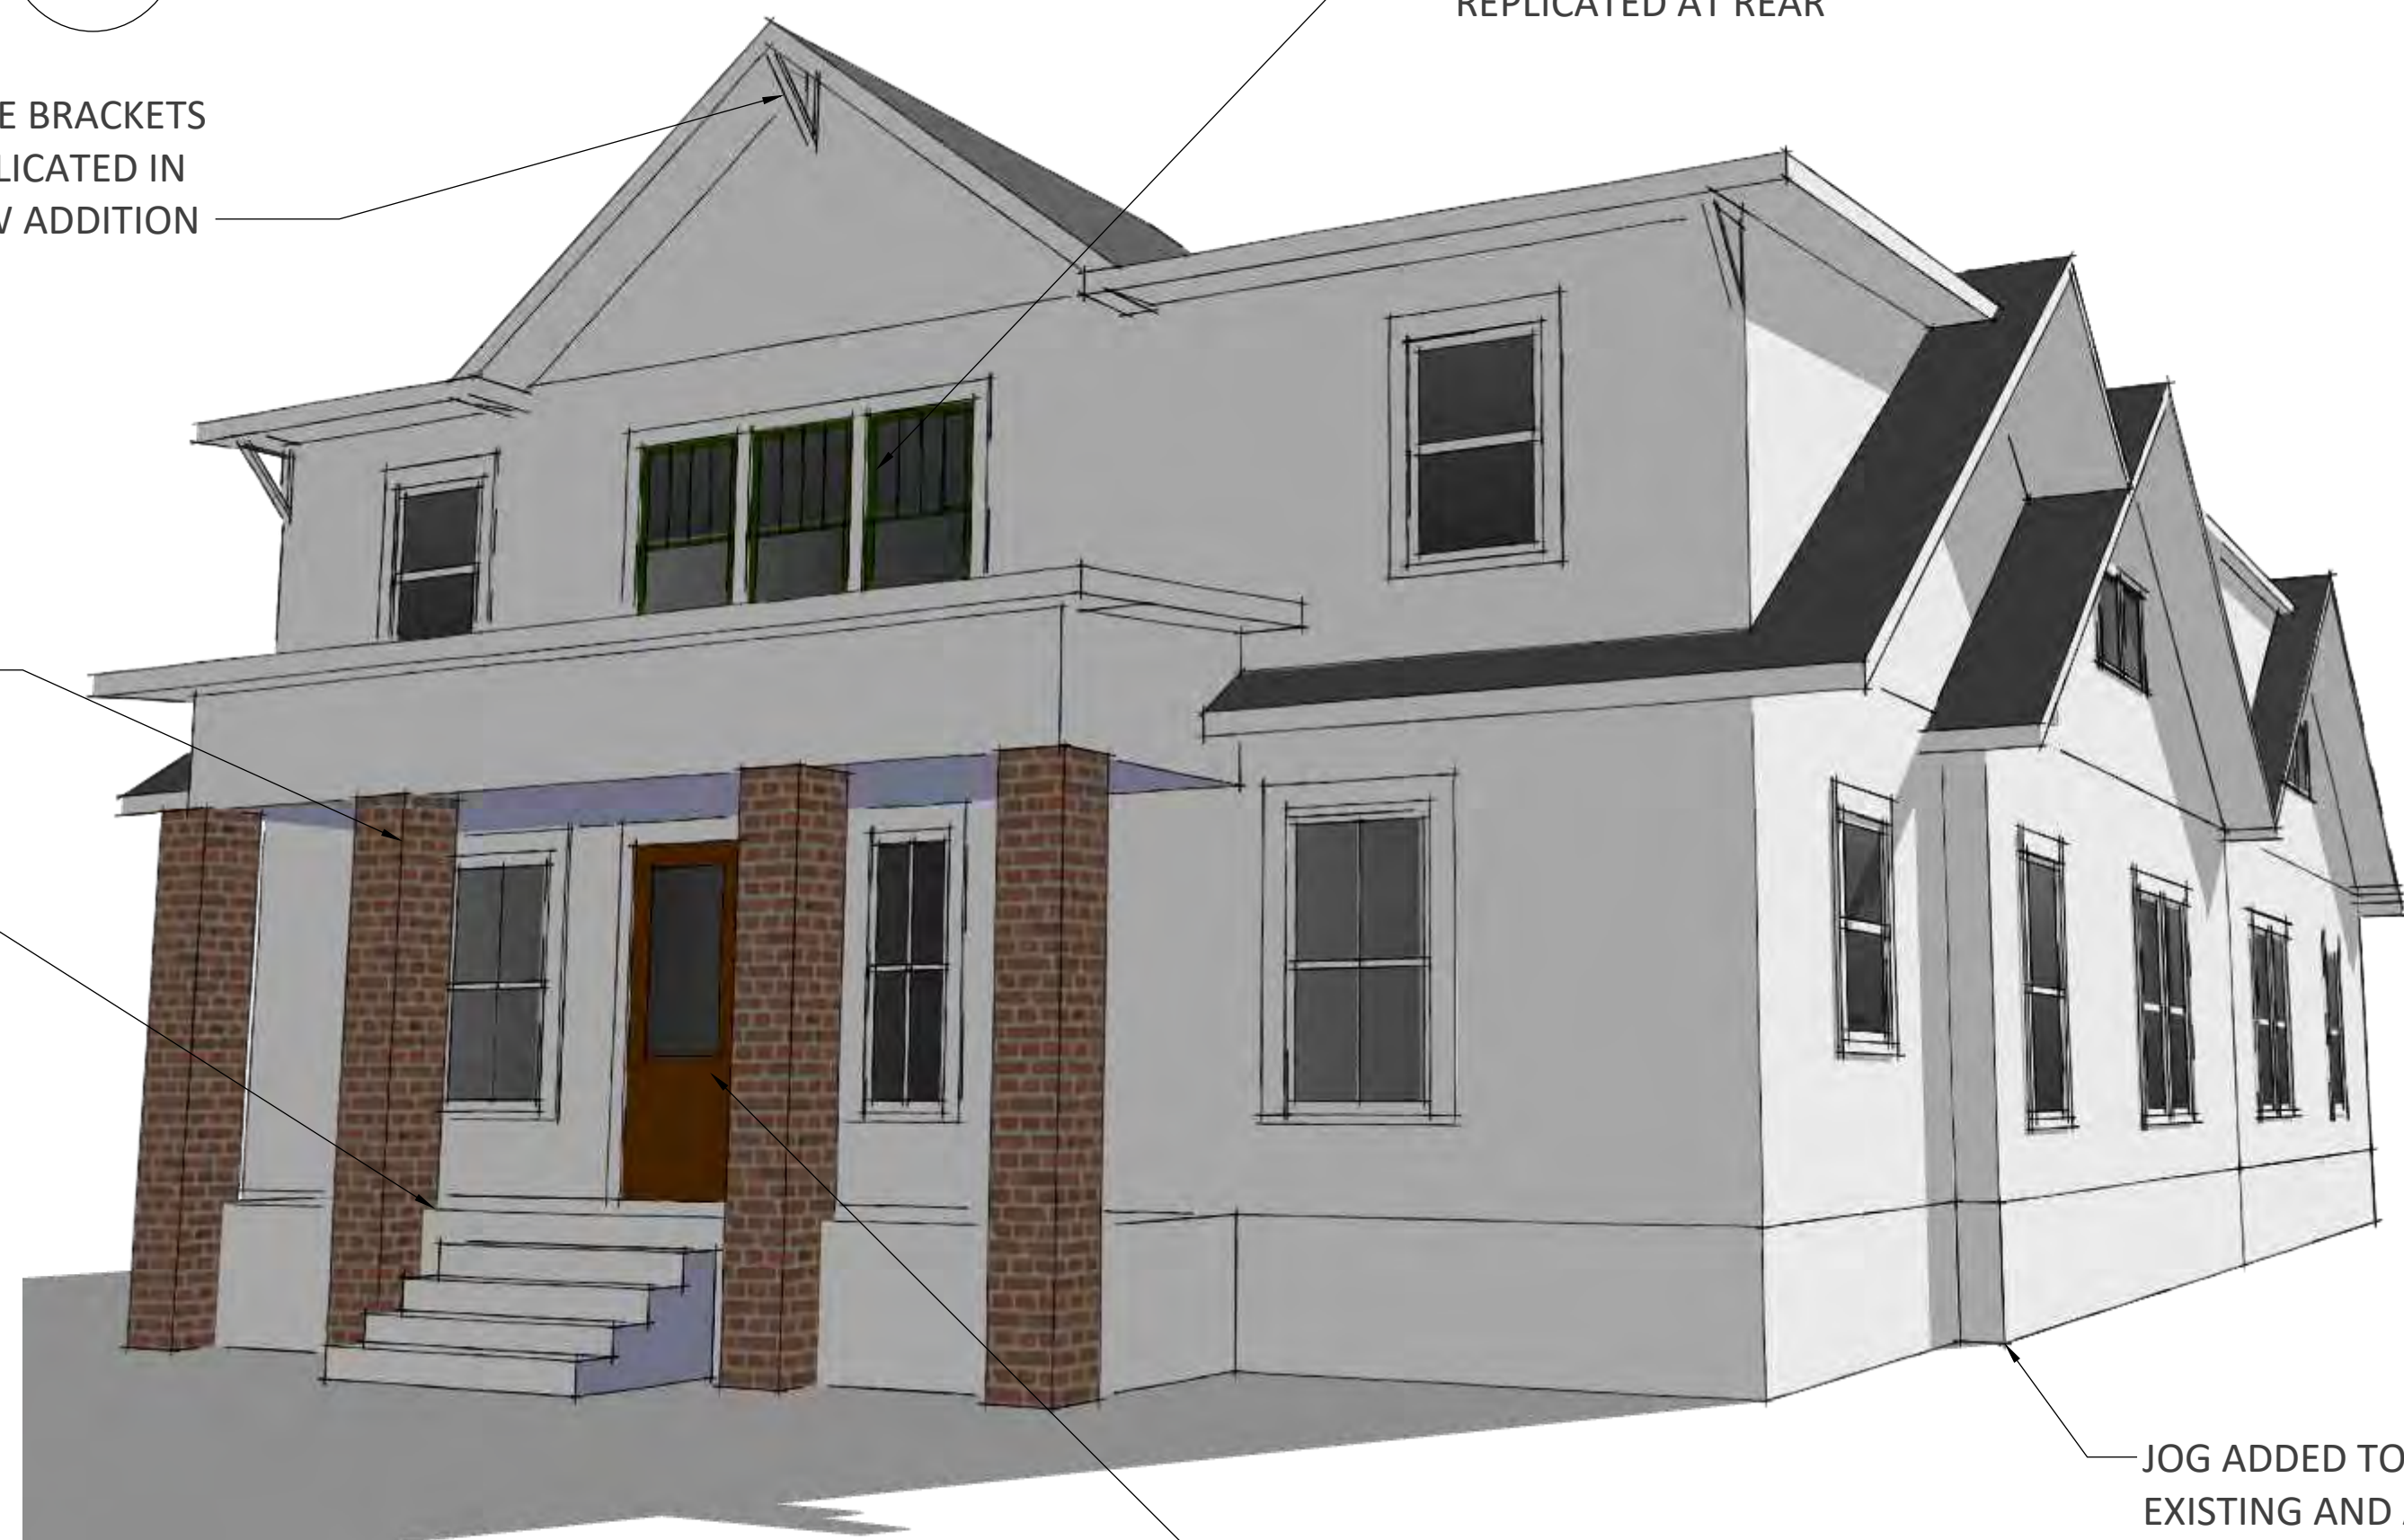
4  
A1.3  
PROPOSED SOUTHWEST 3D VIEW  
NTS

REAR PORCH DESIGN  
MIMICS THE EXISTING  
FRONT PROCH

REAR PORCH WILL HAVE  
RAILINGS THAT MATCH  
THE FRONT PORCH

REAR ENTRY DOORS AND WINDOWS  
MIMIC THE HISTOIC FRONT

JOG ADDED TO MIMIC THE  
EXISTING AND ALSO REDUCES  
THE SIZE OF THE ADDITION

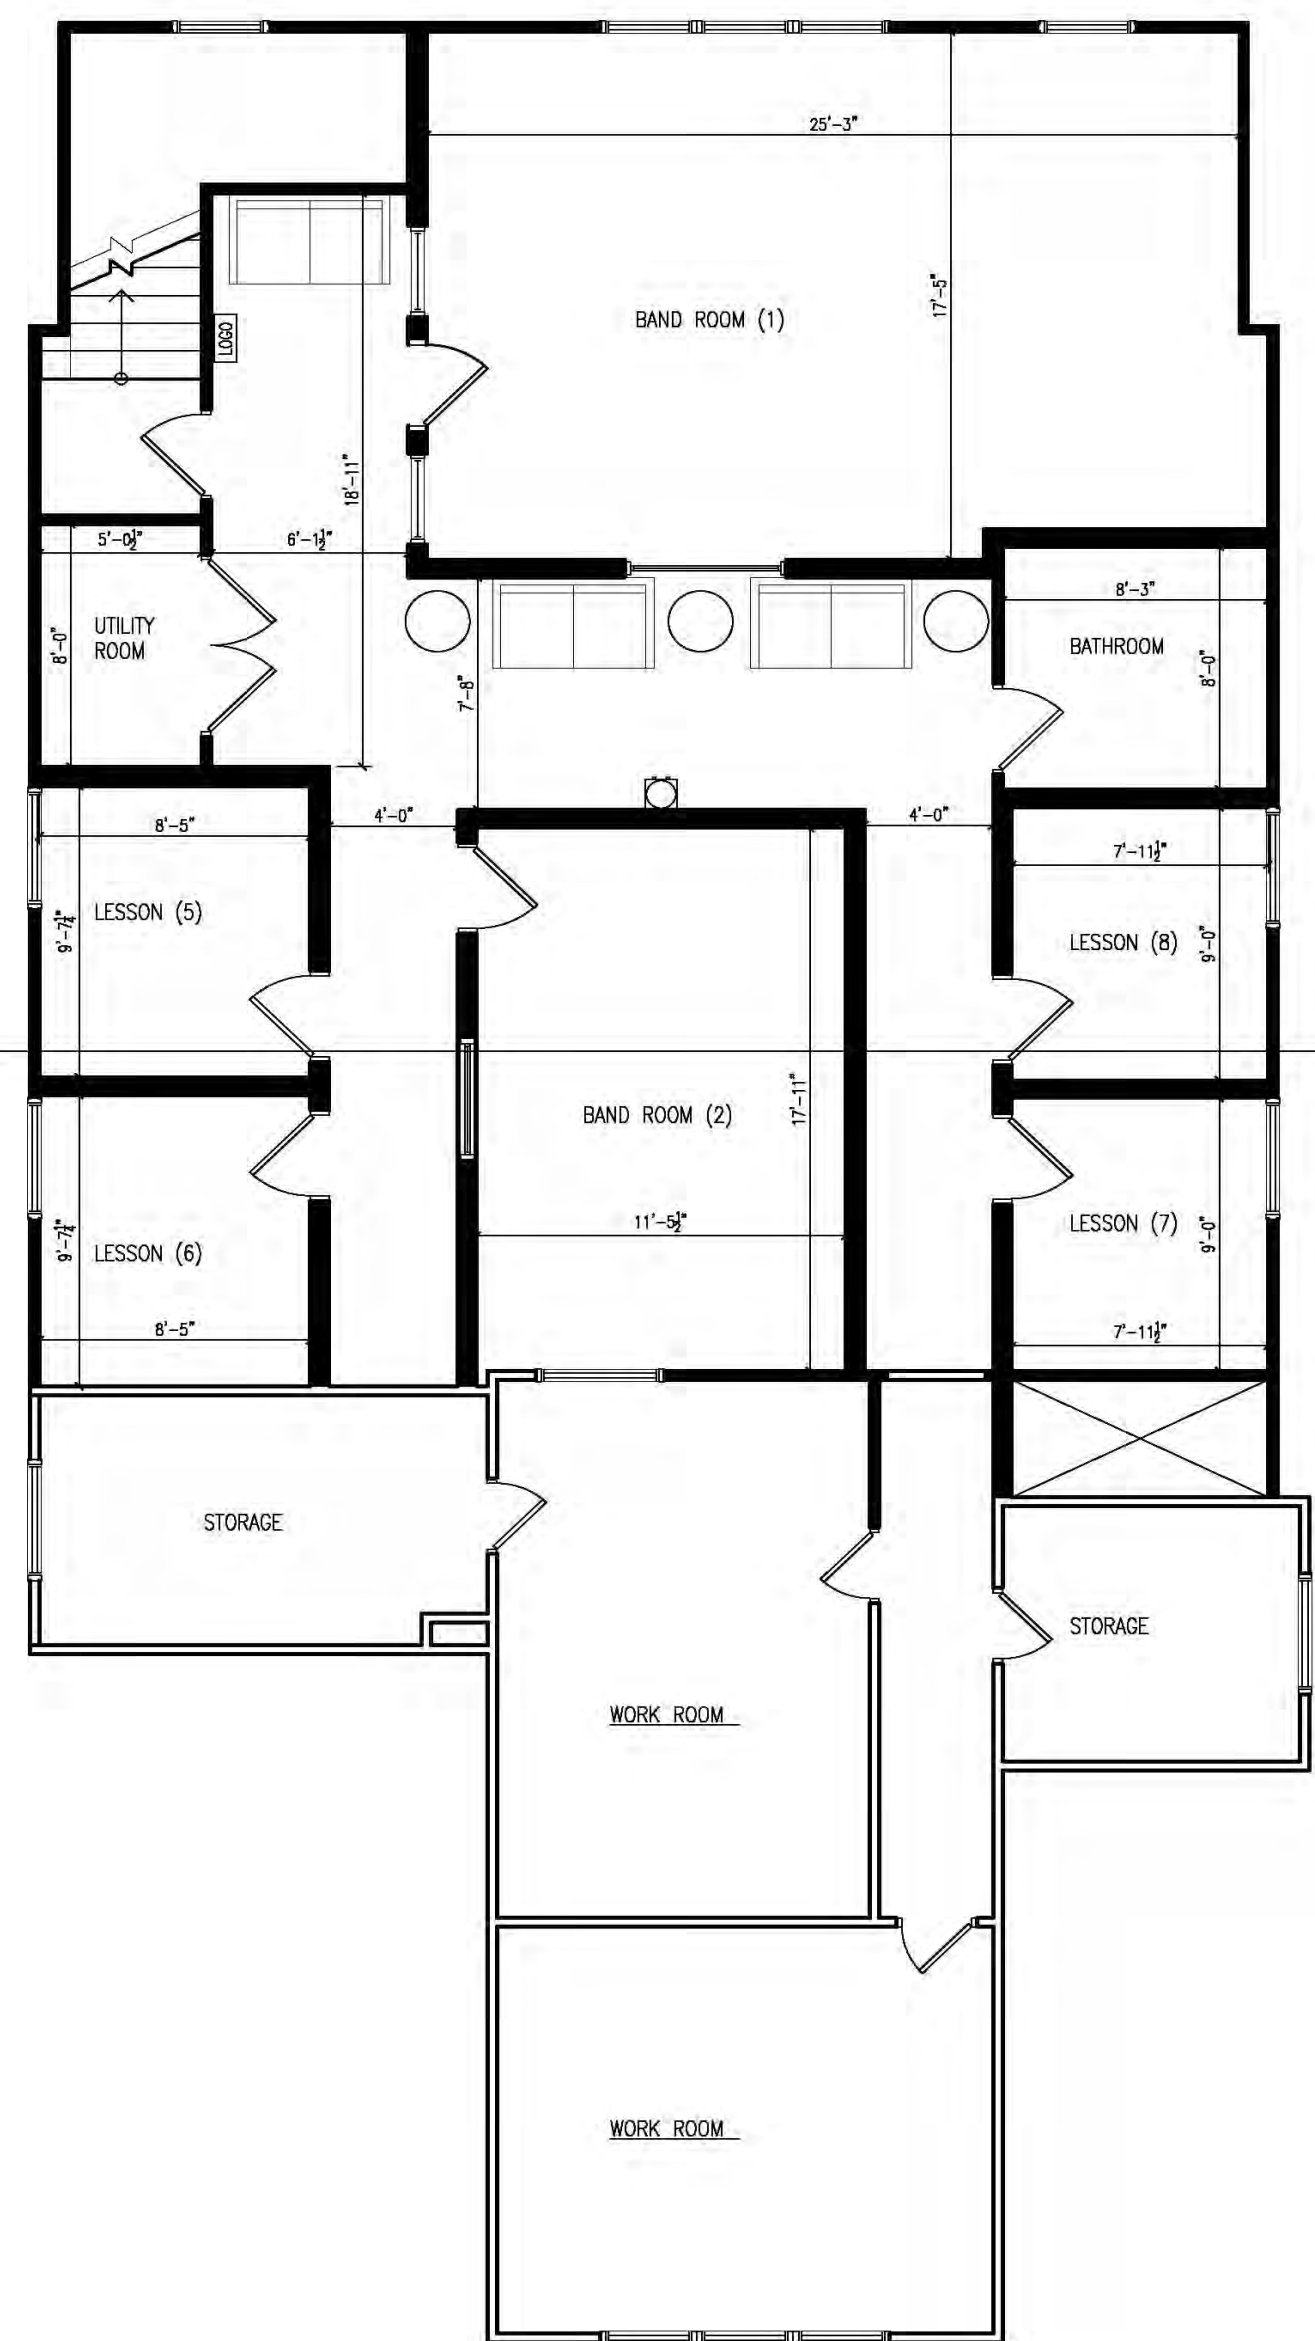
2 PROPOSED SECOND FLOOR  
A1.5 NTS

EXISTING WALLS TO REMAIN  
PROPOSED NEW WALLS
