AERIAL PHOTO of SITE

JOHNSTON MILL • NORTH WING • PRIOR TO RENOVATION.

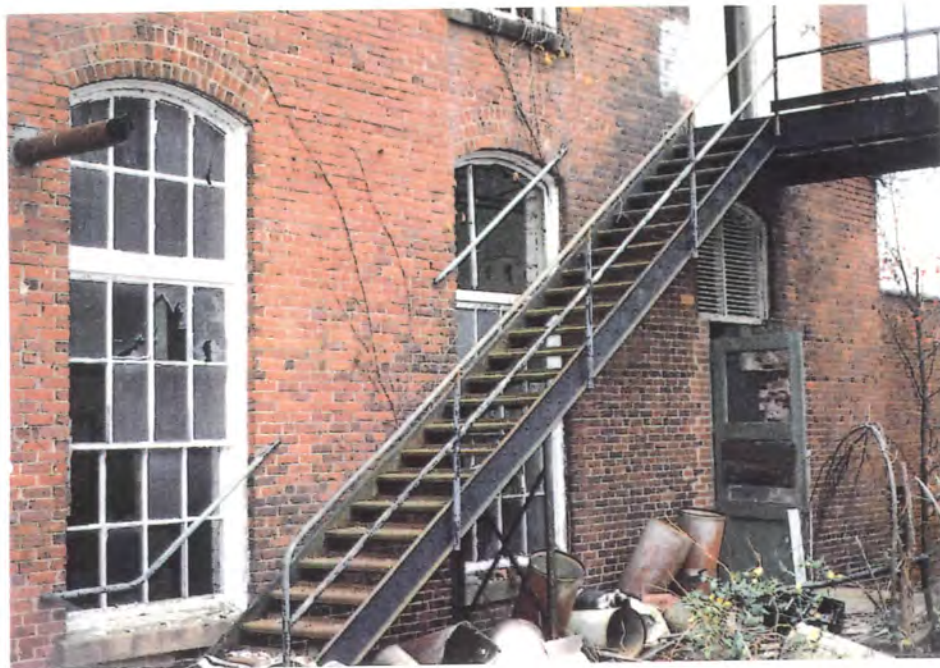
JOHNSTON MILL • NORTH WING ADDITION
REMAINING ORIGINAL WINDOWS

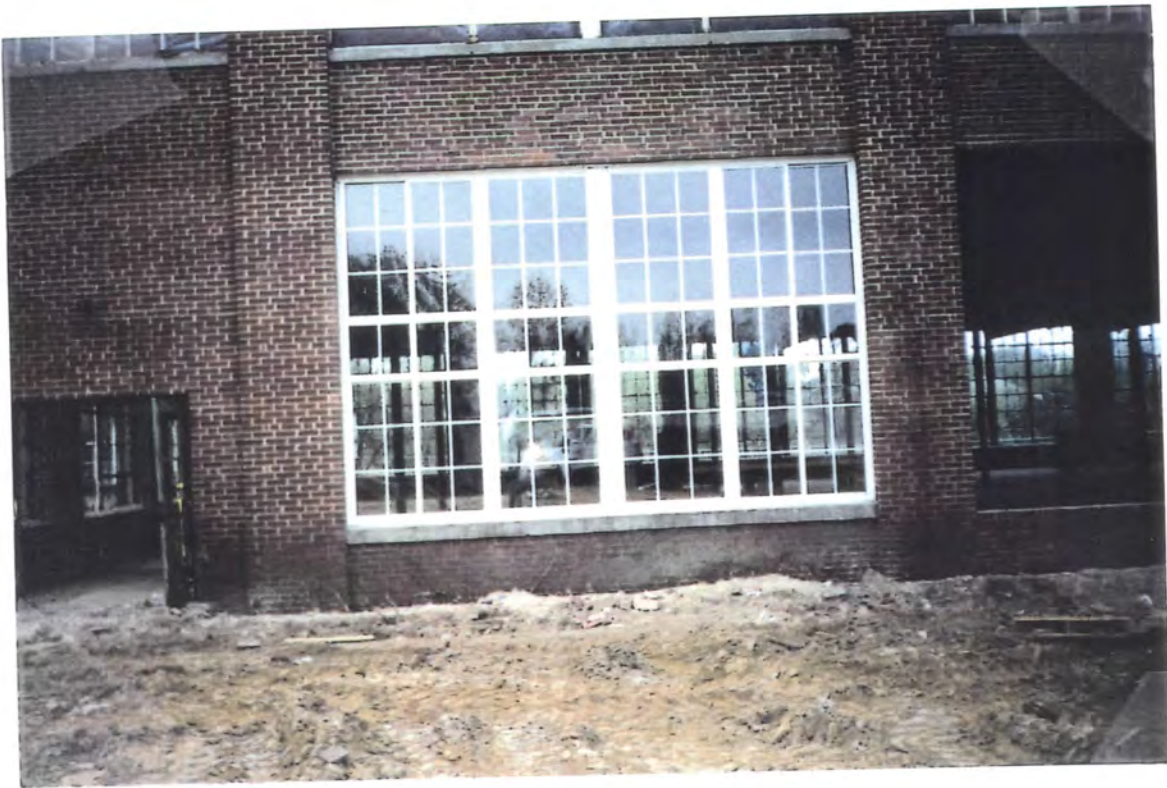
JOHNSTON MILL. SOUTH WING. PROPOSED REPLACEMENT WDO.

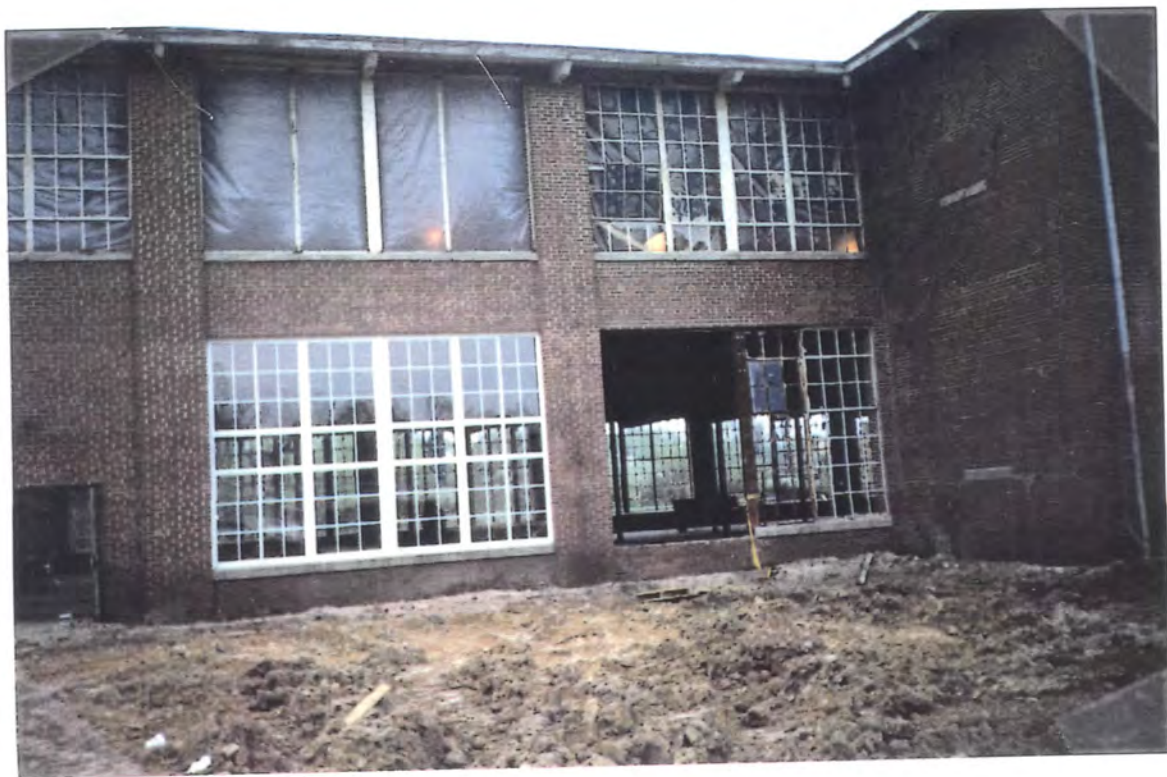
PROPOSED REPLACEMENT WINDOW + EXISTING WINDOW ABOVE.

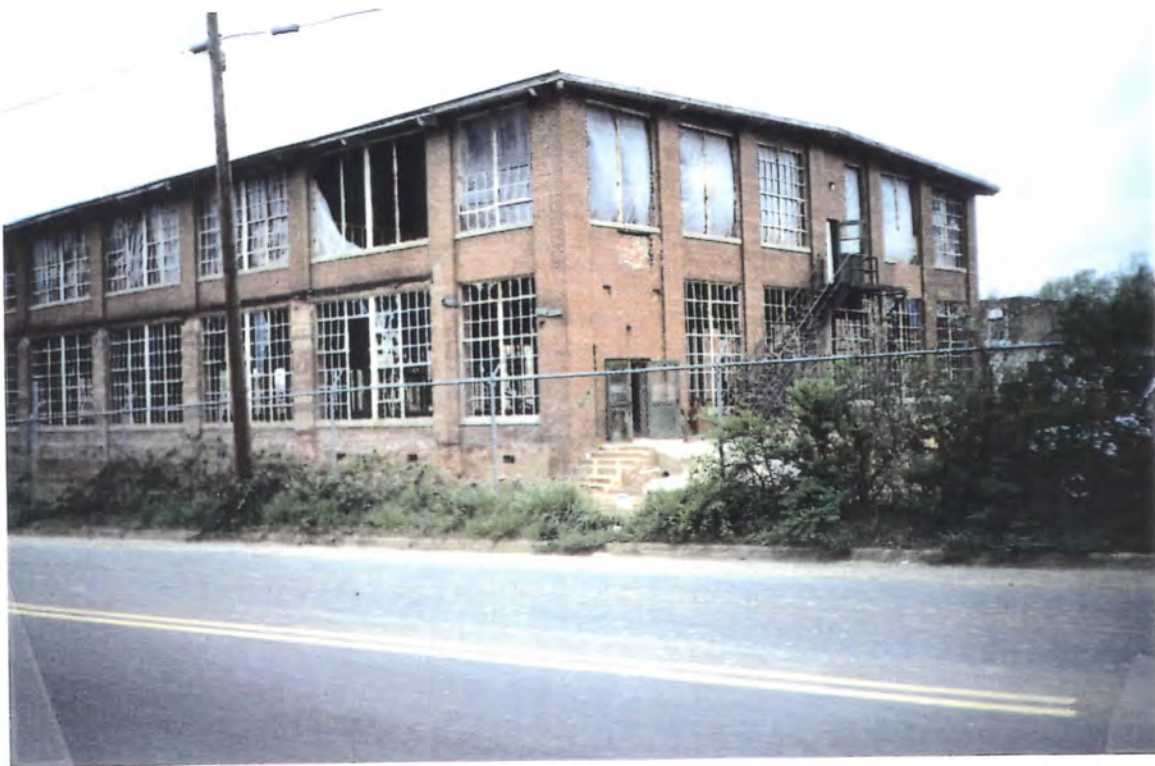
EXISTING / ORIGINAL WINDOWS / SOUTH WING

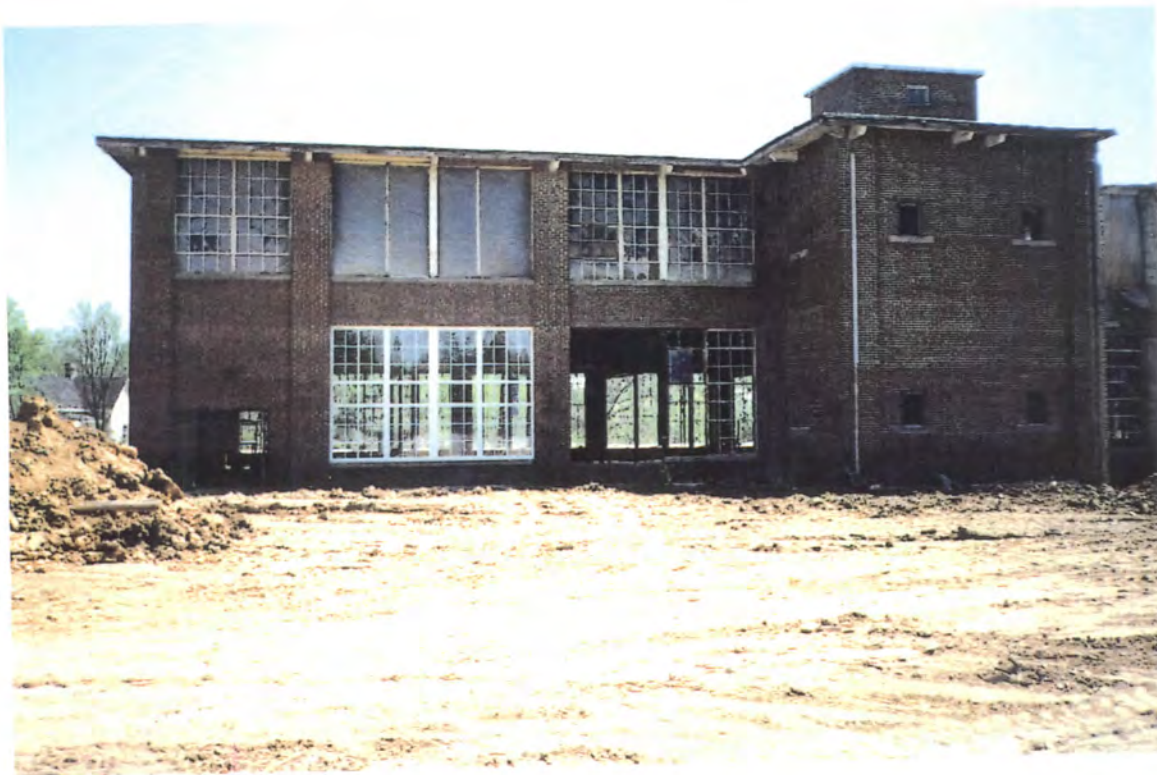
PROPOSED + EXISTING WINDOWS - SOUTH WING

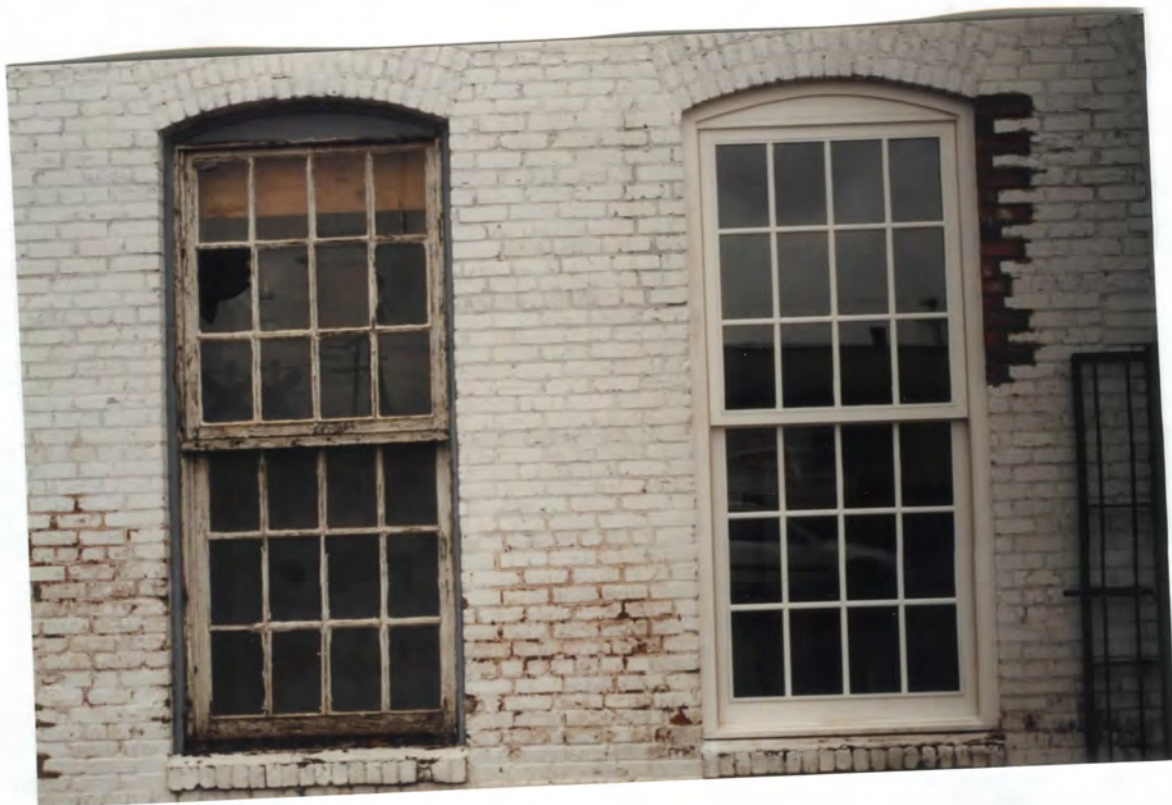
Replacement window (double hung) next to existing top sash awning window

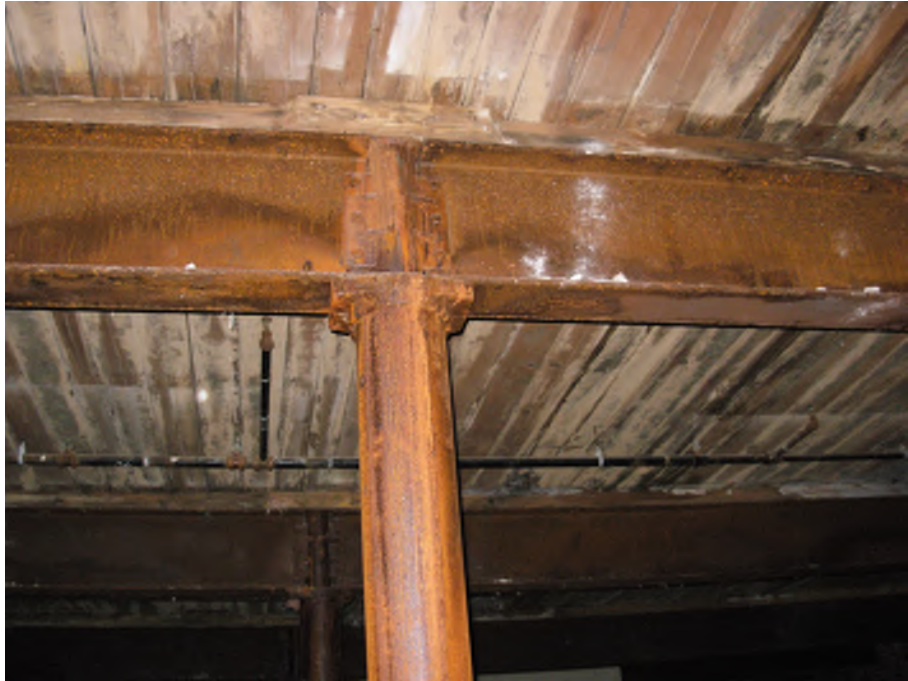
Photo #1: Typical steel framing at column and beam connections.

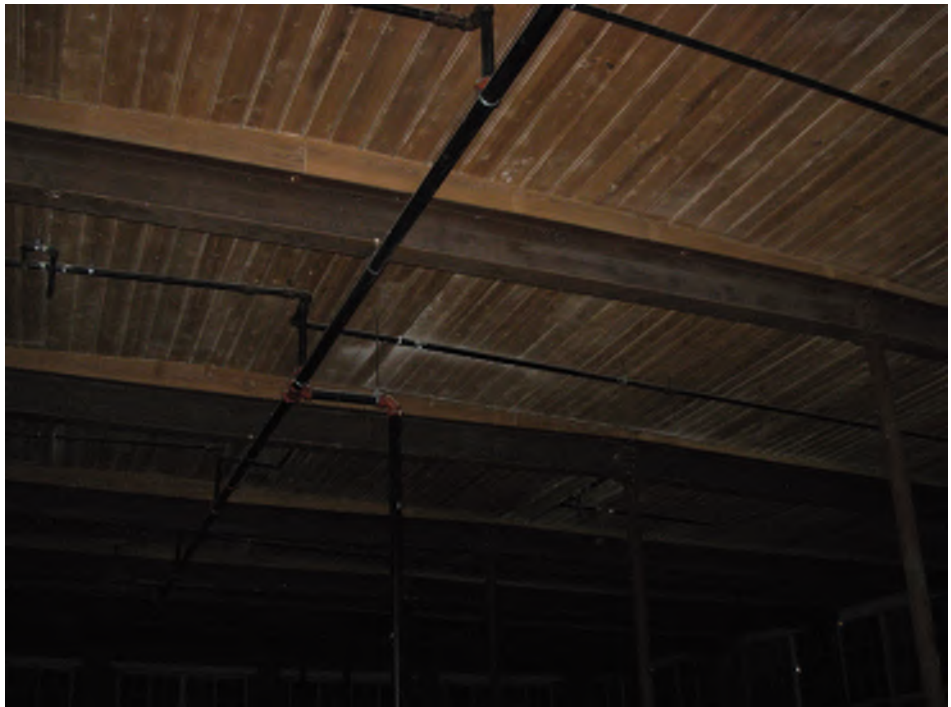
Photo #2: Overall typical steel framing at roof level.

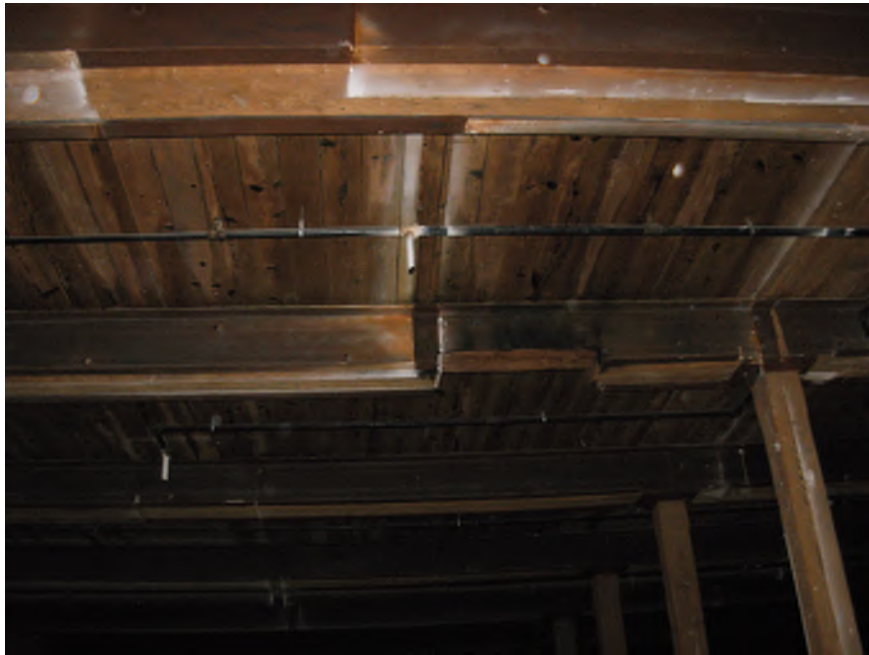
Photo #9: Typical full length channel reinforcing on each side of timber beams. Note the unacceptable torch cut notch in the bottom of the beam. This is a critical section of the beam and should not be notched to this extent.

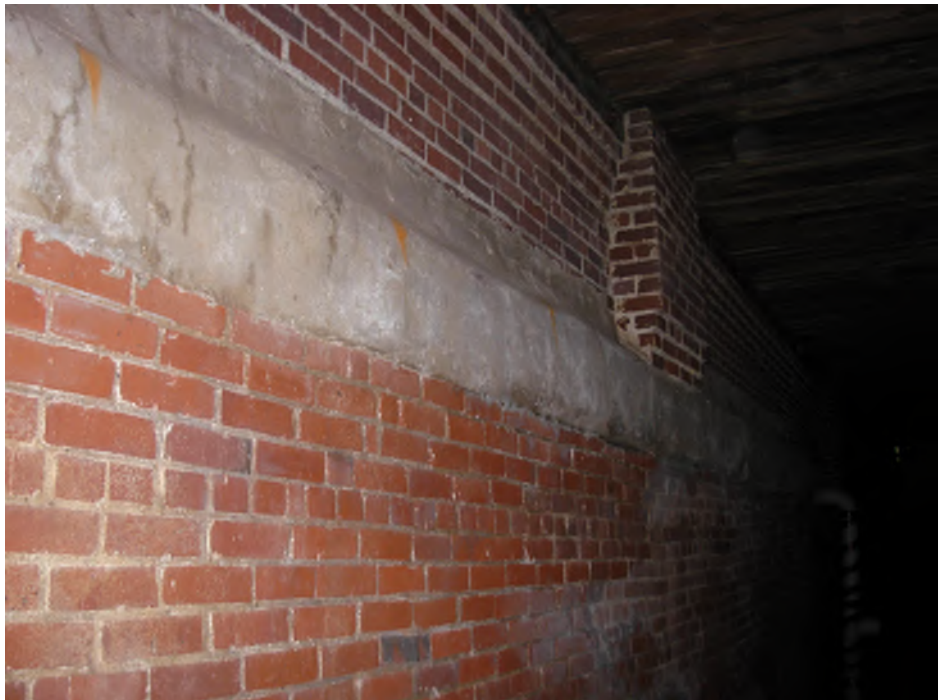
Photo #16: Addition of basement level below continuous footing.

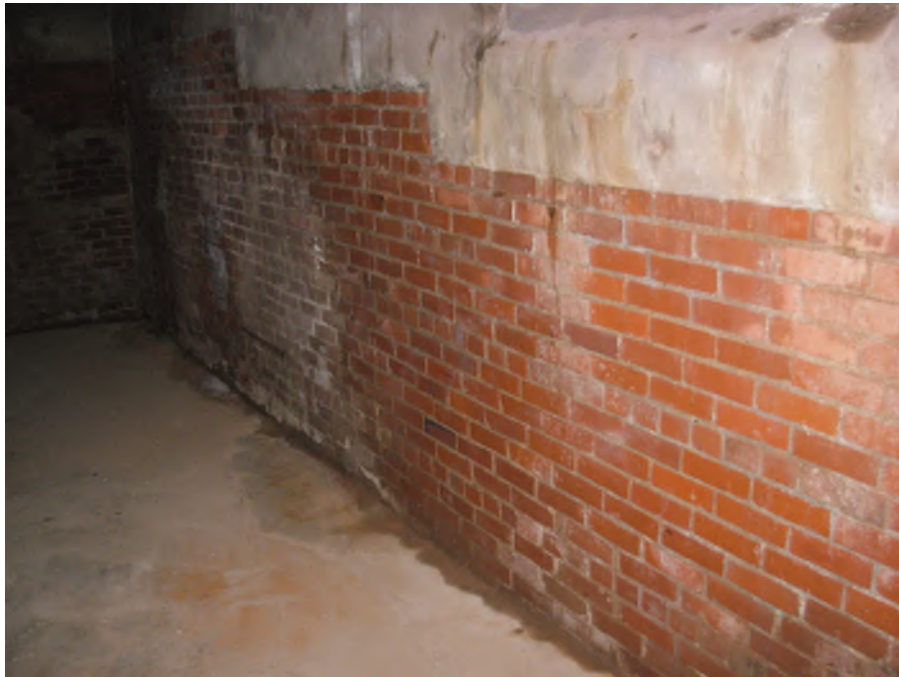
Photo #17: Addition of basement level under original stepped concrete footing.

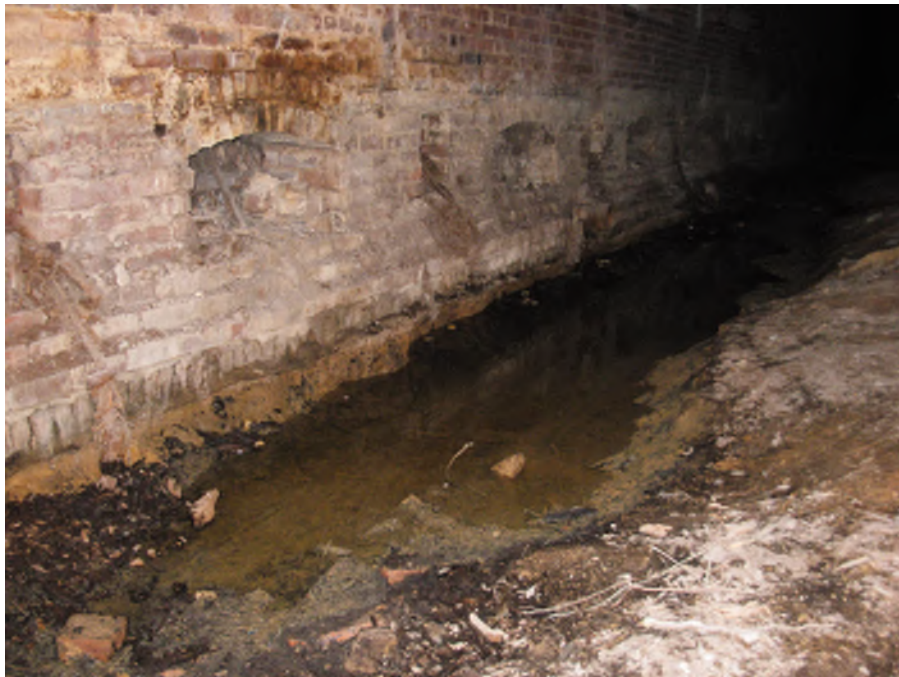
Photo #18: Removed wooden framing at crawlspace area and exposed continuous exterior wall footing which has been undermined by water intrusion.

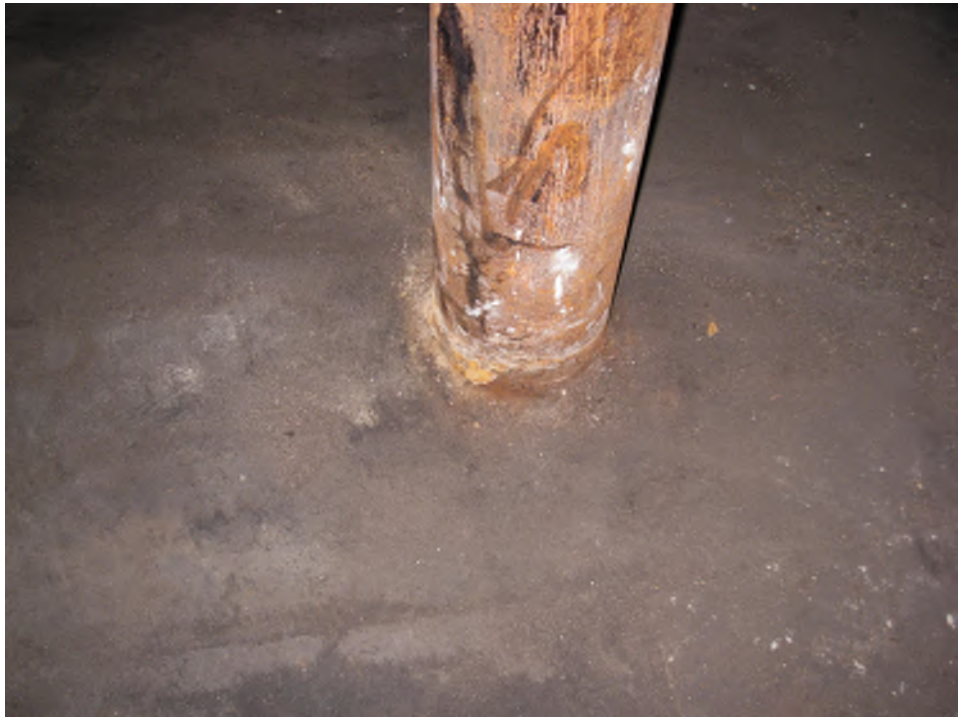
Photo #19: Compacted coal fines and no evident sign of footing size or existence.

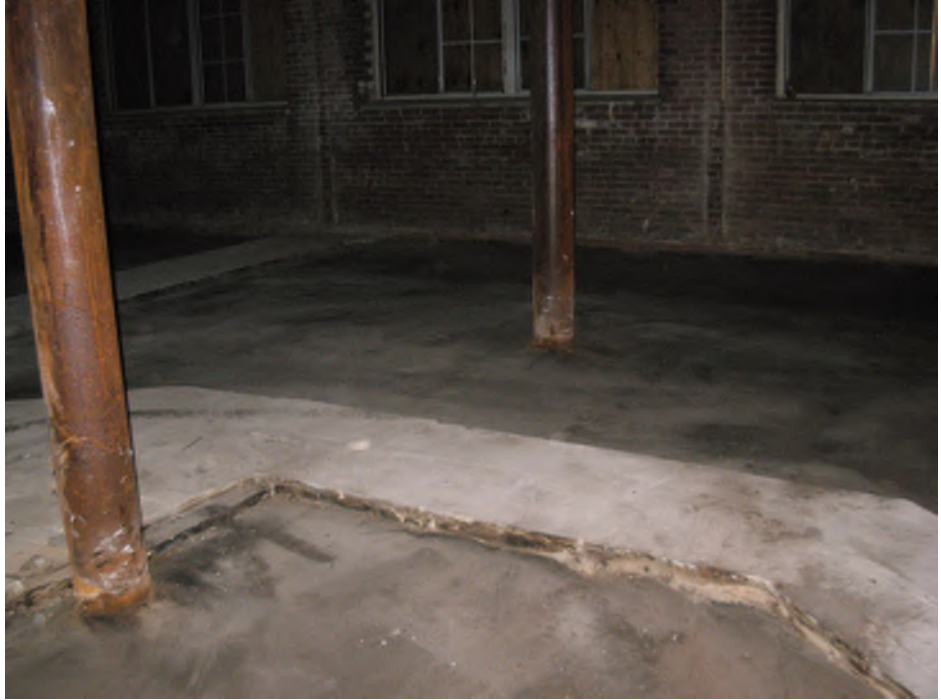
Photo #21: Continuous footings possibly from previous renovation to support load bearing walls.

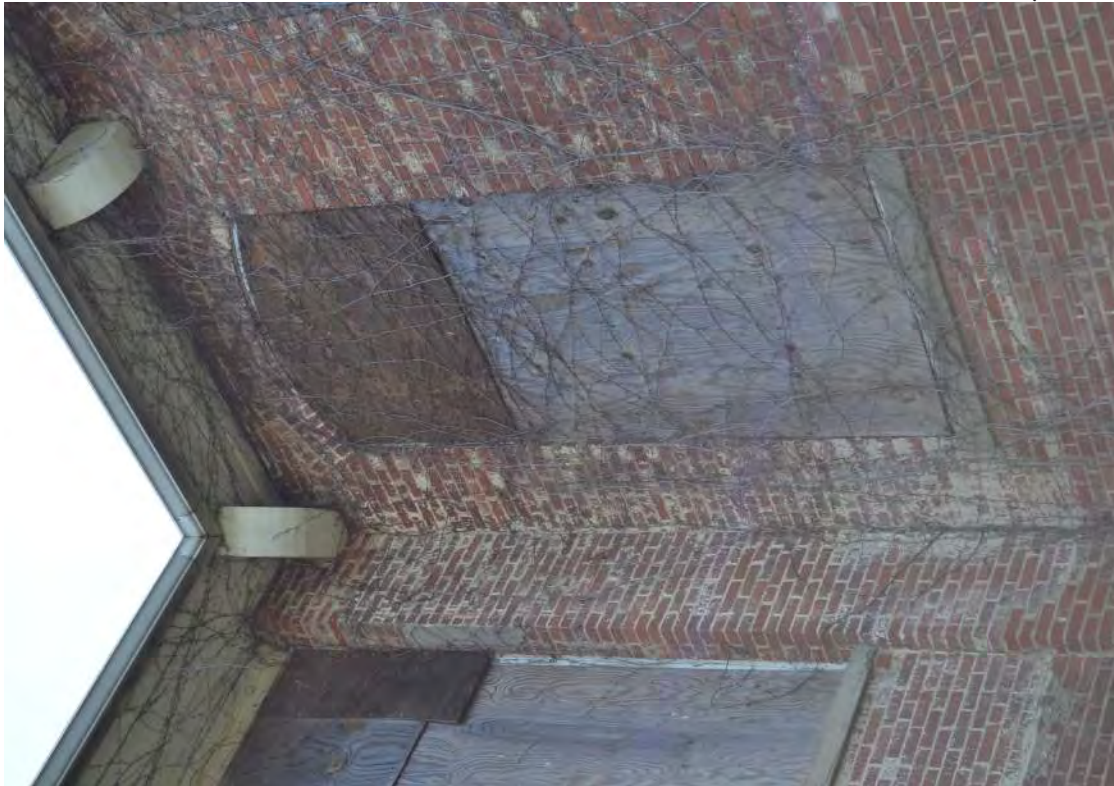
13. Detail at cornice/roof line showing wood fascia and brackets, typical of most

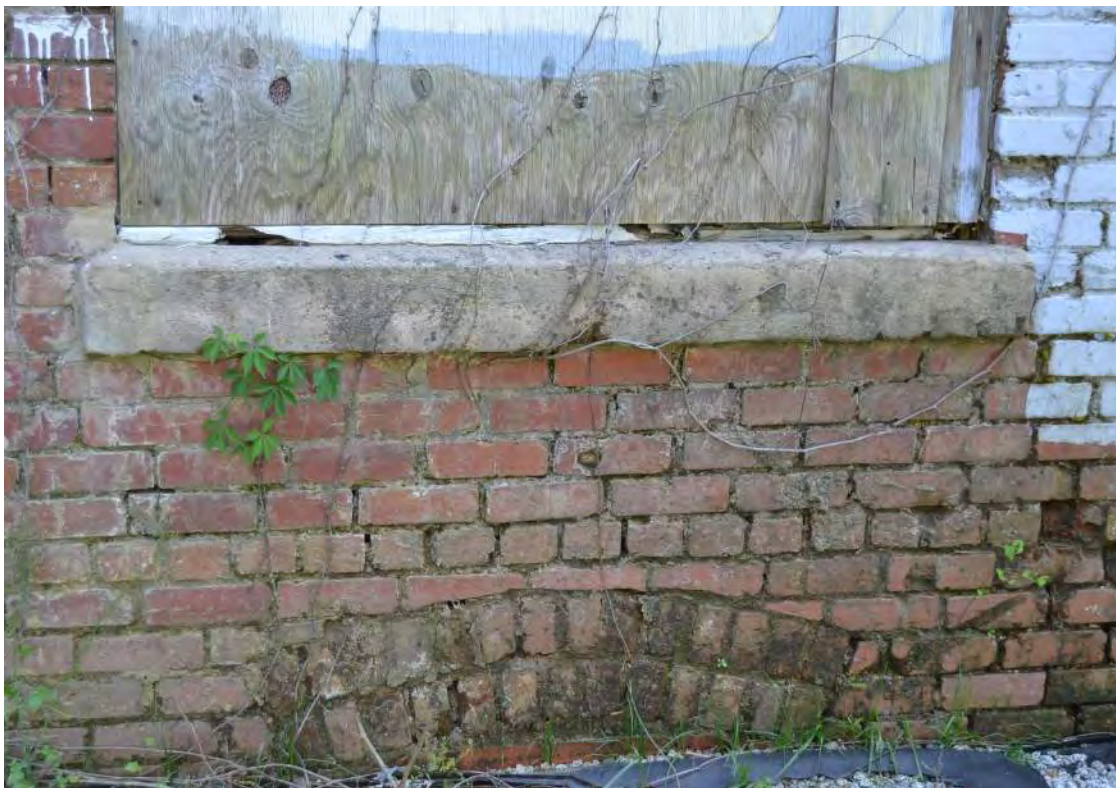
14. Detail of sill at window opening, typical of some

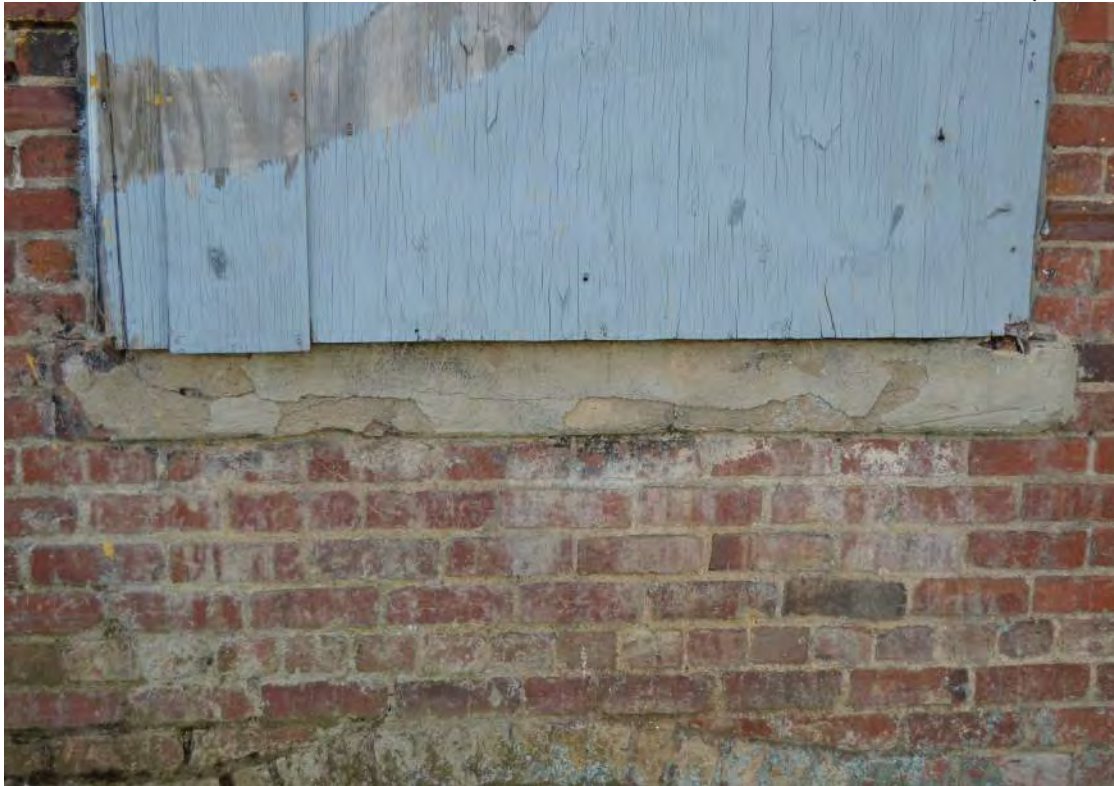
15. Detail of sill at window opening, typical of some

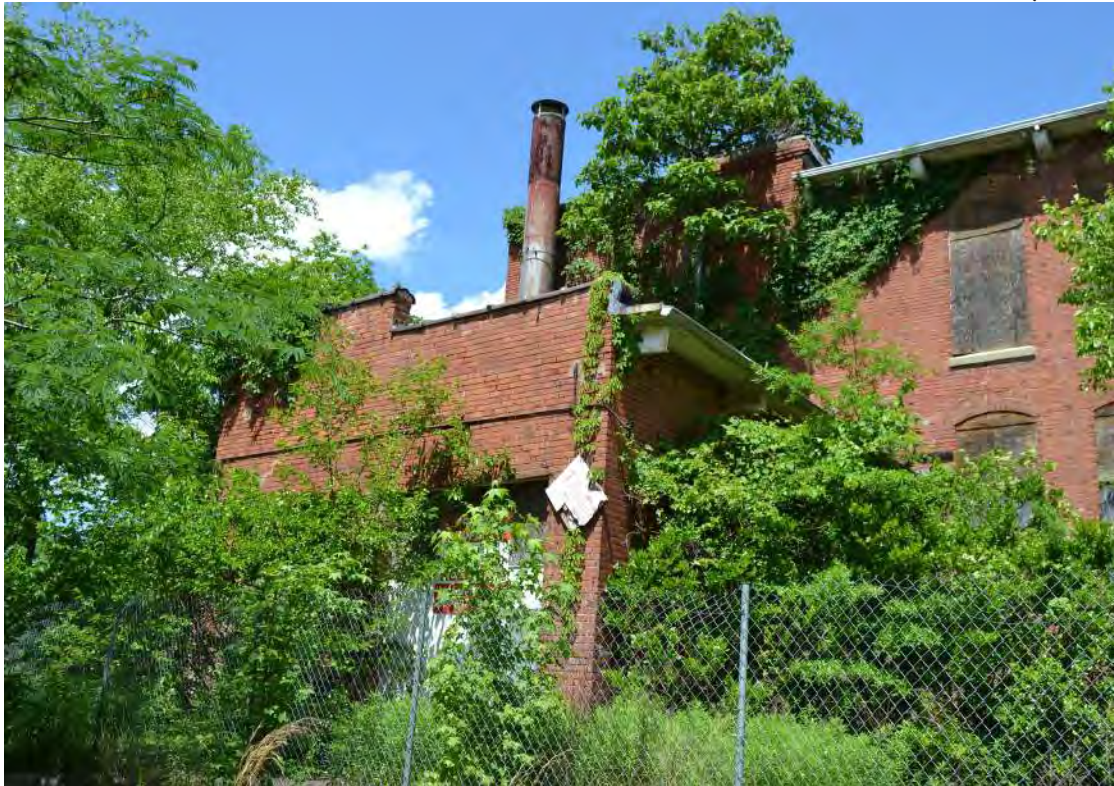
22. View southeast towards west elevation of original portion from within surface lot

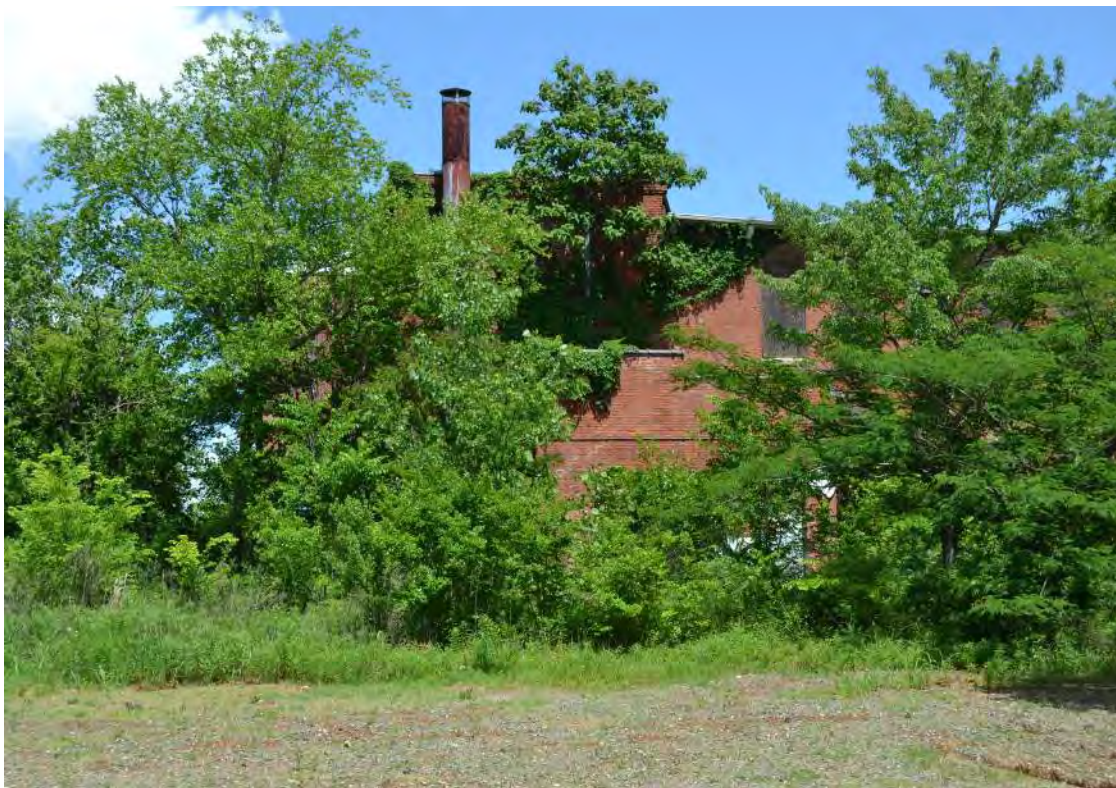
23. West elevation at north wing boiler room, view northeast

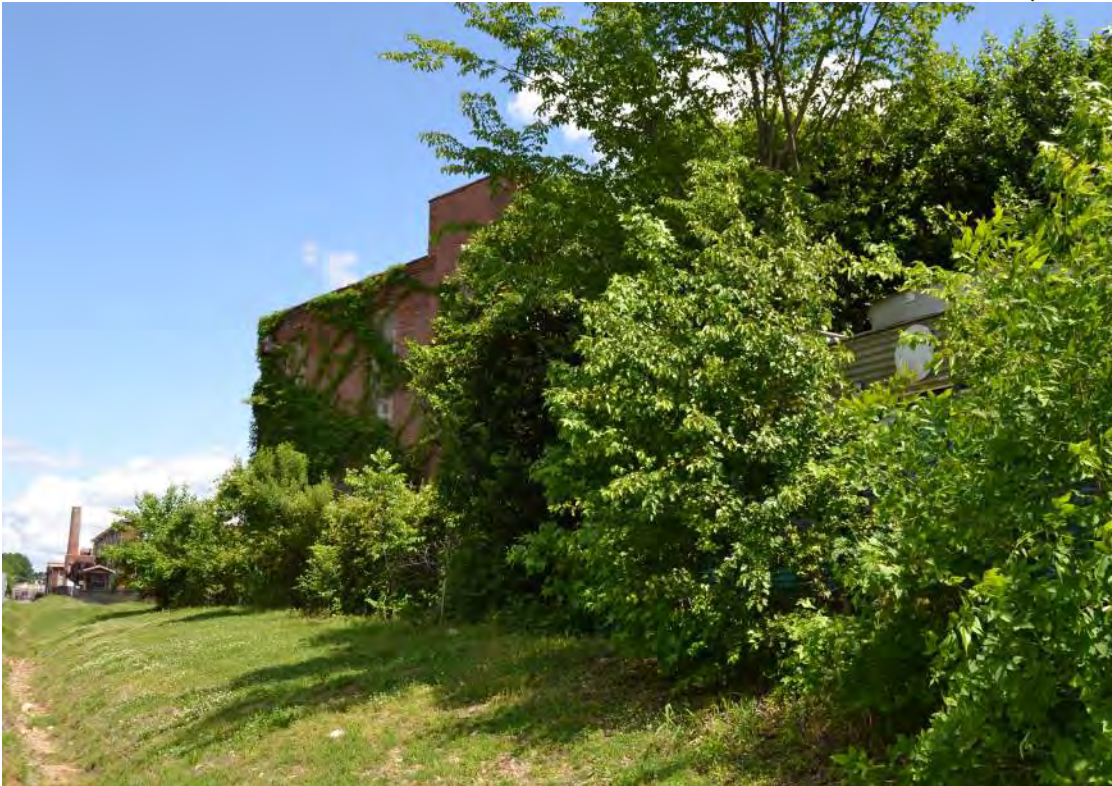
24. West elevation at north wing boiler room, view east

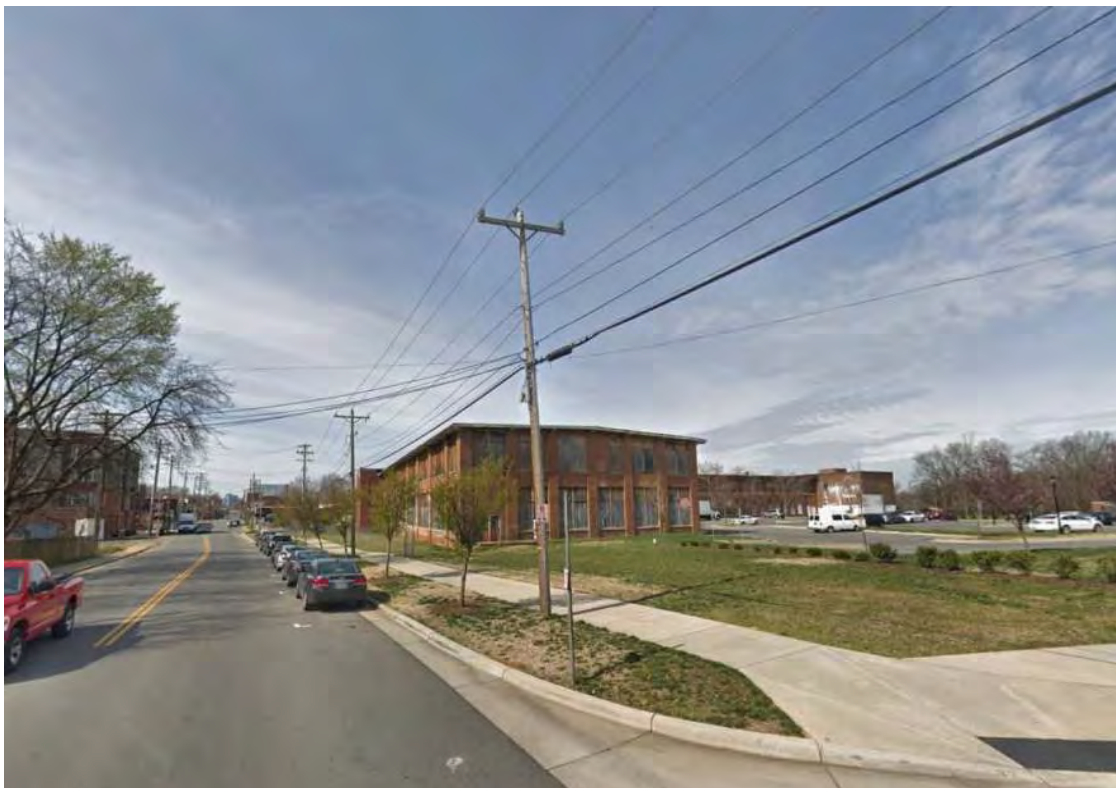
25. North elevation of north wing, view southeast; light rail line at left; unrelated Mecklenburg Mill in far background at left

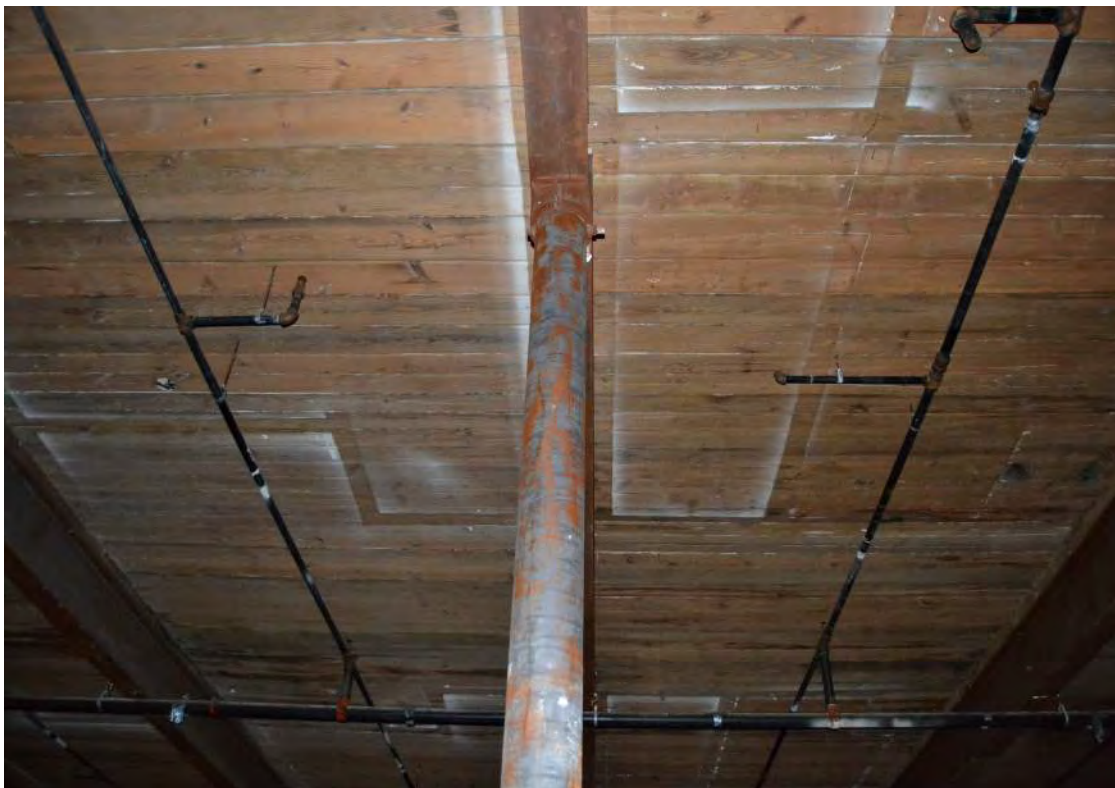
41. First floor, south wing, detail at windows (typical)

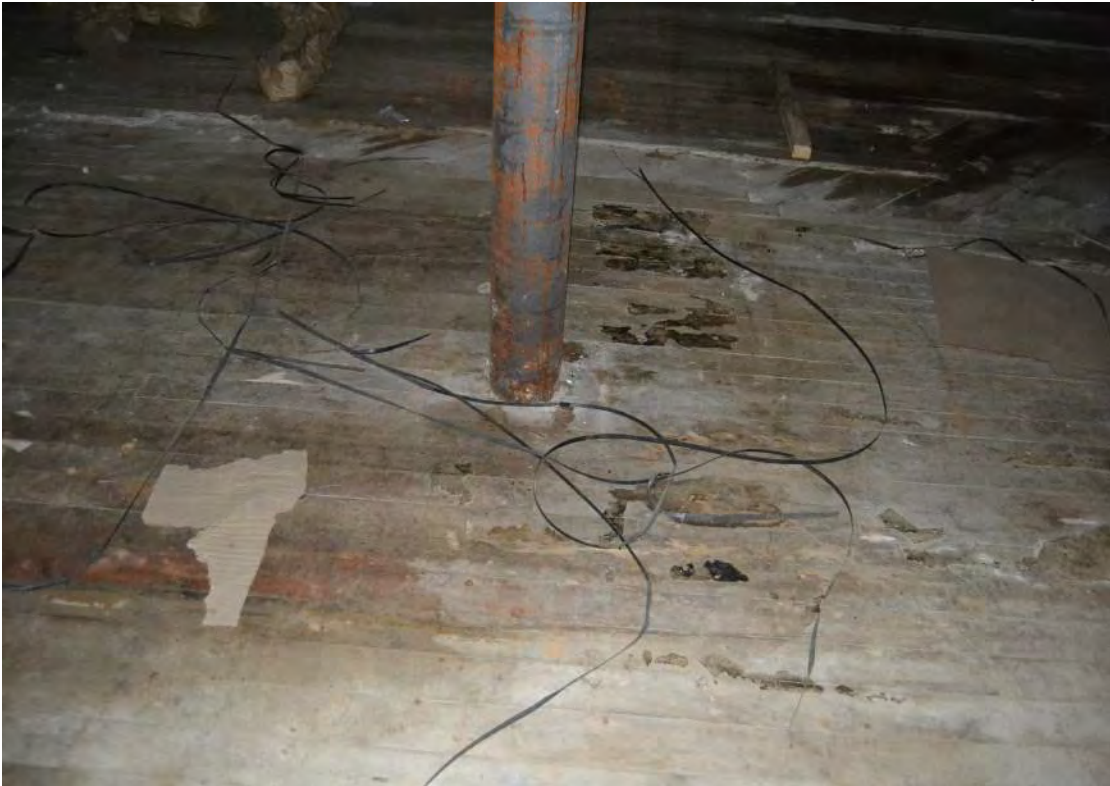
42. First floor, south wing, detail of steel column

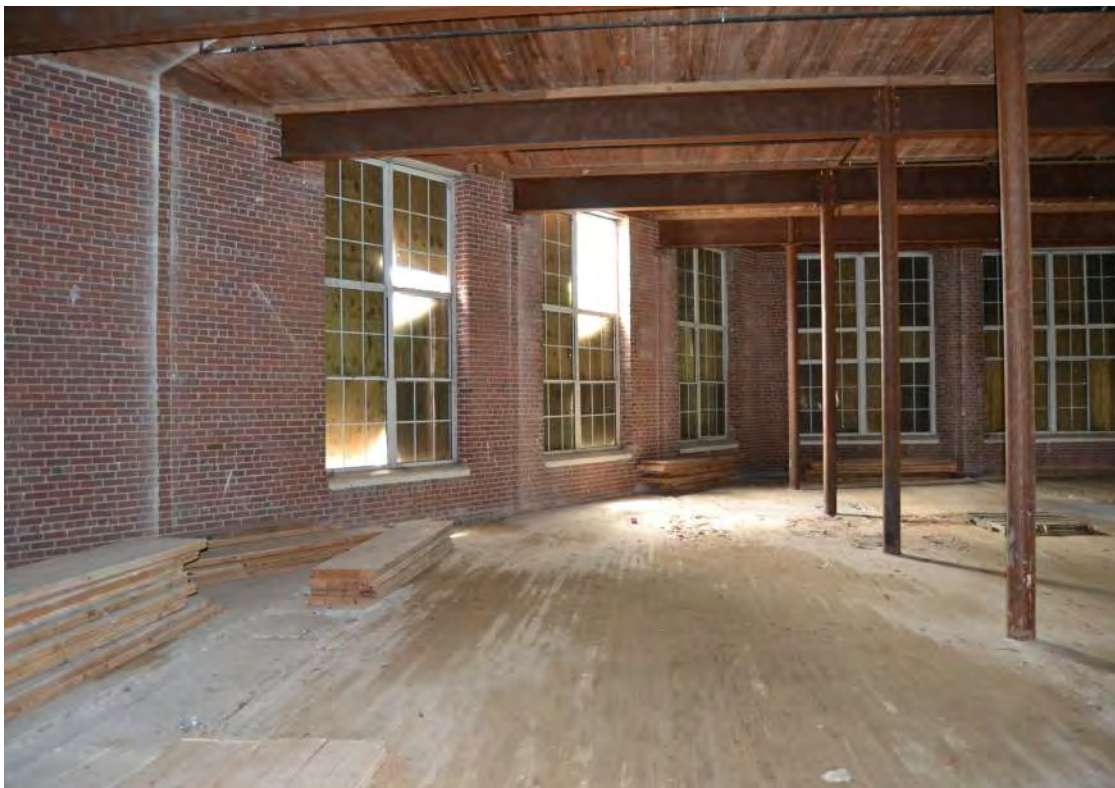
43. First floor, south wing, steel column and floor structure detail; evidence for former gypsum concrete at right

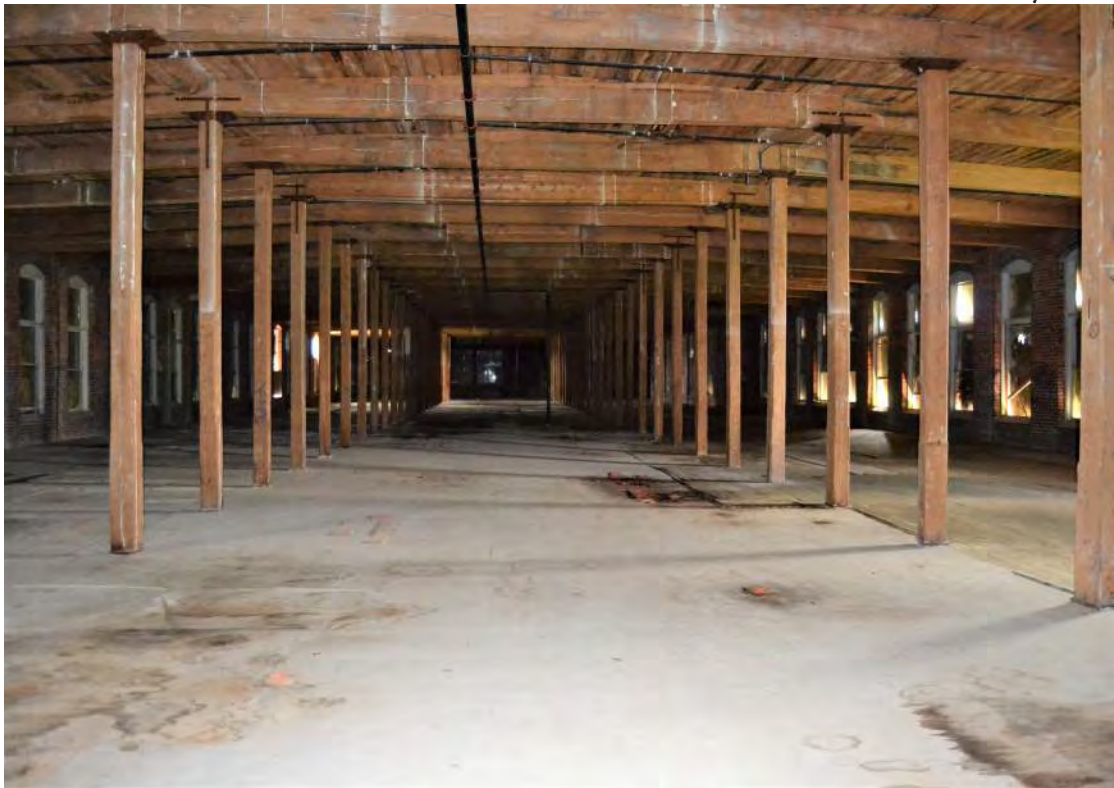
55. First floor, south wing, detail of steel reinforced timbers

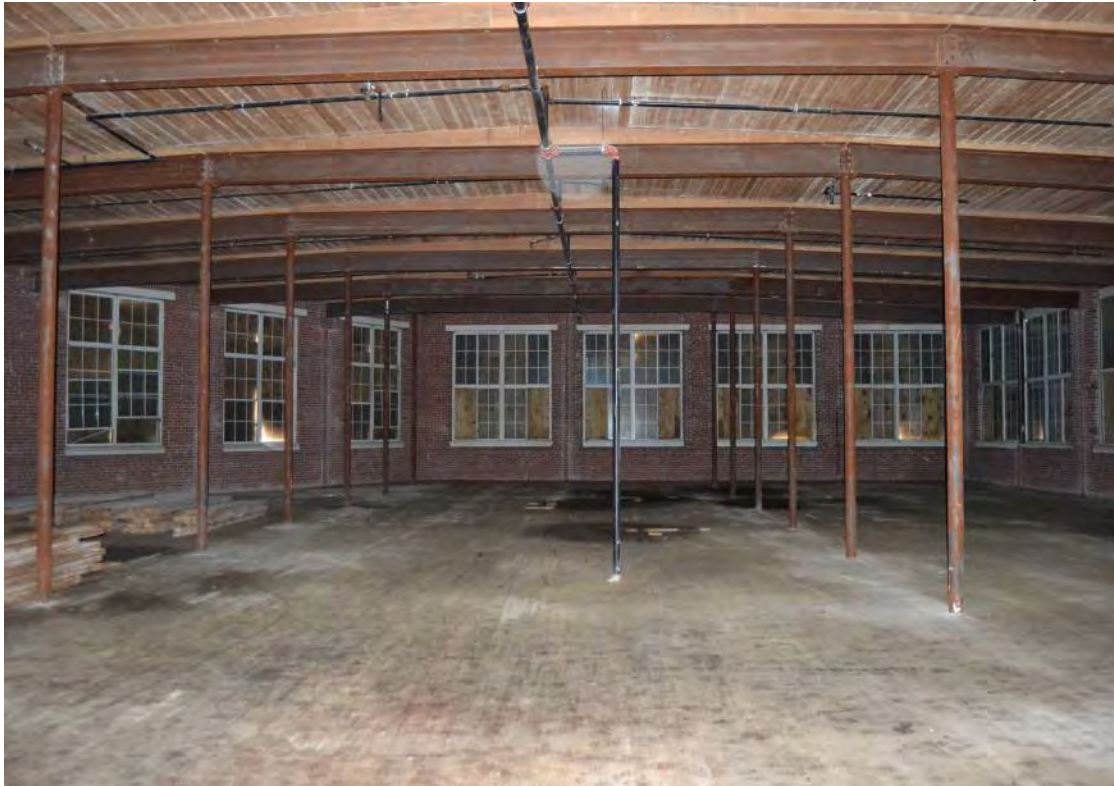
61. Second floor, south wing, detail of steel and wood structure
