HISTORIC PRESERVATION CERTIFICATION APPLICATION PART 2 – DESCRIPTION OF REHABILITATION

Property name Johnston Mill

NPS Project Number 40,603

Property address 3315 North Davidson Street, Charlotte NC 28205

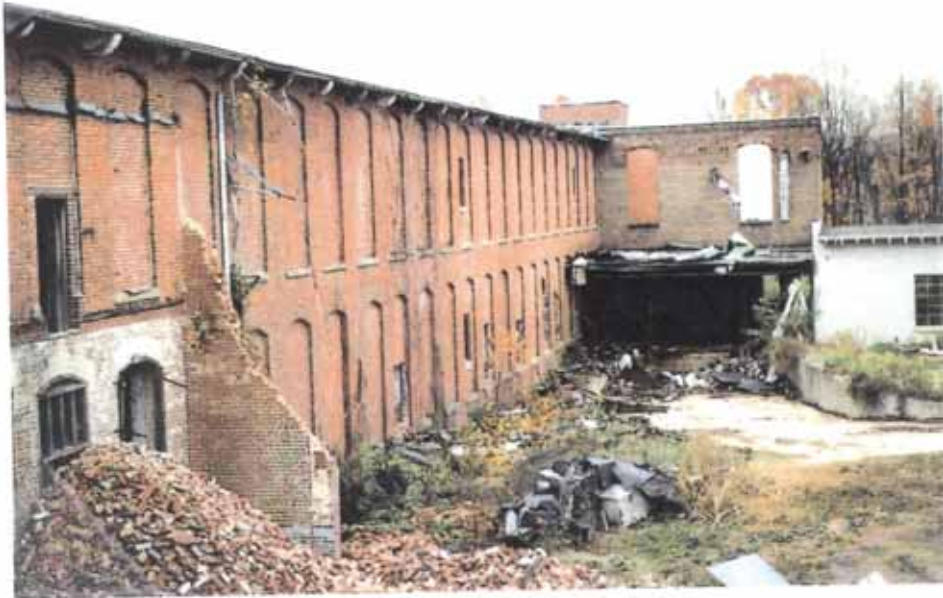
JOHNSTON MILL • NORTH WING • PRIOR TO RENOVATION.

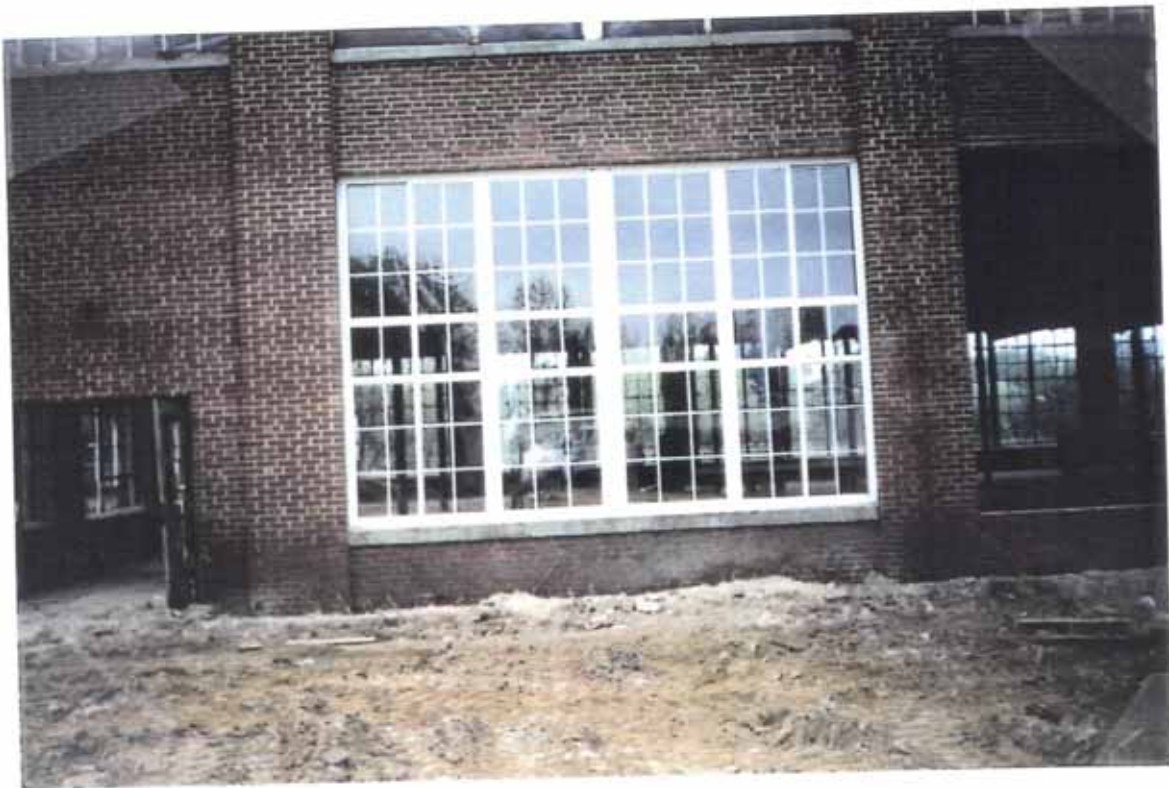
JOHNSTON MILL. SOUTH WING. PROPOSED REPLACEMENT WDO.

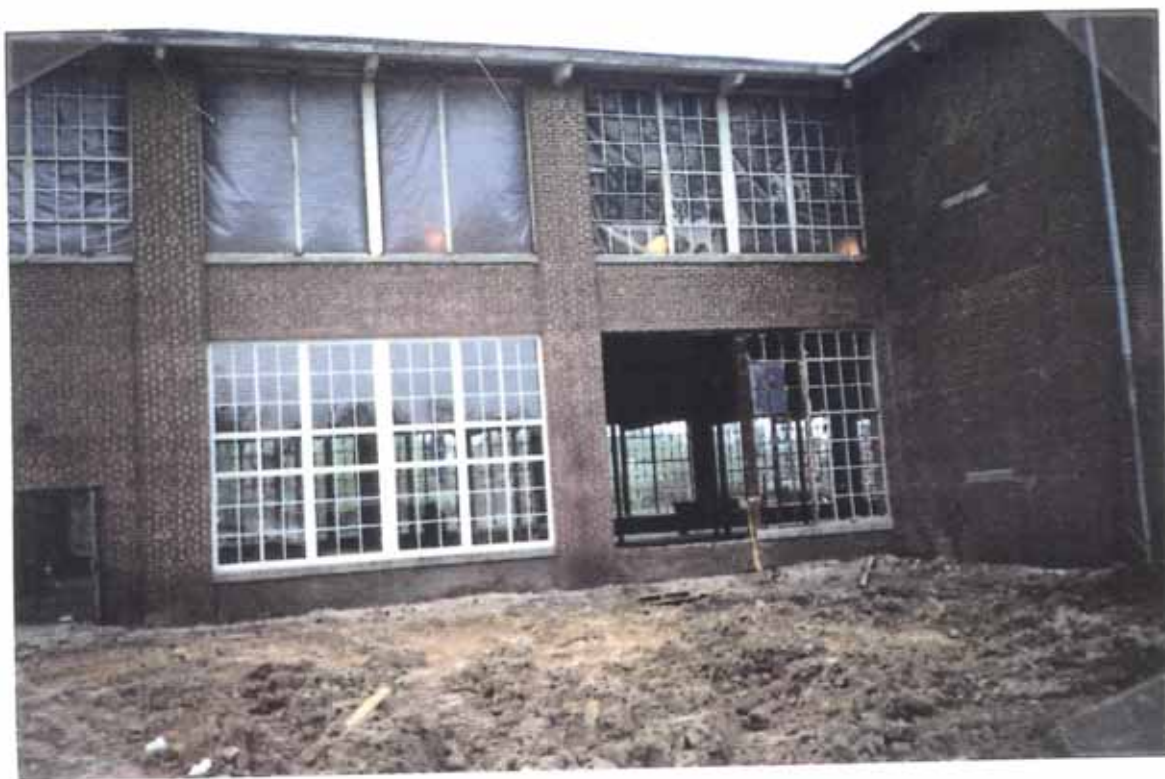
PROPOSED REPLACEMENT WINDOW + EXISTING WINDOW ABOVE.

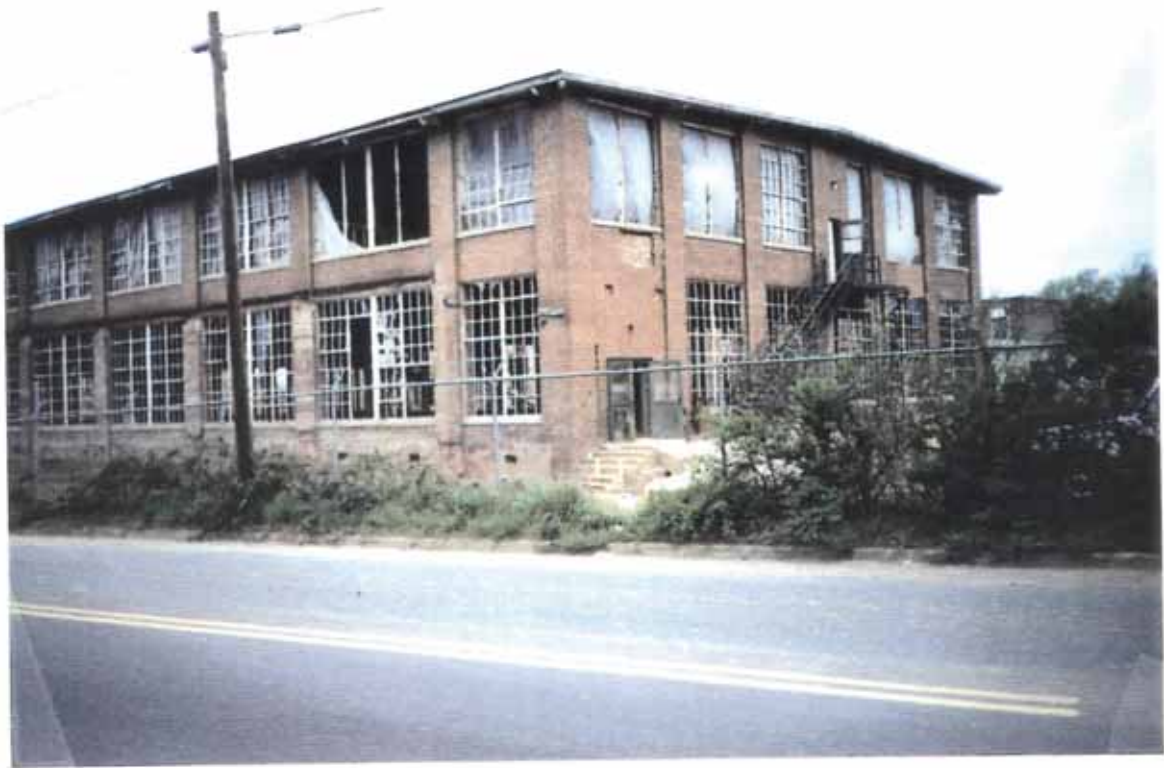
EXISTING / ORIGINAL WINDOWS / SOUTH WING

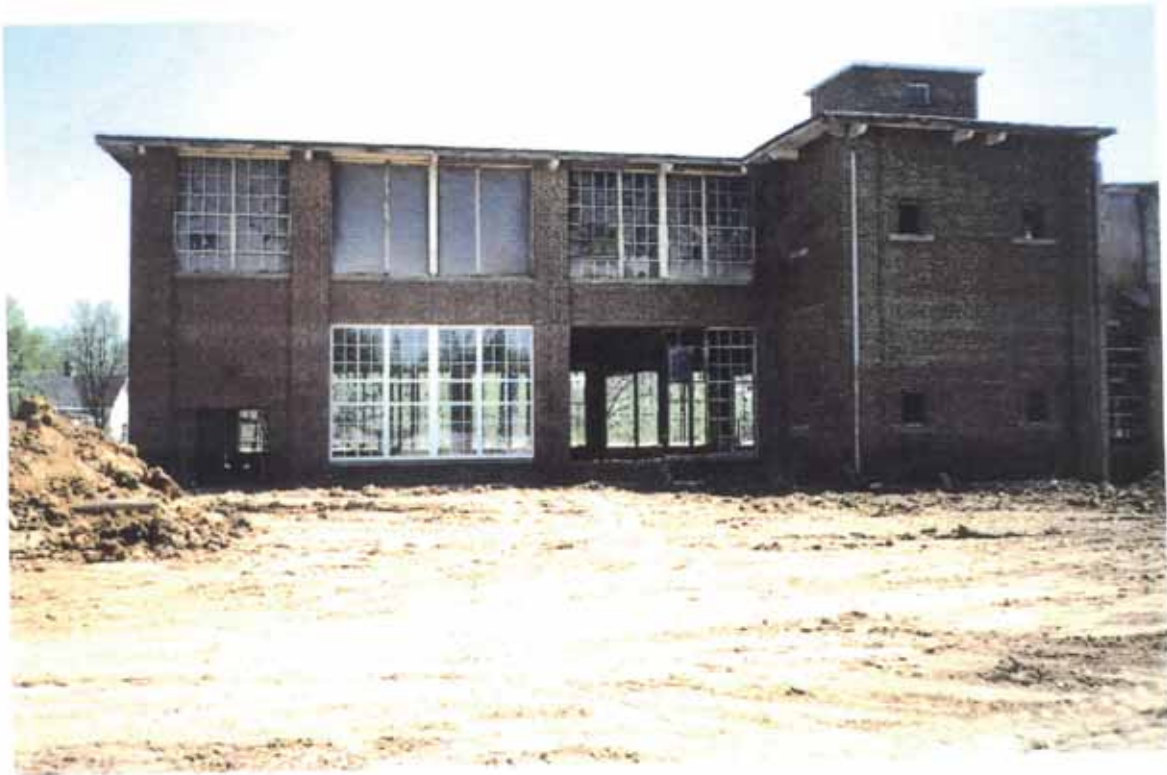
PROPOSED + EXISTING WINDOWS • SOUTH WING

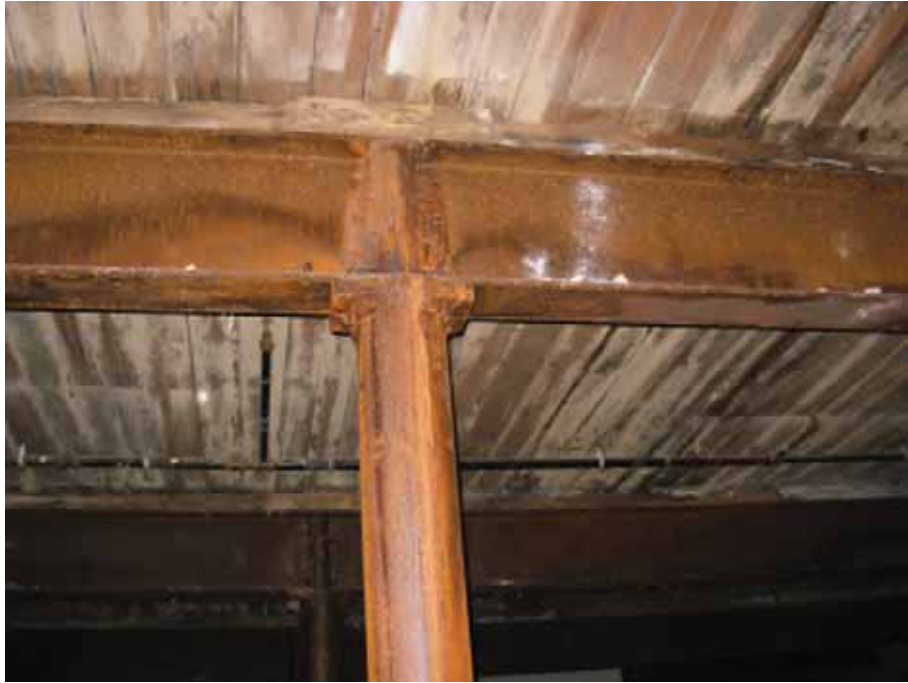
Due to the limited number of items and minimal level of issues seen with the steel structure an in depth synopsis of this portion of the building will not be presented. Instead a few photos are provided to highlight the typical steel construction used in the building. Photos 1 and 2 give a good representation of the steel construction and show the minor surface rusting seen on most members.

Photo #1: Typical steel framing at column and beam connections.

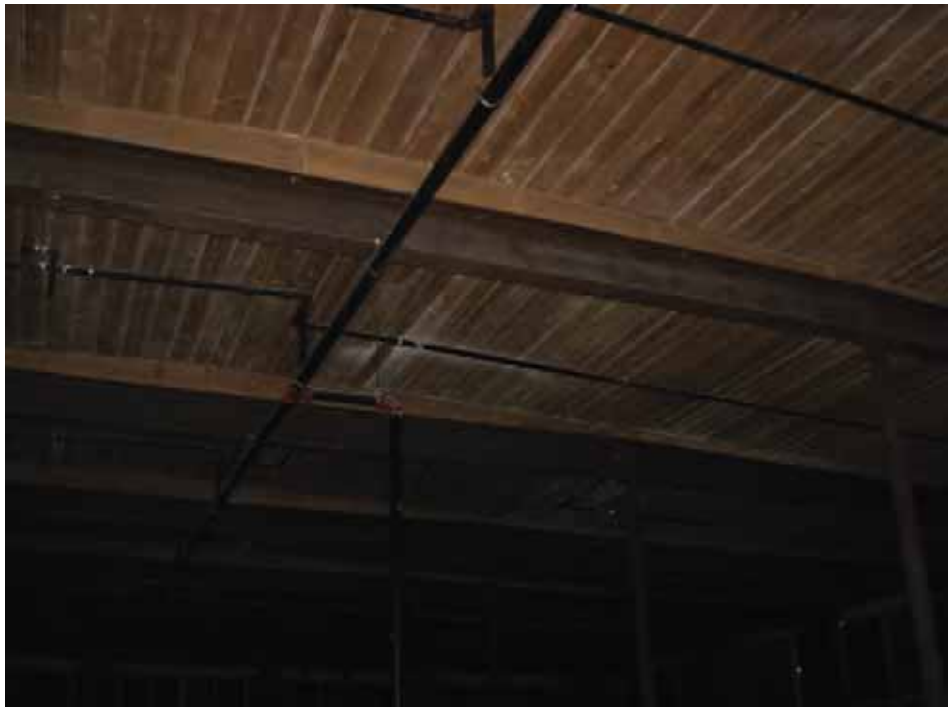
Photo #2: Overall typical steel framing at roof level.

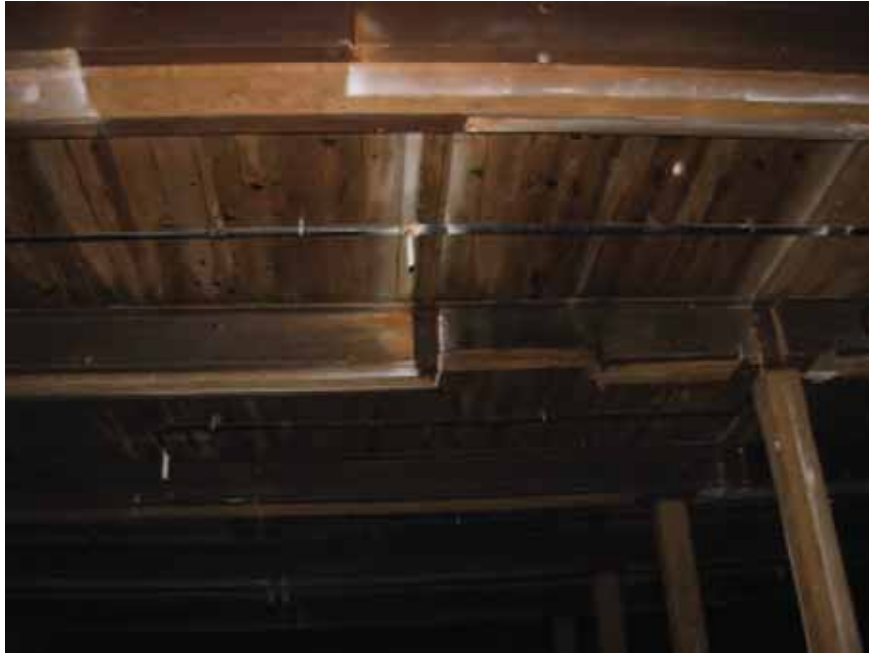
The reason for the channel reinforcing on some of these members is unknown and could have possibly been implemented to increase the load carrying capacity of a structurally sound wooden timber for the original mill operations. Photo 9 shows a very large notch that has been torch cut into the channels and burnt the wood timber between. This type of modification is un-acceptable because the bottom side of the member has been severely compromised on the tension face of the beam.

Photo #9: Typical full length channel reinforcing on each side of timber beams. Note the unacceptable torch cut notch in the bottom of the beam. This is a critical section of the beam and should not be notched to this extent.

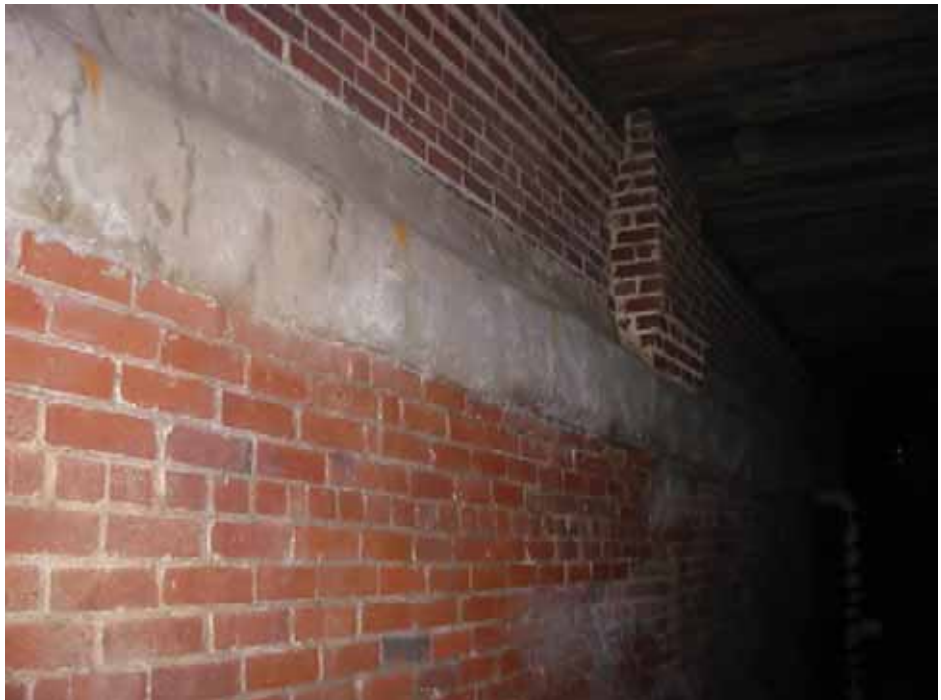
There are some very unique foundation conditions with this building that were observed during our field visits. At one point a basement was added to a portion of the building. From our observations we were unable to determine when the addition was made, but it is clearly seen by photos 16 and 17 where the original continuous footing was excavated under and a new brick wall was placed beneath. In the timber framed portion of the building where the floor framing was already removed the foundation was exposed. At this particular area it was noted that the footing for the exterior bearing walls appeared to be constructed out of brick and were completely exposed. Water had accumulated next to the footing and concerns of the footings being undermined needs to be addressed. Photo 18 shows the condition of the brick footings and water eroding the soil away below. This photo also shows the original beam pockets that no longer support members due to their removal from being severely damaged. In this area of the building we expect significant repair to the foundation and lower brick wall due to water damage. Geotechnical testing should be performed in this area to determine the soil bearing capacity. We can then determine what, if any, repairs to be performed.

Photo #16: Addition of basement level below continuous footing.

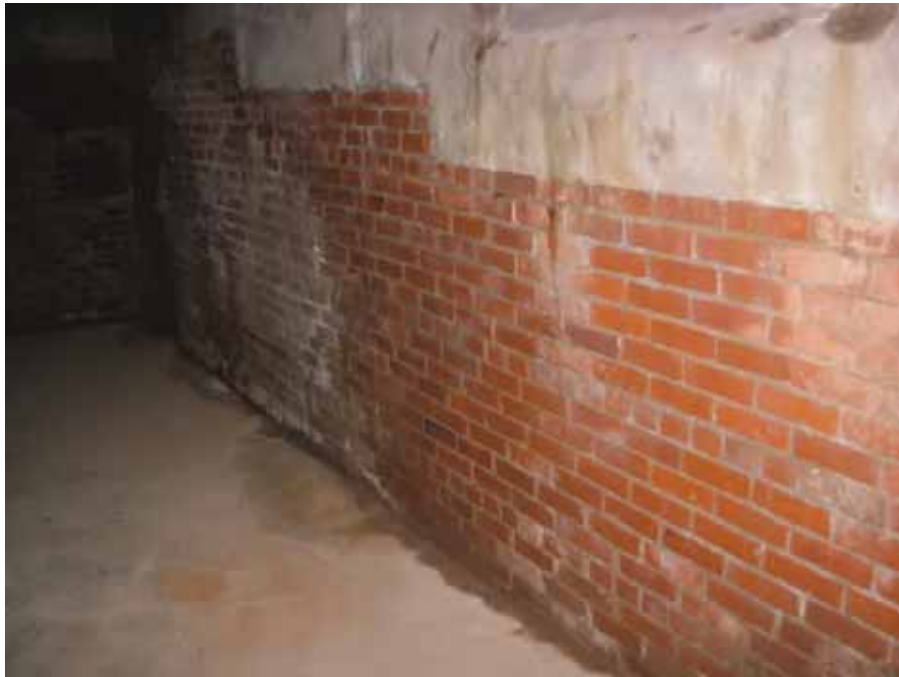
Photo #17: Addition of basement level under original stepped concrete footing.

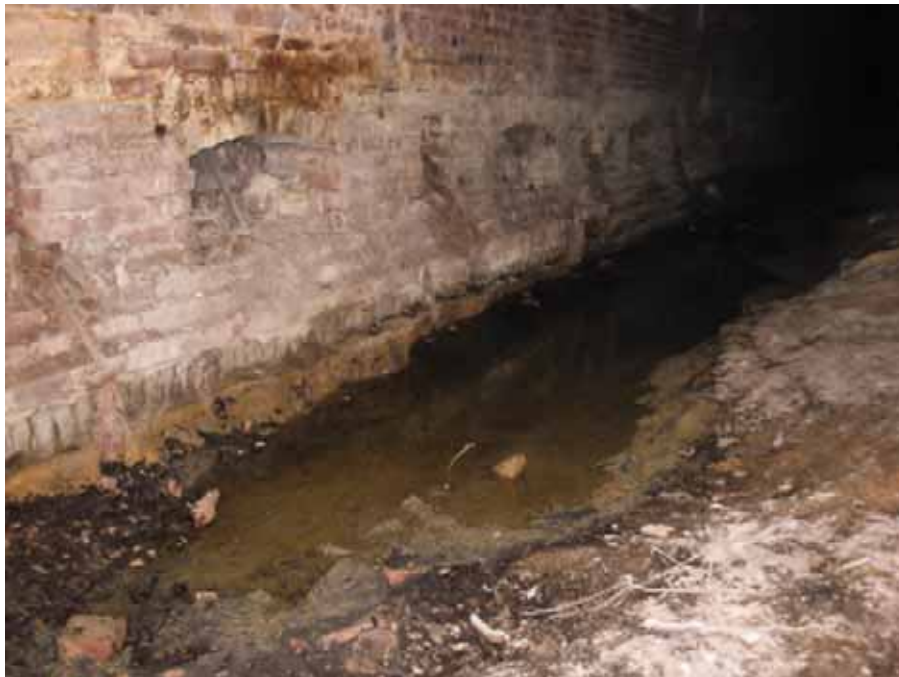
Photo #18: Removed wooden framing at crawlspace area and exposed continuous exterior wall footing which has been undermined by water intrusion.

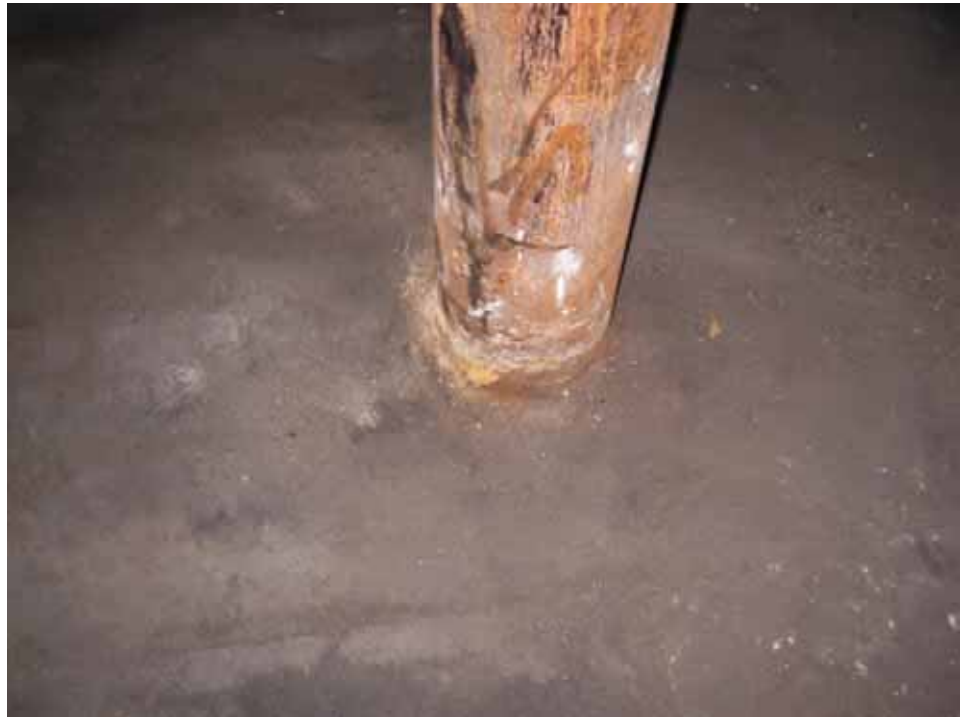
Under the basement portion of the wood timber structure the compacted coal fines can be seen. There was no way to verify the underlying material without creating damage to the existing conditions. During our evaluation we strive to not disrupt or intentionally damage the existing structure to gather more conclusive evidence. With that said we were unable to evaluate if there was any footing present beneath the columns. Photo 19 depicts this condition in the basement. In other areas of the basement under the steel framed sections there appeared to be a slab on grade instead of compacted coal fines found in other areas of the basement. We do not know whether the floor covering was concrete or some form of gypcrete in this area. There were some significant cracks radiating out from the center of the room and spanning across most of the floor area. It appears that there was a sample of the flooring taken at a point of convergence for the cracks. Photo 20 shows the location where the sample was taken and the convergence of these large cracks. We recommend additional geotechnical testing be performed in this area to determine the stability of this area. Depending on the geotechnical findings soil remediation may be required.

Photo #19: Compacted coal fines and no evident sign of footing size or existence.

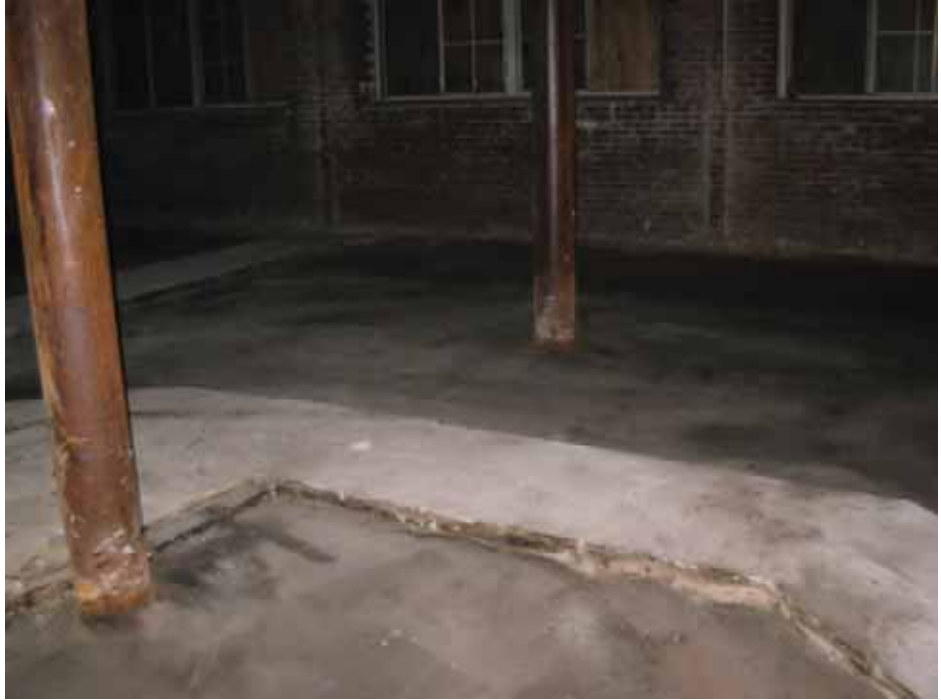
Both the basement areas under the wood framed and steel framed portions of the building had miscellaneous continuous footings exposed. The footings were likely constructed at some point during previous renovations to support load bearing walls. Our evaluation did not evaluate the width or depth of these footings. Photo 21 shows a portion of the continuous footings in the steel framed section of the basement.

Photo #21: Continuous footings possibly from previous renovation to support load bearing walls.
