**Staff Report and Comments
John Douglas House
7601 Christie Lane, Charlotte
Application for COA HLC282**

Issued: November 4, 2022
Revision 1: February 8, 2023
Terracon Project No. FY226106

Re: Structural Evaluation Services
Limited Visual Condition Assessment
John Douglas House
7601 Christie Lane
Charlotte, North Carolina 28202

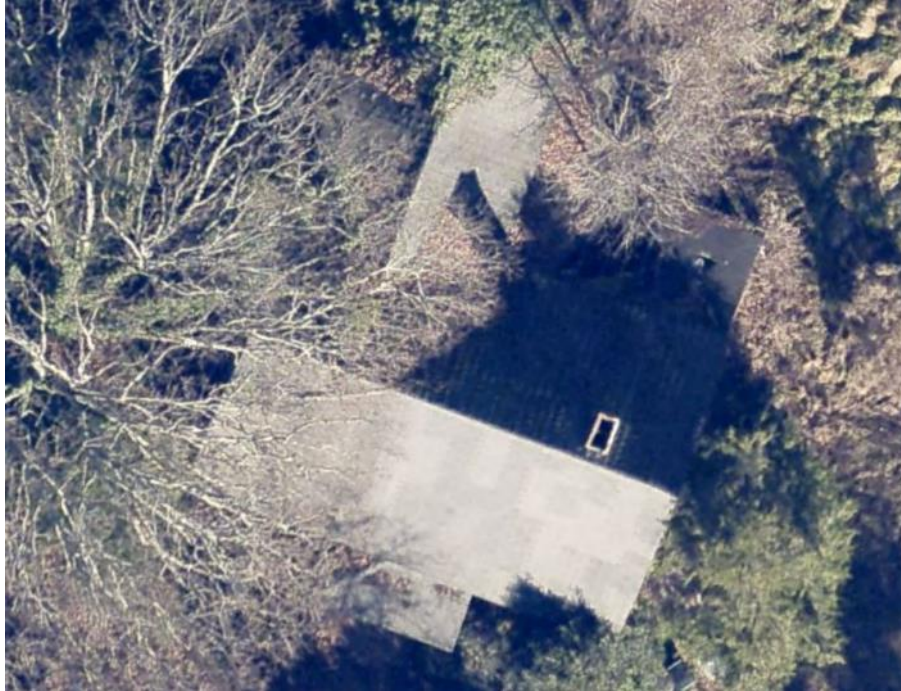
Photograph 1: Eagleview® aerial image obtained from Mecklenburg County's Polaris 3G website, dated 2022

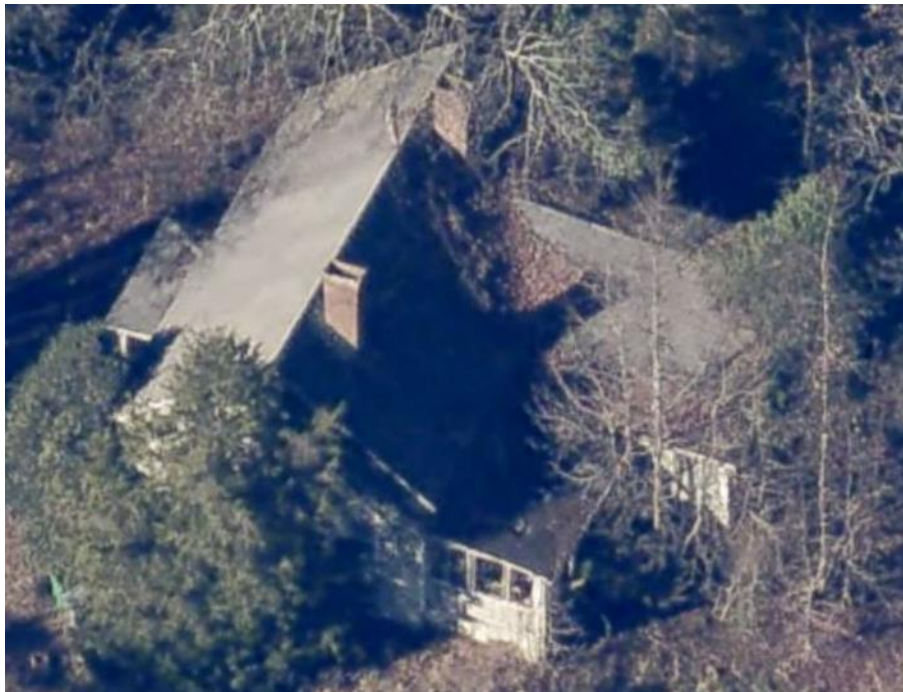
Photograph 2: Eagleview® aerial image obtained from Mecklenburg County's Polaris 3G website, dated 2022.

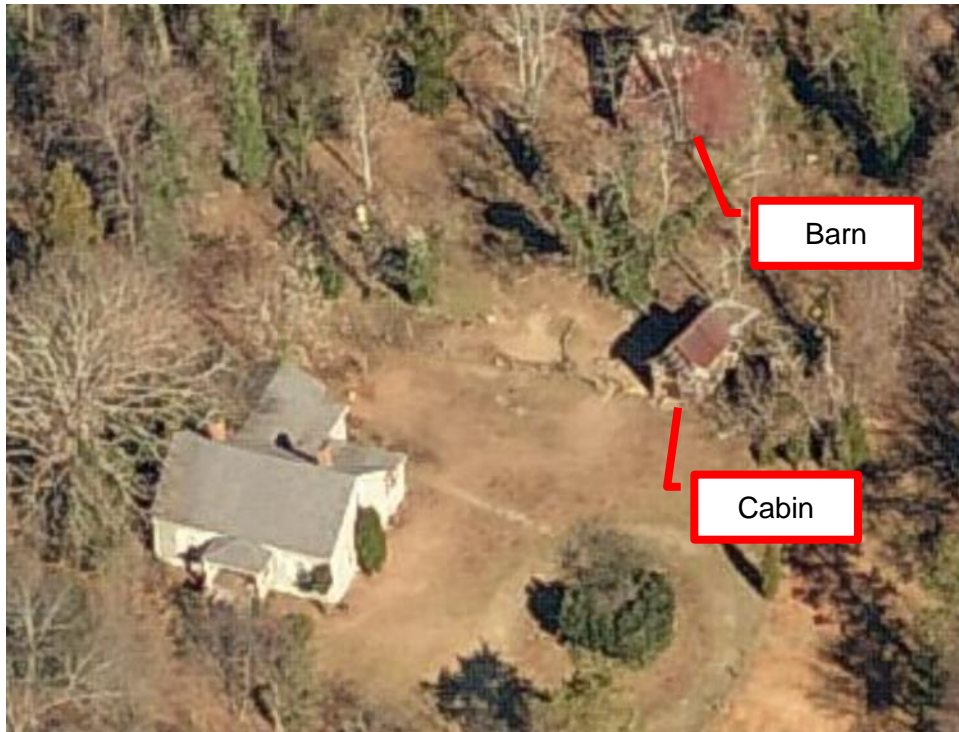
Photograph 3: Eagleview® aerial image obtained from Mecklenburg County's Polaris 3G website, dated 2007. The two known additional structures are highlighted.

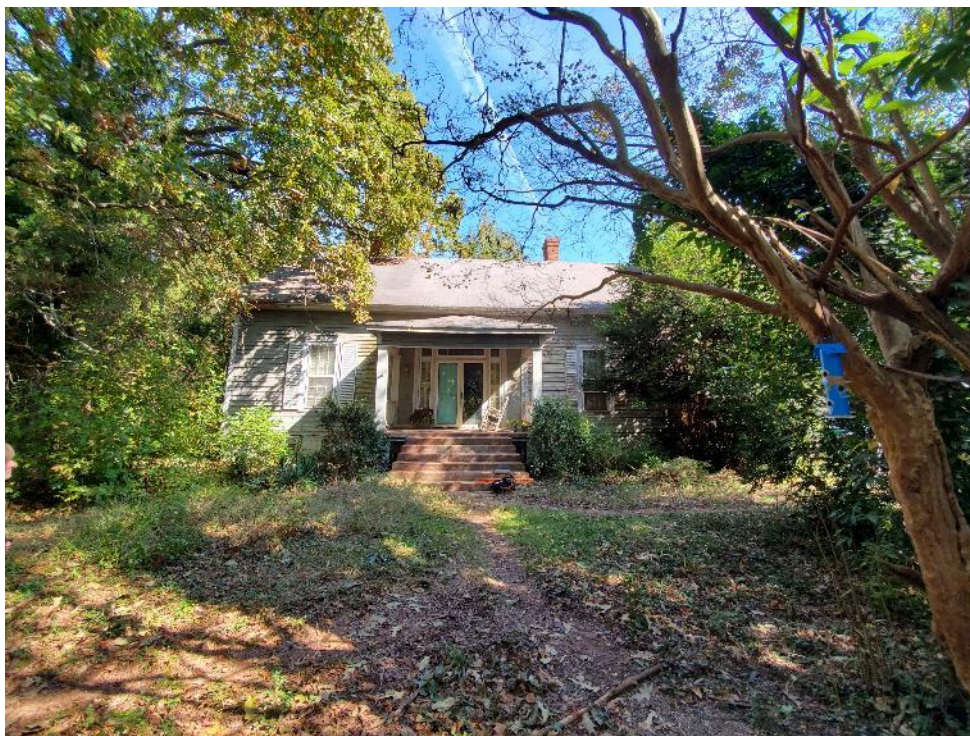
Photograph 4: View of south elevation.

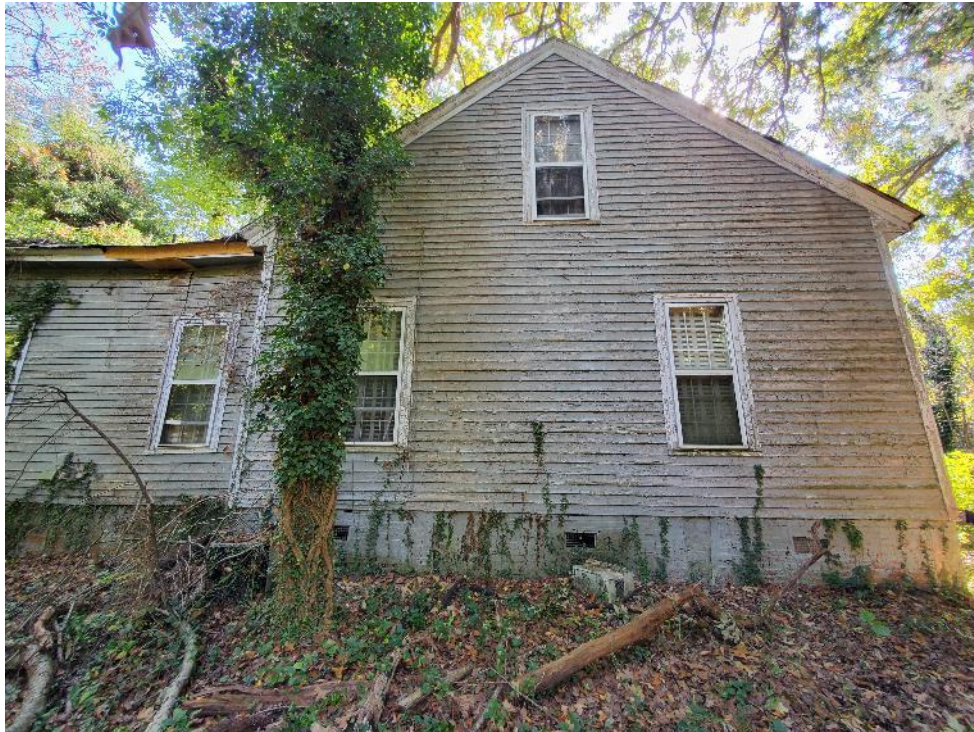
Photograph 5: Partial view of west elevation.

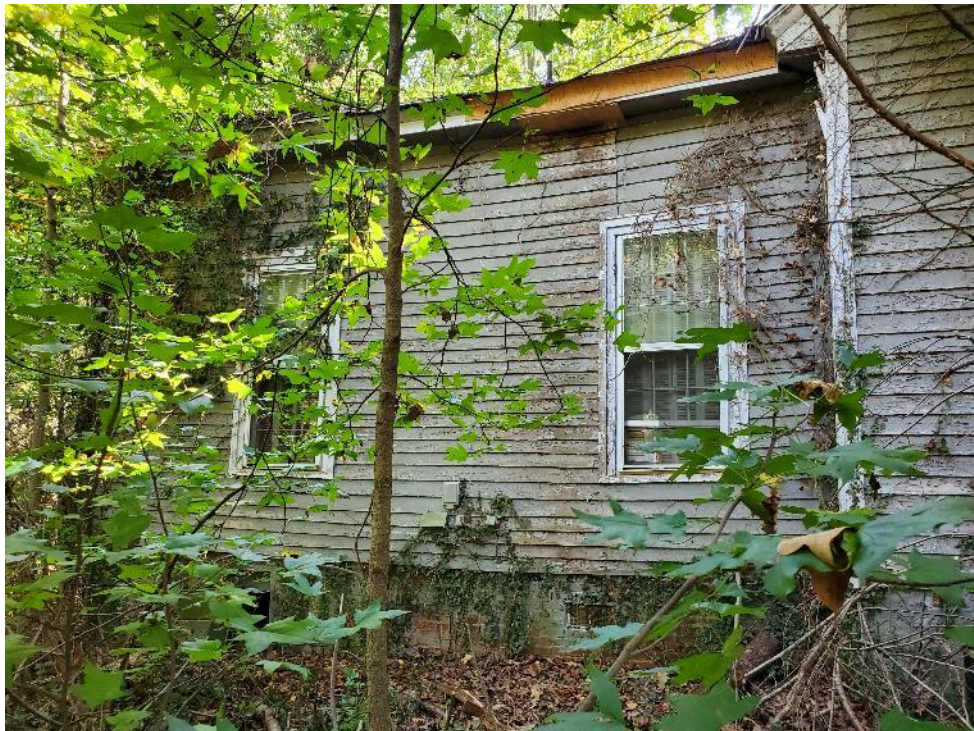
Photograph 6: Partial view of west elevation.

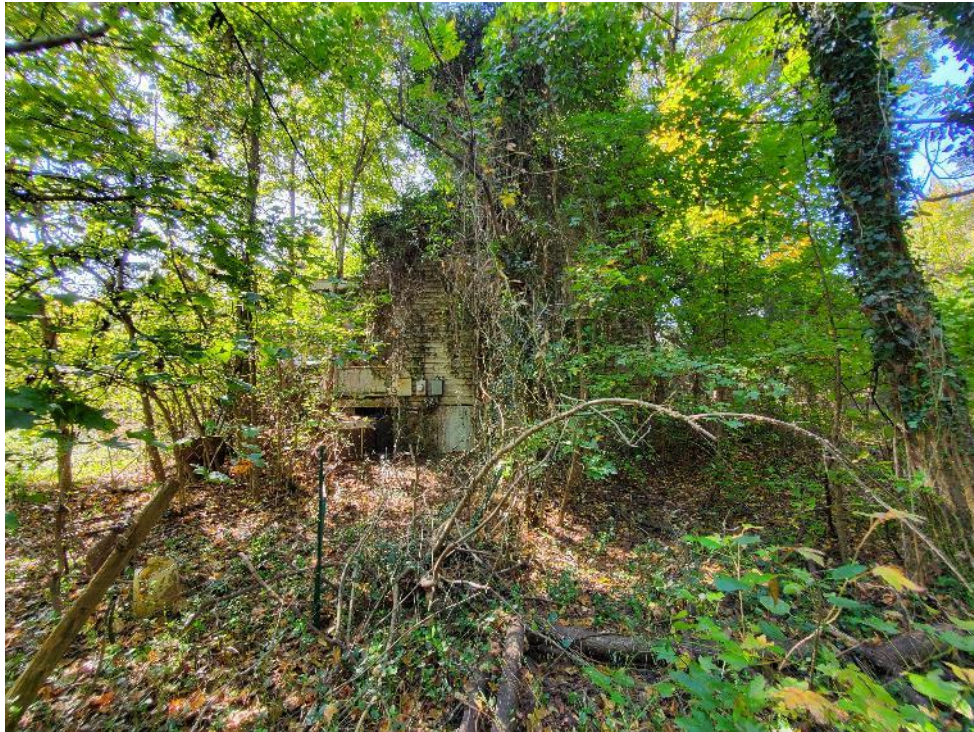
Photograph 7: View of north elevation.

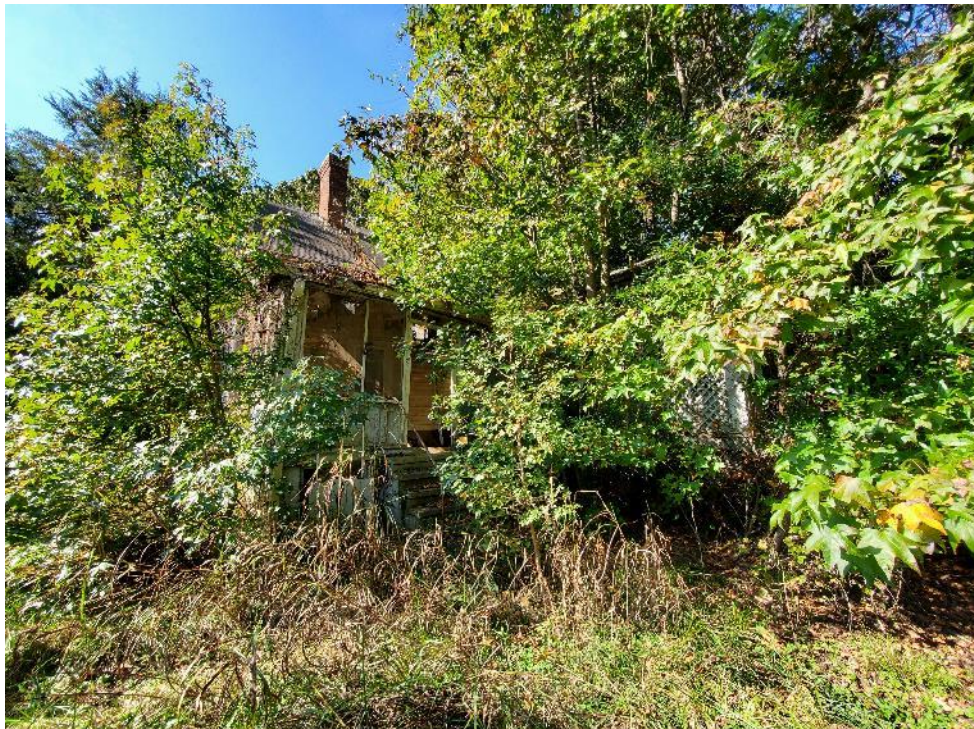
Photograph 8: Partial view of north and east elevation from the northeast direction.

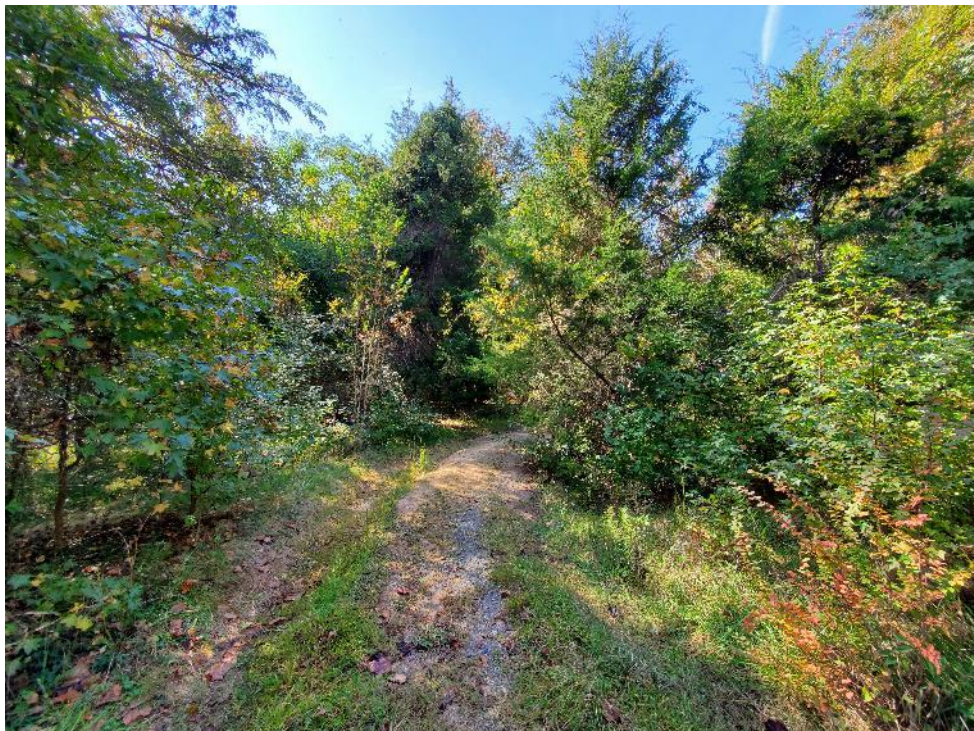
Photograph 10: Representative view of driveway as seen from parking area.

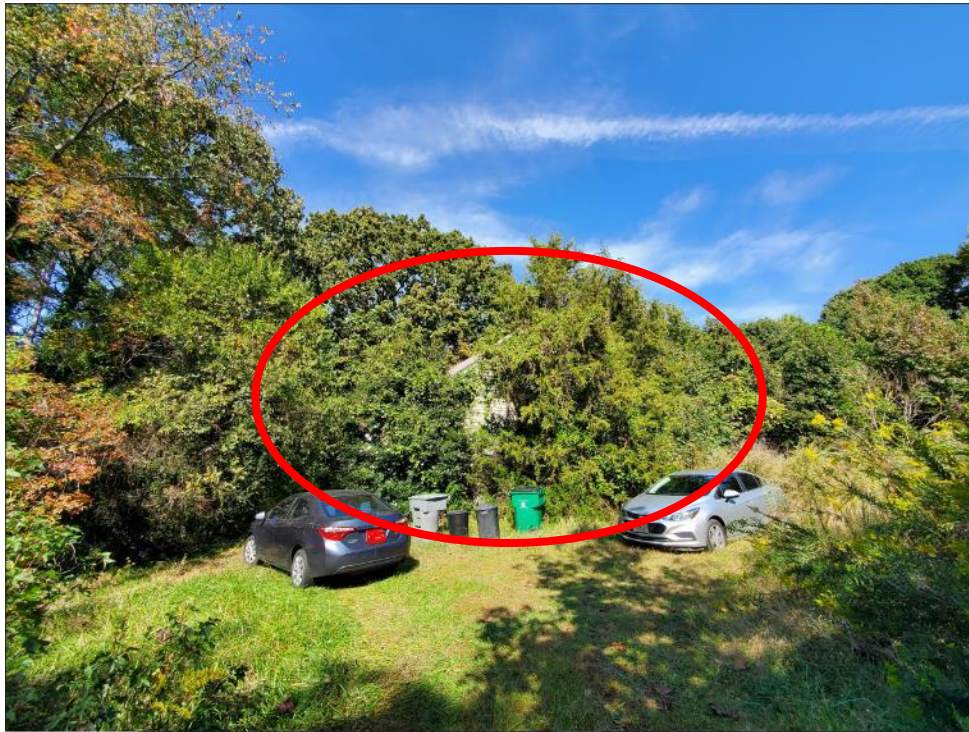
Photograph 11: View of the parking area to the southeast of the residence. Residence is highlighted with an oval.

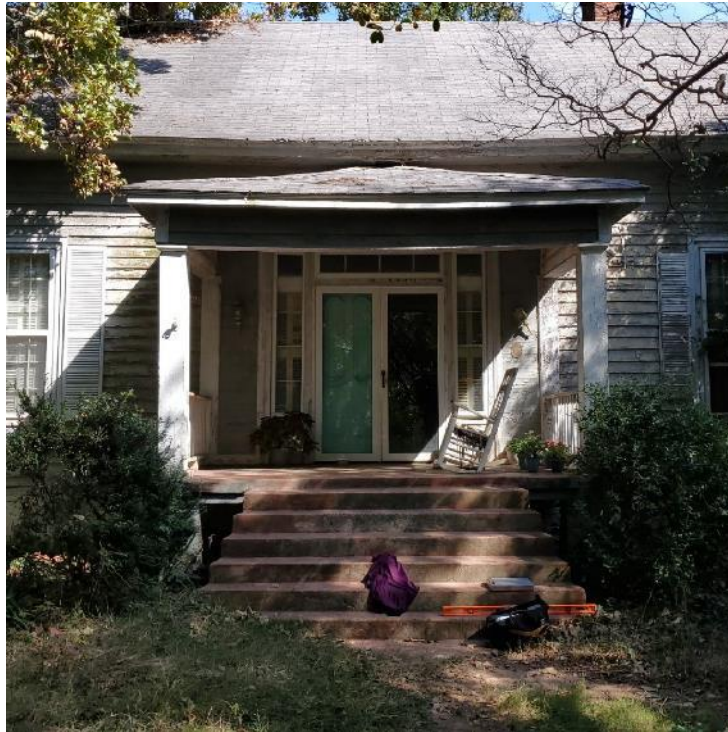
2. The elevated CIP concrete front porch slab was noted to bear on the brick masonry infill between the mass stone piers along the south elevation. The brick infill was noted to be one (1) wythe thick at the porch bearing location. The brick infill in proximity to the front porch bearing was observed to lean away from the residence. The exposed side of the brick was painted (**Photos 15 through 19**).

Photograph 15: Representative view of front porch.

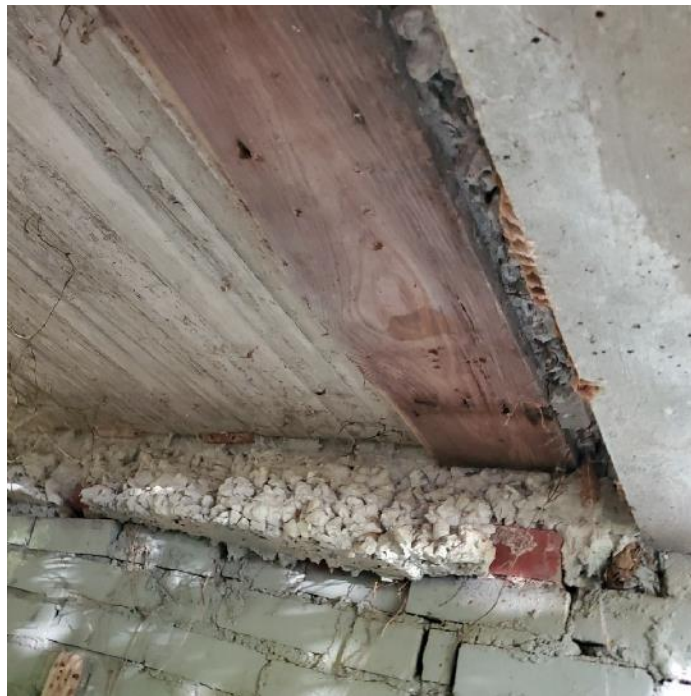
Photograph 16: View of front porch CIP concrete slab bearing on brick masonry infill.

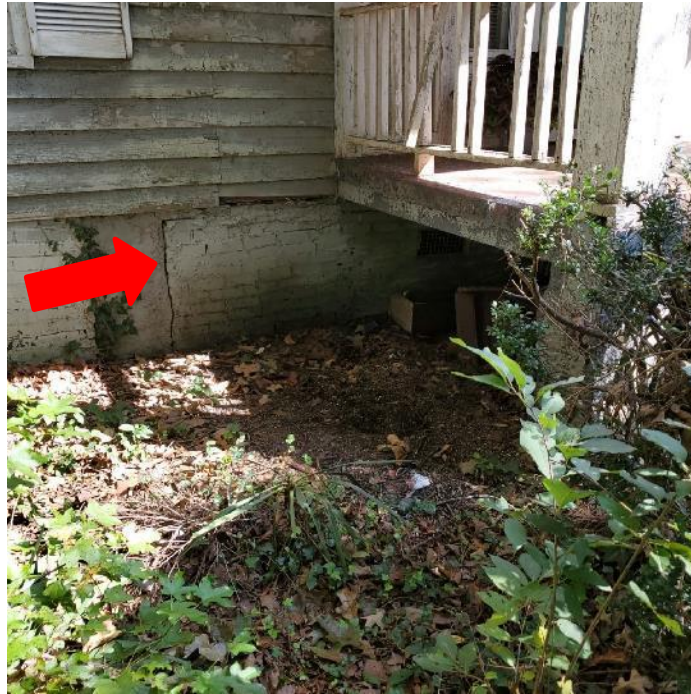
Photograph 17: View of vertical displacement of brick infill adjacent to the front porch (arrow).

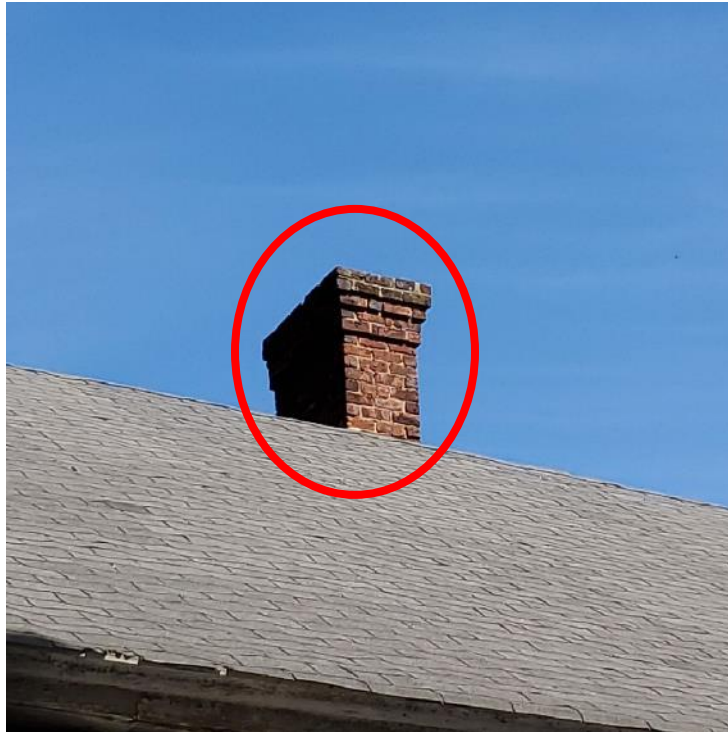
5. The interior chimney at the eastern portion of the residence appeared to have weathered mortar joints above the roof level (**Photo 23**).

Photograph 23: View of chimney above roof level (oval).

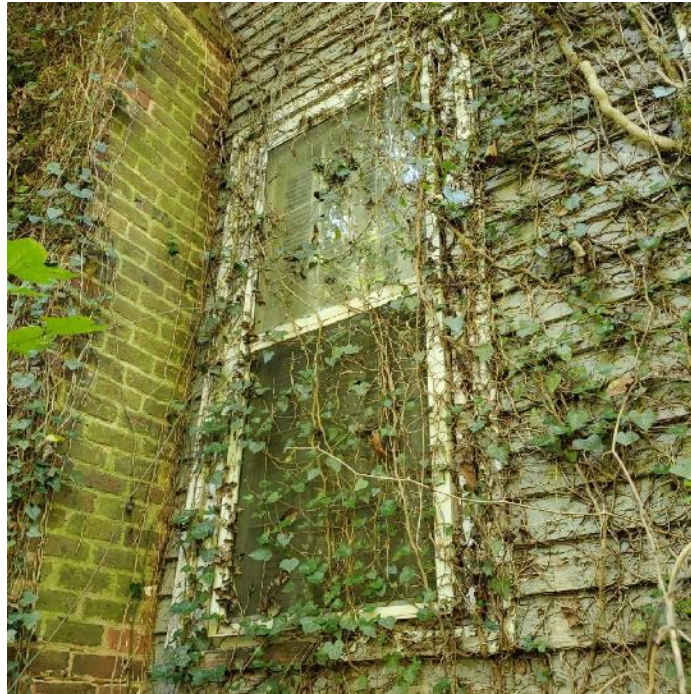
8. Secondary hung window covers were installed outboard of the original single-pane windows. The window covers were newer construction (**Photo 27**).
9. The roof and floor of the L-shaped porch along the east elevation of the rear portion of the residence and along the north elevation of the main portion of the residence had collapsed (**Photos 28 and 29**).

Photograph 27: Representative view of secondary hung window covers installed outboard of the original single-pane windows.

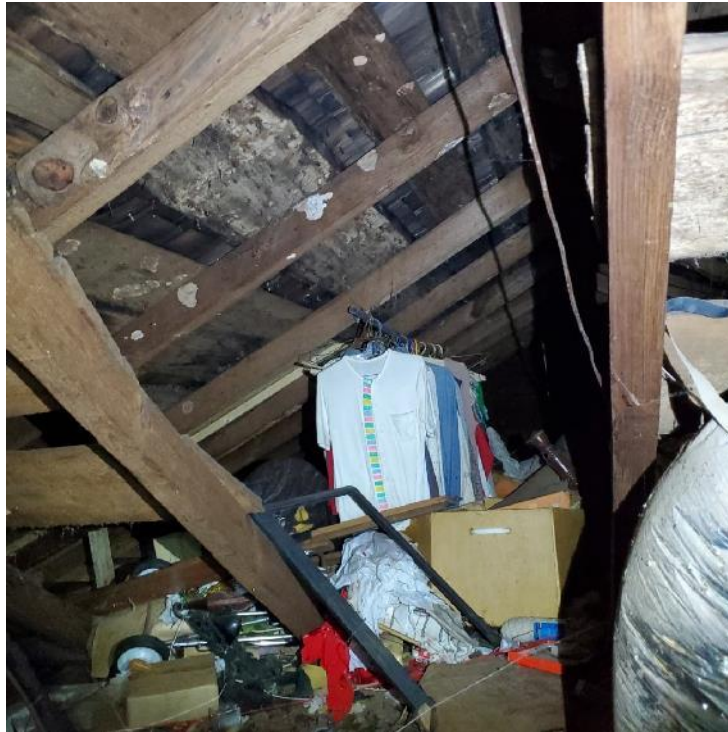
11. The attic space above the transition from the main to the rear portion of the residence was used for storage (**Photo 37**). Water-related staining was noted on the roof deck boards at the overframing for the rear portion of the structure (**Photo 38**).

Photograph 37: View of storage in attic space at original to rear portion transition.

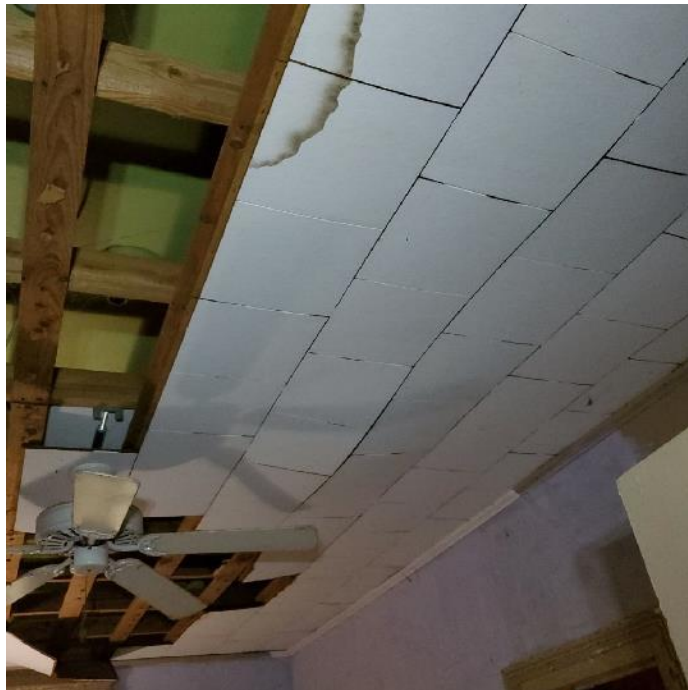
14. A portion of the interior ceiling finishes at the southeast corner of the main portion of the residence had failed (**Photo 43**).
15. A lower ceiling below the original ceiling was constructed in the room located at the northwest corner of the main portion of the residence (**Photo 44**). A lower ceiling below the original ceiling was constructed in the rear portion of the residence.

Photograph 44: Representative view of ceiling below original ceiling.

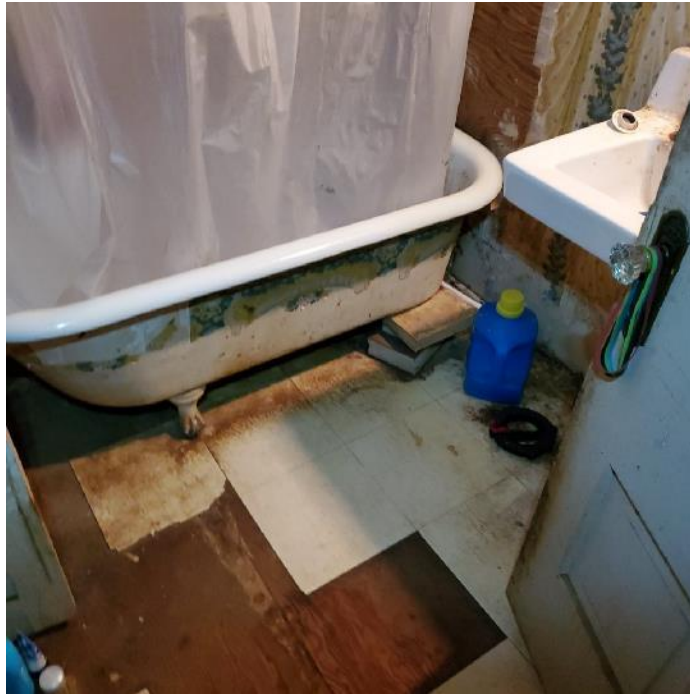
16. A bathroom that appeared to be an addition to the main portion of the structure was observed at the southwest corner of the L-shaped porch (**Photo 45**). A gap was noted between the ceiling finishes and ceiling trim at the southeast corner along the east elevation interior wall (**Photo 46**). The wallpaper at the southeast corner was torn and appeared to be sheared from downward movement (**Photo 47**).

Photograph 45: Representative view of bathroom addition at corner of L-shaped porch.

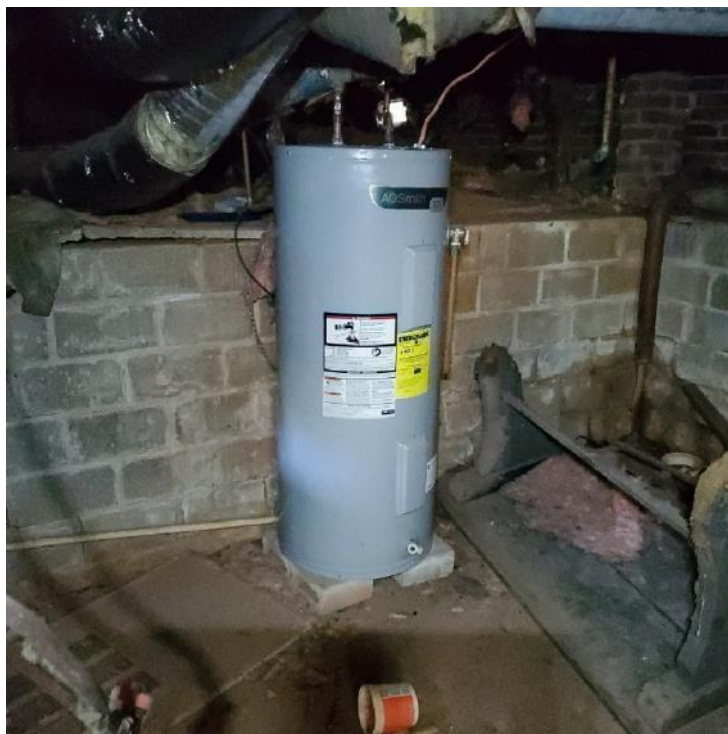
18. The rear portion of the crawlspace was at a lower elevation to provide room for an HVAC system and a water heater (**Photo 52**). A perimeter CMU retaining wall provides the change in elevation at this portion of the crawlspace. Horizontal and step cracking, along with out-of-plane vertical displacement was observed at multiple locations along the CMU retaining wall (**Photos 53 through 55**).

Photograph 52: View of lowered crawlspace floor in the rear portion of the crawlspace.

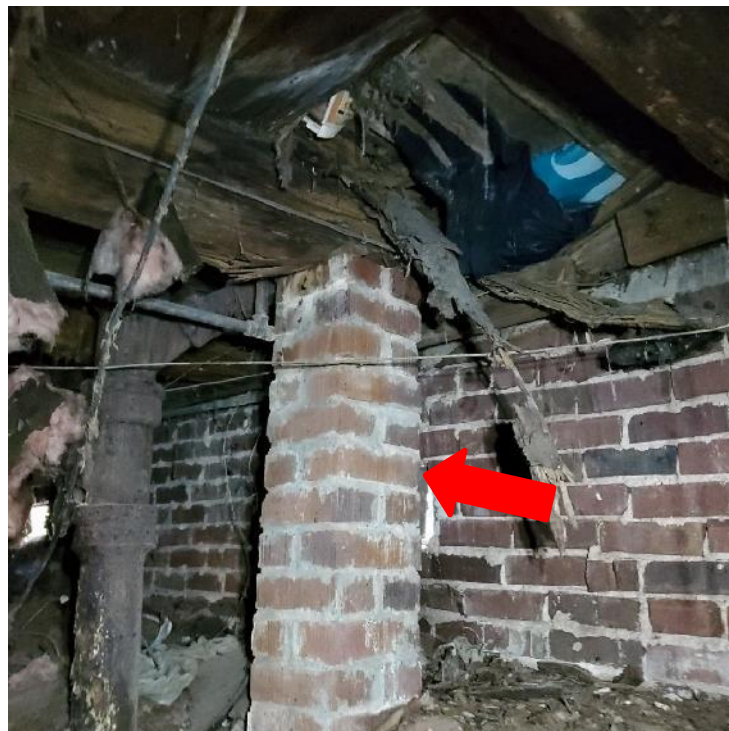
19. A brick pier was observed along the west elevation within the rear portion of the residence (**Photo 56**).
20. A view of the south elevation elevated CIP Concrete front porch slab bearing along the brick masonry infill is provided in **Photo 57**.

Photograph 56: View of brick masonry pier in crawlspace (arrow).

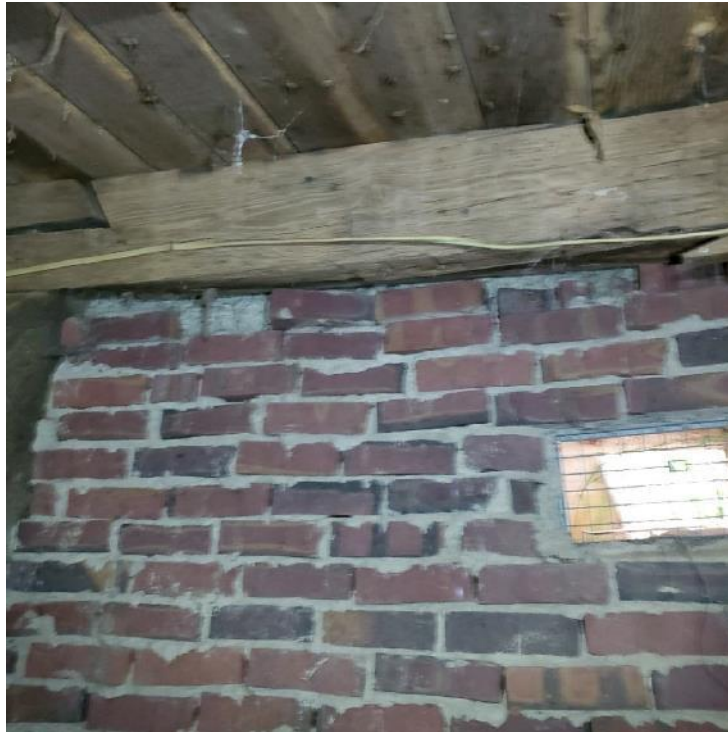
Photograph 57: View of front porch bearing along infill brick masonry wall.

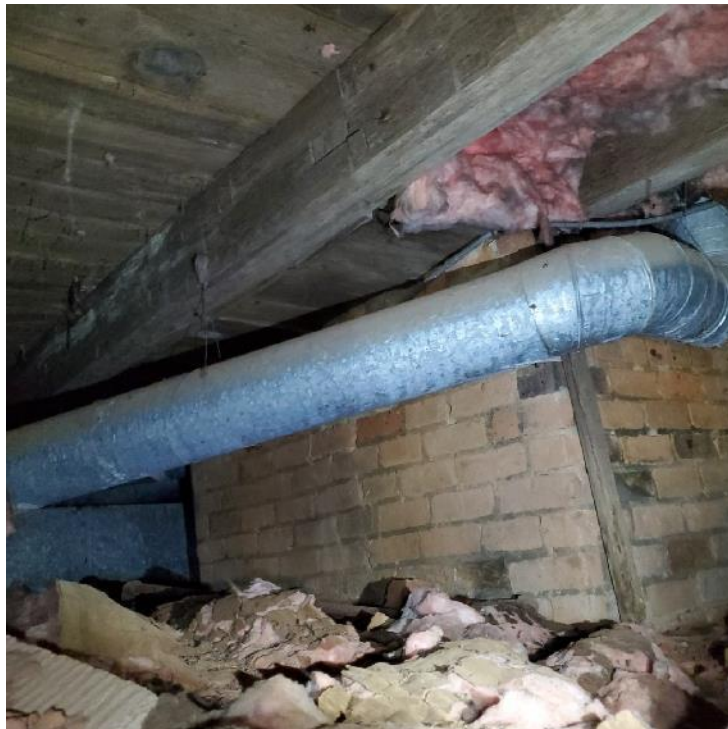
21. The floor framing was observed to bear on the interior chimney brick masonry at the west end of the original portion of the residence (**Photo 58**).

Photograph 58: View of floor framing at interior chimney.

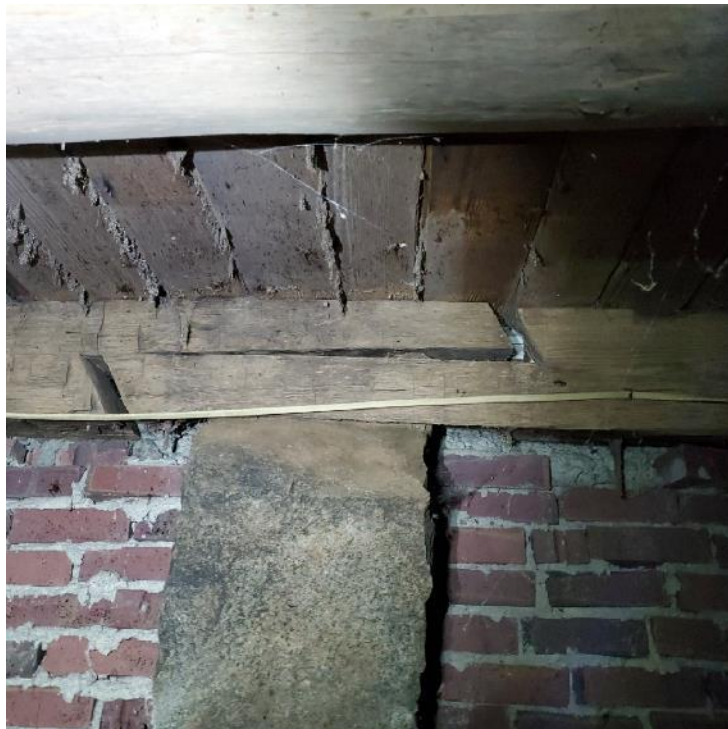
22. Multiple joist members were observed to have cracking extending from the notch at the girder bearing location (**Photo 59**).
23. Potential movement was observed at multiple girder lap joints (**Photo 60**).

Photograph 60: View of potential movement at girder lap splice.
