PROPERTY CONDITION ASSESSMENT

EXCELSIOR CLUB
921 BEATTIES FORD ROAD
CHARLOTTE, NORTH CAROLINA

ECS PROJECT NO. 48:4336

JULY 9, 2025

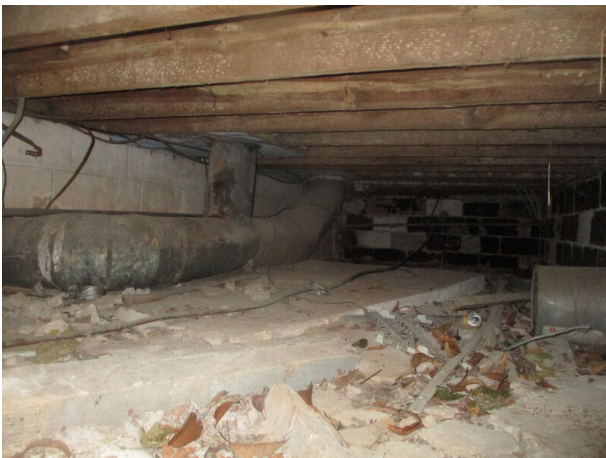
Crawl space

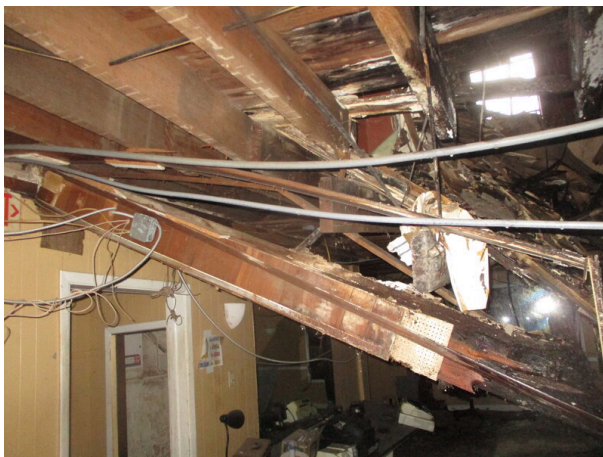
Collapsed framing

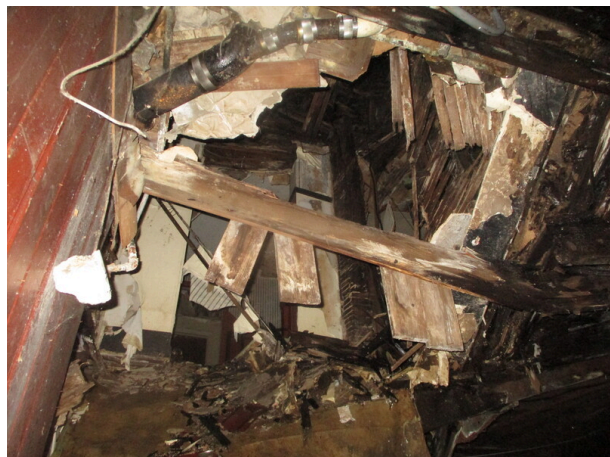
Collapsed framing

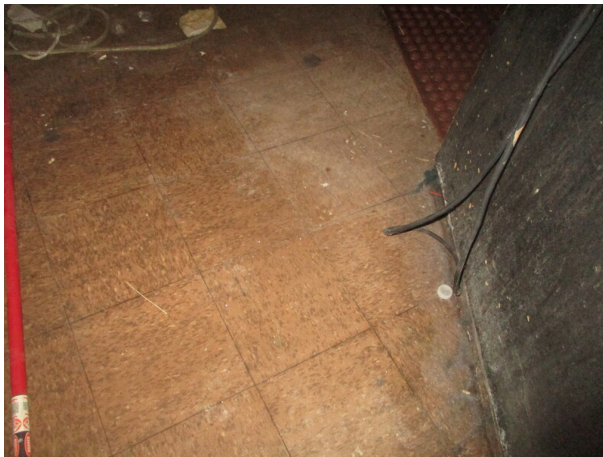
In addition to significant structural damage, water intrusion into the building has been considerable over an extended period of time, and active intrusion was occurring during our site visit. Although an environmental assessment was excluded within our scope of services, we observed apparent microbial growth at multiple locations on ceiling surfaces, along with older 9x9 floor tile that in most cases has been known to contain asbestos.

Apparent 9x9 floor tile

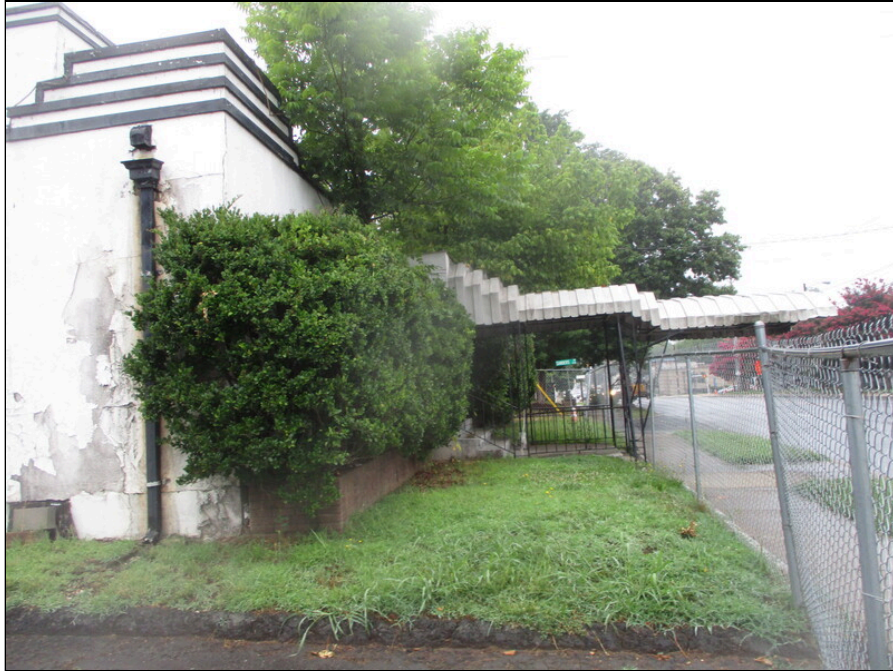
5 - Front awning and perimeter fencing

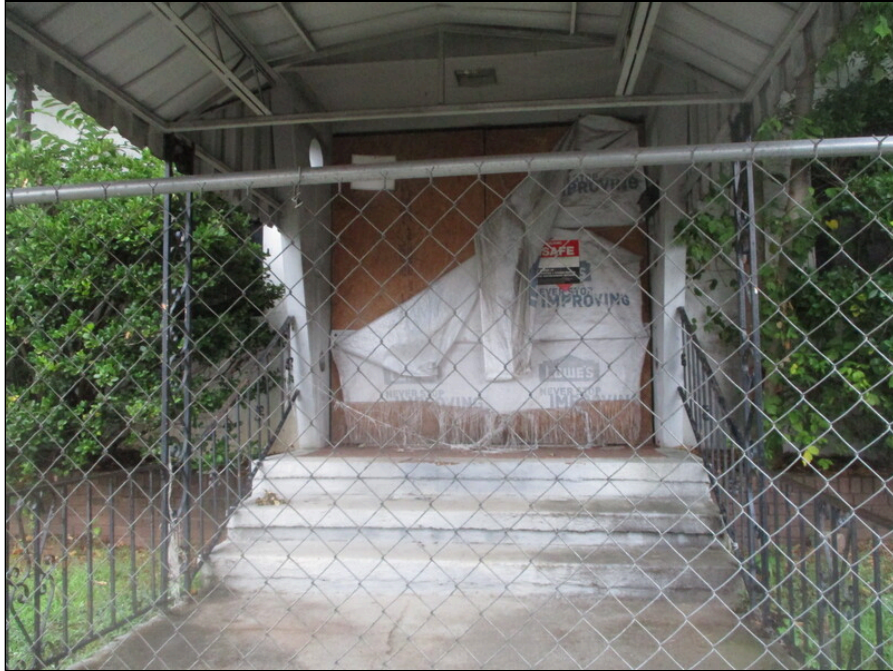
7 - Boarded up main entrance

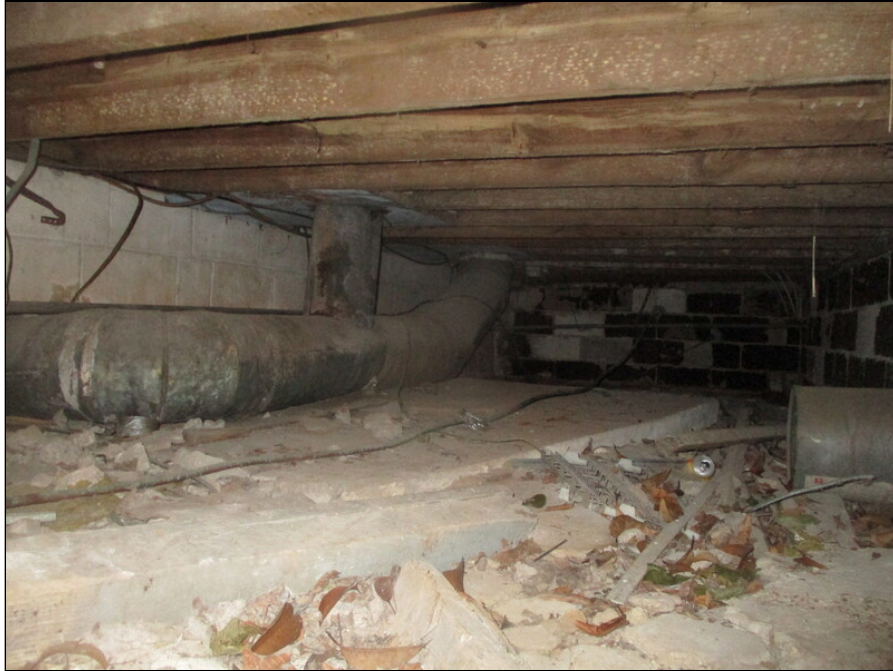
17 - Crawl space

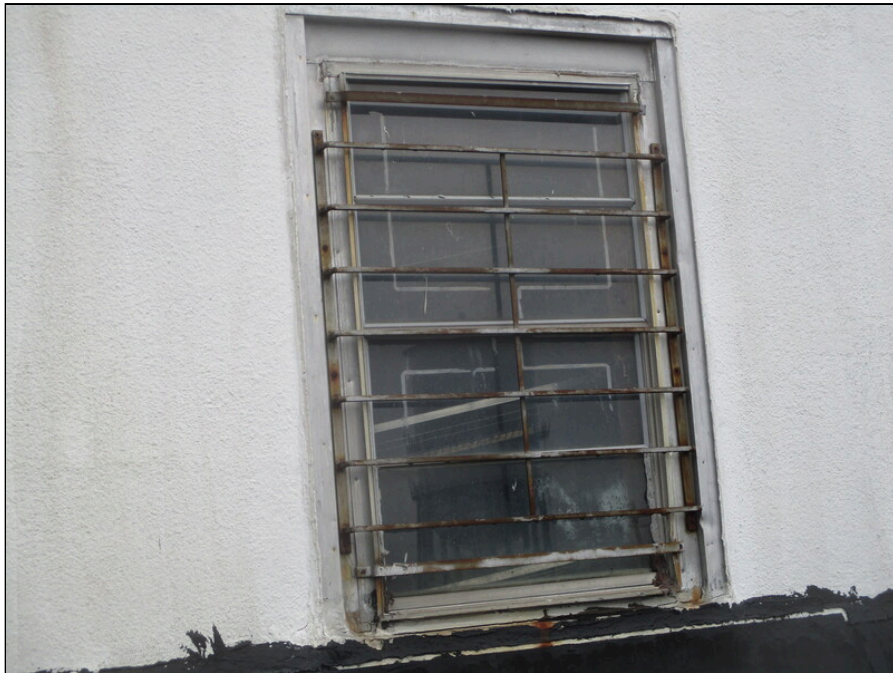
18 - Typical window with bars

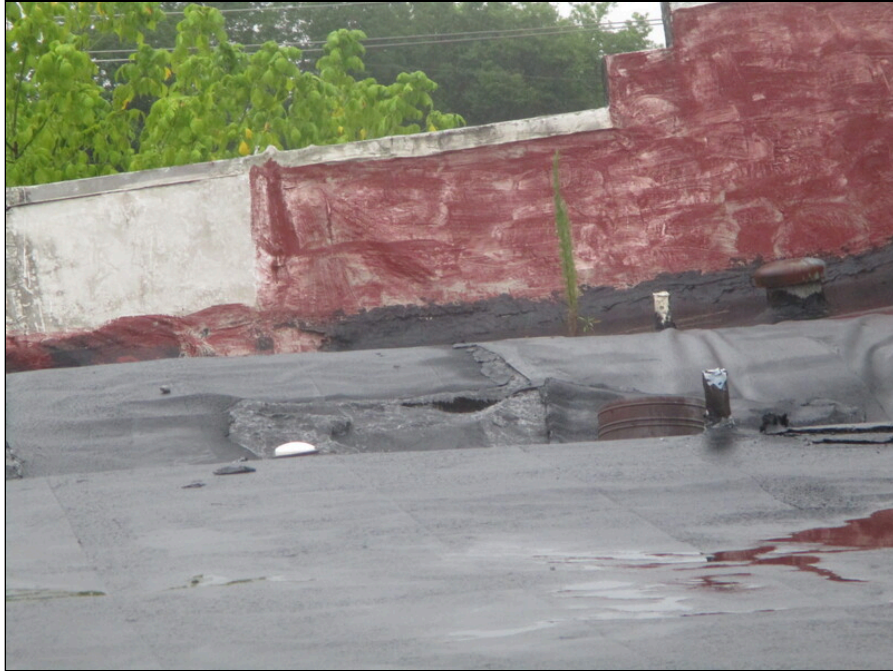
Roof - apparent roof collapse was observed from the roof level (second floor vantage point was inaccessible), resulting in severe cratering/ponding on the roof and a skewed front parapet wall.

23 - High roof apparent partial collapse, note the sloped front parapet

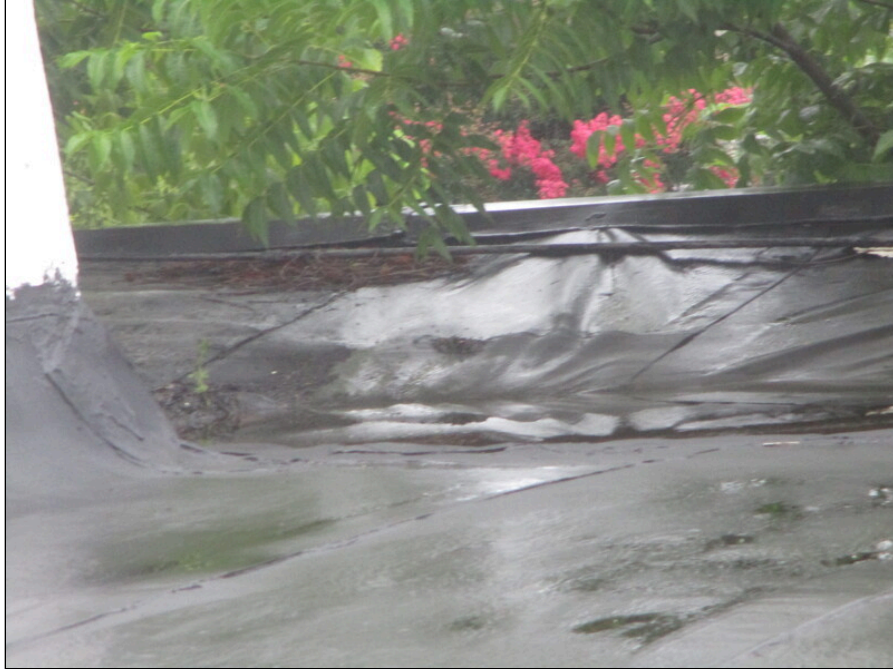
25 - Low roof apparent collapse area

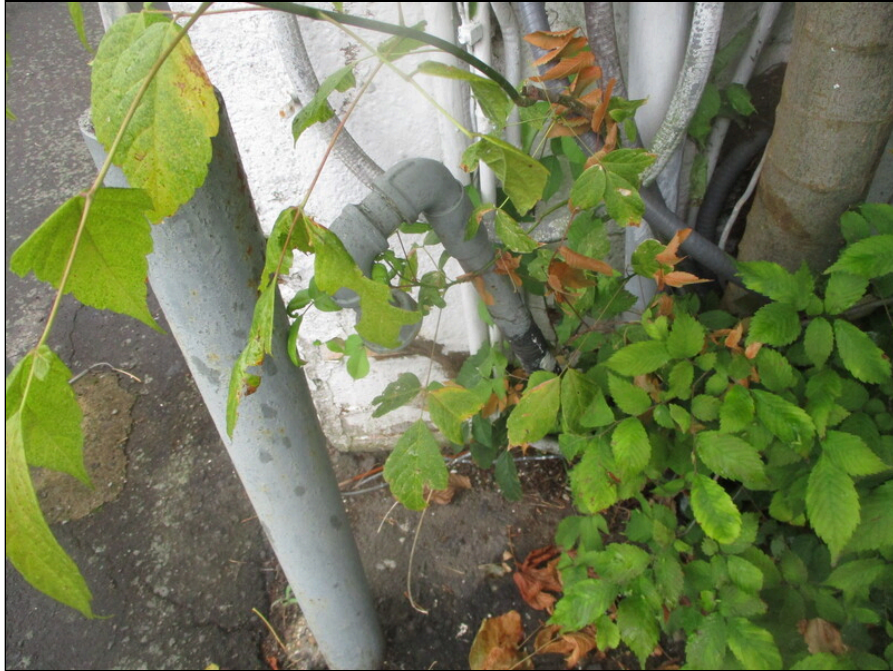
27 - Gas meter removed

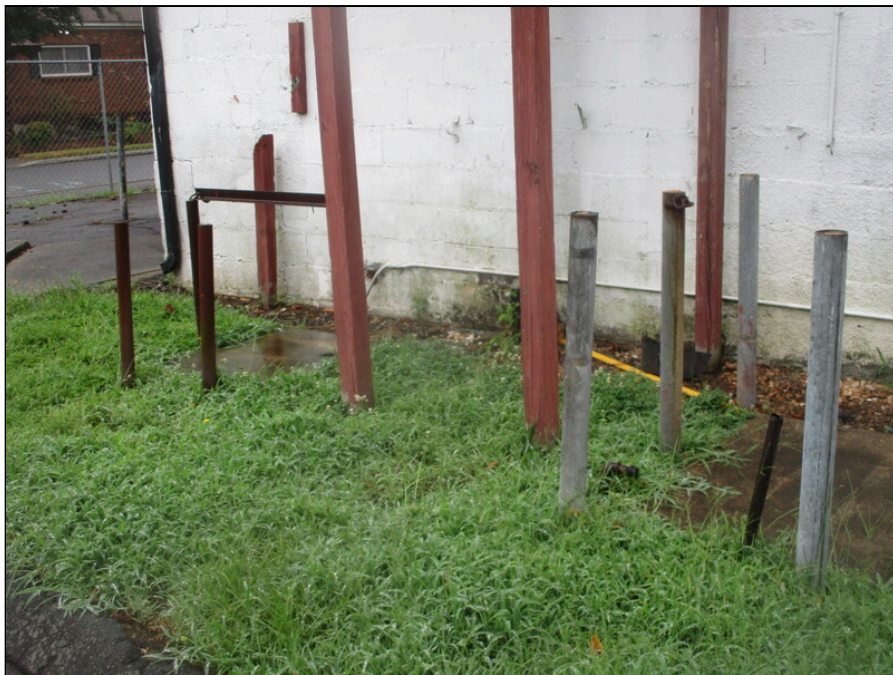
28 - Location of previous condensing units

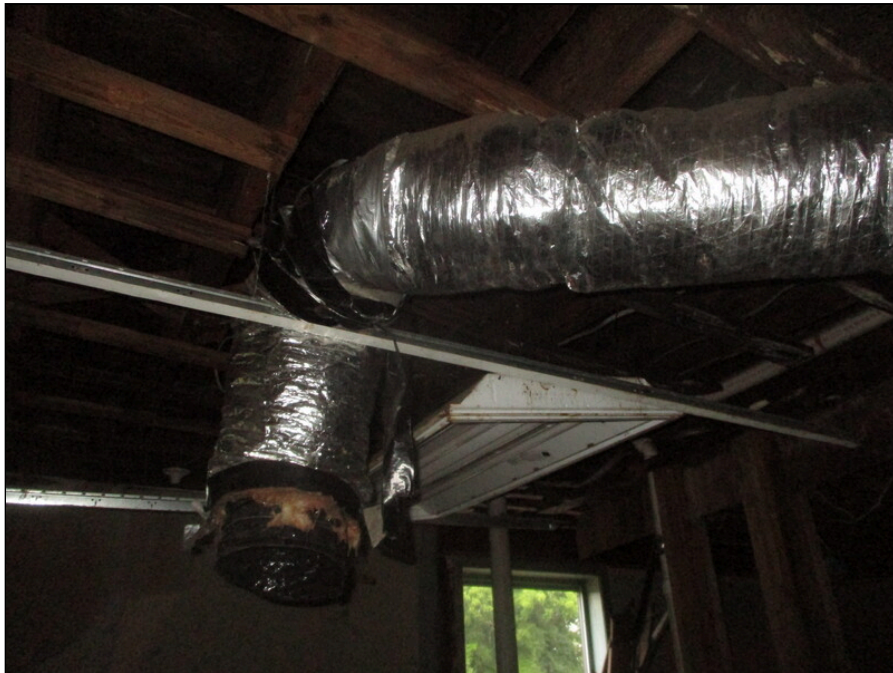
30 - Ductwork remnants

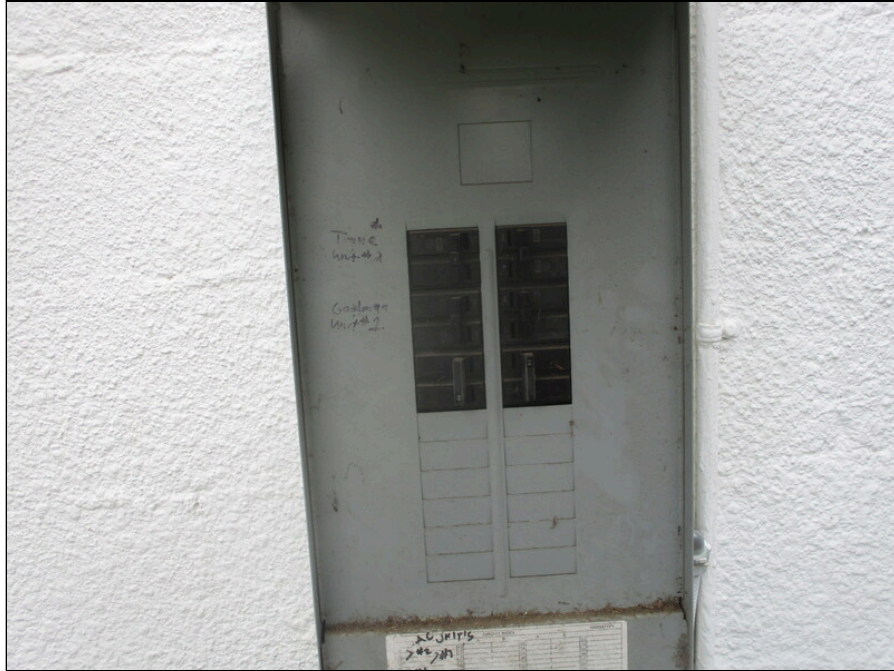
33 - Electrical panel on west exterior wall, circuits for previous condensing units

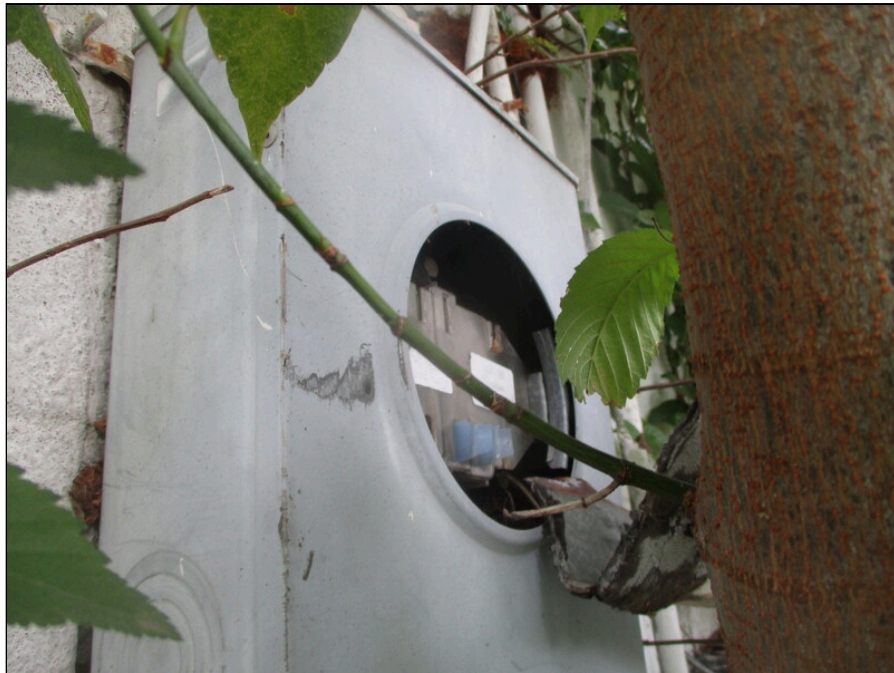
34 - Electric meter removed

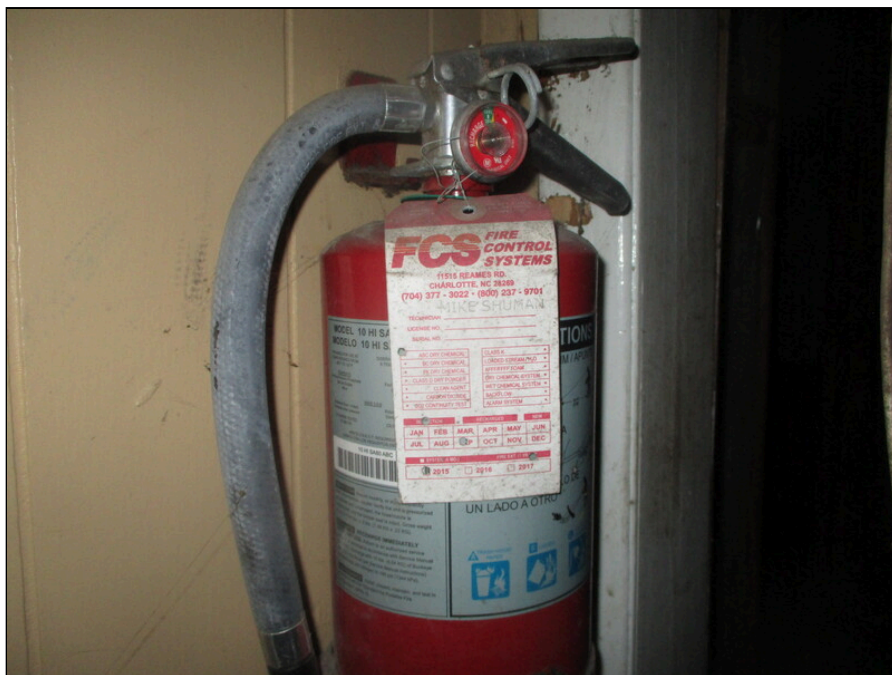
36 - Fire extinguisher, last inspected in 2015

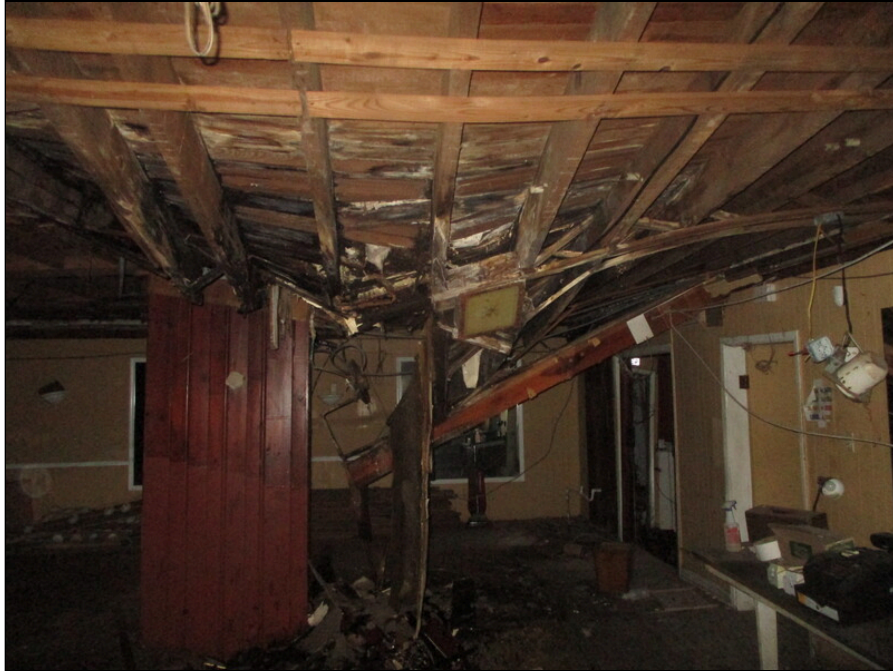
Second Floor - the second floor was inaccessible due to the collapse of the central stairway. In addition, a portion of the second floor framing above the central dance area has failed.

39 - Interior showing partially collapsed second floor

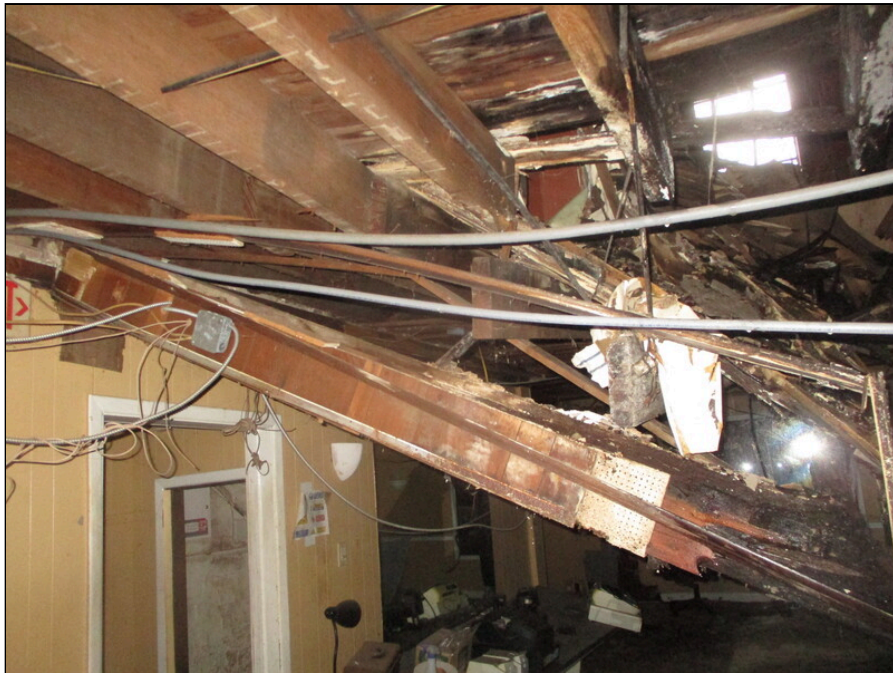
44 - Collapsed framing

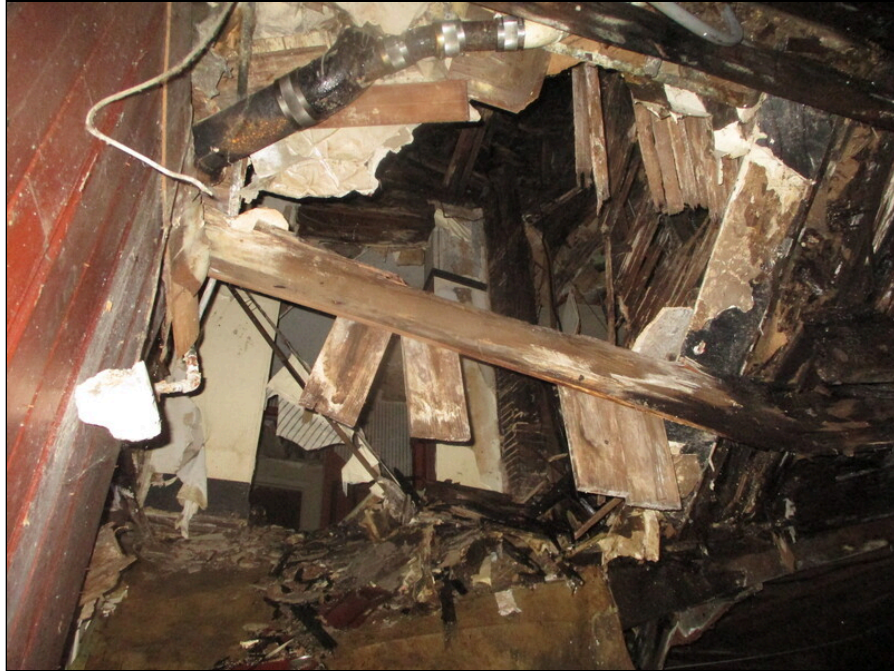
45 - Collapsed framing

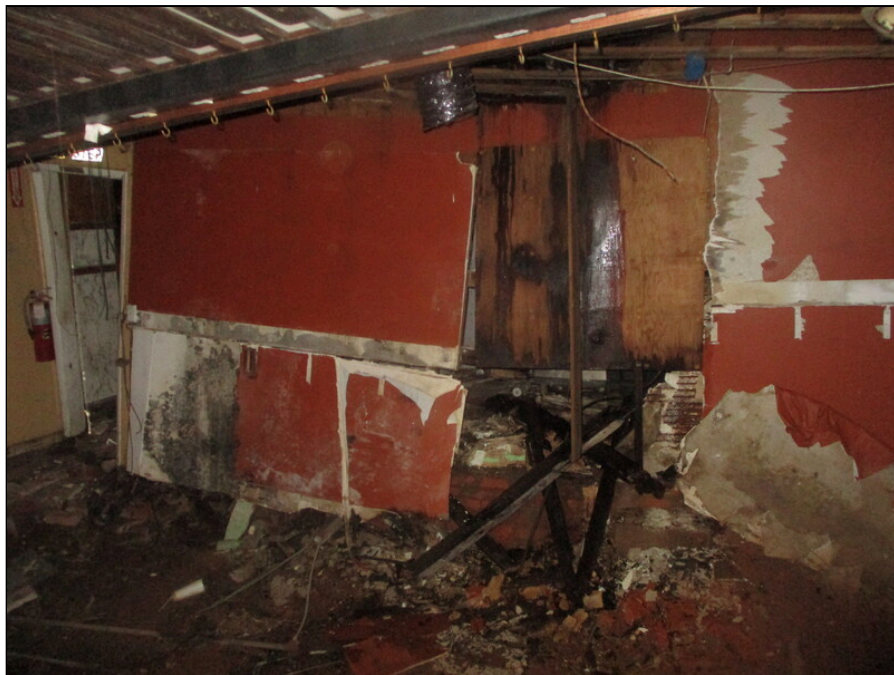
46 - Area of previous demolition

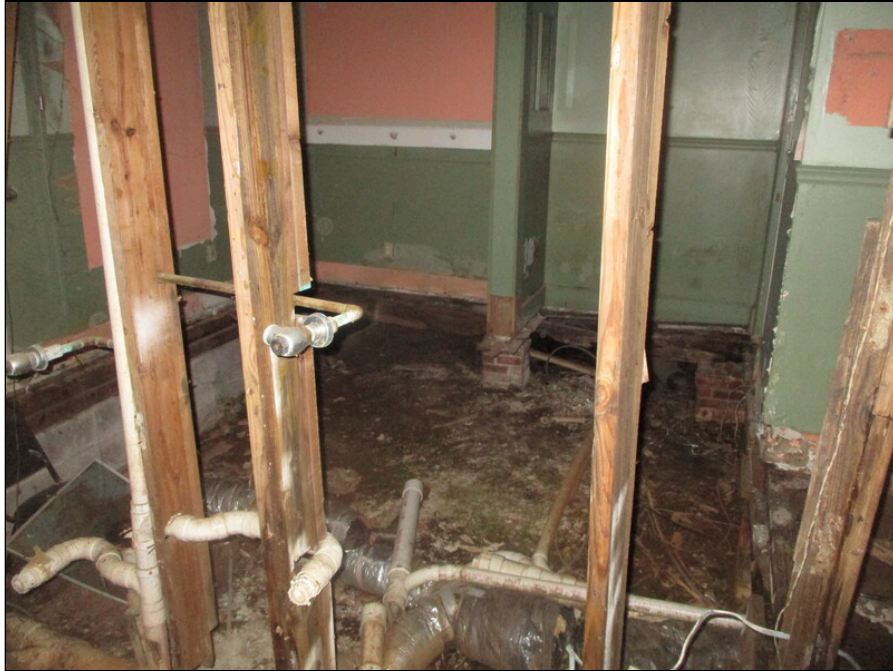
49 - Area of previous demolition

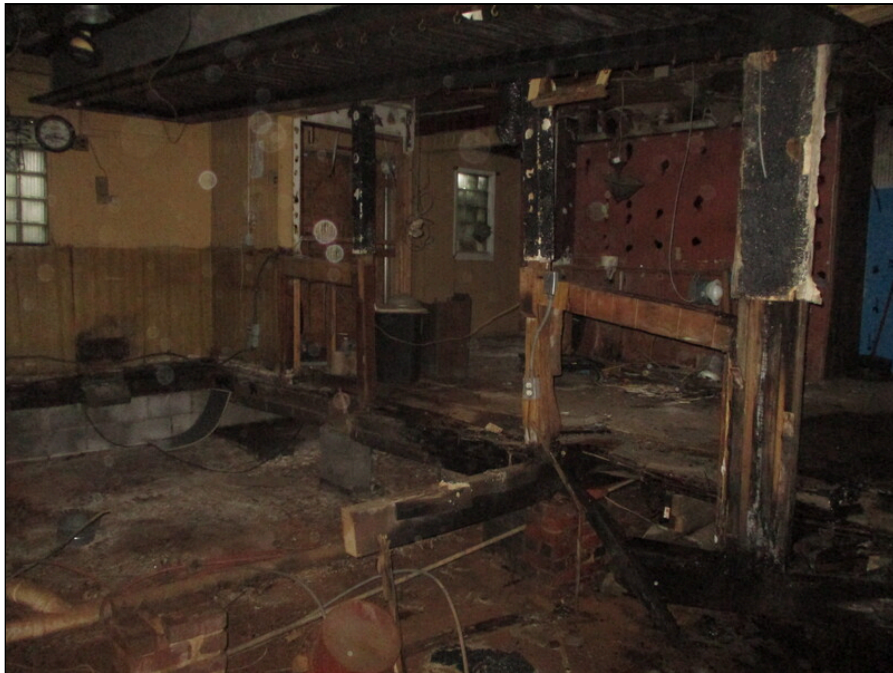
50 - Area of previous demolition

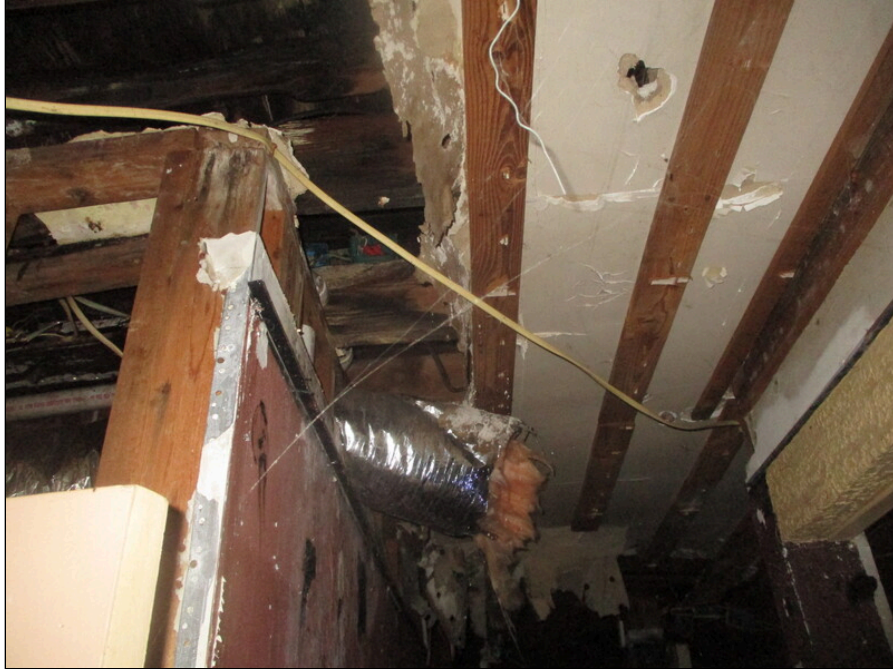
51 - Area of previous demolition

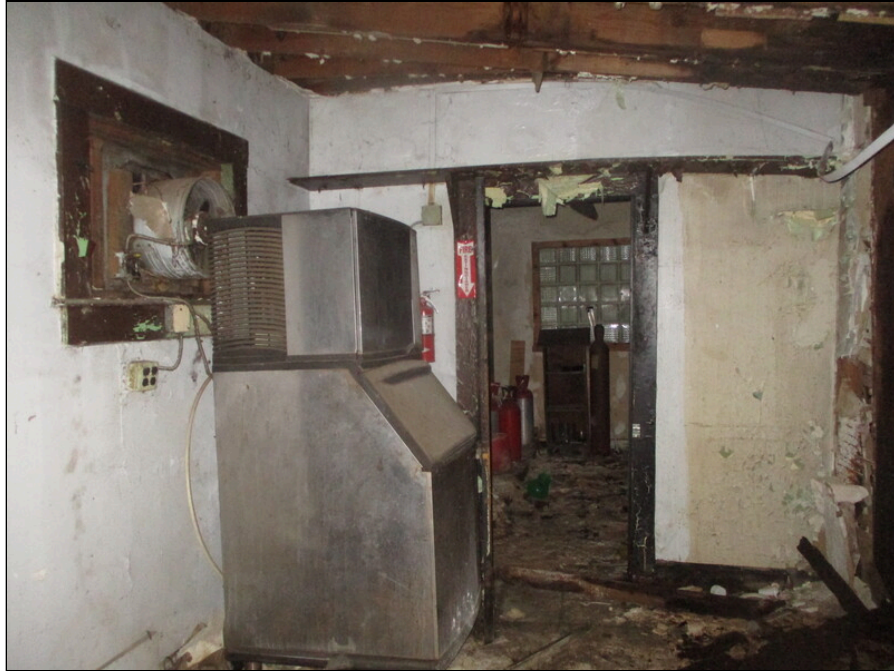
53 - Former kitchen area

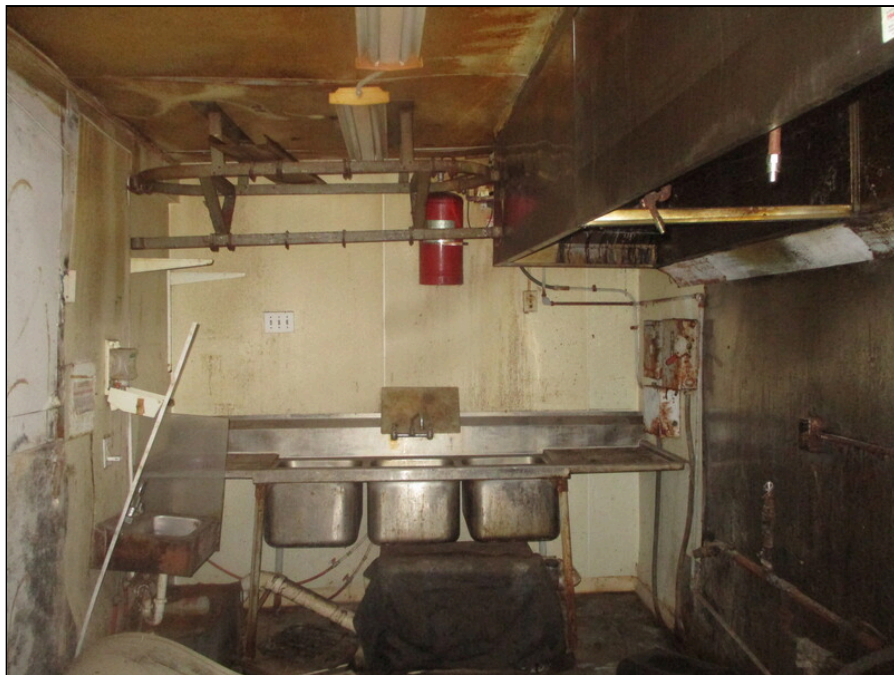
54 - Former kitchen area

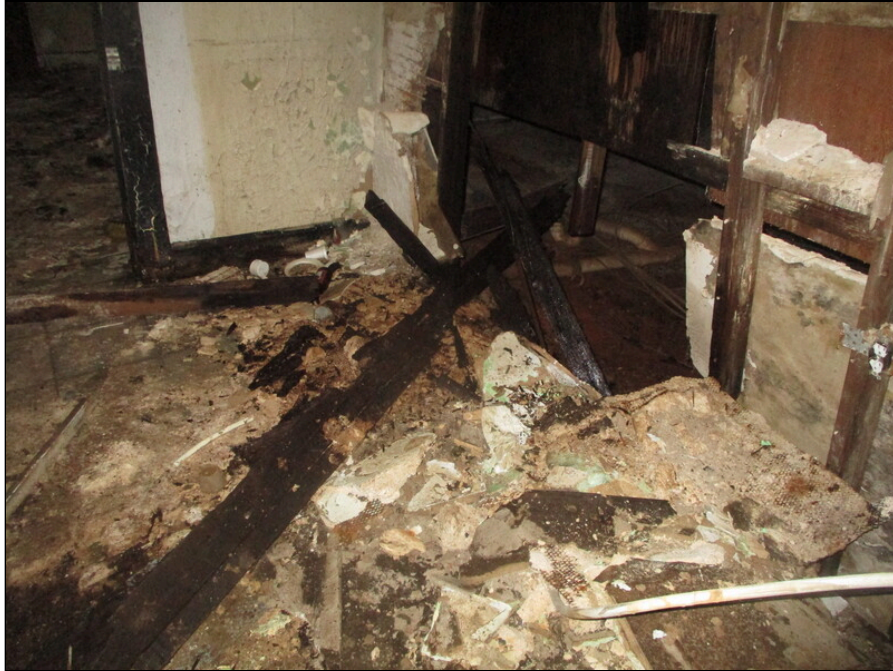
55 - Extensive debris

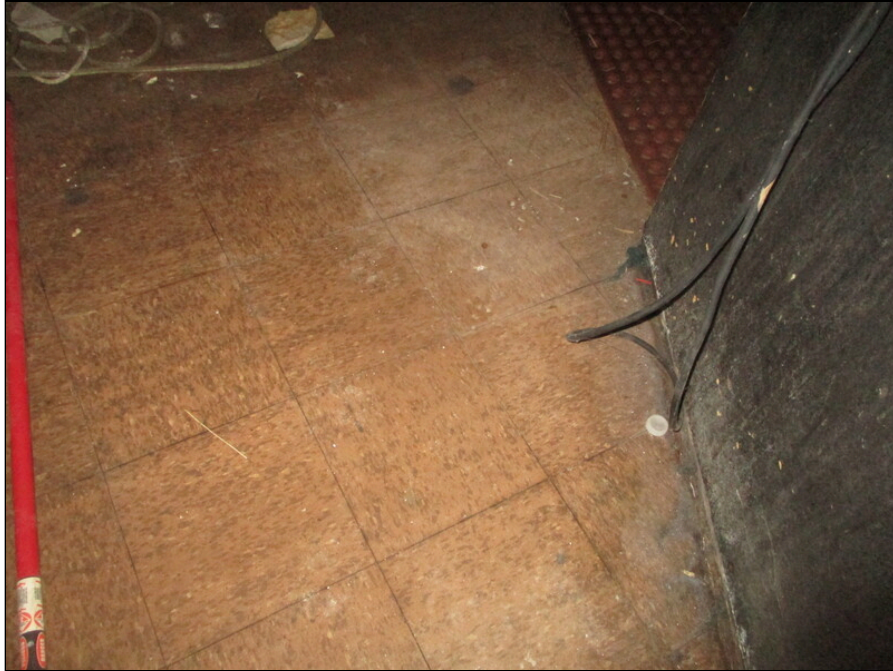
59 - Apparent 9x9 floor tile

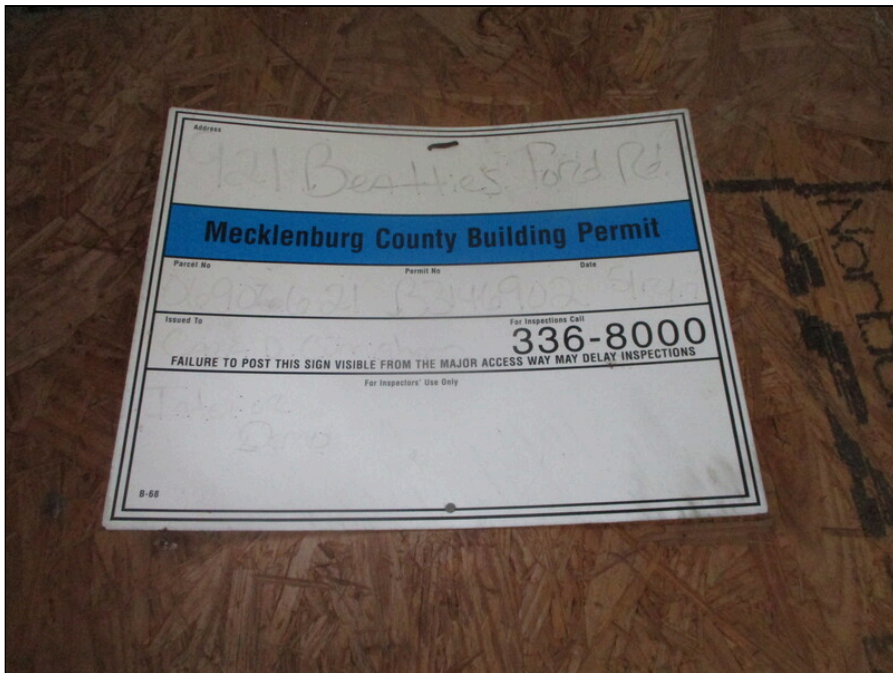
62 - Notice of interior demolition permit from 2017
